Property Inspection Report Exclusively For: Client

PROPERTY INSPECTION REPORT

Report Identification: 2917

Concerning: **Somewhere, Somplace, TX**

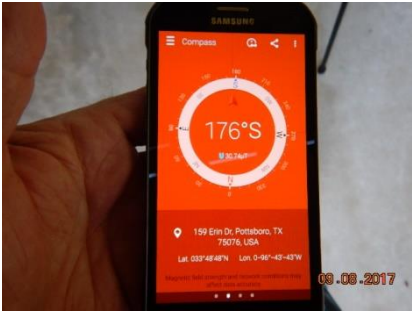
This dwelling faces South.

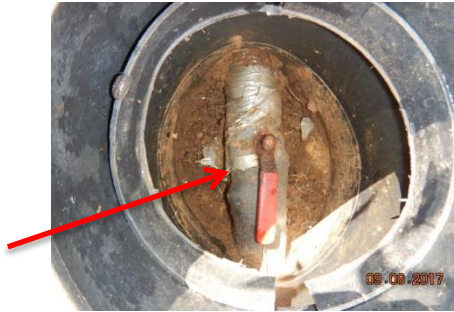
This is the customer shut off valve by the water meter in the front yard.

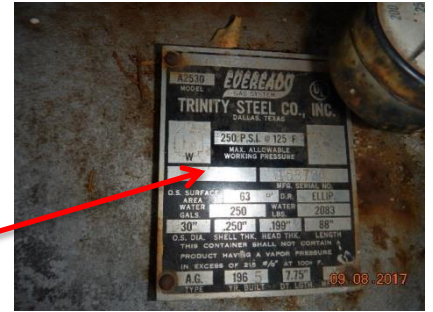
The propane tank ID tag was legible.

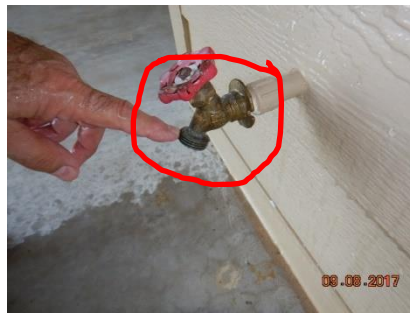
There are two exterior faucets that are missing air gaps.

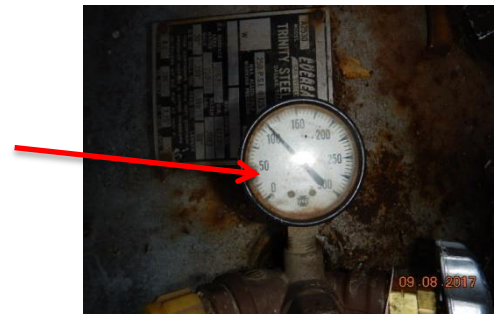
The pressure gauge on the propane tank was working.

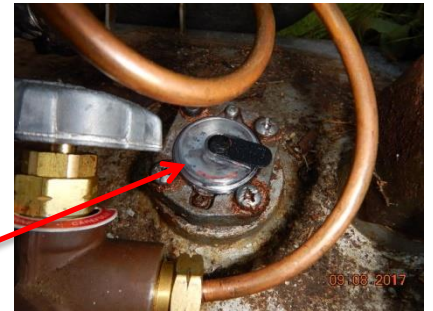
The propane tank has 40% of gas at the time of this inspection.

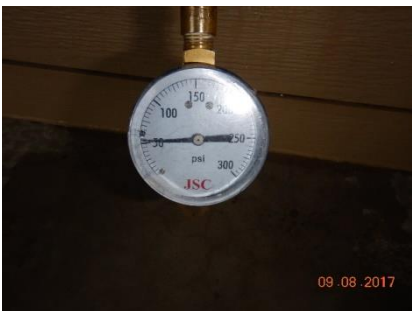
The static water pressure was 55-PSI at the time of this inspection.

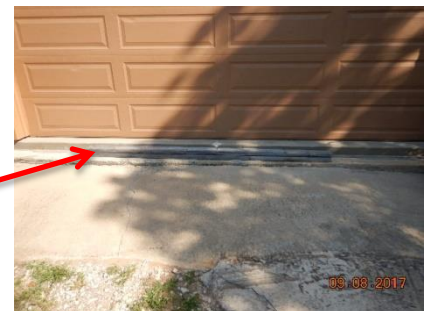
The garage floor to the driveway is missing the apron.

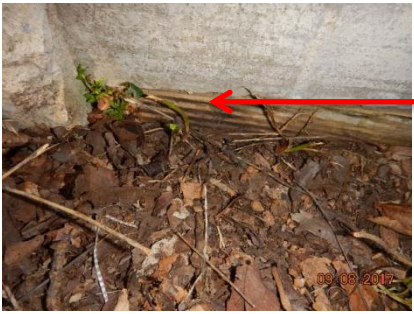
There are form boards imbedded in the foundation along the East side of the foundation.

There are form boards in the foundation on the East side of the foundation.

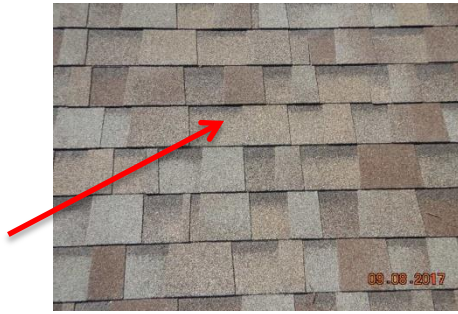
Roof Covering Deficiency Items
 The roof covering was inspected by walking on the roof covering and is a new roof.
 The roof covering is an asphalt laminated composition Timberline® style 30-year style roof covering.

The roof covering is a laminated 30-year roof covering.

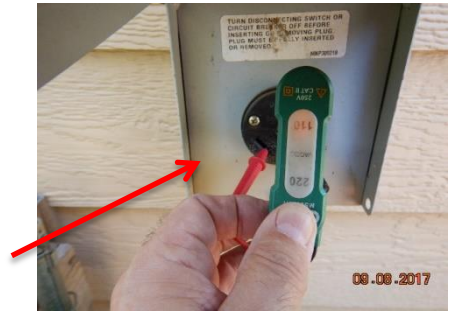
There is an active 30-amp 110v plug at the Southwest exterior corner.

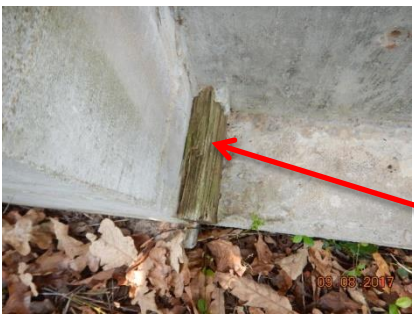
There are form boards in the foundation on the East side of the foundation.

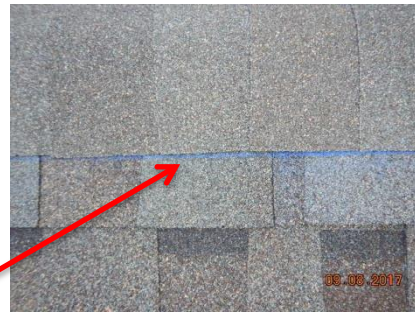
The roof covering has been recently replaced.

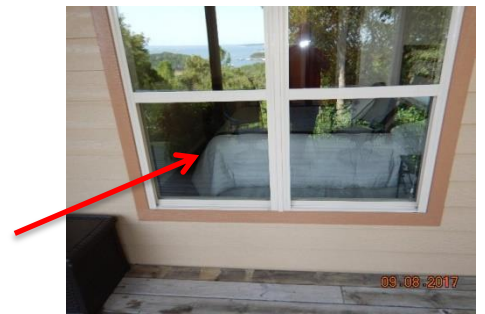
There are windows on the back porch missing screens.

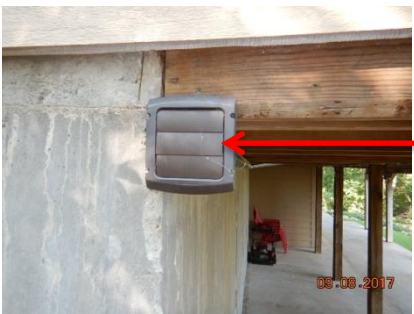
The dryer vented to the East wall.

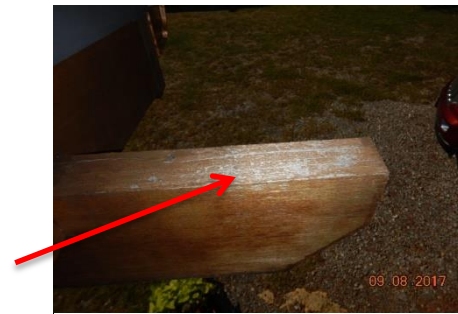
Rafter extension outside the roof edge is missing waterproofing stain.

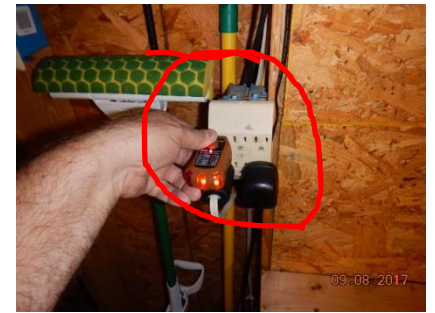
There are some outlets in the garage that are not on a GFCI circuit.

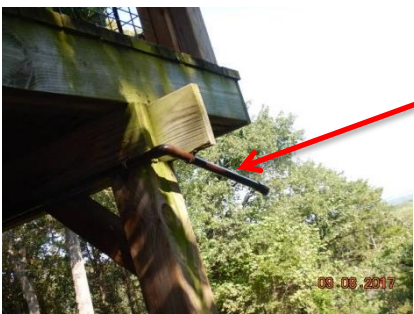
Not sure what this pipe is for.

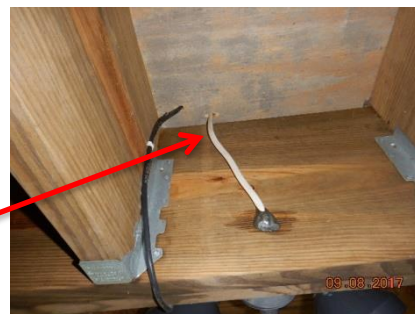
There is exposed romex below the laundry room area floor.

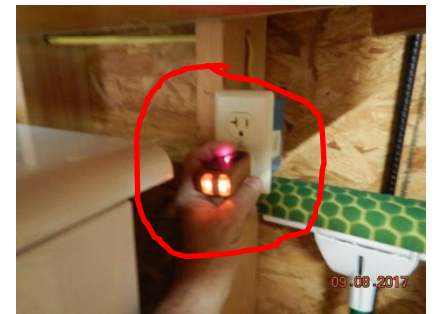
There are some outlets in the garage that are not on a GFCI circuit.

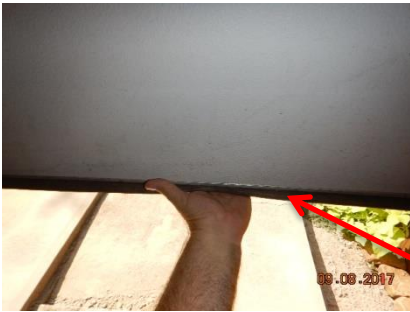
The close tension on the garage door operator is set too high.

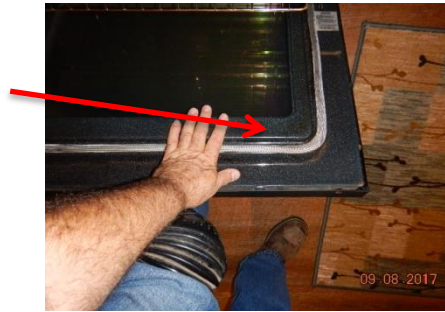
The range is not connected to an anti-tip device.

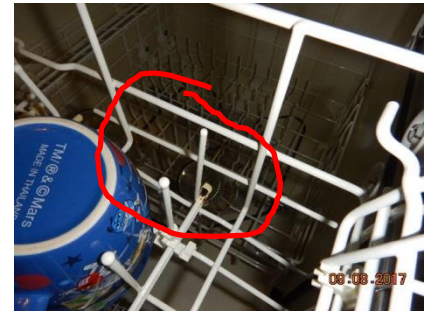
The dishwasher racks have rusted tines.

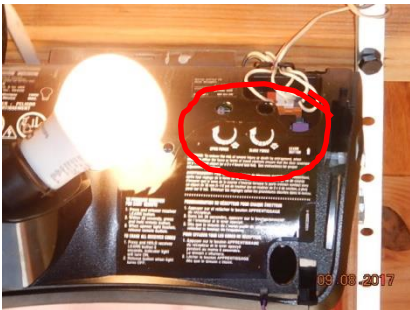
The close tension on the garage door operator is set too high.

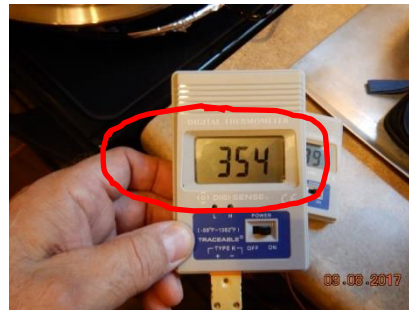
The lower oven heated to 354° when set to 350°.

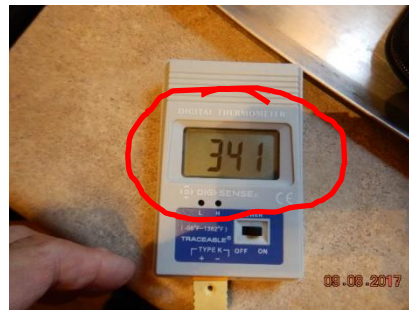
The upper oven heated to 341° when set to 350°.

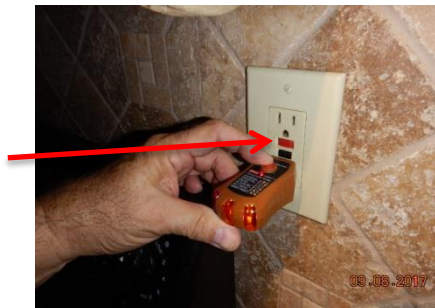
The GFCI outlet next to the range did not trip.

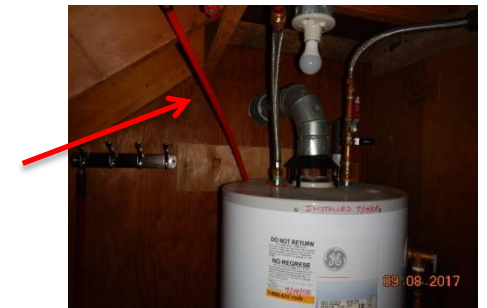
There is no upper and no lower combustion ventilation in the water heater closet.

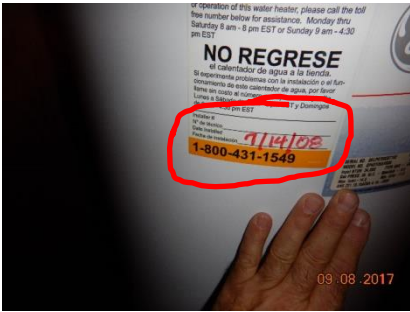
This water heater was installed July 2008.

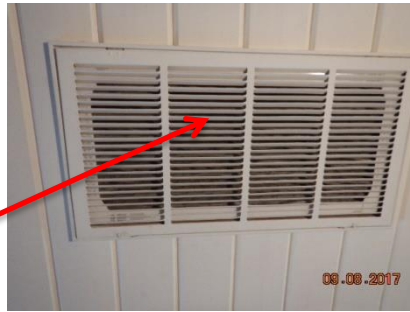
The HVAC return filter is in the den ceiling and is a 12" x 24" x 1" disposable filter.

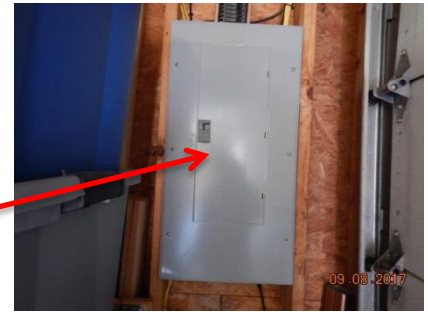
General Electric 200-amp main panel is in the garage.

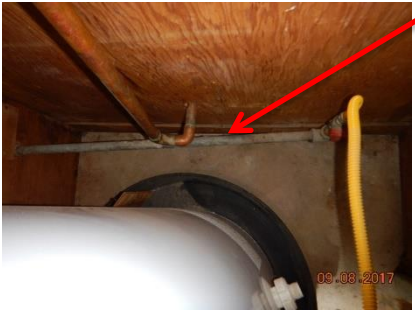
The gas line to the water heater is galvanized iron pipe and should be black pipe.

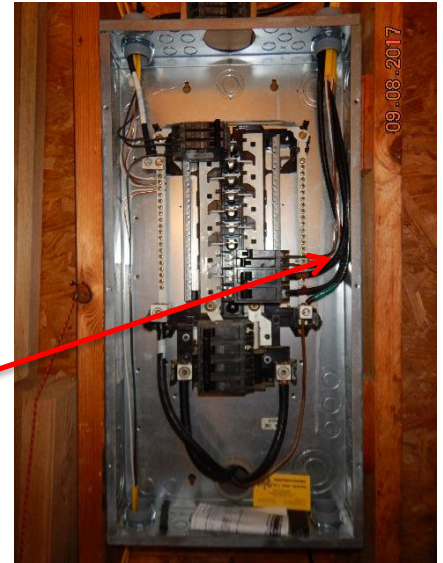
The GE main panel is wired with all copper wiring.

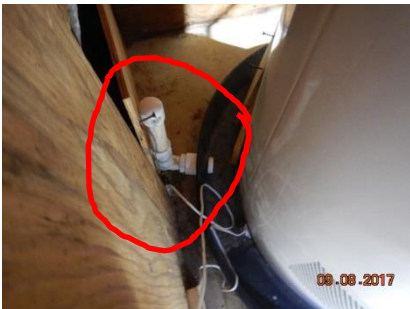
The water heater drain pan drain line has been blocked off.

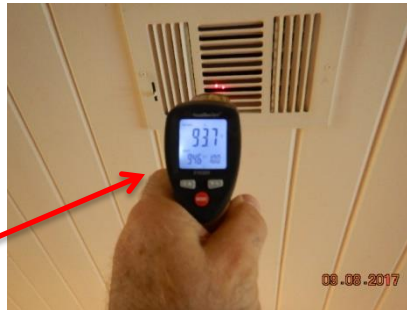
The furnace in the attic was sealed and was not accessible to inspect the heat strips. The output at the diffusers is indicating normal operation in the heat mode.

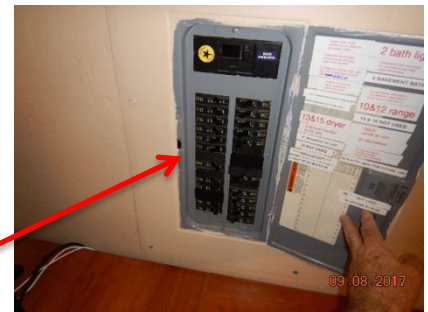
Square D 200-amp sub-panel center with 150-amp main breaker in the Southwest bedroom.

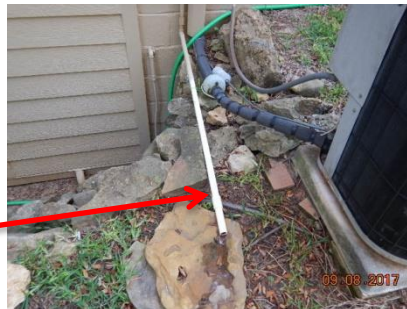
The A/C condensate drain is draining to the West side of the foundation.

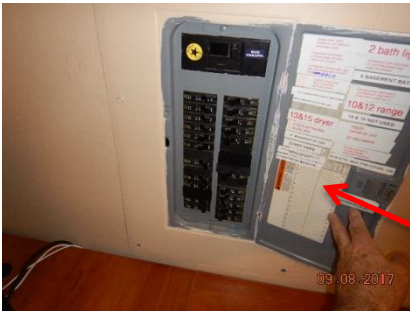
This sub panel appears to be marked on all breakers.

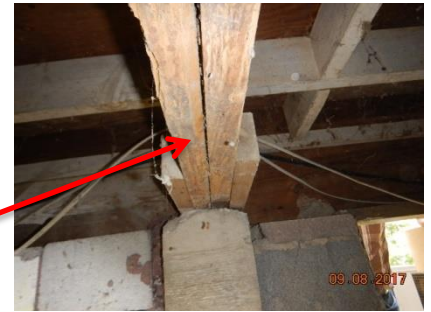
There is old evidence of old WDI in the crawl space.

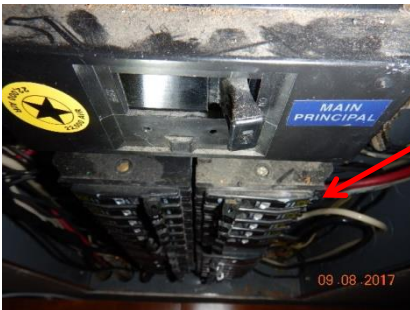
This sub-panel is wired with all copper wiring.

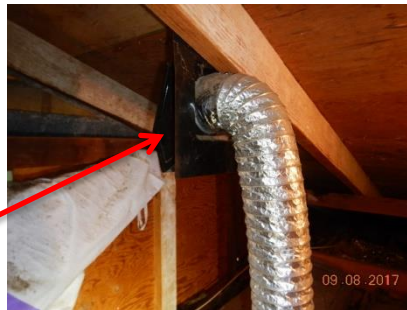
The upstairs washroom exhaust fan vents to the attic.

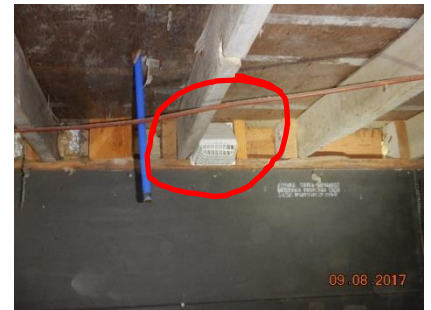
The downstairs washroom exhaust fan vented to the crawl space.

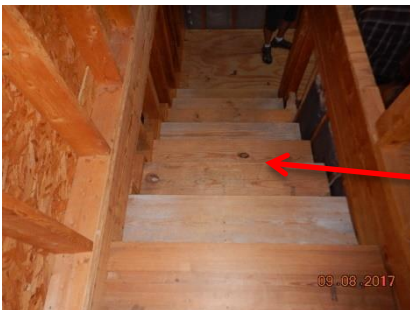
<p>Stairway Deficiency Items</p> <p>The stairway to the living area over the garage is unfinished and there are no hand rails.</p> <p>The steps at the West end of the front porch have four or more risers and is missing hand railing.</p>

The unfinished stair way will require handrailing when completed.

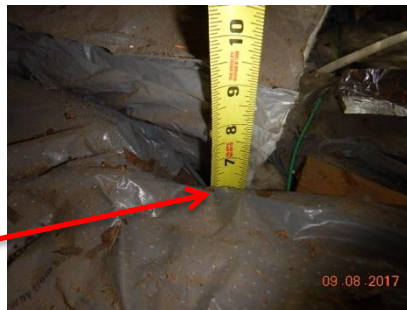
The attic has 6" of rolled insulation throughout the attic area over the main house.

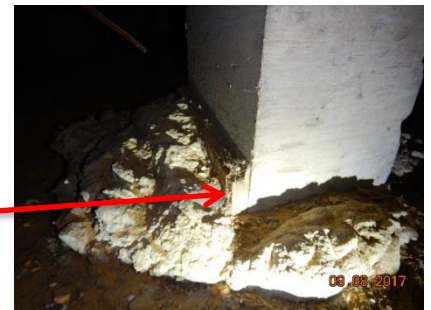
There are form boards imbedded into some piers in the crawl space.

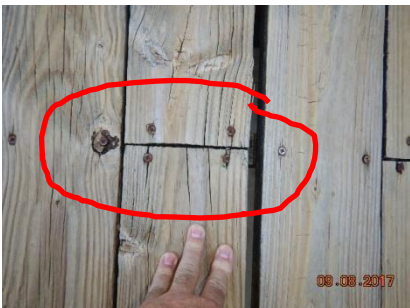
Porch, Balcony, Deck or Carport Deficiency Items
Some of the boards on the North decks have loose screws. The decking is weathered and should be checked at all fasteners & the deck restrained.

There are some boards with loose fasteners and the decking is in need of weatherproofing.

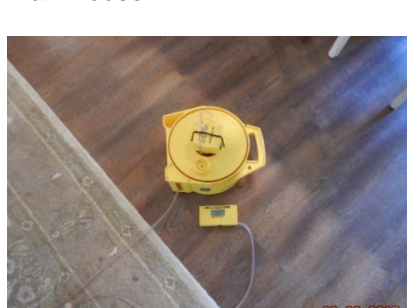
The floor elevations were checked with an electronic digital water level.

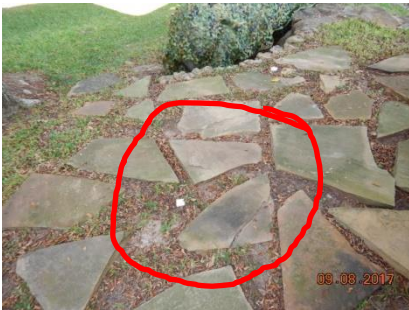
The current home owner says the septic tank is below this rock.

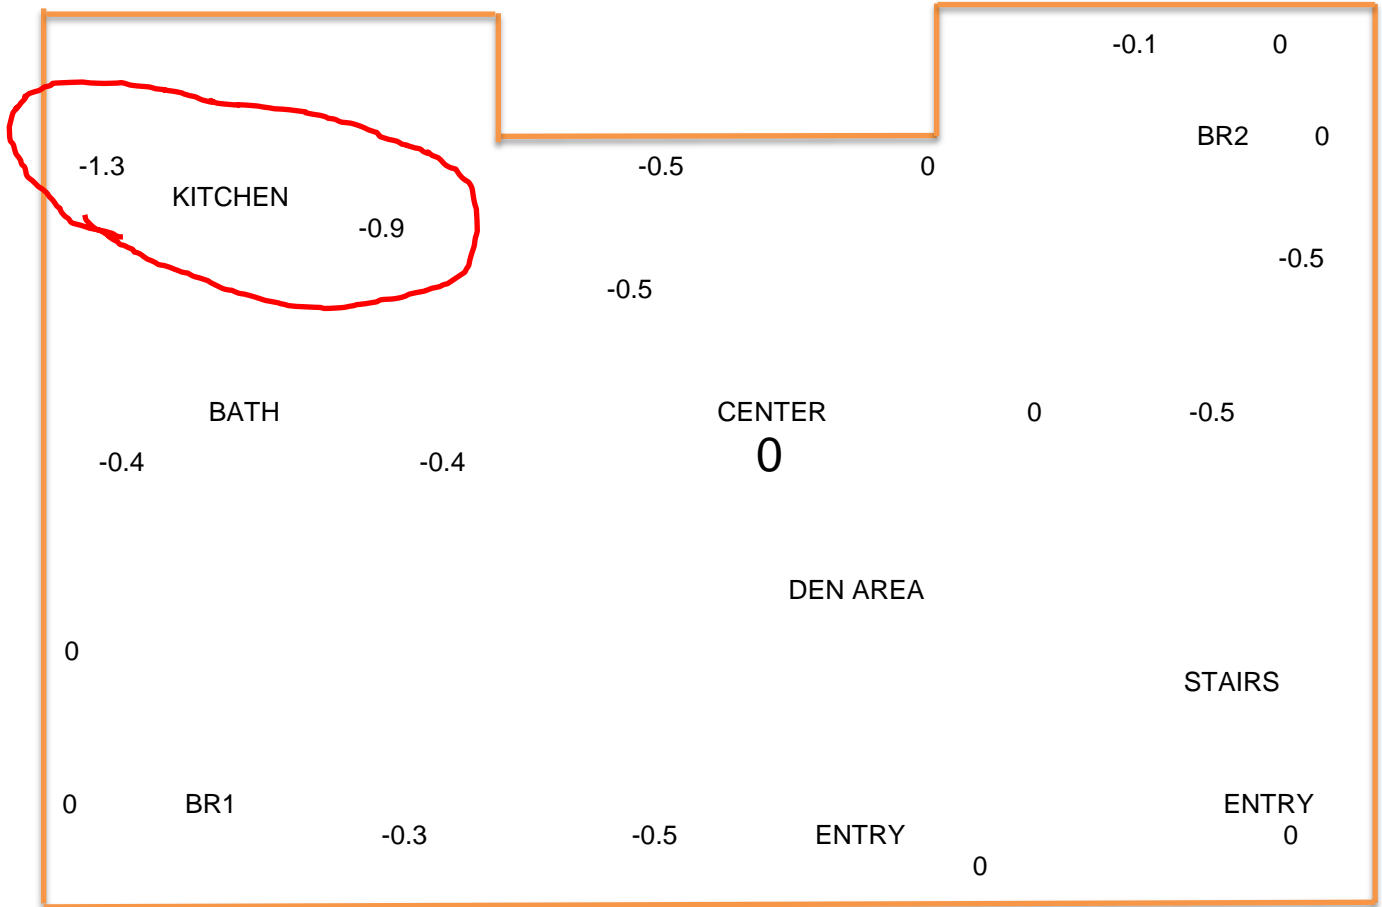
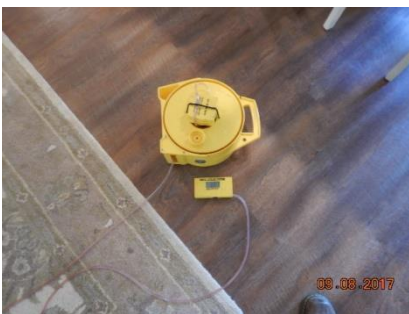
Foundation elevations using digital water level

The monolithic slab foundation was checked by walking around the exterior & interior walls & by using an electronic digital water level throughout. The foundation has settled about 1.3" in the kitchen area and about 3/4" at the bottom of the stairs in the basement area. All other areas are within builder's tolerances which is less than +/- 3/4".

The foundation appears to have settled about 1.3" in the kitchen area that may have been from old poor drainage issue. It appears the drainage has been corrected and the settling has been retarded. All other area appears to be within builders tolerances.
