Dunlap Home Inspection, Inc.

Property Inspection Report

2322 Norma Dr, Mesquite, TX 75149
Inspection prepared for: Clay & Annie Hervery
Real Estate Agent: -

Date of Inspection: 7/1/2020 Time: 1:00 PM
Age of Home: 1961 Size: 1284
Order ID: 989

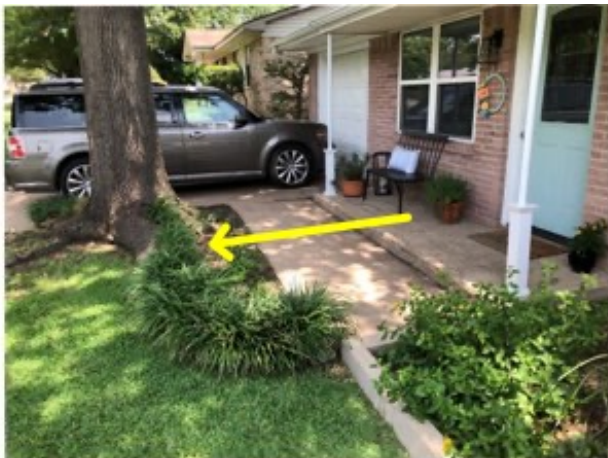
FOUNDATION FAILURE: TREE ROOT

Large tree(s) near house foundation. Client should consider removal of tree(s) or the installation of root barrier to reduce possibility of damage to house foundation from tree roots and moisture removal.

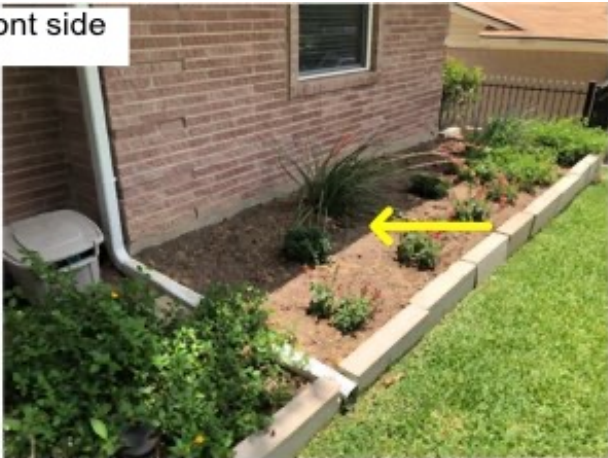
Front side

Soil grade and drainage patterns around areas of the building do not appear to properly direct water away from foundation to aid in controlling runoff water and could cause differential movement of the foundation or water penetration during heavy rains.(front side)

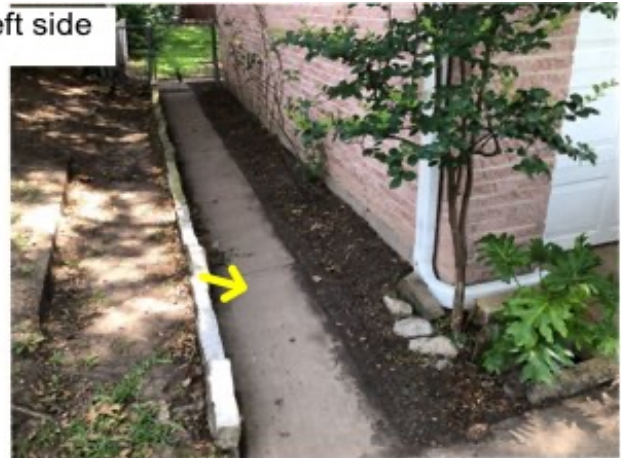
Left side

Soil grade and drainage patterns around areas of the building do not appear to properly direct water away from foundation to aid in controlling runoff water and could cause differential movement of the foundation or water penetration during heavy rains.(front side)(left side)

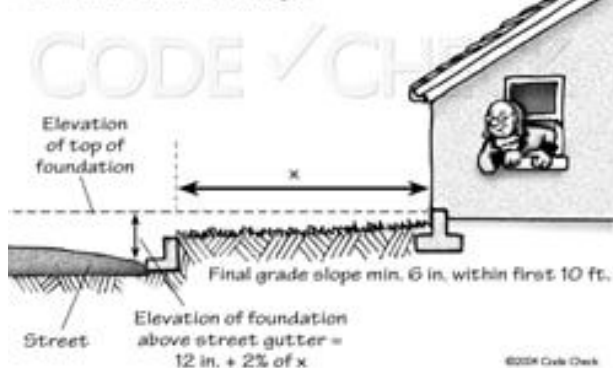
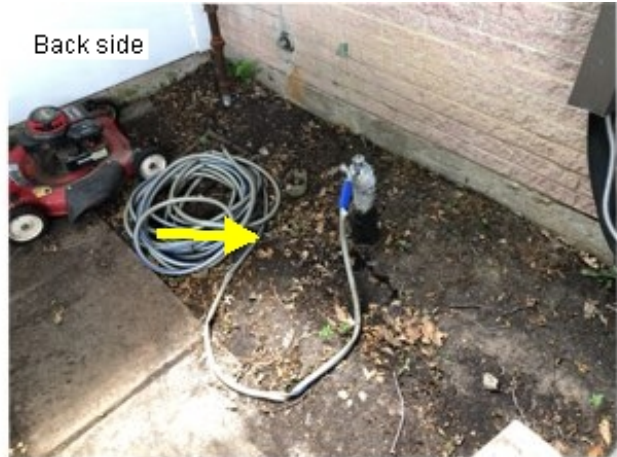
Graded Site Drainage

Conditions are present and visible which may adversely affect foundation performance, such as water ponding/erosion.(back side)

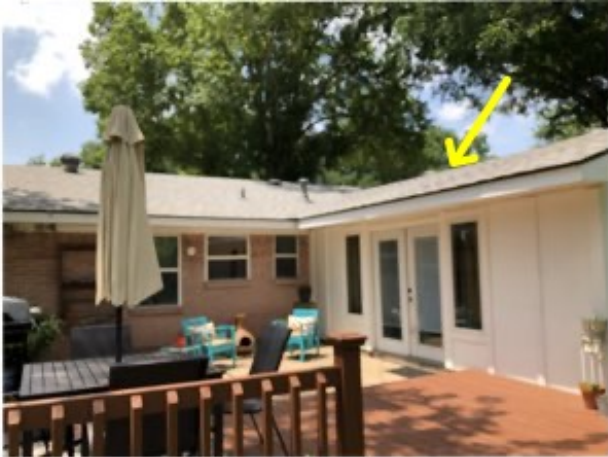
The roof had only partial gutters. The Inspector recommends installation of a full gutter system to help improve drainage.

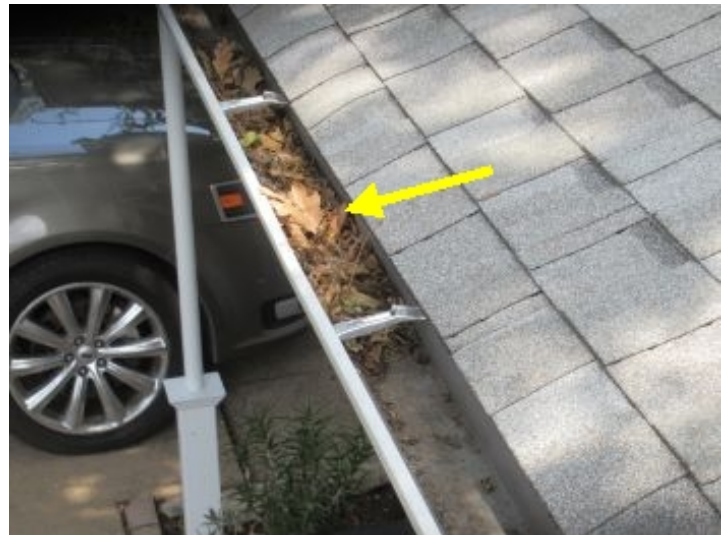
Gutters need general maintenance, cleaning out debris

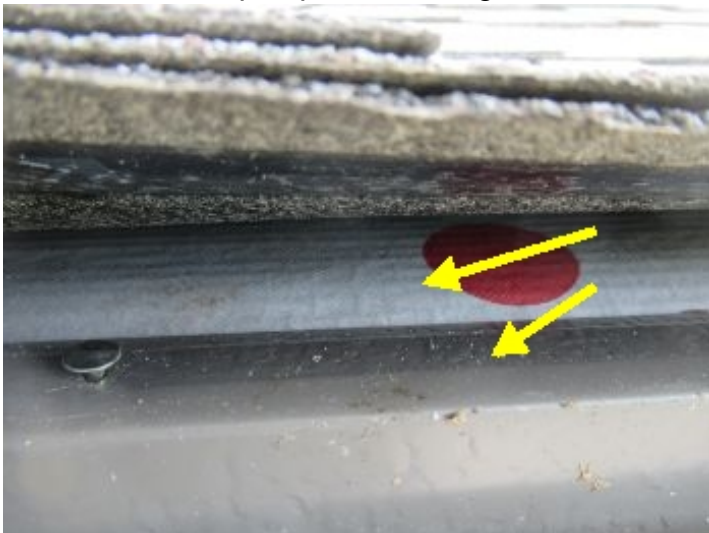
The underlayment should be installed on top of the drip edge at the downhill side of the roof.

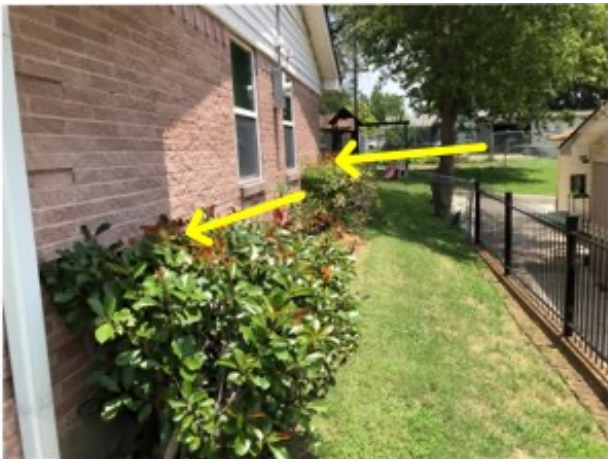
Bushes / trees / foliage should not contact siding of building to prevent damage and insect access

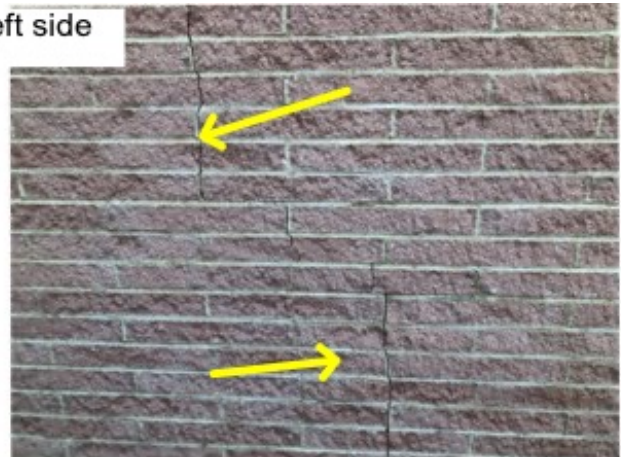
Left side

Cracking visible in brick exterior walls appeared to be consistent with cracking caused by differential settling of soil beneath the foundation. Differential settlement happens when soil beneath the foundation settles at different rates in adjacent areas.

The Inspector recommends that the cracks be patched to avoid damage from moisture intrusion.(left side)

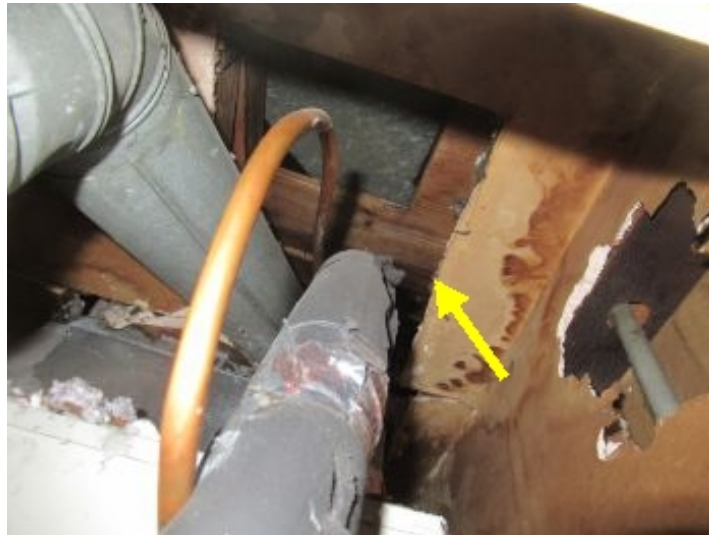
Ceiling above air handler is open allowing for debris to enter mechanical closet

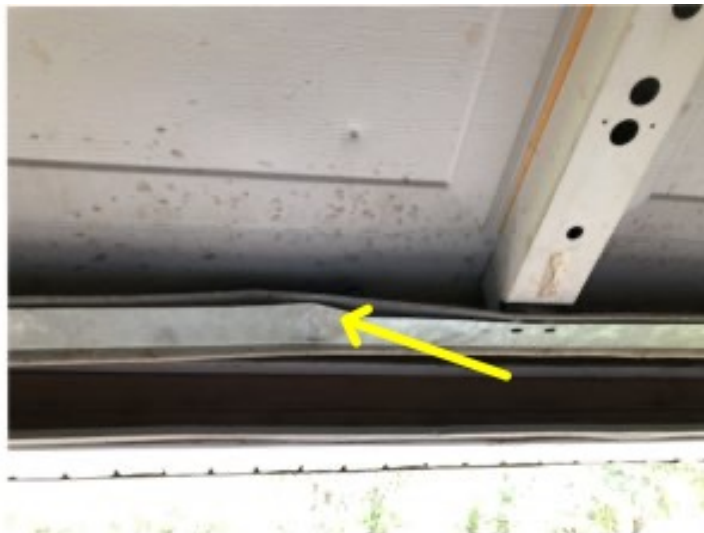
Garage door is damaged/bent

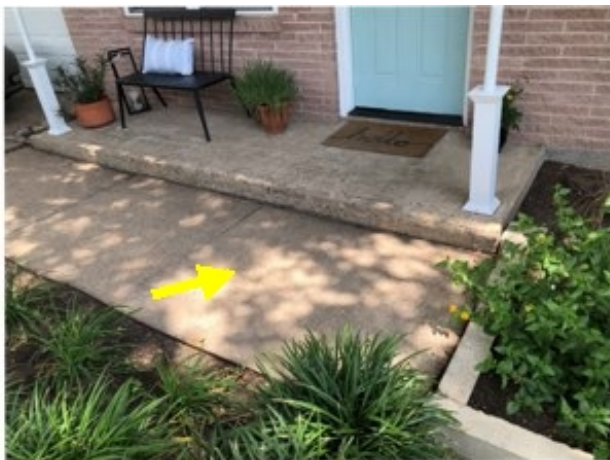
Sidewalk slopes towards front porch

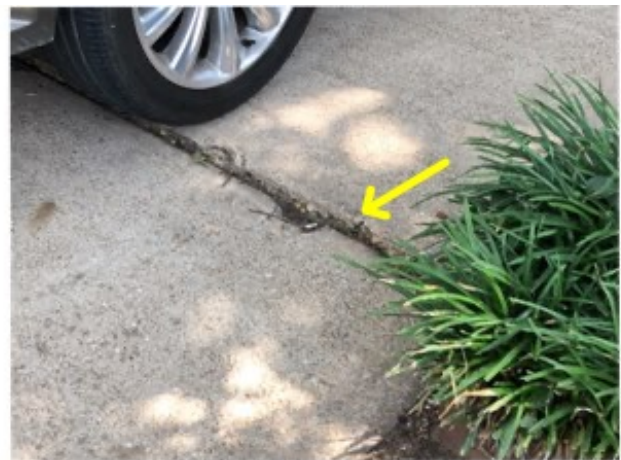
Driveway has settled and has multiple cracks and uneven surface.

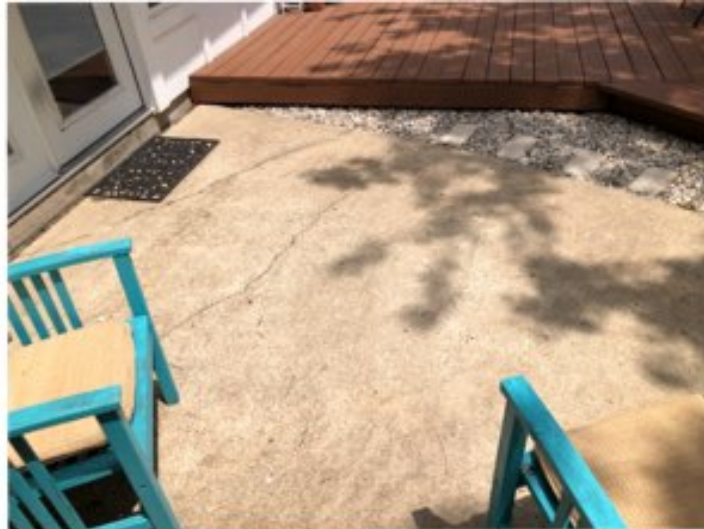
The patio was not level or flat at the time of the inspection. This condition appeared to be the result of heaving or settling of soil beneath the patio.

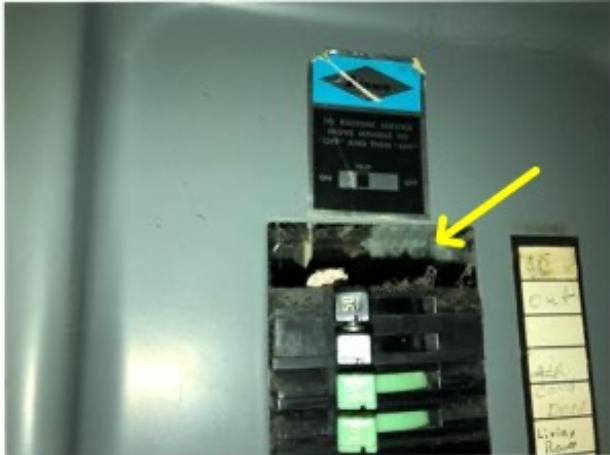
Unfilled holes or knockouts in the main electrical service panel may allow persons to come into contact with energized electrical components. This condition is a potential shock/electrocution hazard and should be corrected by a qualified electrical contractor.

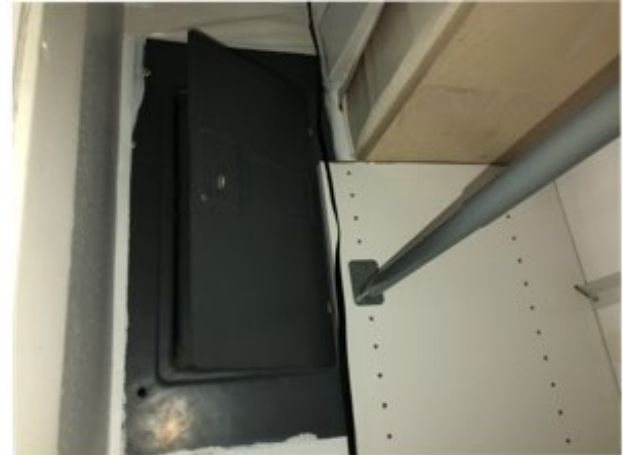
Unable to remove panel due to shelving

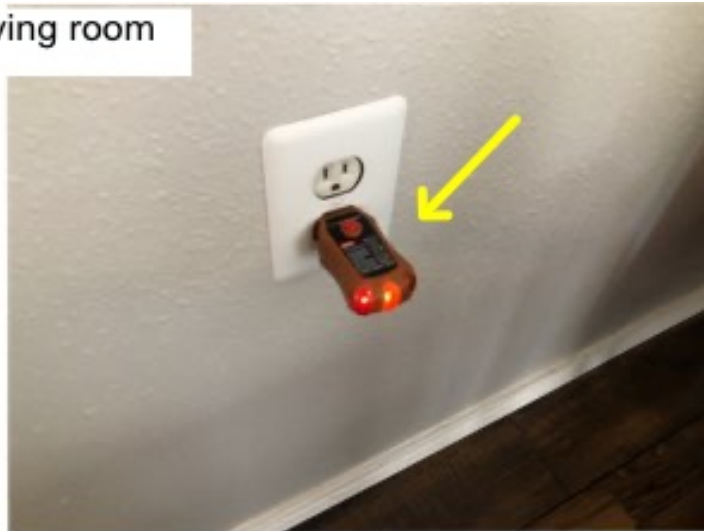
Living room

An electrical outlet has hot and neutral wires reversed. This condition should be corrected by a qualified electrical contractor.(1)living room

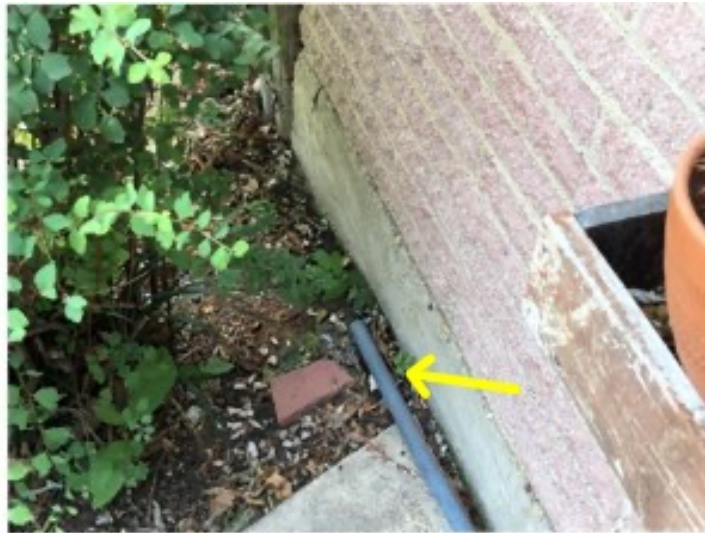
Condensation line should be extended 5' past foundation

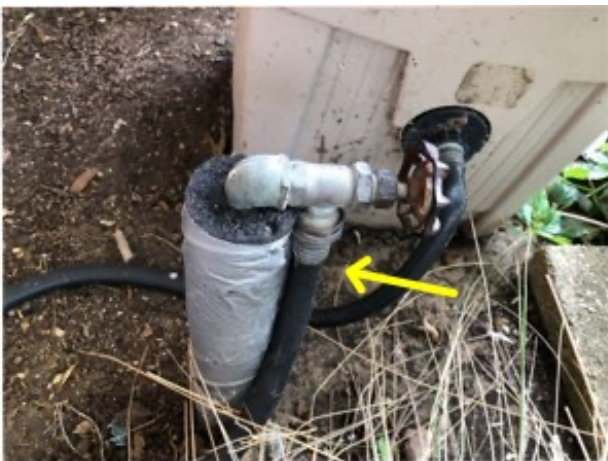
Exterior hose spigot(s) do not have code approved anti-back flow devices installed.

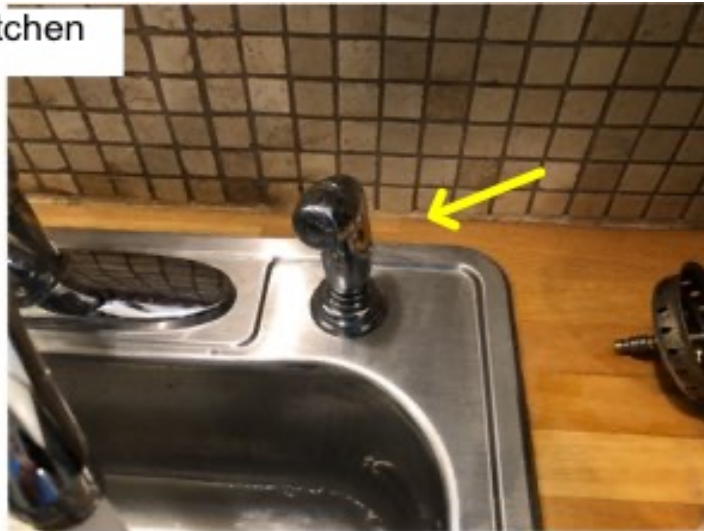
Kitchen sink spray wand not functioning

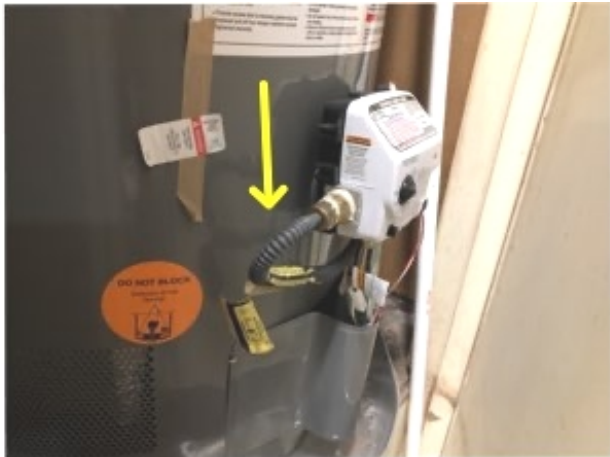
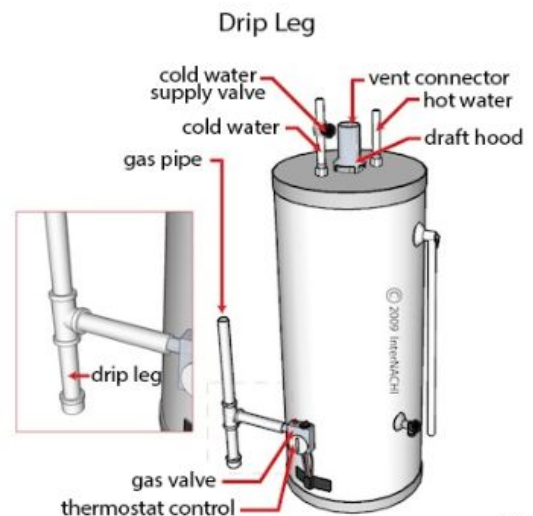
The gas supply pipe contained no drip leg. A drip leg is generally recommended but not always required, depending on the local Authority Having Jurisdiction (AHJ). The purpose of a drip leg is to prevent particulates or moisture from condensation from entering and clogging the water heater gas valve, which can cause the water heater to shut down.

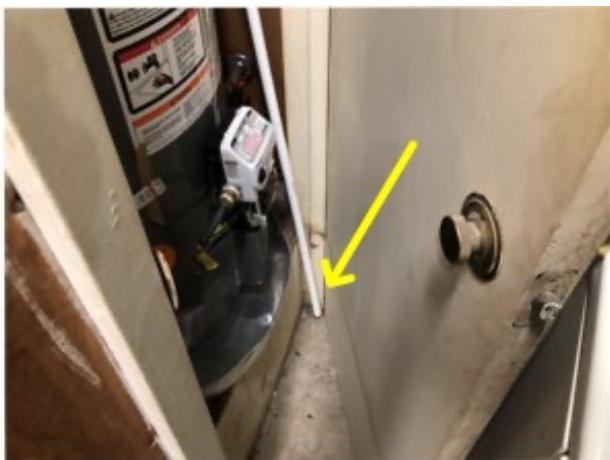
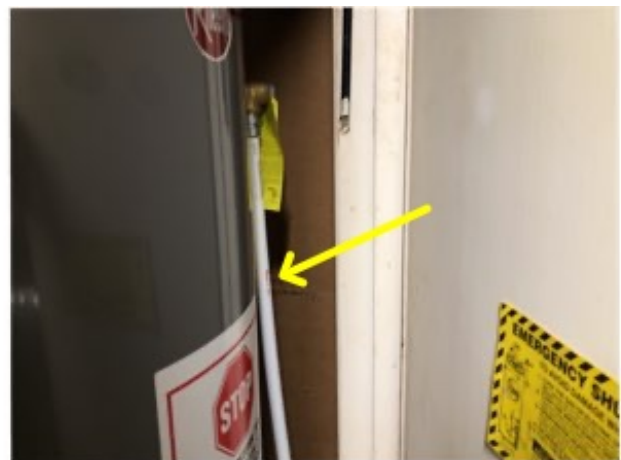
TPR Drain line is improperly routed. Drain line should be run to exterior of house not garage floor

Improper material used for tpr drain line; should be copper/cvpvc not pvc

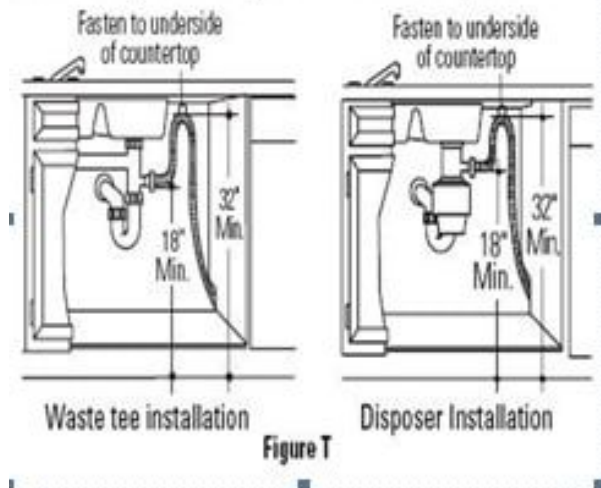
Drain line needs to be elevated above side inlet of drain to prevent debris and gray water from draining down line and back into dishwasher.

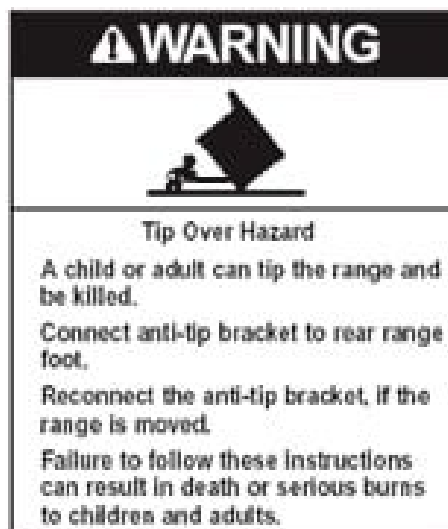
Stove does not have recommended anti-tip bracket on back side of unit.
