# CONEJOS RIVER

## DIVERSION INFRASTRUCTURE INVENTORY

**Structure Name:** CORDOVA D

**Date:** April 15, 2019

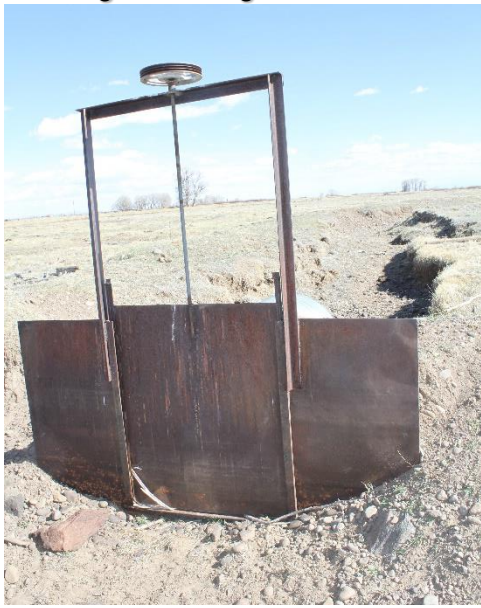
Headgate looking downstream

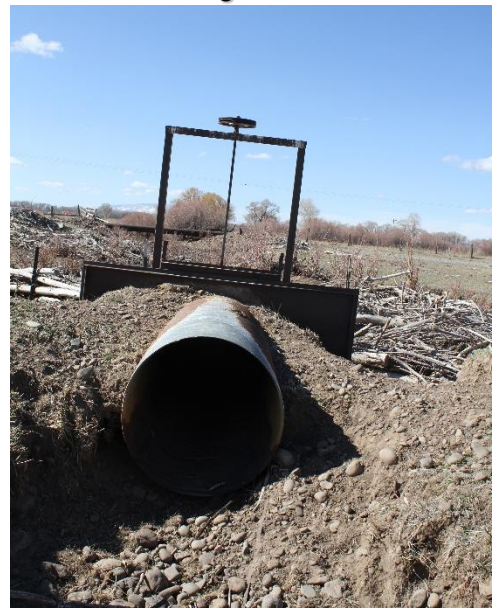
Headgate outlet

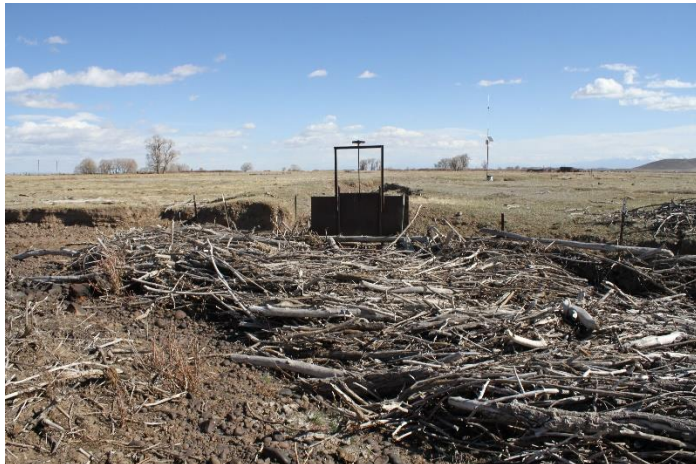
**Structure Description:** Located on the North Branch of Conejos River. The headgate sits along the east bank of the river. There is a trash rack consisting of a log boom, t-posts, and checkboards upstream of the headgate. The structure has a very minimal stacked rock diversion dam. Woody debris and sediment accumulation is an issue at this structure.

Headgate and trash rack structure

**Repair(s) or Improvement(s) Currently Needed:** The headgate needs to be reset. The diversion dam should be improved to reduce maintenance and to divert water at low flows. Fish passage and riparian restoration should be considered as part of any future repairs or improvements. This structure also needs regular debris clearing. The river channel here also needs bank stabilization work.

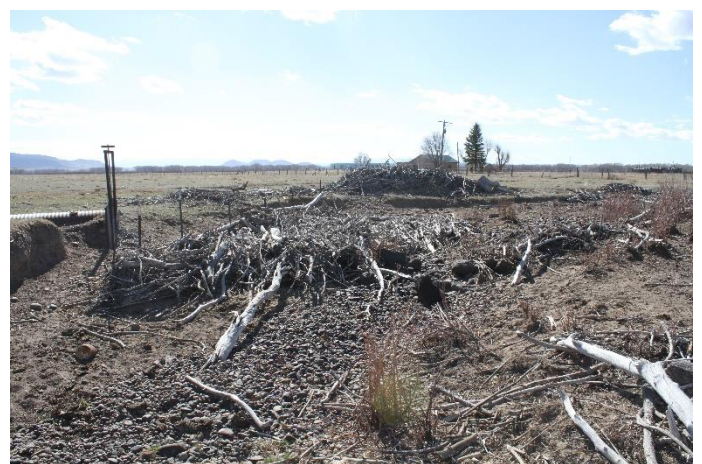
Diversion dam and headgate

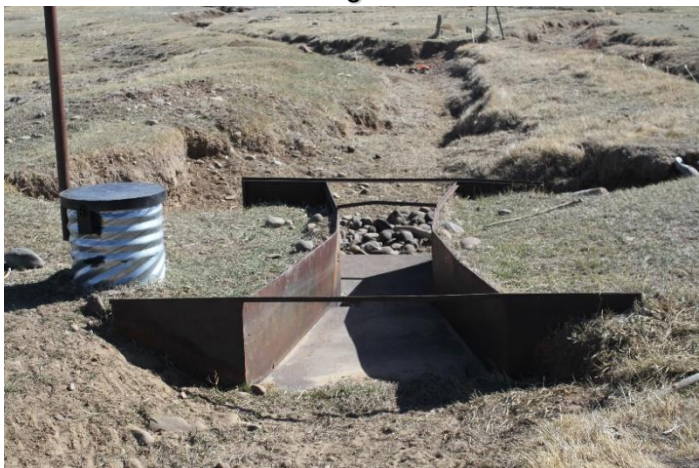
Flume looking downstream

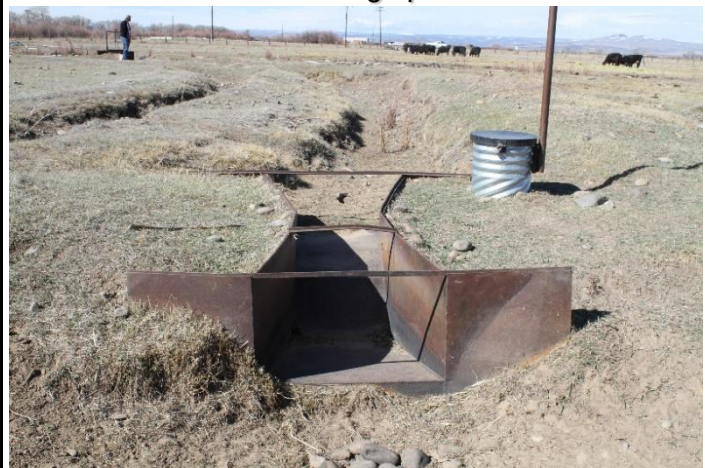
Flume looking upstream
