TALC
Home Inspe

Inspection Report

Property Address:
303 Wheeler Avenue
Georgetown KY 40324

Talon Home Inspections, LLC

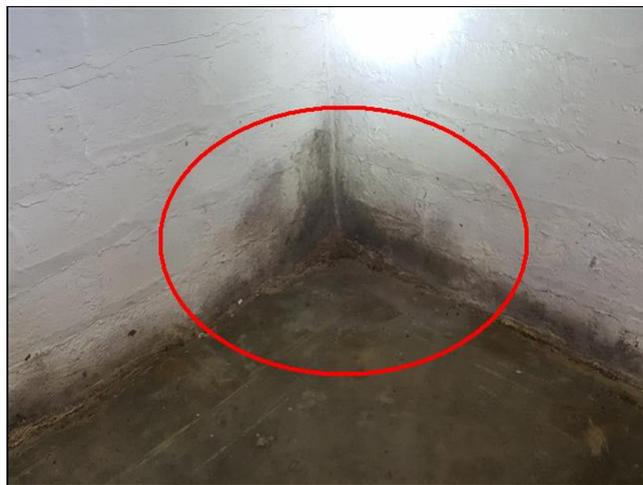
1.0 Item 2(Picture)

1.0 Visible signs of water intrusion/stains in the basement walls at the rear left and right corners of the basement wall was noted. 90% of water entry into the foundation walls has been found to be caused by improper grading or defective gutter/drainage systems. Refer to Roofing and Exterior of this report for improvements and recommendations. After corrections recommend these areas be monitored to see if other corrections are needed.

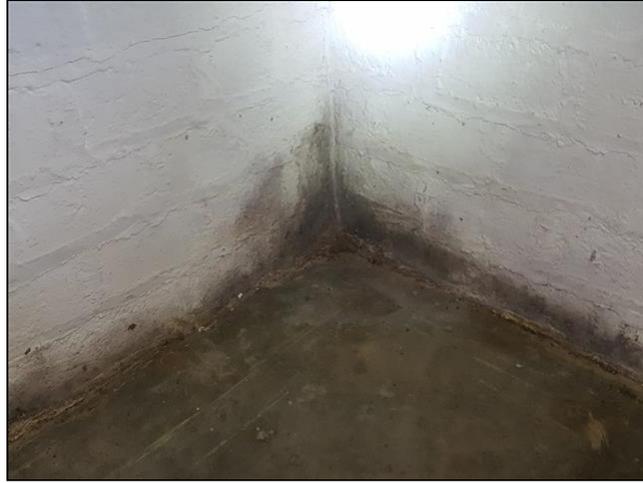
1.1 Item 9(Picture) rear right corner of home

1.1 (3) Efflorescence was found on the bottom courses of the block walls at the unfinished basement where indicated in the photos which indicates moisture is in contact with the masonry. The white chemical deposits (Efflorescence) are caused by water evaporation from the exterior. This does not necessarily indicate that water intrusion is occurring in the basement. I recommend checking the gutters and the downspout drain lines for proper operation. Efflorescence is found on many homes without water intrusion occurring inside the home. But, it should alert you to the possibility that future steps may be needed.

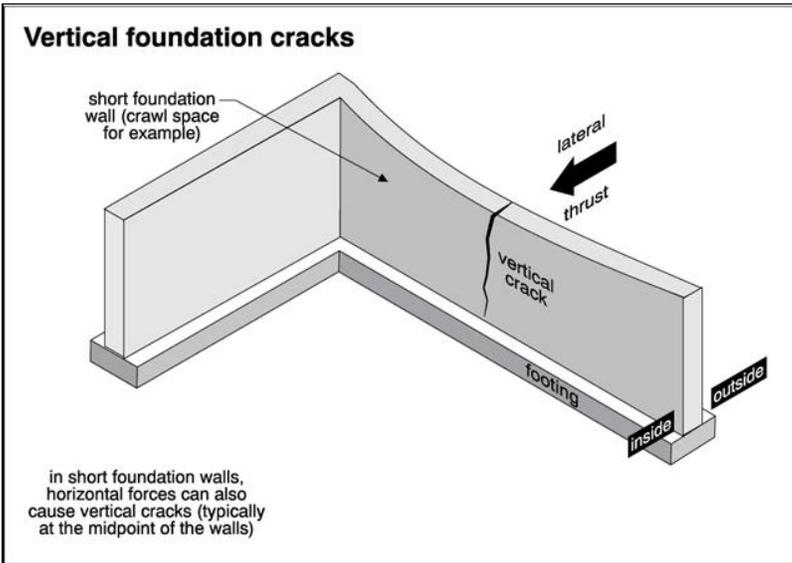
1.1 Item 15(Picture)

1.1 (4) The vertical settlement crack(s) in the foundation wall in the basement was noted. These cracks do not appear significant. This condition is common in many homes and does not usually represent a serious structural concern unless the cracks are between an 1/8 or 1/4 inch thick. Recommend the crack be sealed to prevent water intrusion into the basement and minimize further deterioration. [Sealing Concrete Cracks](#) It is recommended that you monitor periodically to see if further movement occurs and if so a foundation contractor should be consulted to correct and prevent further movement.

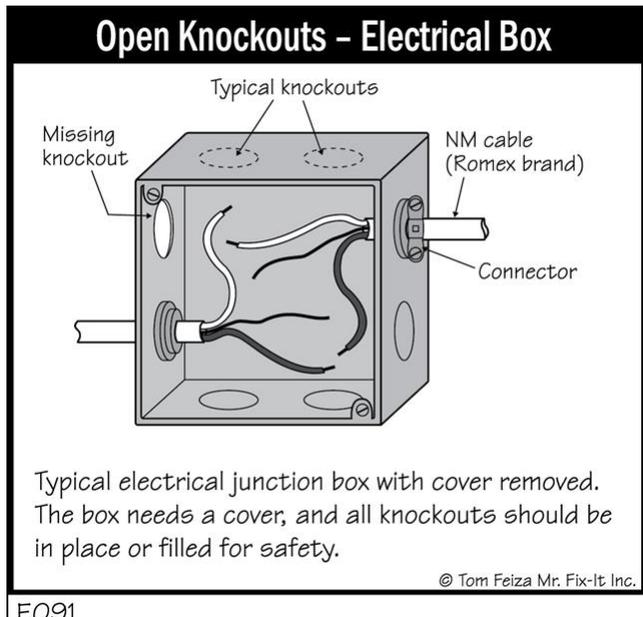
E091
1.10 Item 2(Picture)

1.10 (1) Cable clamps (sometimes referred to as bushings or grommets) are required where wiring passes into the electrical junction boxes. Cable clamps serve to protect the wiring from the metal edges of the box to prevent a short from occurring or from the box becoming energized which can result in a death via electric shock. This is a safety issue. Recommend a qualified licensed electrician repair as needed.

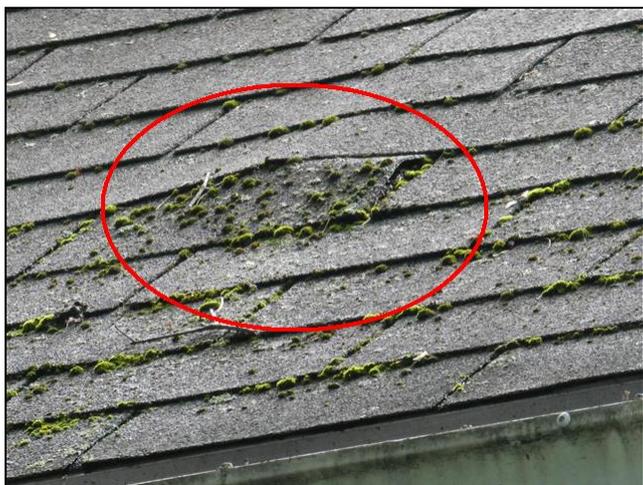
2.0 Item 3(Picture)

2.0 (3) The roof covering is lifted on the rear left side of the home. Recommend this be repaired by a roofing contractor to prevent water entering which can lead to damaged roof sheathing.

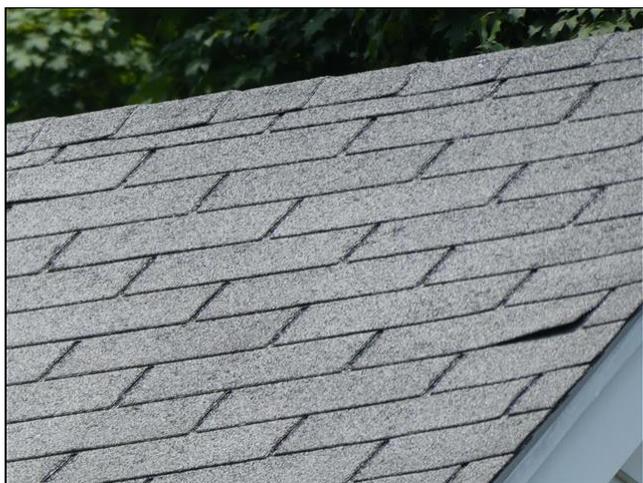
2.0 Item 4(Picture)

2.0 (4) Signs of loss of protective granules, curling and fibers exposed of the roof shingles are starting to appear especially at the front of the home. This indicates that the roof is close to the end of it's life span. This usually increases the potential for ultraviolet damage to the membrane. Recommend a qualified roofing contractor further evaluate the roof to determine if replacement is required now before roof leaks start to develop. If the roof is not to be replaced it should be closely watched and repaired or replaced at the first sign of leaking to prevent damage to the interior finishes or roof framing in the attic.

Note: This part of the roof faces the sun all day thus reason why this area of the roof shingles are deteriorating faster than all other shingles on the roof at the rear of home. This section of the roof may need repairing earlier than the rest of roof.

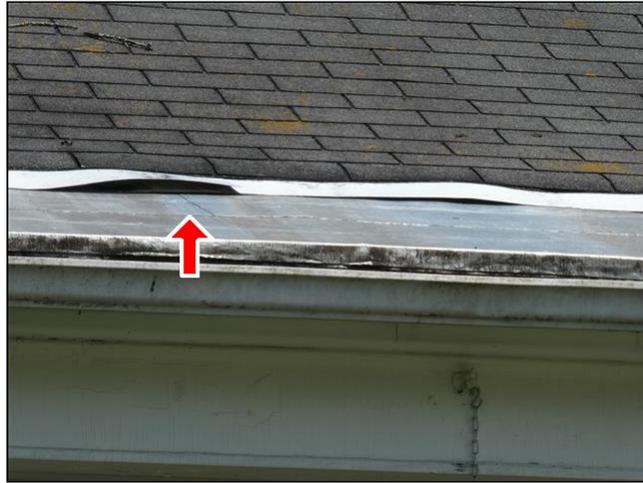
2.1 Item 1(Picture)

2.1 The flashing at the front of home (above porch roof) needs flattening and is loose. Recommend they be re-secured to prevent water entering underneath flashing and to allow ease of water runoff to reduce the risk of leaks. Recommend repair or replace as needed using a qualified roofing contractor.

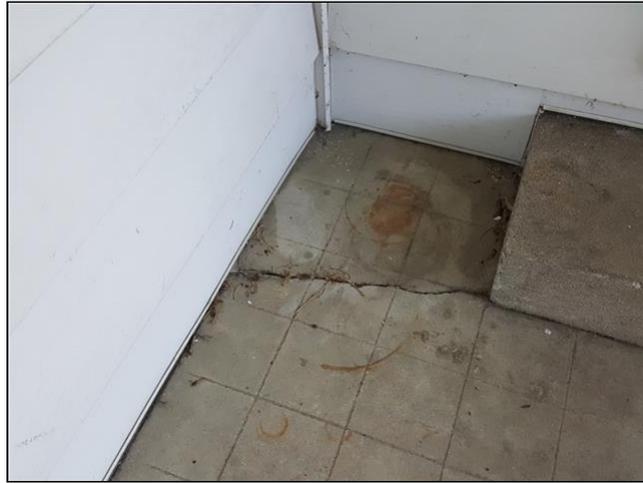
3.4 Item 1(Picture)

3.4 (1) The concrete porch is cracked and chipped in various areas. Further deterioration of the flooring can occur via water entry which could lead to possible cracking of concrete. Recommend these areas be repaired by a qualified masonry contractor.

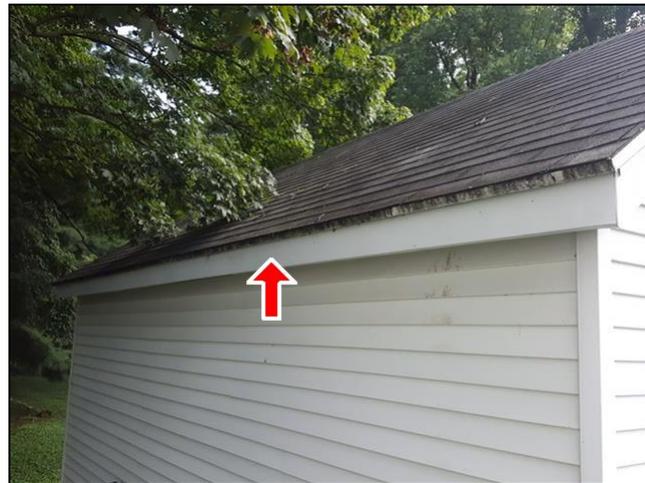
4.0 Item 1(Picture) right side

4.0 (1) The gutters are missing at the garage on both sides. This can possibly cause settlement of the foundation, water to enter under the slab, and/or soil erosion near the foundation perimeter. Recommend gutters be installed on both sides of the roof. Ensure downspouts drain water roof runoff away from the garage and have splash blocks installed to prevent soil erosion near the foundation perimeter. A qualified contractor is recommended for these repairs.

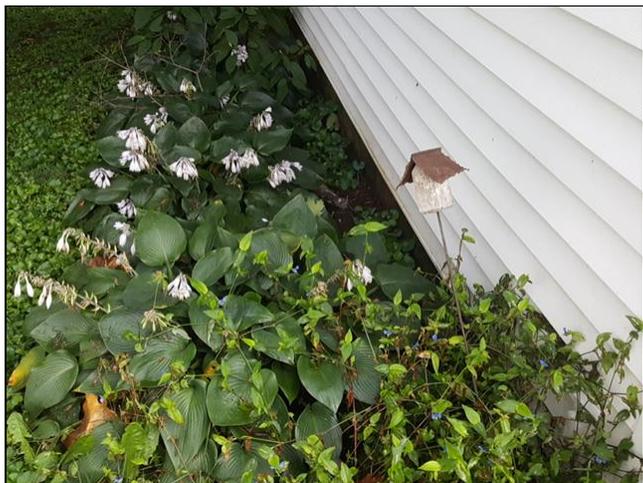
4.2 Item 1(Picture) left side

4.2 There are depressions in the soil around the foundation perimeter of the garage of the home. Recommend filling all depressions and re-grading the soil so the soil slopes away from the home around the foundation to ensure water pooling does not occur in these areas. Water pooling could lead to to garage leakage.

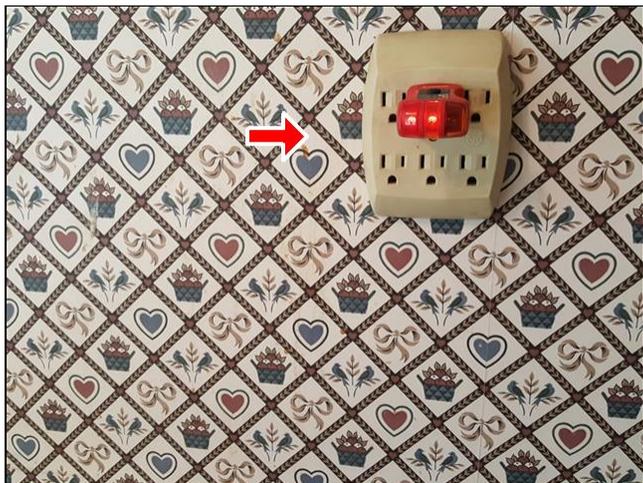
5.7 Item 2(Picture)

5.7 (3) The outlet in the kitchen where indicated in the photo(s) is improperly wired with the hot and neutral wires reversed. This is extremely dangerous and a potential shock hazard. You **CAN BE SHOCKED** causing a possible death when the switch to the appliance is off when plugged into the outlet. Recommend a qualified licensed electrician repair as needed for safety prior to moving.

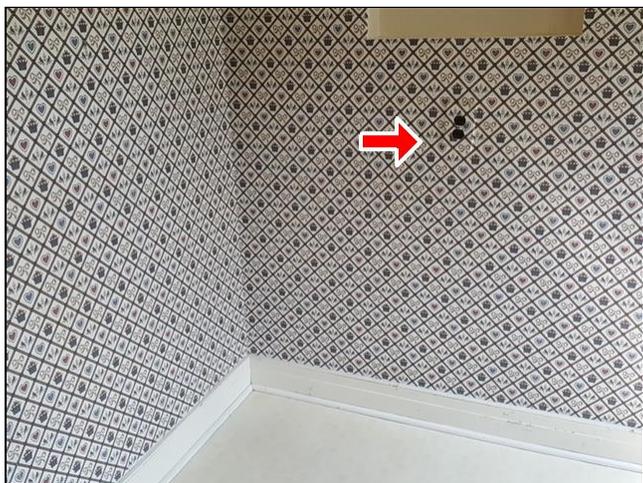
5.7 Item 3(Picture)

5.7 (4) Recommend the two prong outlet in the kitchen be replaced with a 3-prong and grounded and converted to GFCI for safety. A qualified electrician is recommended for replacement.

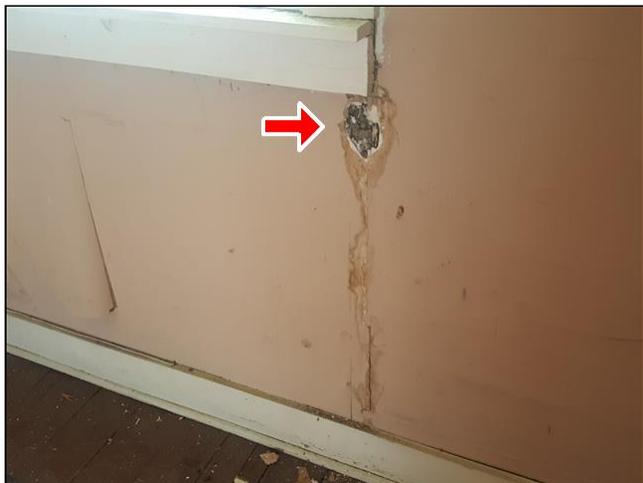
6.1 Item 4(Picture)

6.1 (2) The wall in the 3rd Bedroom where indicated in the photo reveals a water stain indicating a leak did or still exists. Although there was no leaking or elevated moisture content found at this time, could not determine how the stain existed. The area tested dry at the time of inspection. Perhaps ask the owner of the home to explain stain. Inspections are limited and destructive inspections are excluded. Recommend cleaning the wall then monitor this area to see if a leak is active and if a leak does exist, recommend further investigation and repair as needed. The repair work will likely involve the removal of the covering in order to determine where the leak is coming from and if it still exists. The extent of damage cannot be realized until the covering is removed.

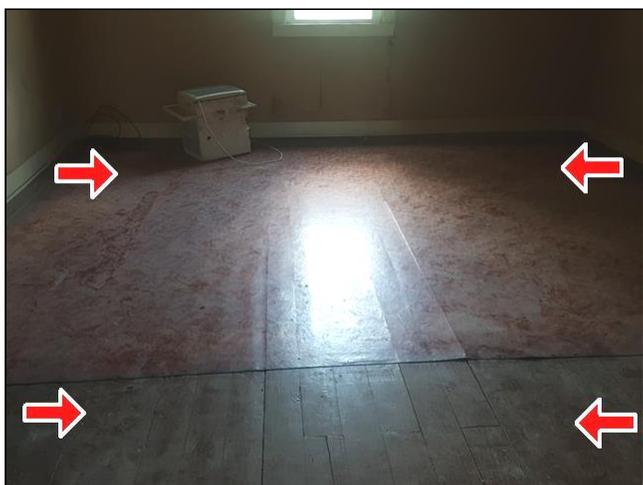
6.2 Item 1(Picture)

6.2 The floor slopes a little towards the center of the room because of framing shrinkage. This is not a structural concern and is normal and to be expected in a house of this age. This is for your information.

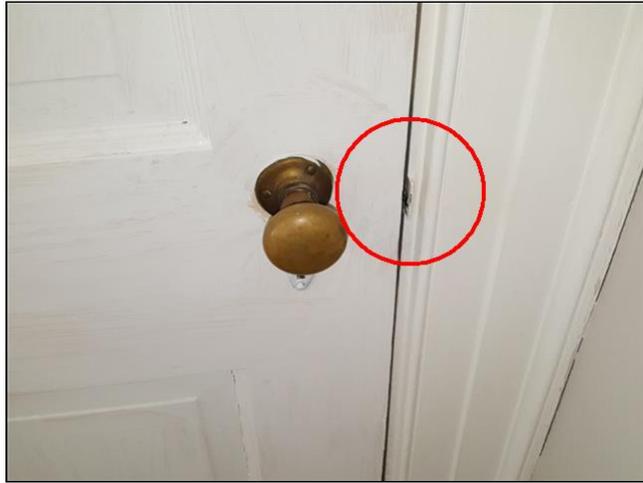
6.4 Item 4(Picture) master bedroom

6.4 (2) The door knob hardware is not latching in the Master and 2nd Bedrooms where indicated in the photo. It requires an adjustment. The strike plate may need to be adjusted or trimmed to be able to lock/ close the door. Recommend repair as needed.

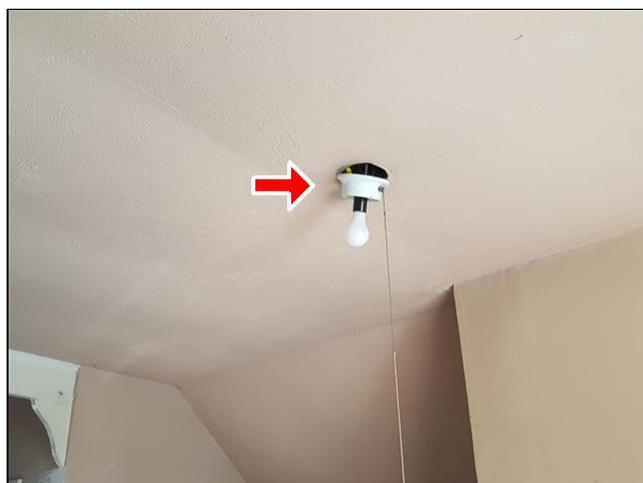
6.7 Item 1(Picture)

6.7 (1) The light fixture in the loft area upstairs is loose at the ceiling. This is a safety issue as the light fitting may fall causing an injury and/or wire connections come loose which may cause a short that could result in a fire. Recommend securing as needed. A qualified contractor or electrician maybe needed for repairs for safety.

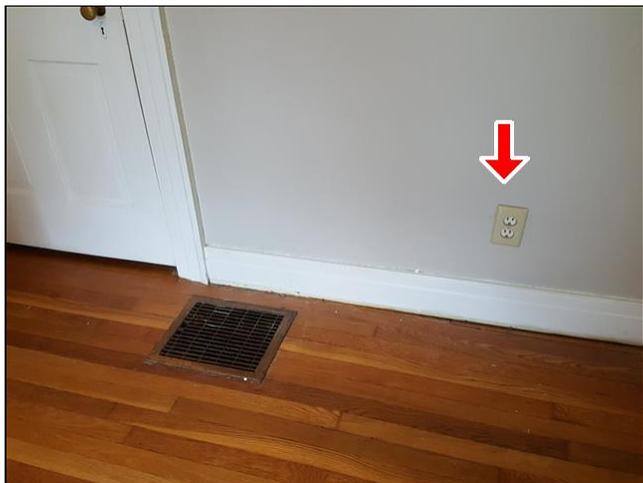
6.7 Item 14(Picture)

6.7 (4) The outlet in the 2nd bedroom where indicated in the photo(s) is loose at the wall or in the outlet box. Electrical issues are considered a hazard until repaired. This is a safety issue that needs to be corrected due to an electric shock or fire from loose connections could occur if not repaired. Recommend a qualified licensed electrical contractor correct as needed.

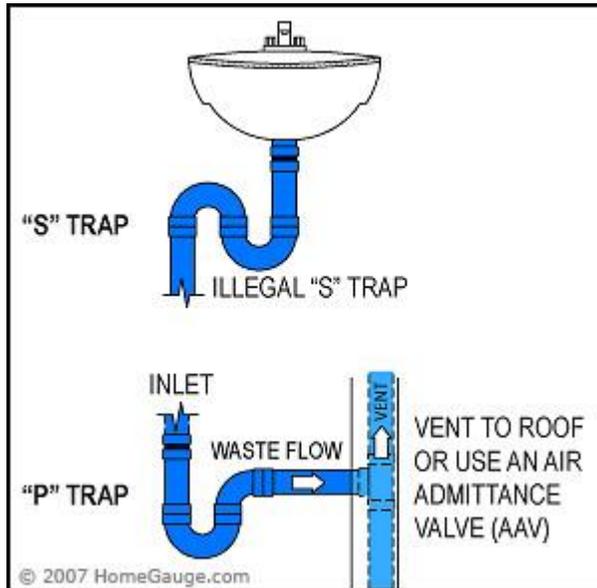
7.5 Item 3(Picture)

7.5 (2) An "S" trap is being used under the 2nd bathroom sink. "S" traps should be replaced during any new plumbing work as they are subject to siphoning problems. "S" Type drain traps do not meet today's standards and are now illegal to be used in Kentucky. This type of trap could allow all the water to drain from the trap and allow sewer gases to enter the house. Care should be taken to keep the trap "primed". Fixtures should be monitored for sewer odor. Examination of the drain trap and correction by a licensed plumber is recommended.

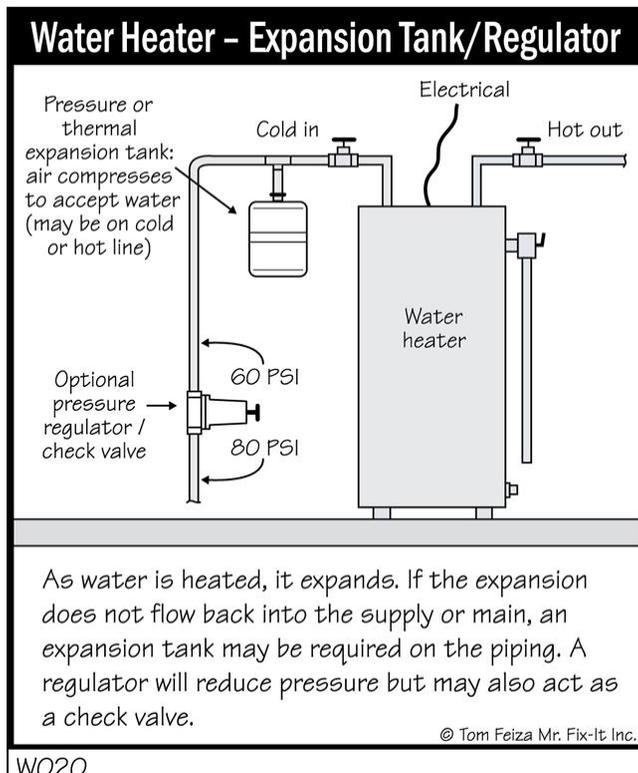
8.2 Item 1(Picture)

8.2 (2) Your water heater does not have a "Thermal Expansion tank" installed to prevent a possible leak at the TPR or "pop-off" valve. If the water pressure gets high enough it can damage valves in the plumbing fixtures, joints in the supply pipes and even the water heater. Thermal expansion always occurs in water heaters. Like most substances, water expands as it is heated. There were no visible leaks or drips at the TPR valve during the inspection. If your water heater does begin to drip or leak, then a thermal expansion tank may be needed. This is for your information.

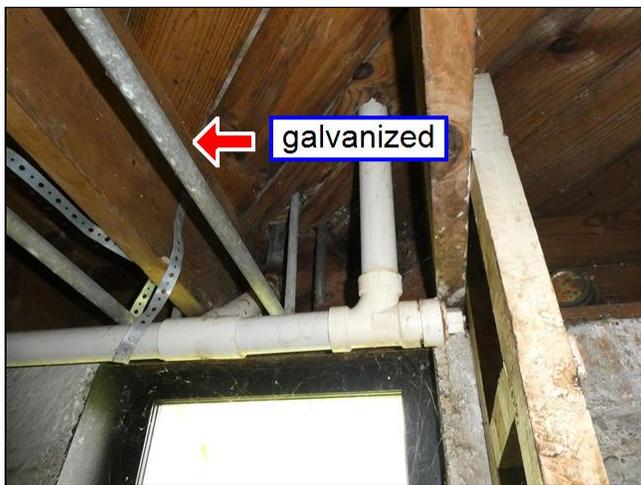
8.9 Item 1(Picture)

8.9 (1) Cast Iron drain lines and Galvanized water supply lines are known to corrode internally and will leak at the joints after a long period of time. The corrosion will eventually restrict the drainage and flow and leaks will occur. The cast iron drainage lines and galvanized supply lines are fifty or more years old and could fail at any time. Replacement of the both lines should be strongly considered before major leaks occur. This is for your information. There were no present leaks visible in the basement and water pressure was within normal parameters at time of inspection.

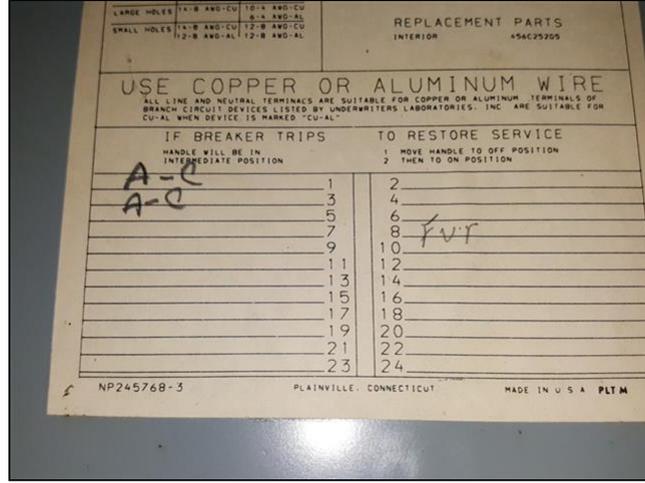
9.3 Item 1(Picture)

9.3 (1) The breaker for the Air Conditioner is oversized in the panel box. Currently it has a 40 amp breaker installed, whereas the data plate on the Air Conditioner specifies maximum breaker of 25 amps. The concern with an oversized breaker is typically causing possible damage to the equipment, and if the unit pulls more than 25 amps it could cause the insulation on the wires to start to melt. This will void warranty on the unit. Recommend a qualified HVAC contractor and/or electrician further evaluate to determine if correction is needed.

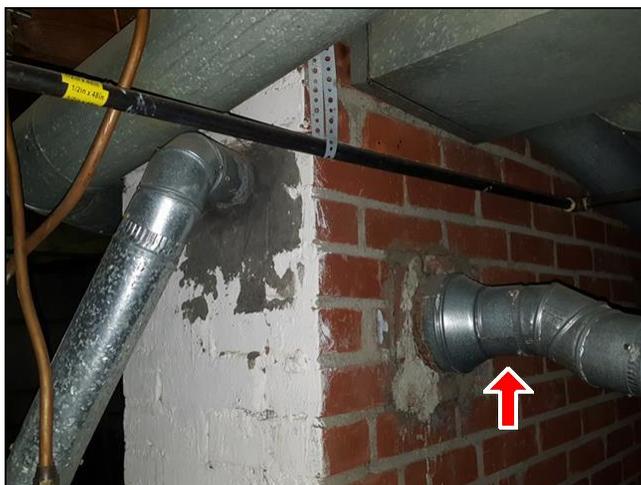
10.10 Item 1(Picture)

10.10 The chimney is being used for venting the gas furnace. A stainless steel vent pipe should be installed and properly sized for the gas appliance to prevent damage to the interior of the chimney mortar joints, possible entry of CO (carbon monoxide) gases into the home, and sized to promote good drafting of the gas appliance. Clay flue tile is usually to large to allow proper drafting. A cap should be installed at the same time. Strongly recommend that a qualified licensed plumber examine the chimney to determine if the chimney or flues have been damaged and require repairs to prevent CO entry into the home and to verify that the flue or clay liner is properly sized to provide good drafting of the gasses. There was no access to the chimney.

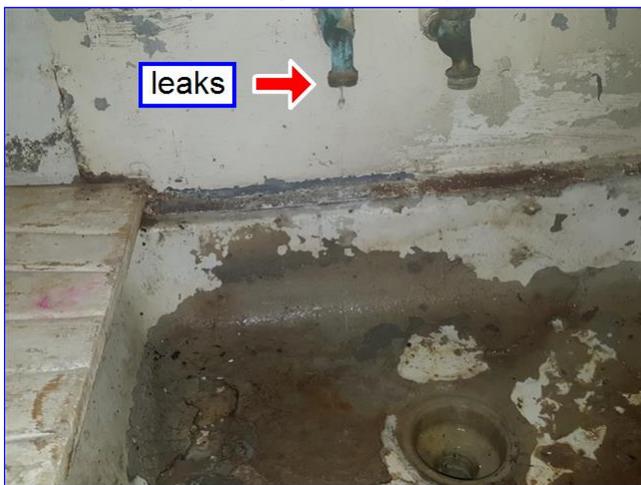
5.0 Item 2(Picture)

(2) The hot water faucet at the washer dryer sink in the basement leaks at the stem when water is turned off . Repairs by a licensed plumber is recommended.

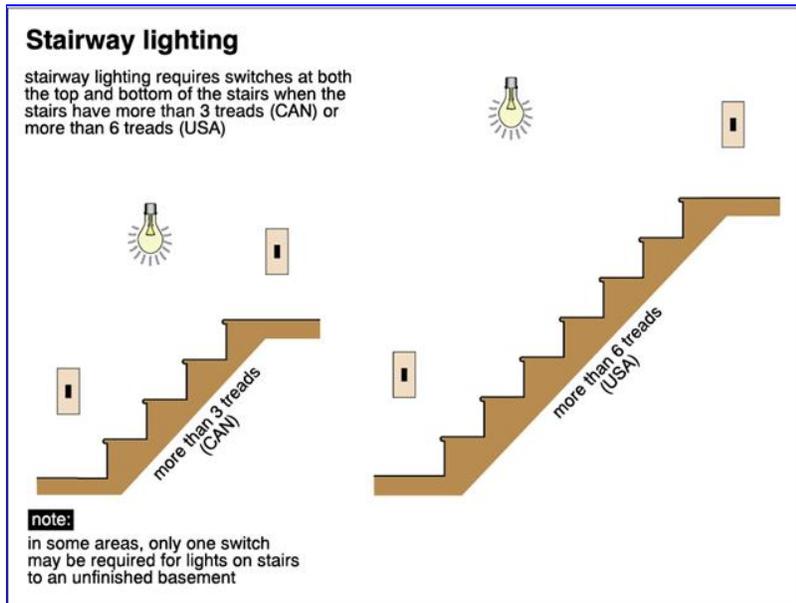
6.3 Item 5(Picture)

(4) The lighting for the staircase leading to the basement is poorly lit. This is a safety hazard as it could contribute to falls. Recommend a light be installed by a qualified licensed electrician to provide adequate illumination.

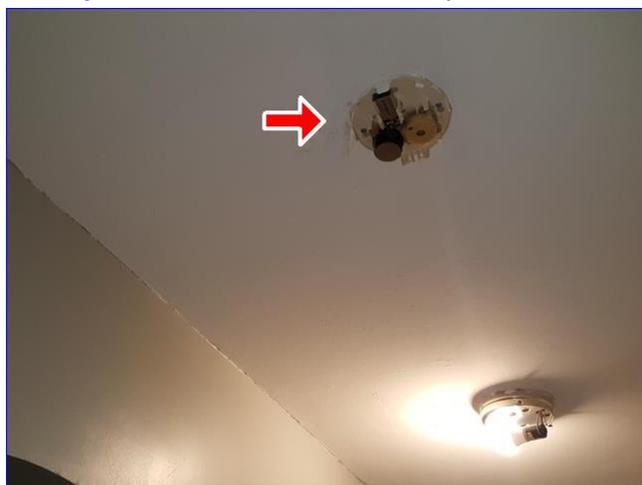
6.8 Item 1(Picture)

(3) The smoke detector is missing a cover at the hallway. Without a working smoke detector in your home you have no first alert to a possible fire. Recommend replacement as needed.
