Home Inspection Report

2037 Evergreen Terrace, West Versesert, NY 10001

Monday, October 7, 2024

1197248

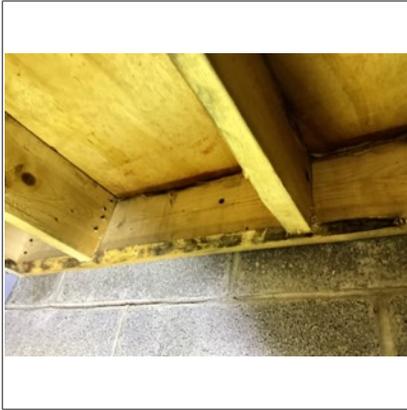
Floors •Liberties have been taken with good framing techniques with regards to a lack of joist hangers under the basement stair framing. You should have repairs made when other structural or carpentry work is being done on the building.

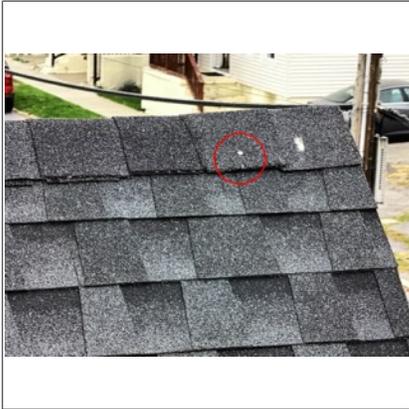
Sloped •Repair: Minor repairs to the roofing are needed. Exposed nails should be sealed as needed.
•Debris should be removed from the roofing to reduce risk of leaks and early roof wear.

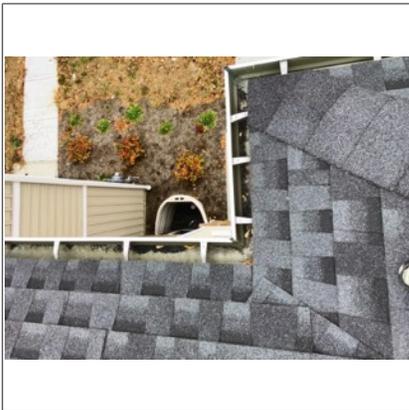
Gutters & downspouts •Repair: The gutters require cleaning to avoid spilling roof runoff around the building - a potential source of water entry or water damage.

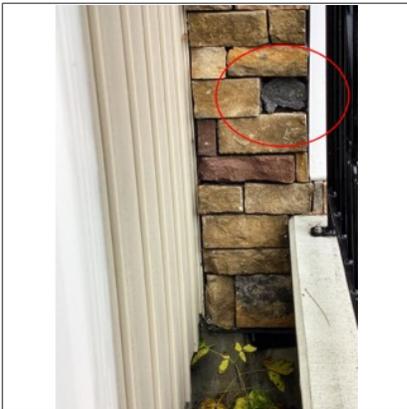
- Ext. walls** •The openings in the siding should be sealed and secured as needed to avoid moisture, insect and or wind damage.

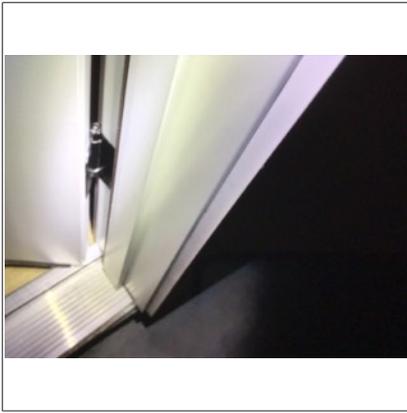
- Garage** •Improve: The door between the house and garage should be fitted with an operable automatic closer or the auto close style hinges should be replaced or adjusted. This will reduce the potential of toxic automobile gases entering the house.

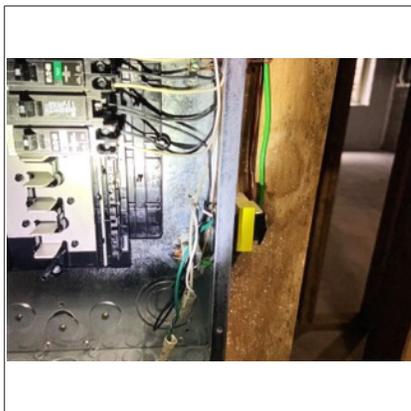
Main distribution panel •Repair: A circuit within the main distribution panel that is doubled up (referred to as a "double tap") should be separated. Each circuit should be served by a separate breaker.

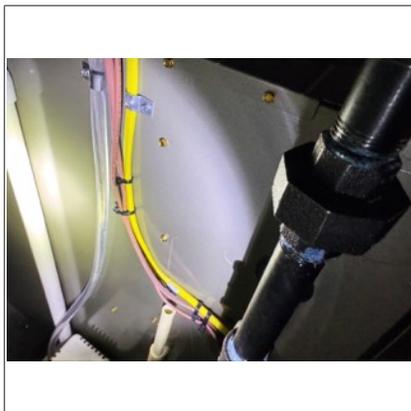
Distribution wires Wiring: Touching Ducts/Pipes, exposed on exterior and or interior finishes should be relocated or protected by a rigid conduit.

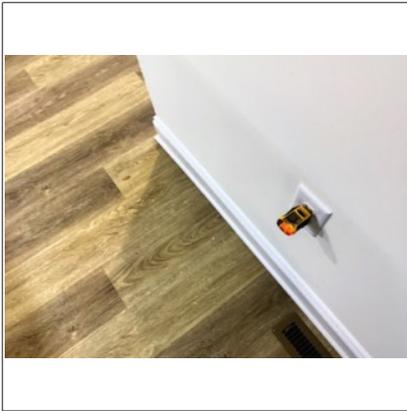
Outlet •The installation of a ground fault circuit interrupter (GFCI) is recommended for all kitchen outlets. A GFCI offers increased protection from shock or electrocution.

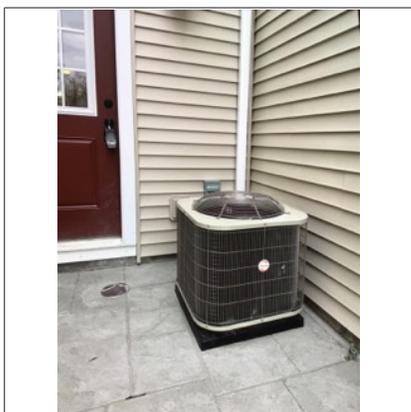
Central air conditioning •The air conditioning system requires servicing.
•The outdoor unit of the air conditioning system requires cleaning.

- The outdoor unit of the air conditioning system should remain level. This should be improved as needed, when and if needed.
- The outdoor unit of the air conditioning systems requires cleaning on a frequent basis.

- It is recommended that just the top of the air conditioning outdoor unit be covered in the months that it is not in use. A top cover can prevent debris from becoming lodged inside the unit. You can use something as simple as a single piece of plywood that is properly secured. It is important not to cover the sides of the AC unit as it may cause trapped moisture that can decay the fins and encourage nesting of rodents, insects or the like. It is important to remember to remove the cover in the spring before use.

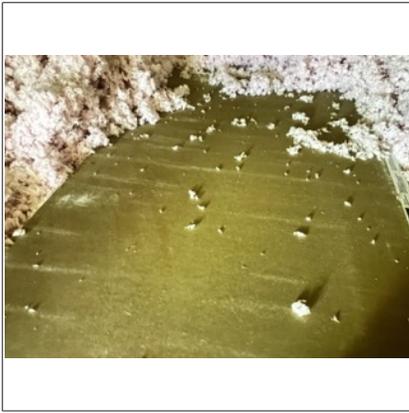
Attic / roof •For improved energy savings, the attic access door should be insulated.

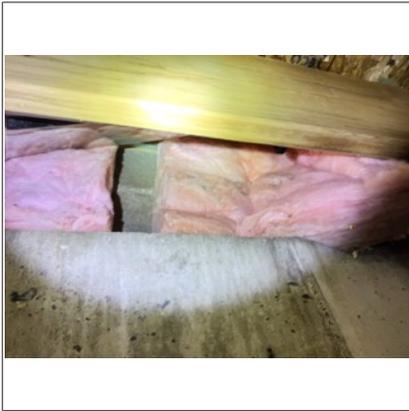
Basement

•Insulation improvements in the voids of the rim joists of the basement walls may be desirable, depending on the anticipated term of ownership.

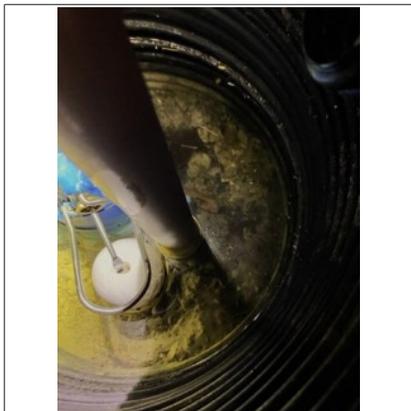
- Gas piping** •The flexible gas line is not ideal and black iron pipe should ideally be installed to replace it. Flexible gas lines are not as durable as traditional black iron.
- Sump pumps** •Debris in the sump pit should be removed.

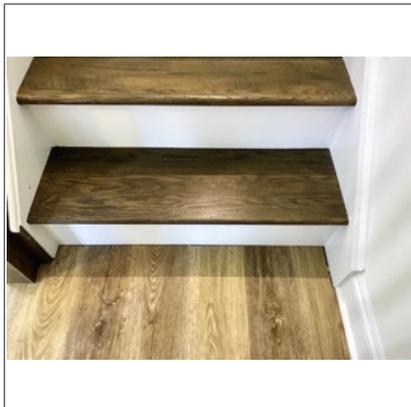
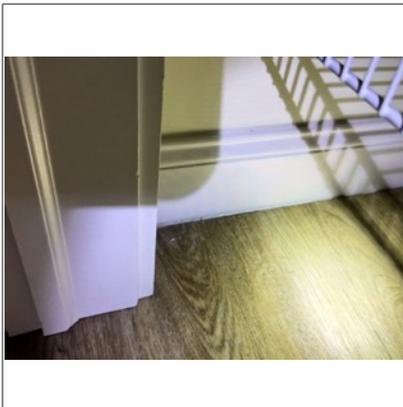
Floors •Repair: The installation of the trim is incomplete.

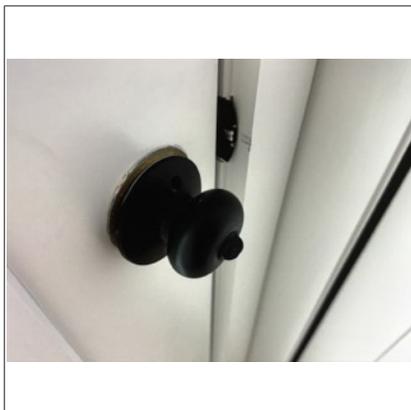
Door •Repair: Loose second floor rear door hardware should be improved.

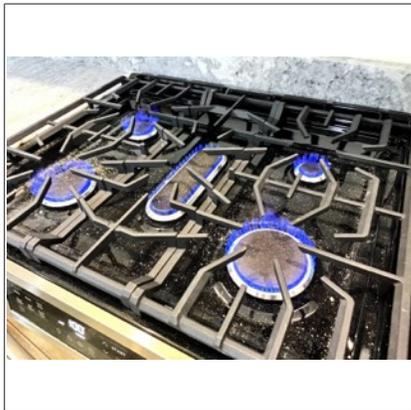
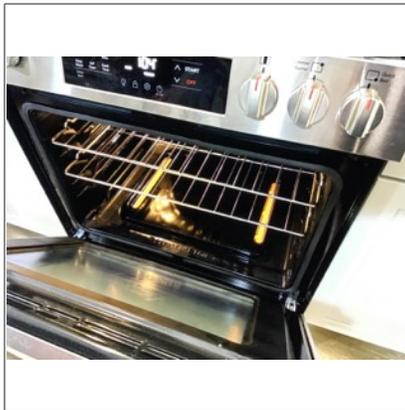
- Gas range unit** •The proper installation of an anti-tip bracket is recommended to safely secure an oven to the floor to provide extra protection when excess force is applied to an open oven door.

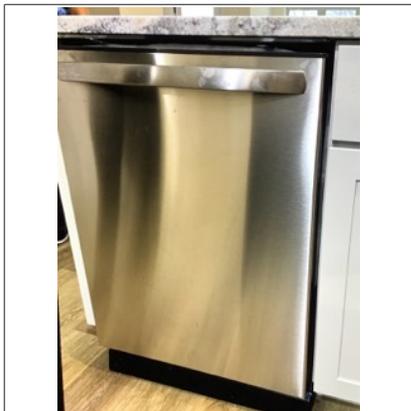
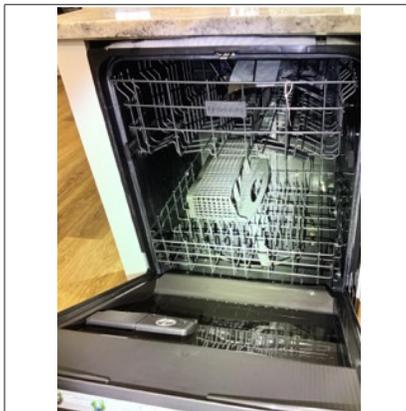
- Dishwasher unit** •Repair: The dishwasher is inoperable, should be approximately installed and secured to the counter top or cabinets.

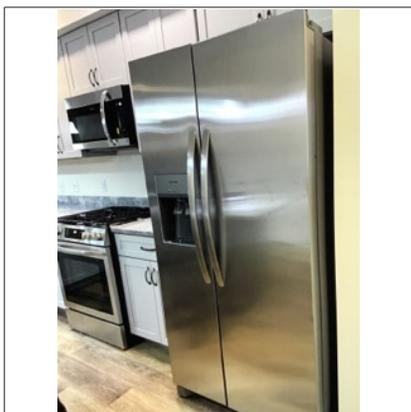
Refrigerator unit •Repair: The freezers ice maker of the refrigerator was iced up at the time of the inspection. Defrosting is recommended as needed.

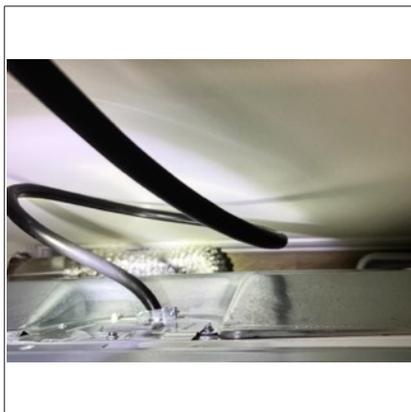
Clothes dryer unit •It is strongly encouraged that the flexible dryer vent be changed to an appropriate solid type material.
