# SAGUACHE CREEK DIVERSION INFRASTRUCTURE INVENTORY

**Structure Name:** FRIESE D 1

**Date:** April 12, 2019

Saguache Creek Stream  
Management Plan

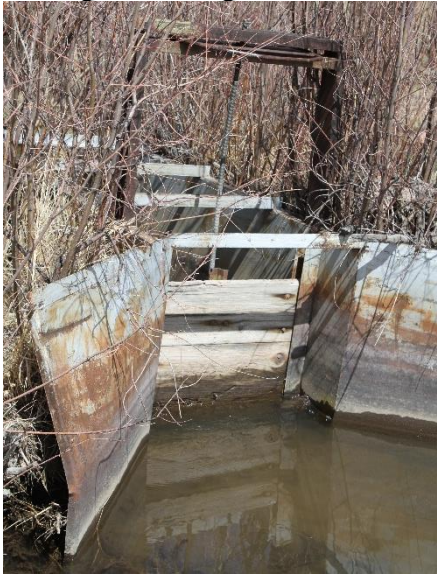
Headgate looking downstream

**Structure Description:** This ditch is located at the apex of a meander. A boulder diversion dam directs water to the headgate, which is located on the north bank of the stream. Downstream of the diversion dam, a scour pool has formed and the north bank of the stream is eroding. The headgate functions but leaks badly.

**Repair(s) or Improvement(s) Currently Needed:** The leaky headgate needs to be repaired and the ditch and flume also need to be cleaned regularly. The diversion dam could be improved to mitigate downstream erosion and reduce maintenance Fish passage and riparian restoration should be considered as part of any future repairs or improvements.
