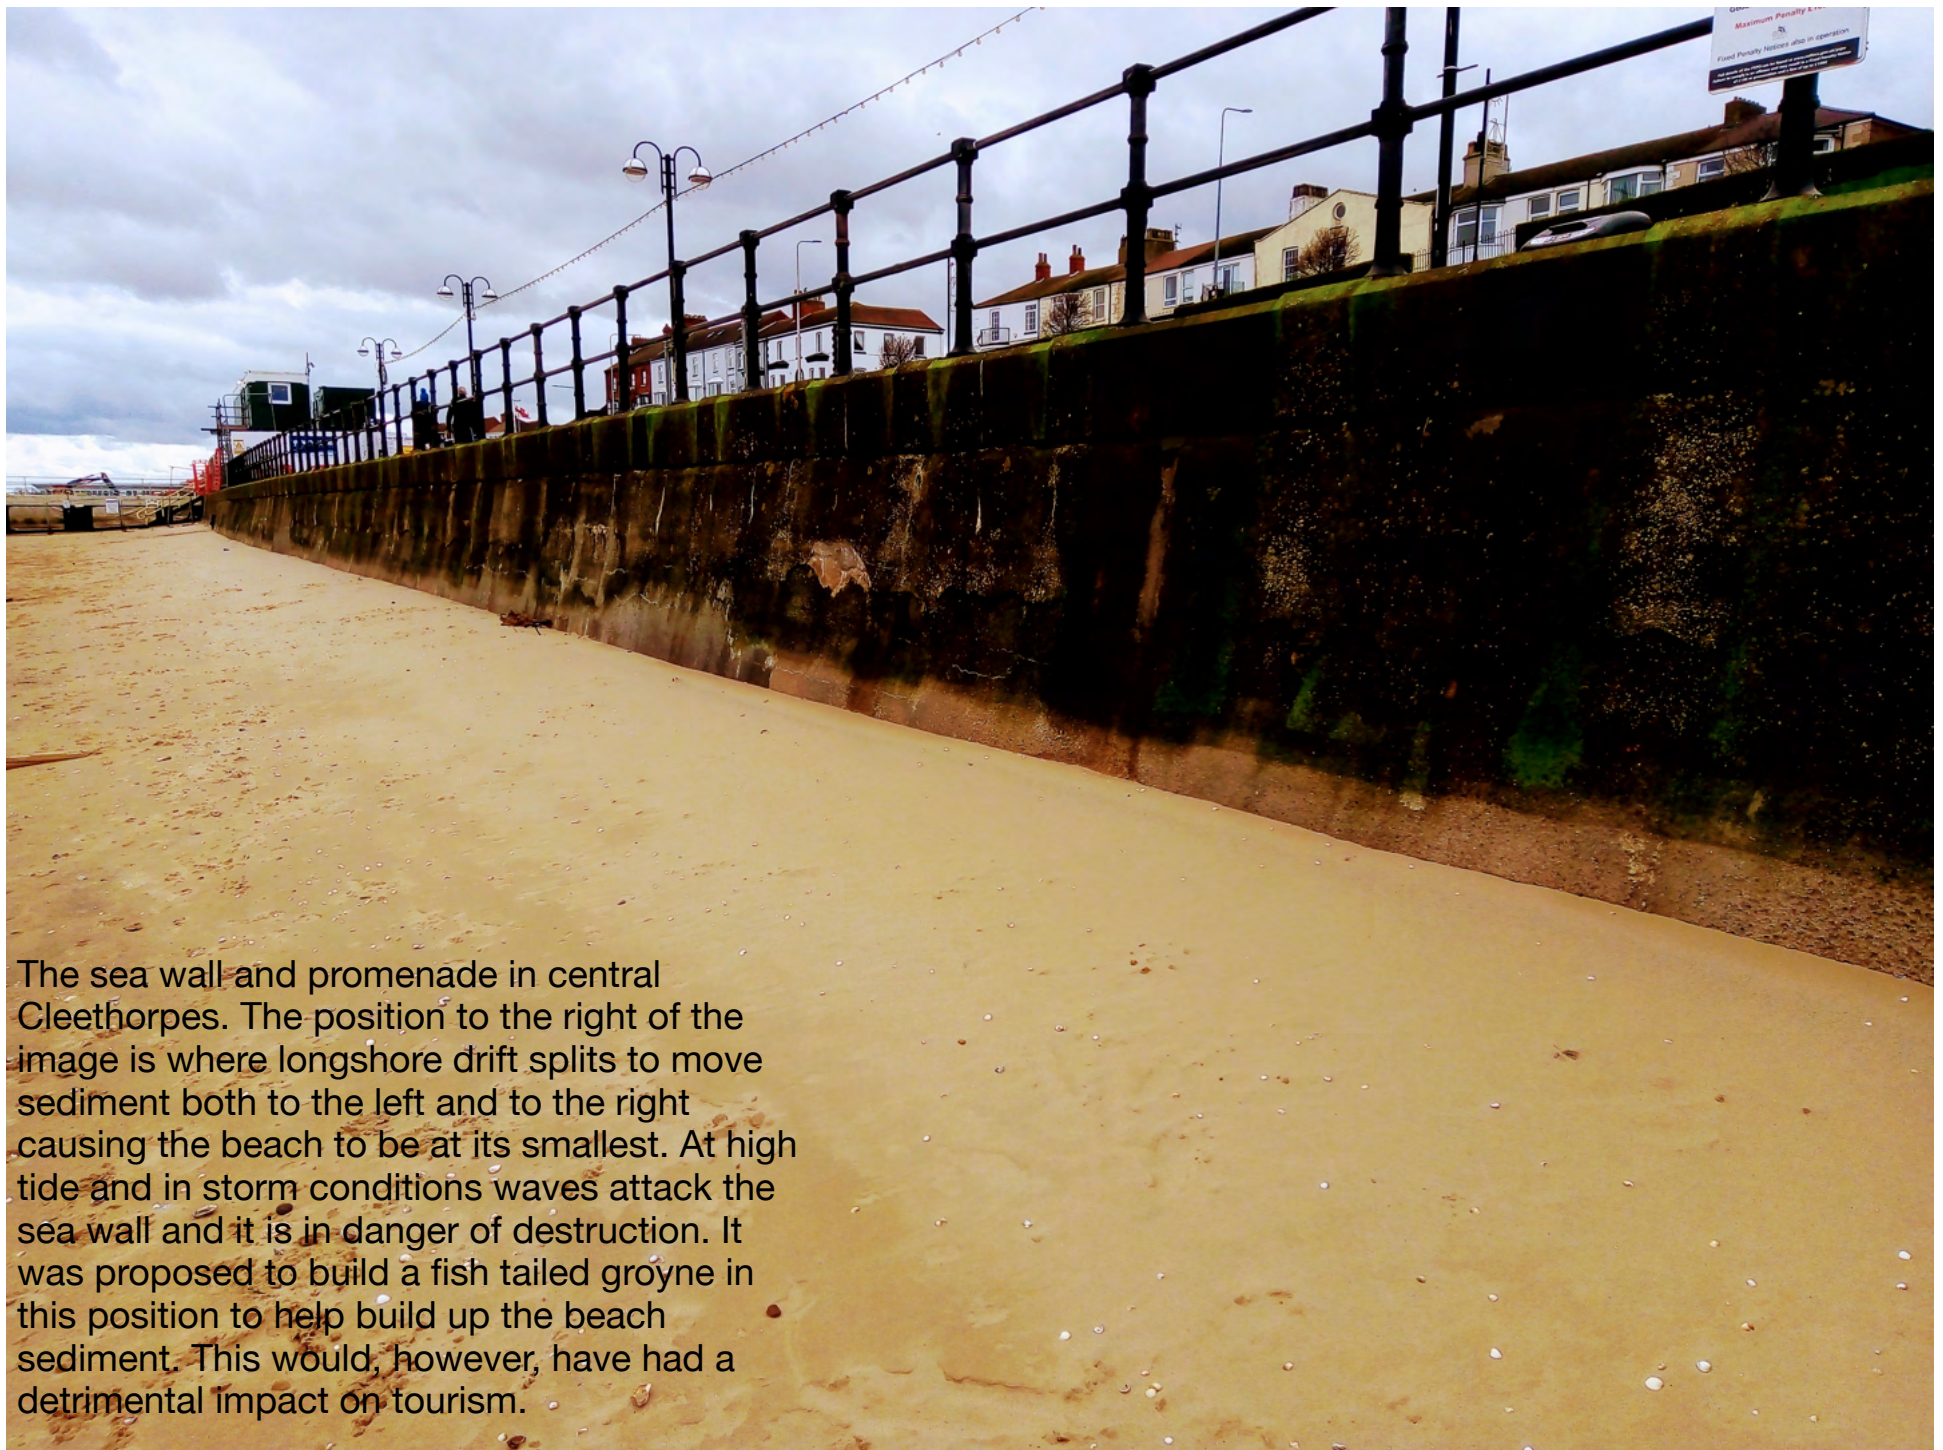
The sea wall and promenade in central Cleethorpes. The position to the right of the image is where longshore drift splits to move sediment both to the left and to the right causing the beach to be at its smallest. At high tide and in storm conditions waves attack the sea wall and it is in danger of destruction. It was proposed to build a fish tailed groyne in this position to help build up the beach sediment. This would, however, have had a detrimental impact on tourism.

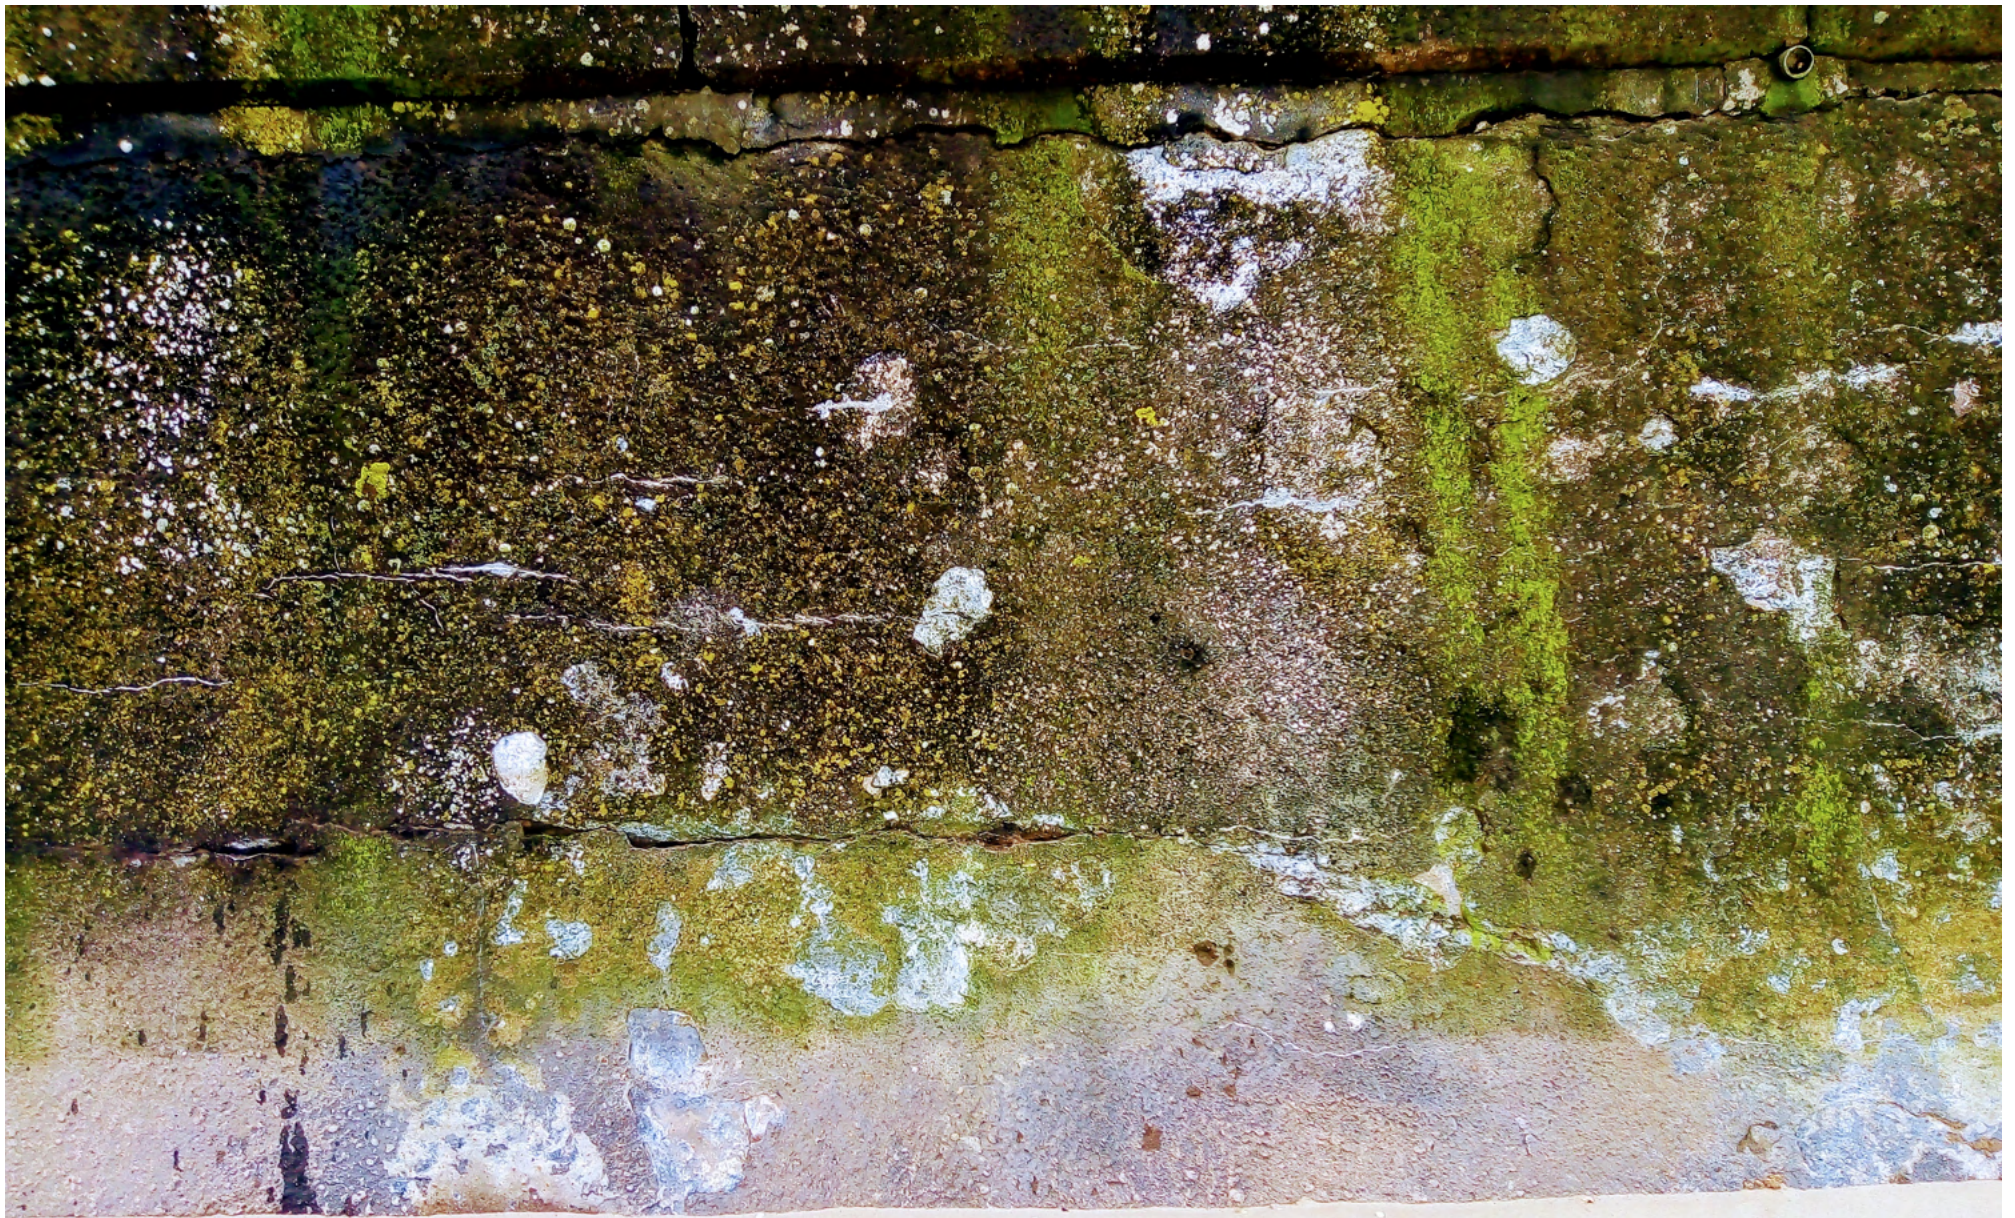
A close-up view of the sea wall on the central promenade of Cleethorpes shows the damage done by waves to a structure that is beyond its design life. It is clear that repairs have been attempted.

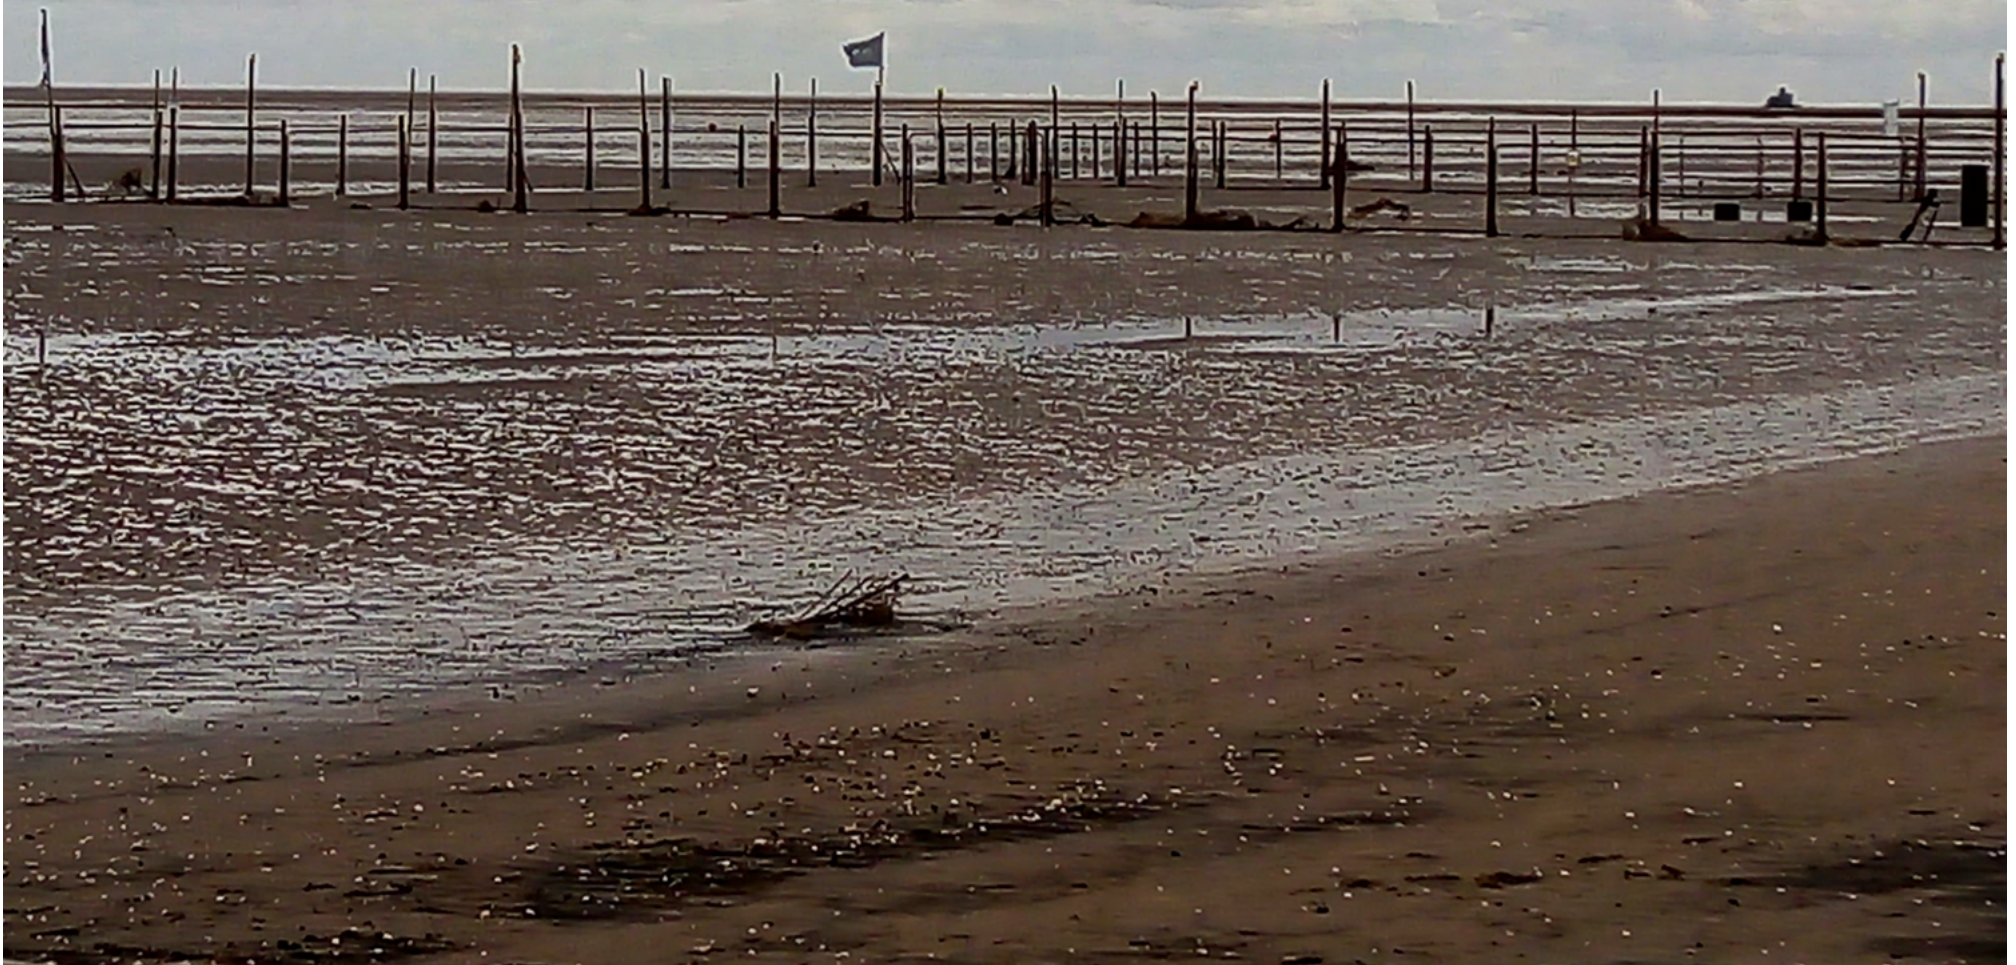
The foundations for the new Lifeboat Station that is being built in central Cleethorpes. This structure may take the place of a groyne and enable the accumulation of more sand to help absorb wave energy and protect the sea wall. It may, however, disrupt longshore drift and shoreline currents and make the deposition of sandy beach more difficult.

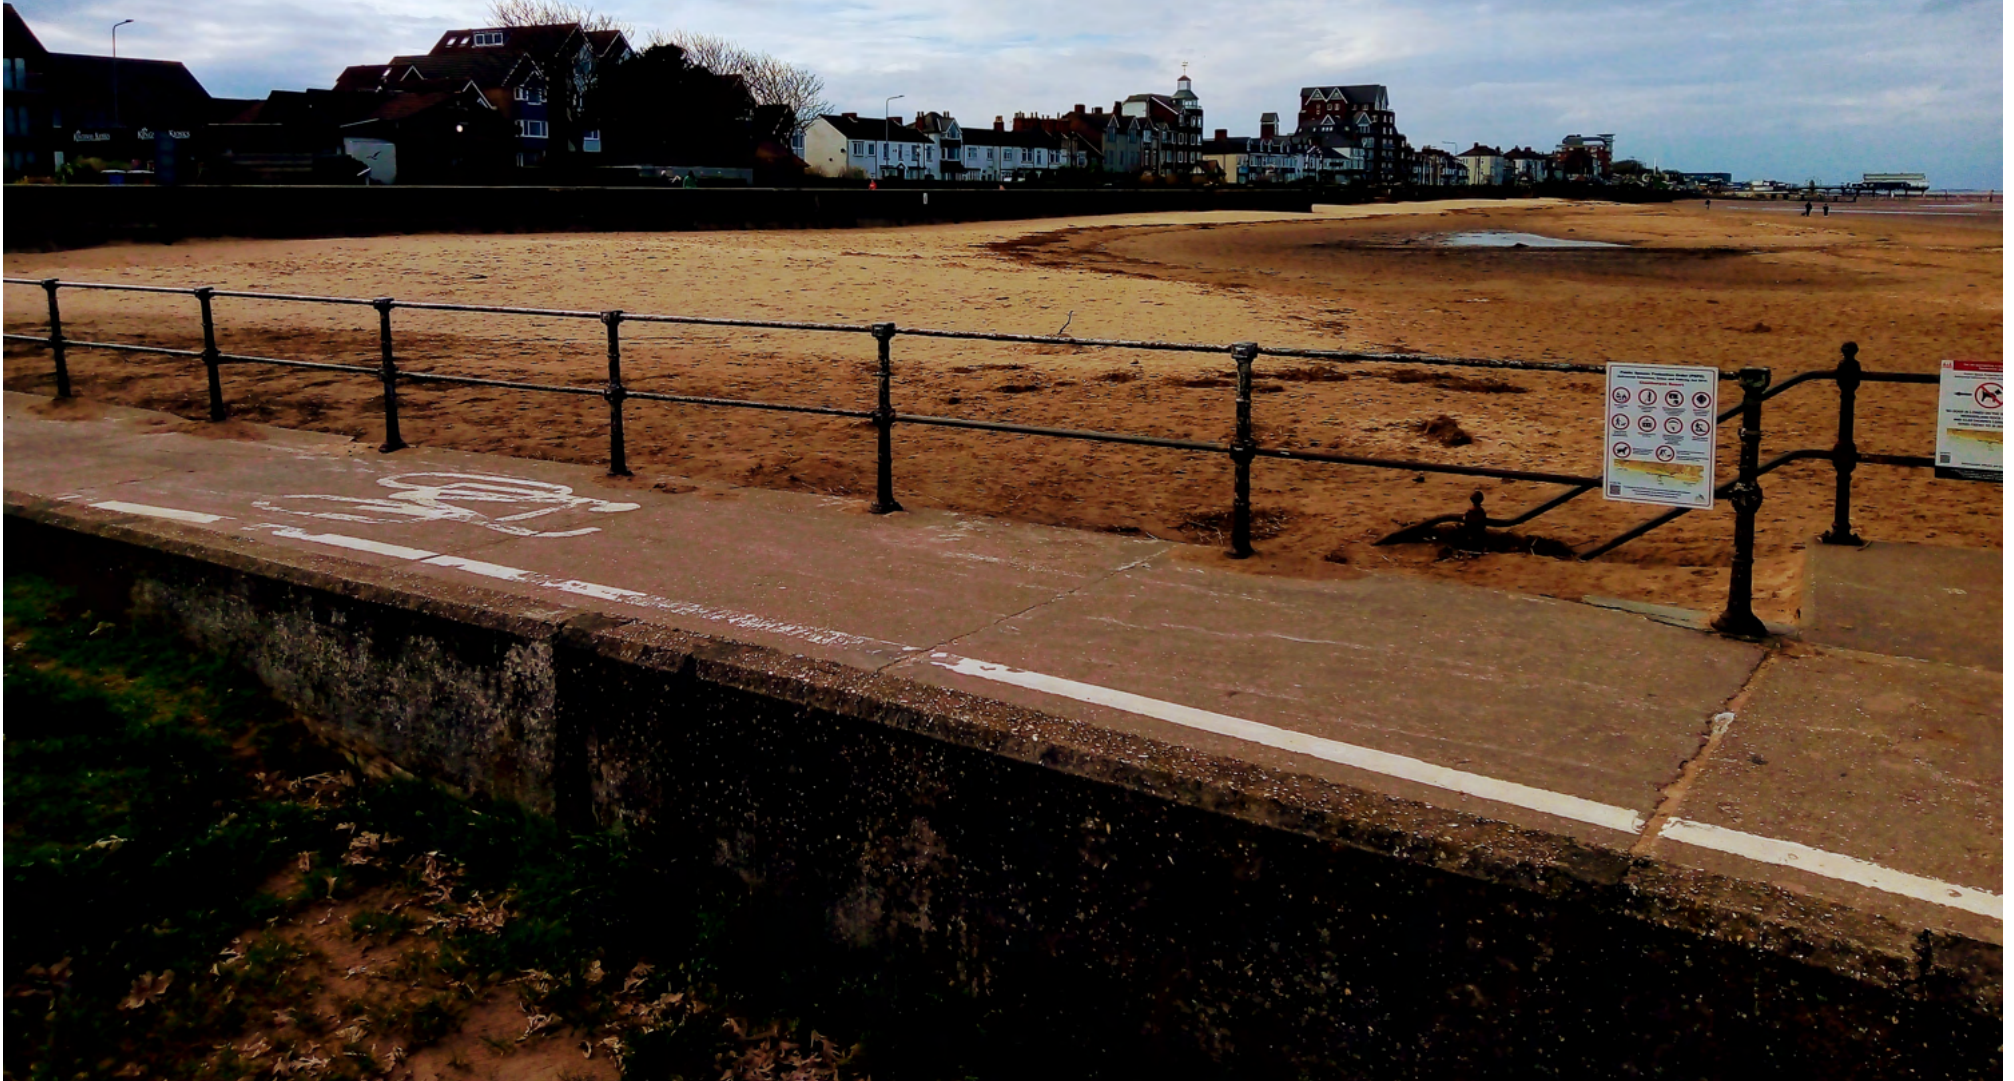
A view from the Leisure centre on the central promenade with longshore drift from north to south, towards the photographer. It is clear that the construction of the Leisure Centre had encouraged the accumulation of sand making it less likely that high tide waves will reach the sea wall, as evidenced by the large pale coloured area of dry sand adjacent to the sea wall.

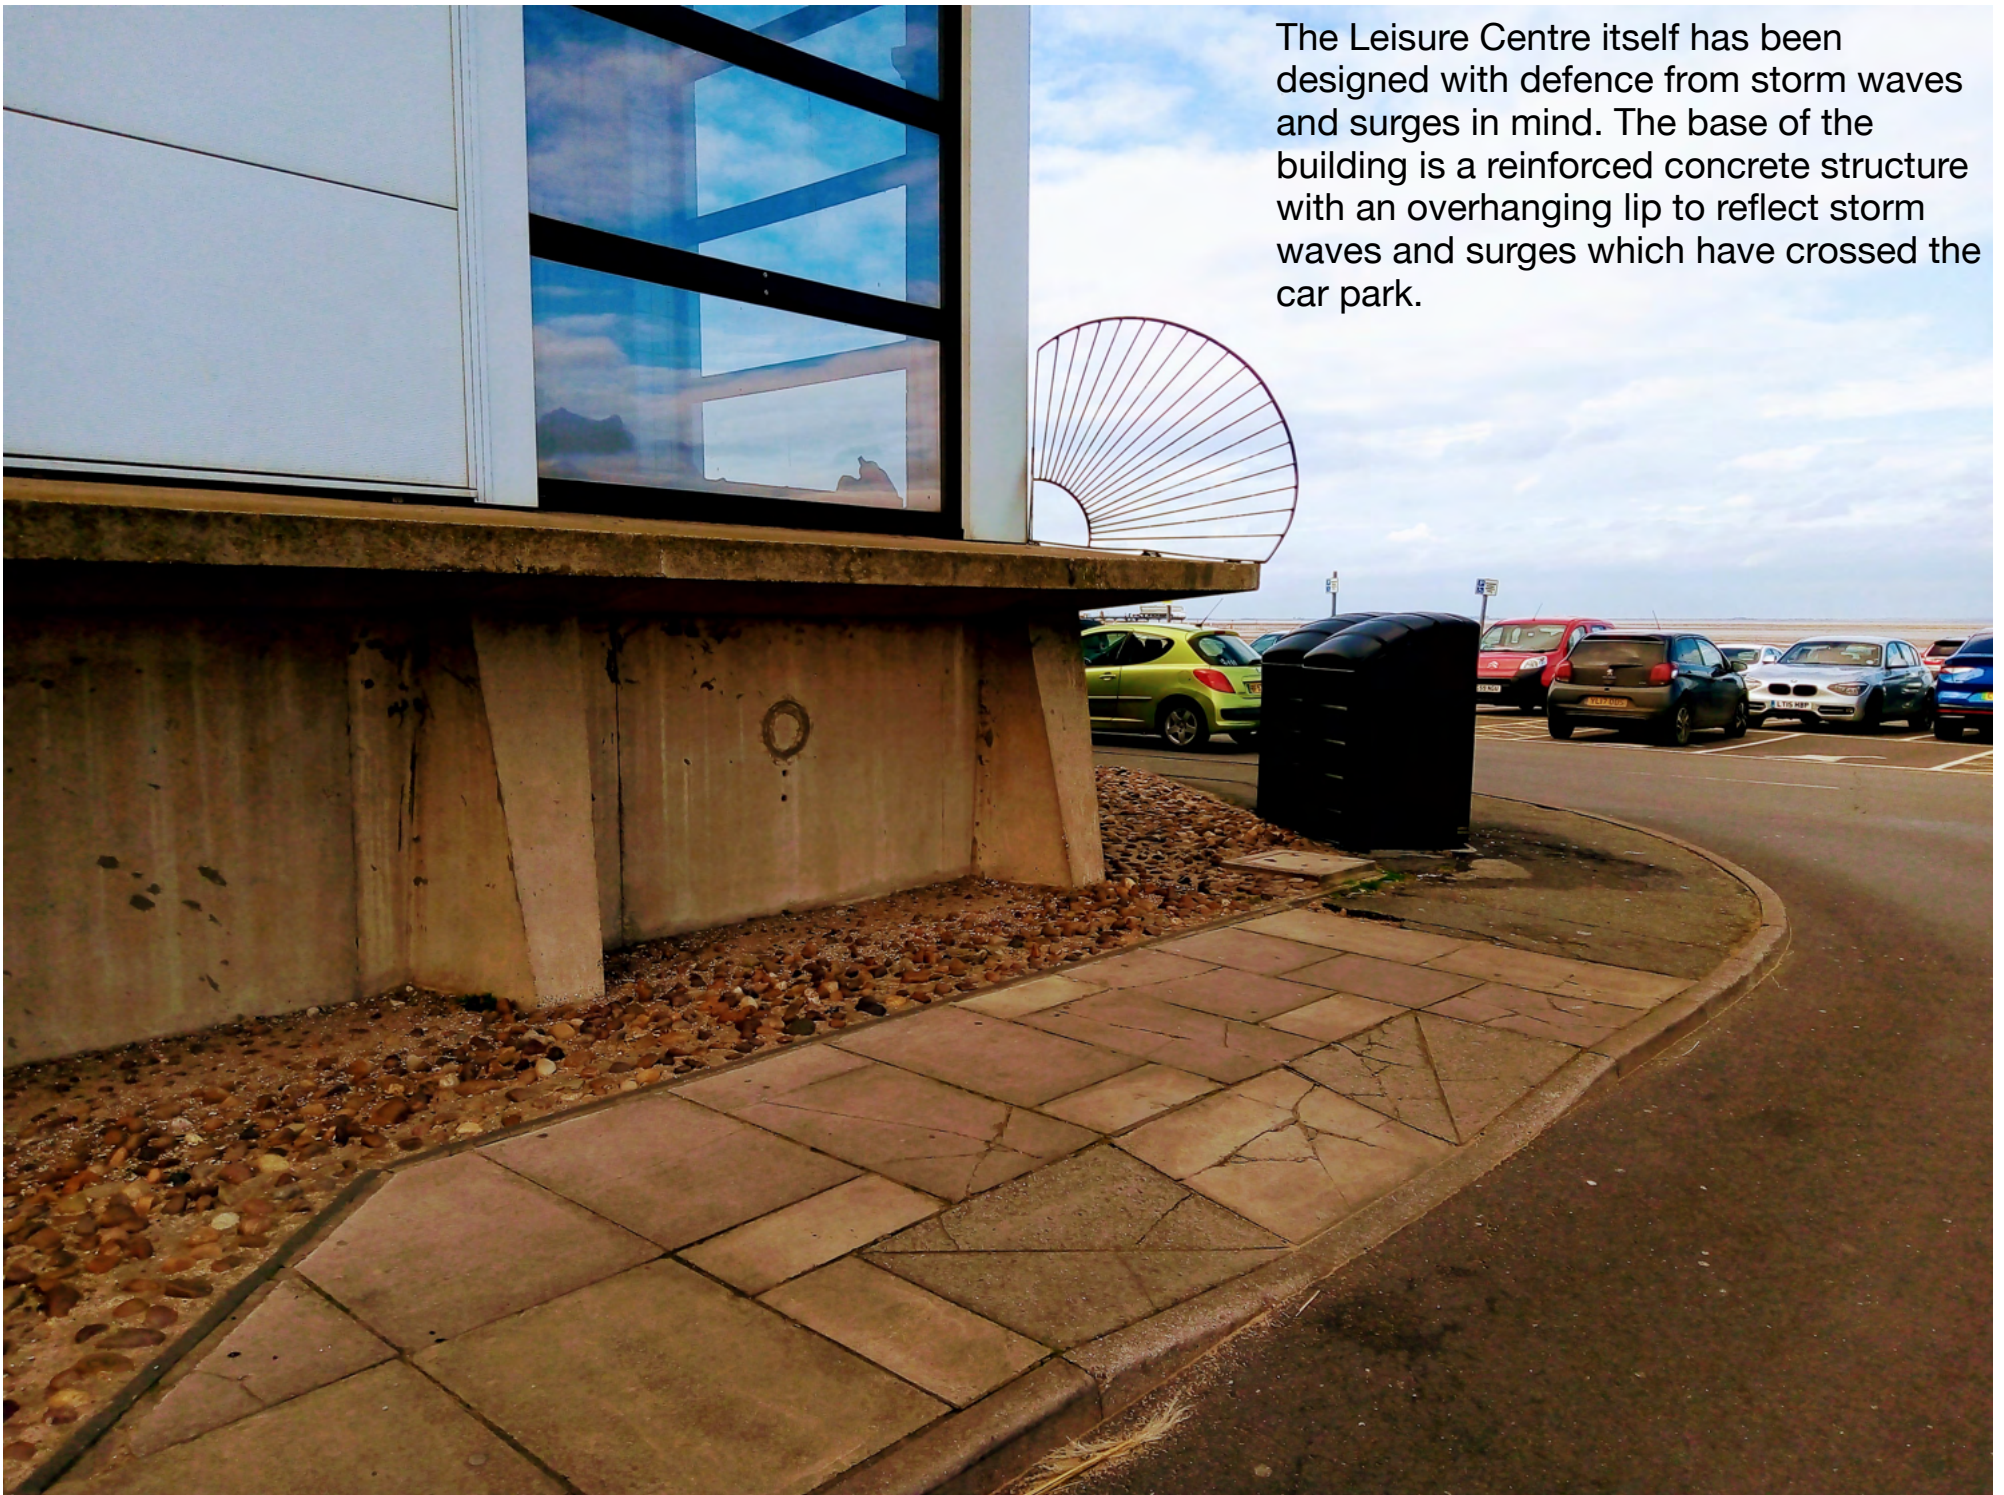
The Leisure Centre itself has been designed with defence from storm waves and surges in mind. The base of the building is a reinforced concrete structure with an overhanging lip to reflect storm waves and surges which have crossed the car park.

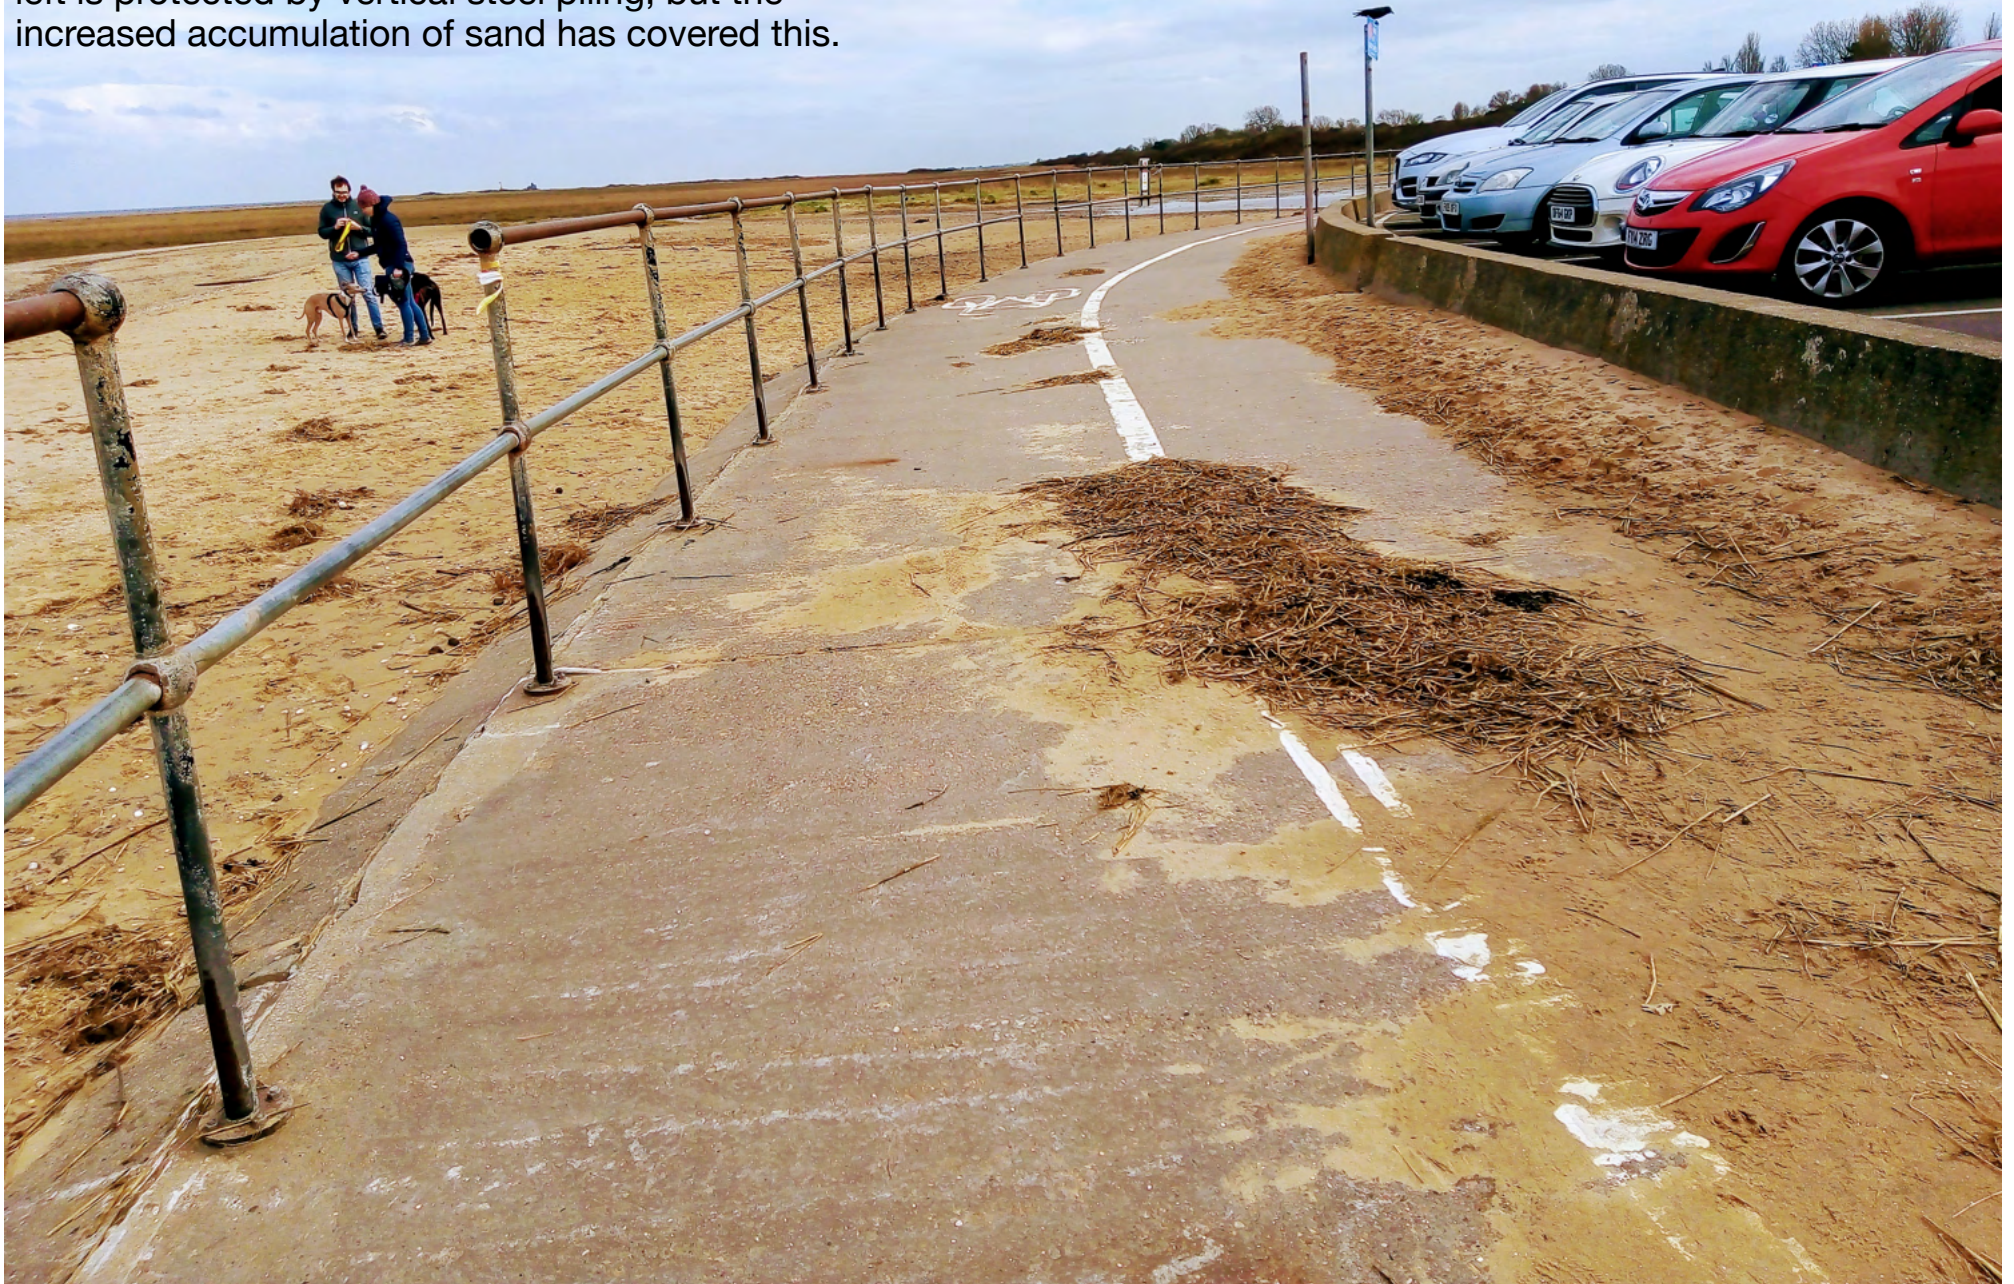
The path around the car park is designed to be covered by the sea occasionally as you can see by the strand line of material deposited at high tide in the centre of the path. The edge of the path to the left is protected by vertical steel piling, but the increased accumulation of sand has covered this.

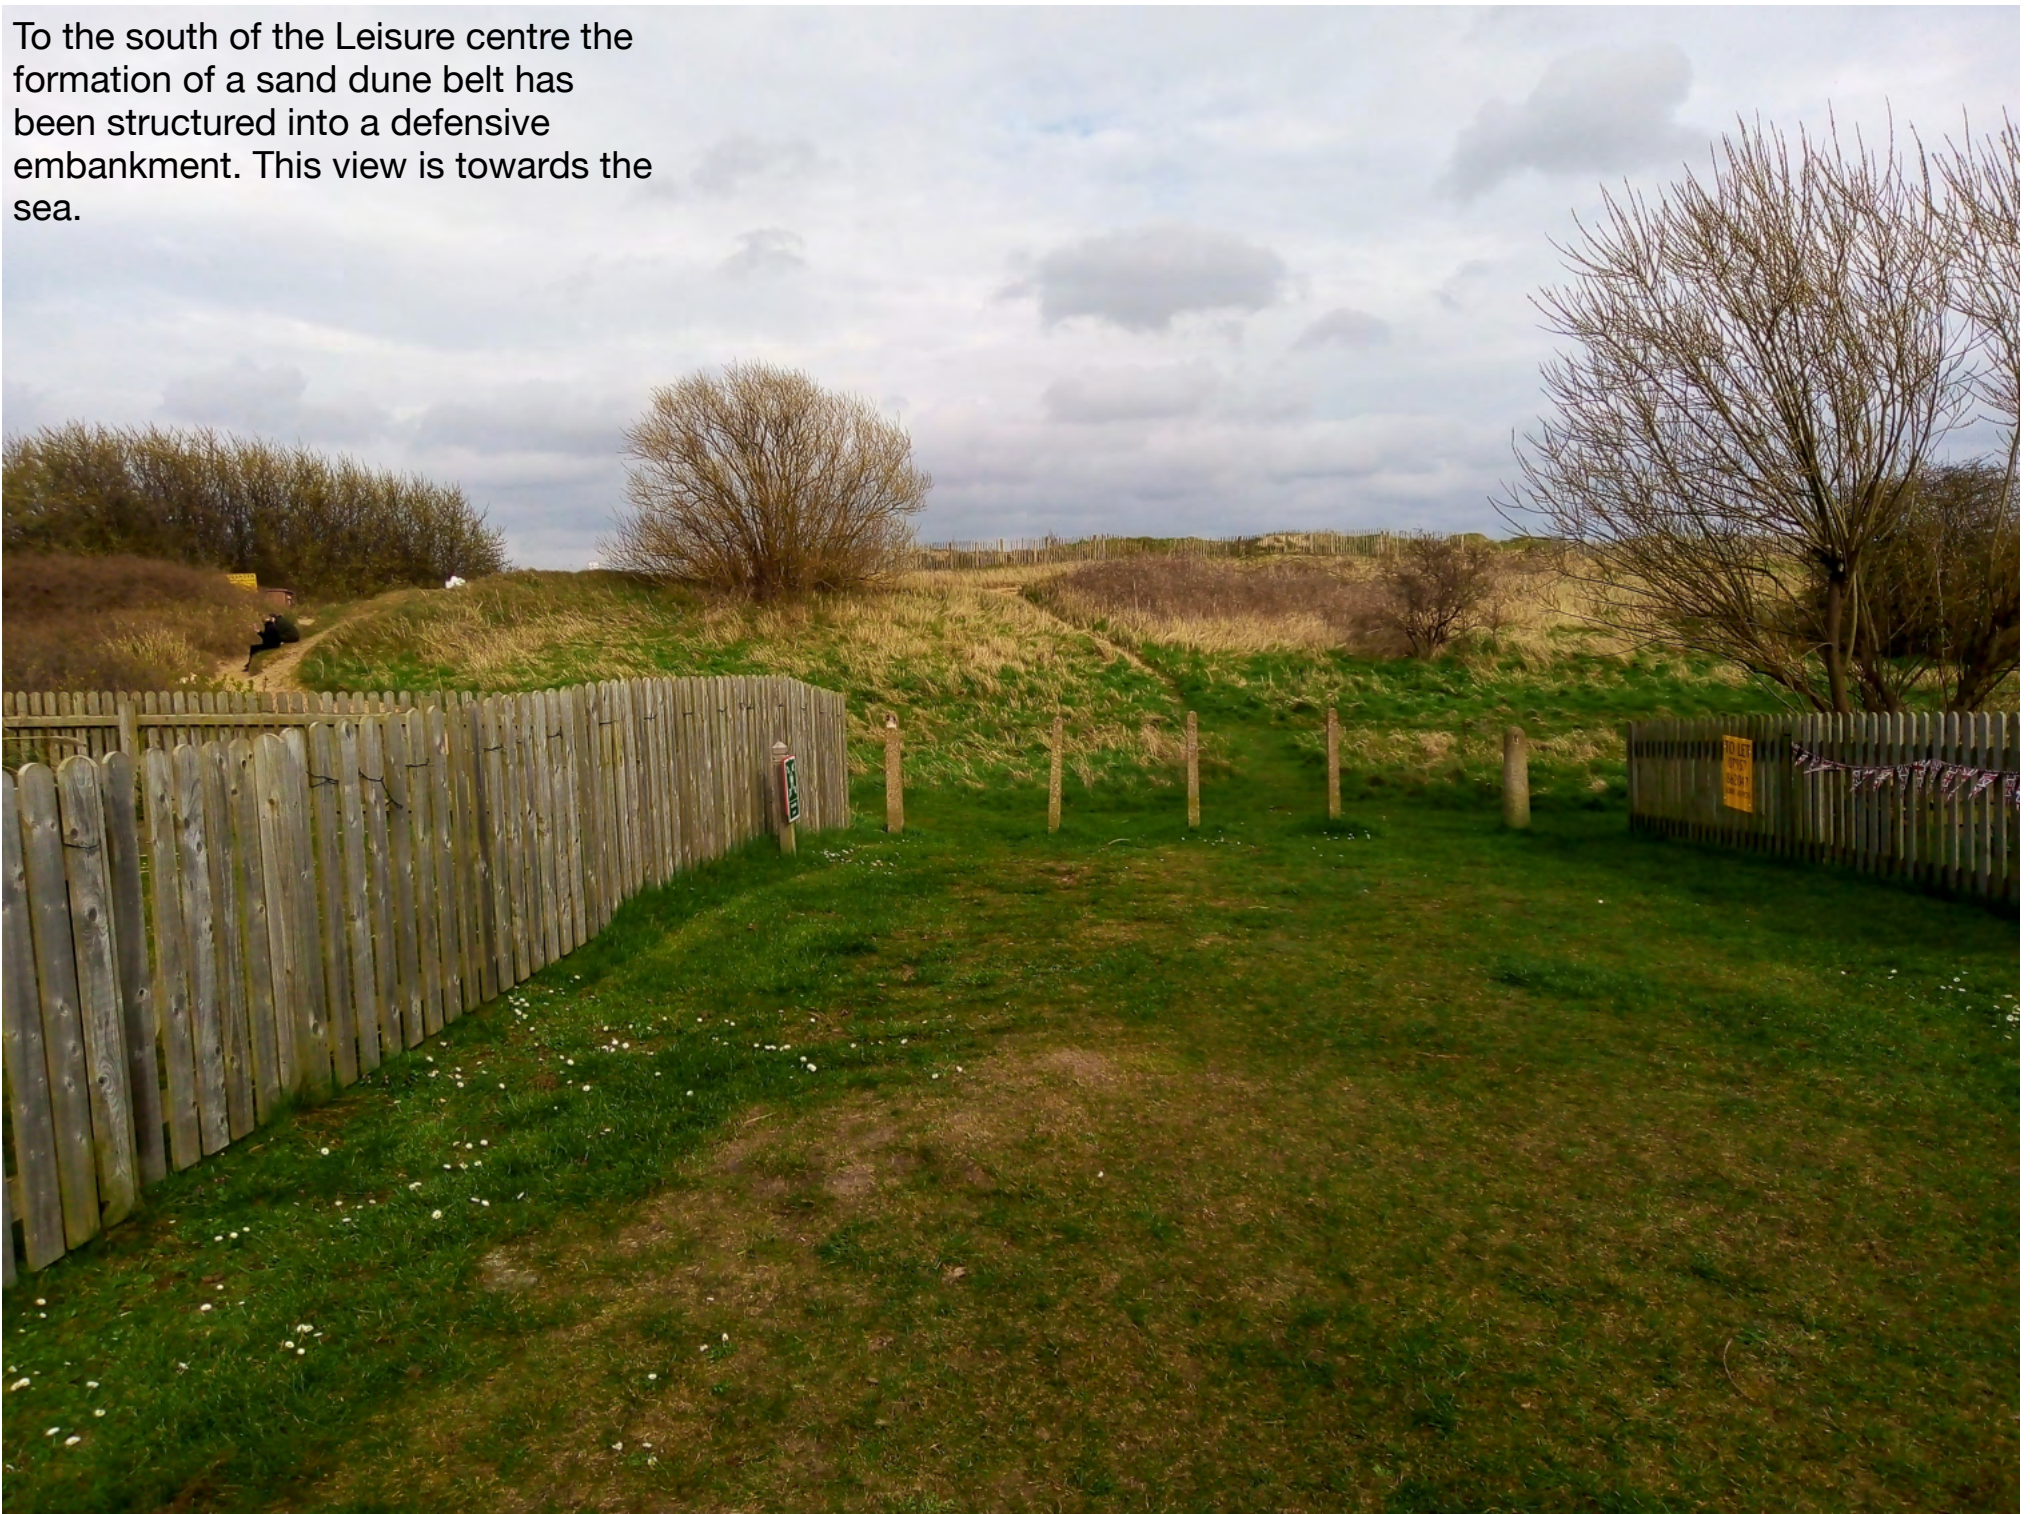
To the south of the Leisure centre the formation of a sand dune belt has been structured into a defensive embankment. This view is towards the sea.
