SAGUACHE CREEK DIVERSION INFRASTRUCTURE INVENTORY

Structure Name: I L GOTTHELF D

Date: April 12, 2019

Saguache Creek Stream Management Plan

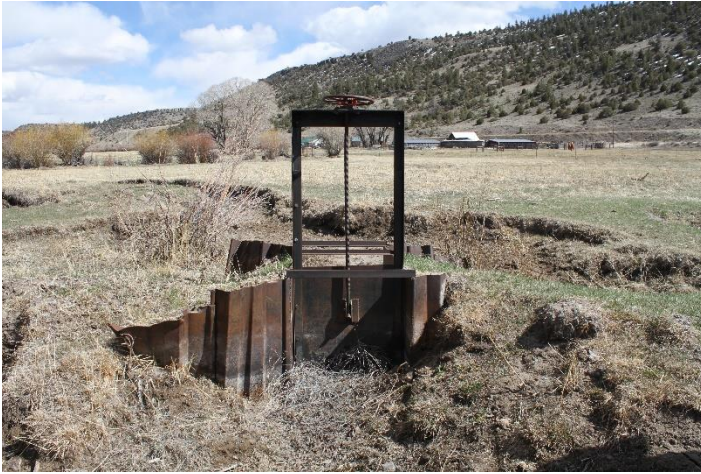
Headgate looking downstream

Repair(s) or Improvement(s) Currently Needed: The headgate is tilted and needs to be reset. The head walls also need to be repaired. The diversion dam could be improved. The flume also needs to be reset to prevent flood flows from bypassing it. Fish passage and riparian restoration should be considered as part of any future repairs or improvements.

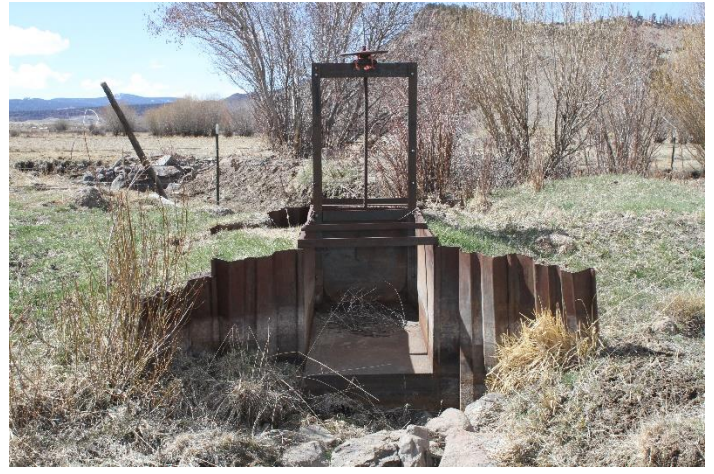
Headgate outlet

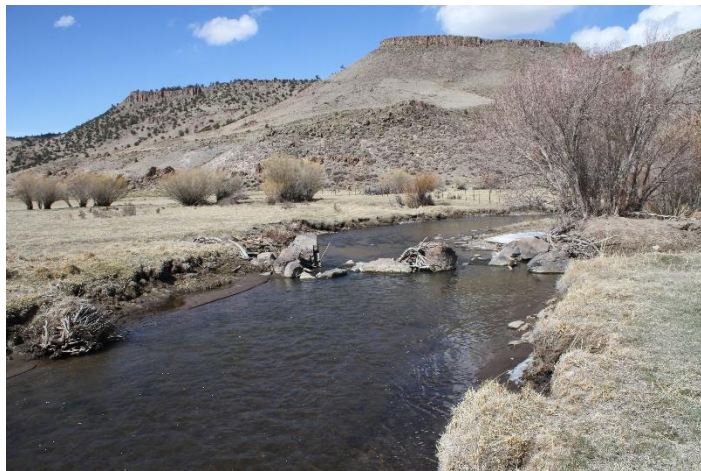
Headgate and diversion dam

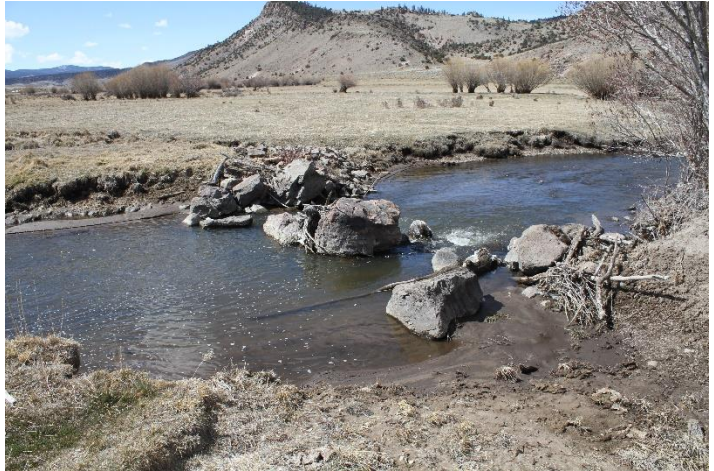
Diversion dam

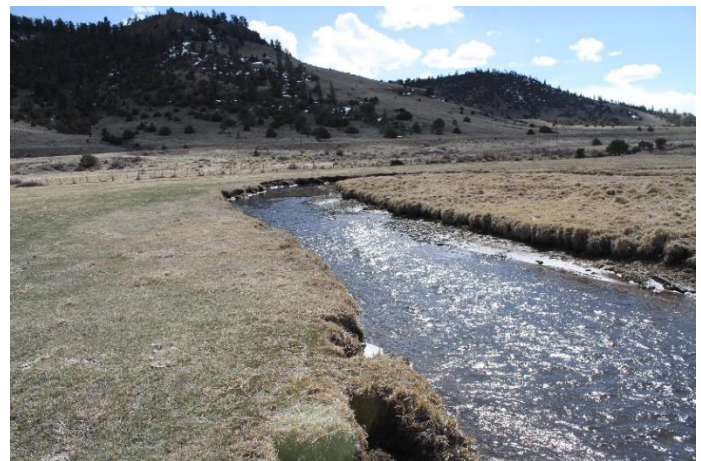
Flume looking downstream

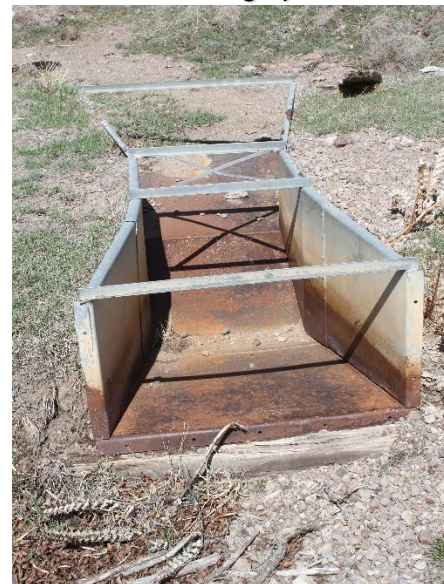
Flume looking upstream
