# SAGUACHE CREEK DIVERSION INFRASTRUCTURE INVENTORY

**Structure Name:** WARD HIGHLINE D ALT

PHOTO LOG

Saguache Creek Stream  
Management Plan

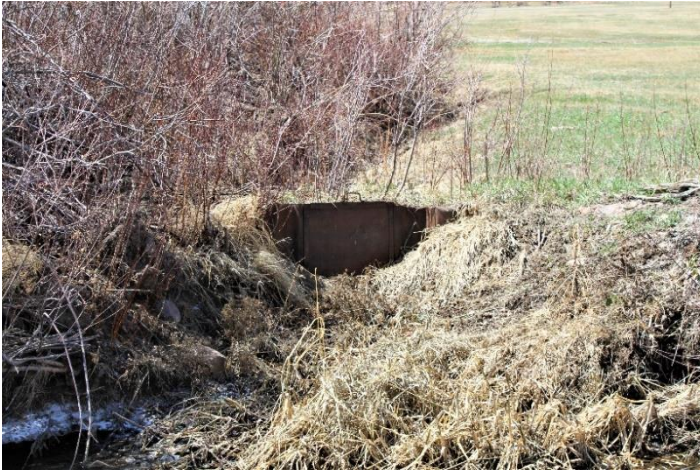
**Repair(s) or Improvement(s) Currently Needed:** Debris and sediment accumulate in front of the headgate, which needs to be cleaned regularly. The diversion dam should be improved or replaced. Fish passage and riparian restoration should be considered as part of any future repairs or improvements.

Headgate looking downstream

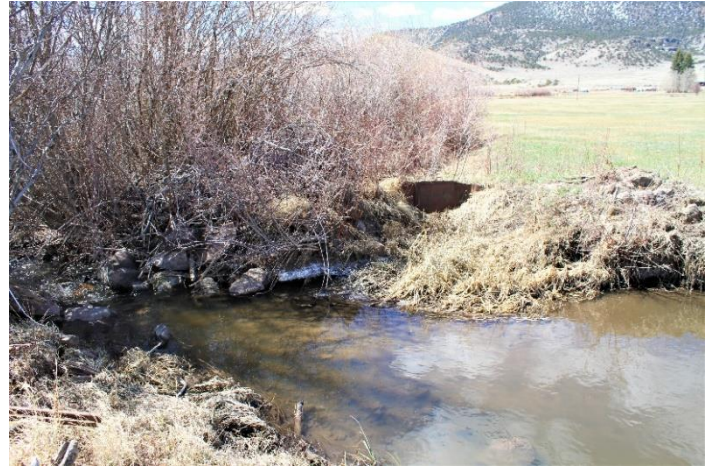
**Structure Description:** This ditch shares a diversion dam with the Ward Highline Ditch. Roughly 500 feet downstream of the Ward Highline Ditch headgate, a small stacked rock diversion dam directs water to the headgate. This ditch is seldom used, but the diversion dam does not function well and should be improved.

Headgate and diversion dam

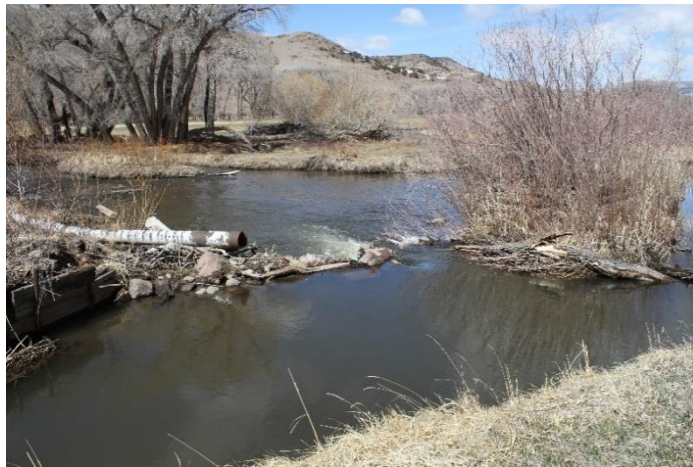
Diversion dam and feeder ditch

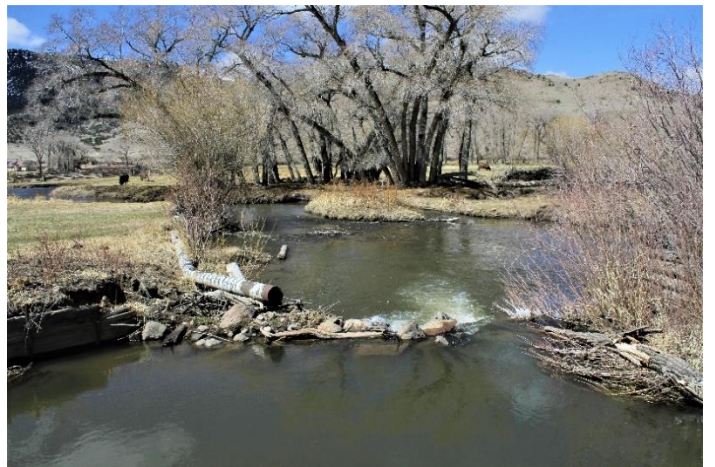
Diversion dam

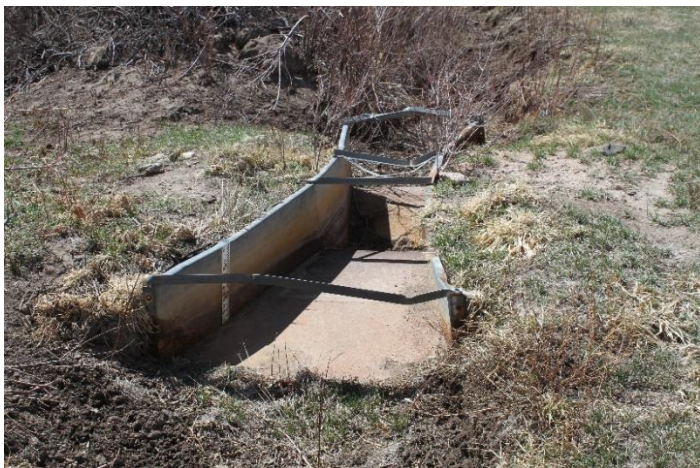
Flume looking downstream

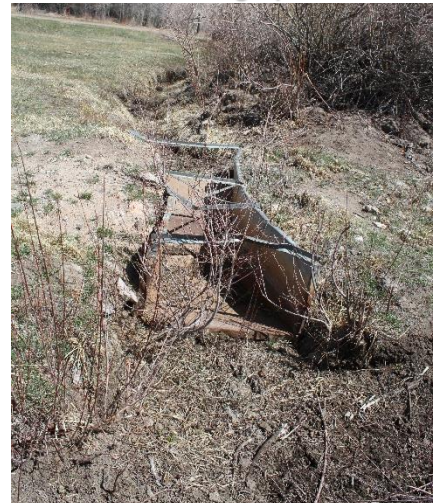
Flume looking upstream
