DEPARTMENT OF REGULATORY
AND ECONOMIC RESOURCES

MINIMUM INSPECTION PROCEDURAL GUIDELINES
FOR BUILDING ELECTRICAL RECERTIFICATION

- a. Name on Title: Village at Dadeland Condominiums (H)
- b. Street Address: 7650 SW 82nd St. Miami, Florida 33143
- c. Legal Description: Village at Dadeland Condominiums
- d. Owner's Name: Village at Dadeland Condominiums
- e. Owner's Mailing Address: 7650 SW 82nd St. Miami, Florida 33143
- f. Folio Number of Property on which Building is Located: 30-4035-047-XXXX
- g. Building Code Occupancy Classification: R2 - Residential
- h. Present Use: Condominium, Residential
- i. General Description, Type of Construction, Size, Number of Stories, and Special Features

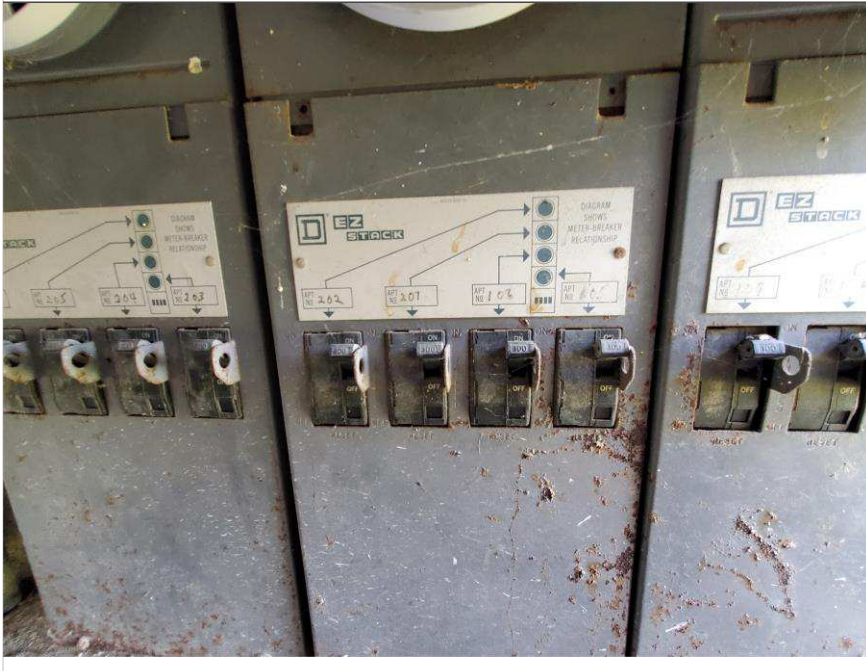
Photo 9 – Village of Dadeland Condominium Association

Existing Electrical Room - 1st FL
Apartment Meters and Main
Switches

Old and oxidized meter stacks.

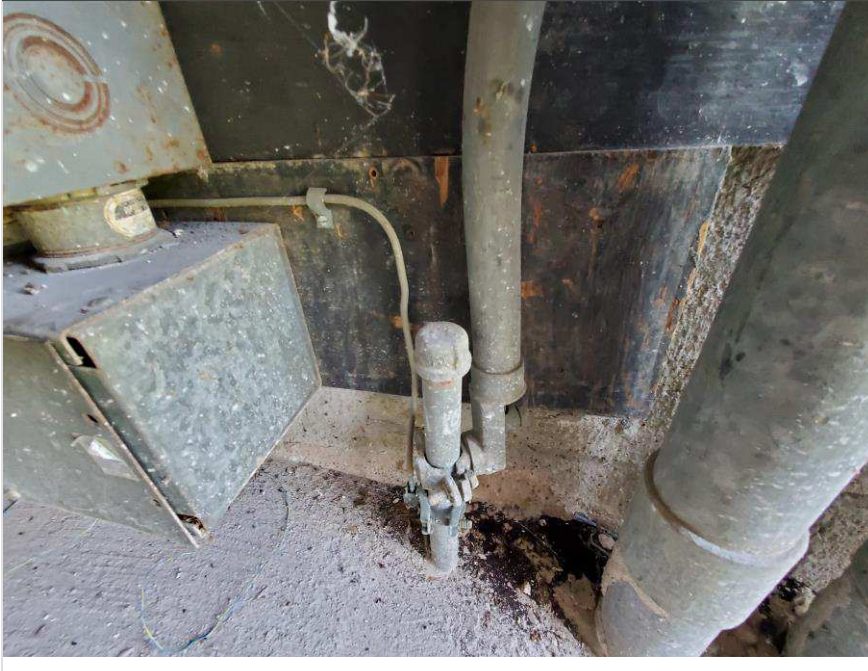
Photo 11 – Village of Dadeland Condominium Association

Existing Electrical Room - 1st FL
Main Distribution -Grounding

Grounding resistance to be tested to determine if repairs and/or maintenance are required.

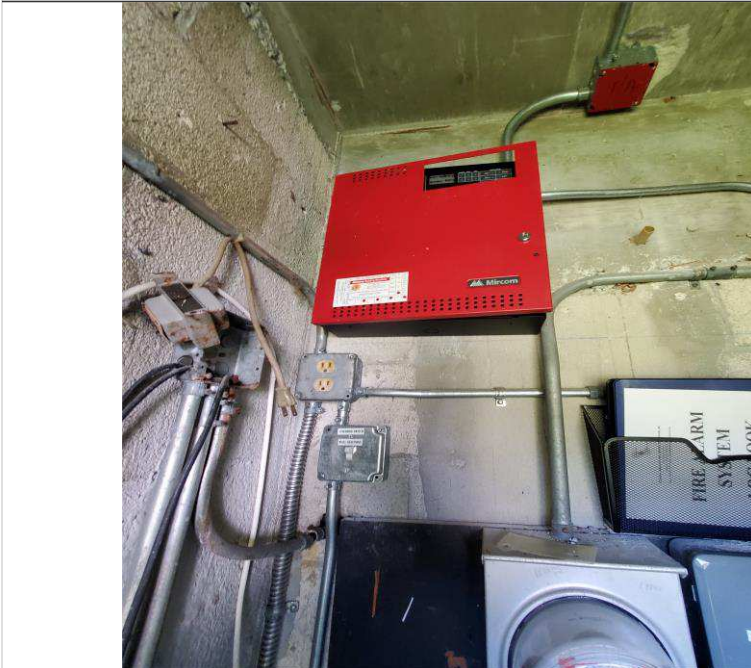
Photo 12 – Village of Dadeland Condominium Association

Existing Electrical Room - 1st FL
Fire Alarm Panel

All penetrations or openings in walls are to be fire caulked.

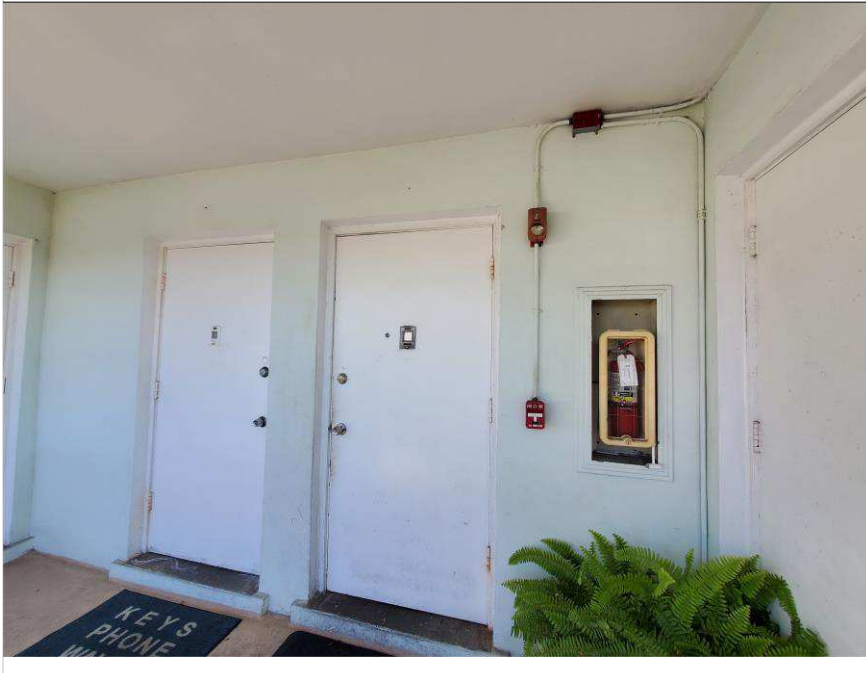
Photo 15 – Village of Dadeland Condominium Association

Fire Alarm - Old and Weathered
Fire Alarm Devices and Control
Center

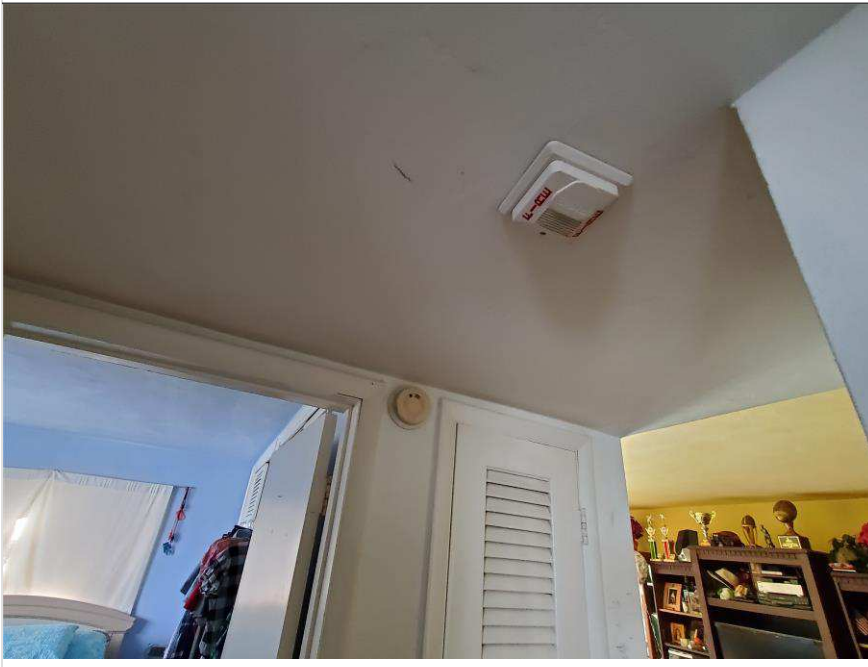
Photo 22 – Village of Dadeland Condominium Association

Apartments - Old Smoke Detectors

Old Smoke or CO₂ detectors to be replaced.

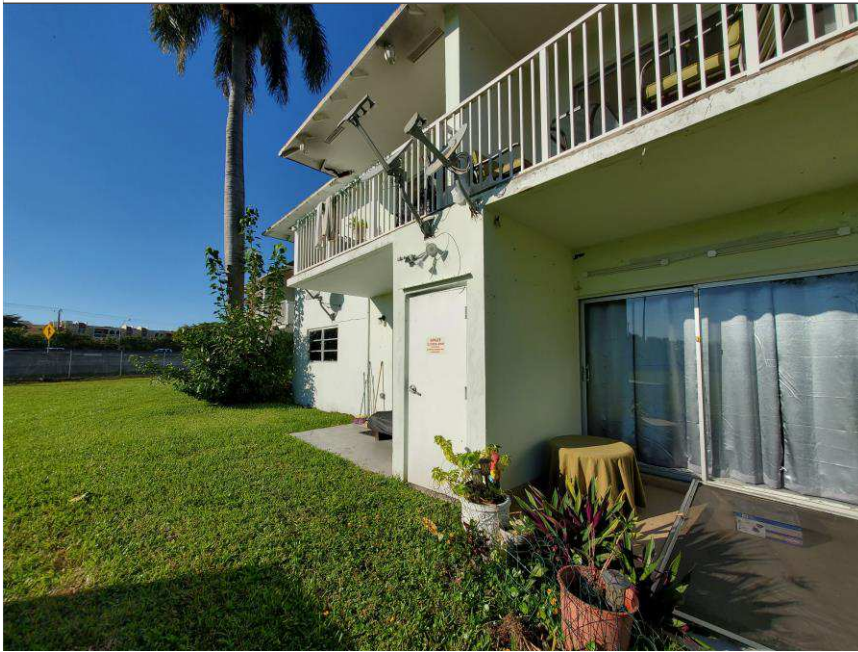
Photo 1 – Village of Dadeland Condominium Association

Existing Electrical Room - 1st FL
No Storage Permitted

Building Number sign is missing.

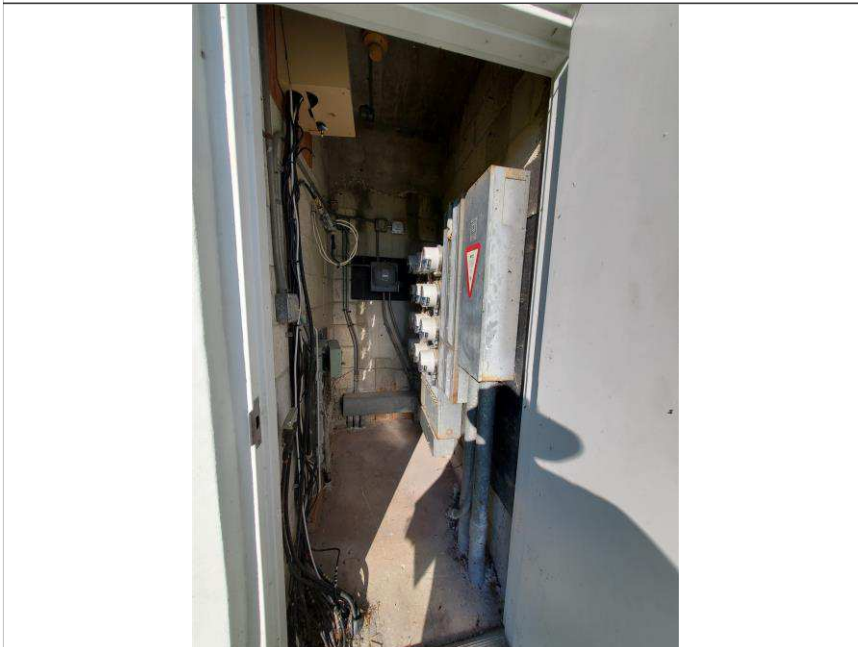
Photo 2 – Village of Dadeland Condominium Association

Existing Electrical Room - 1st FL
Main Switches for Apartments,
Meters, and Gutter.

Insufficient clearance in front of
electrical components.

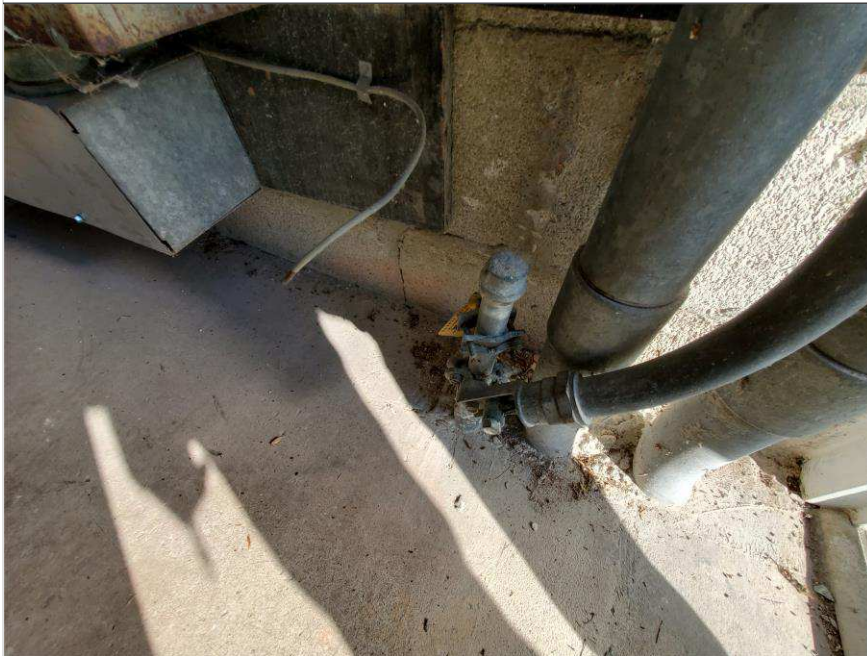
Photo 12 – Village of Dadeland Condominium Association

Existing Electrical Room - 1st FL
Main Service- Grounding

Grounding resistance to be tested to determine if repairs and/or maintenance are required.

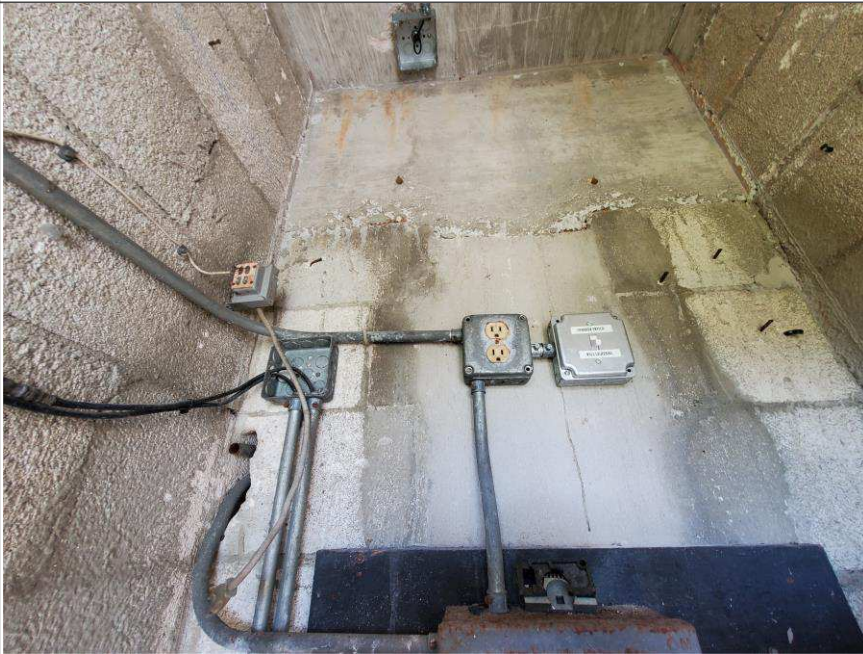
Photo 13 – Village of Dadeland Condominium Association

Existing Electrical Room – 1st FL

All wall penetrations to be fire caulked.

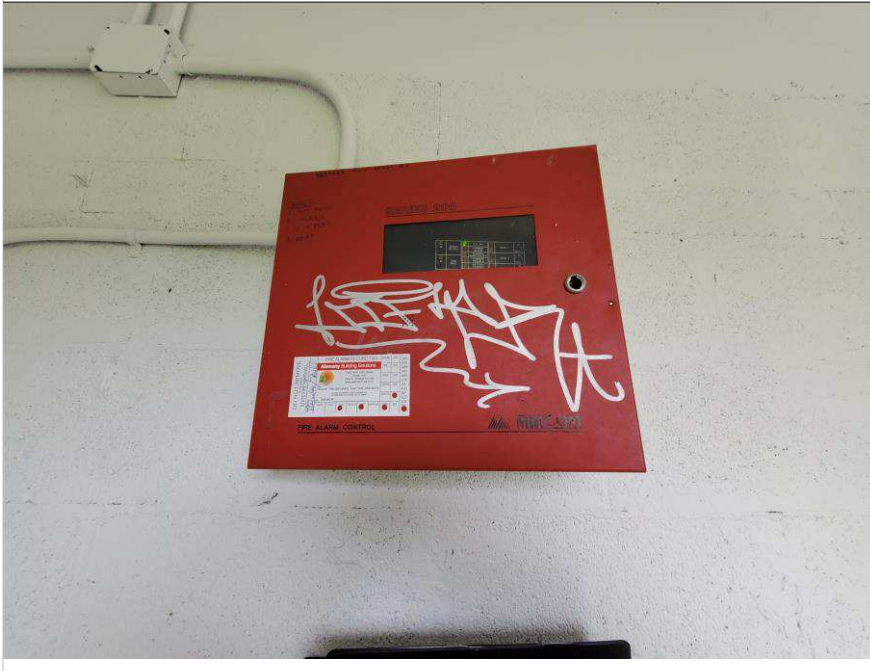
Photo 15 – Village of Dadeland Condominium Association

1st FL - Laundry/Water Heater
Room
Fire Alarm Panel

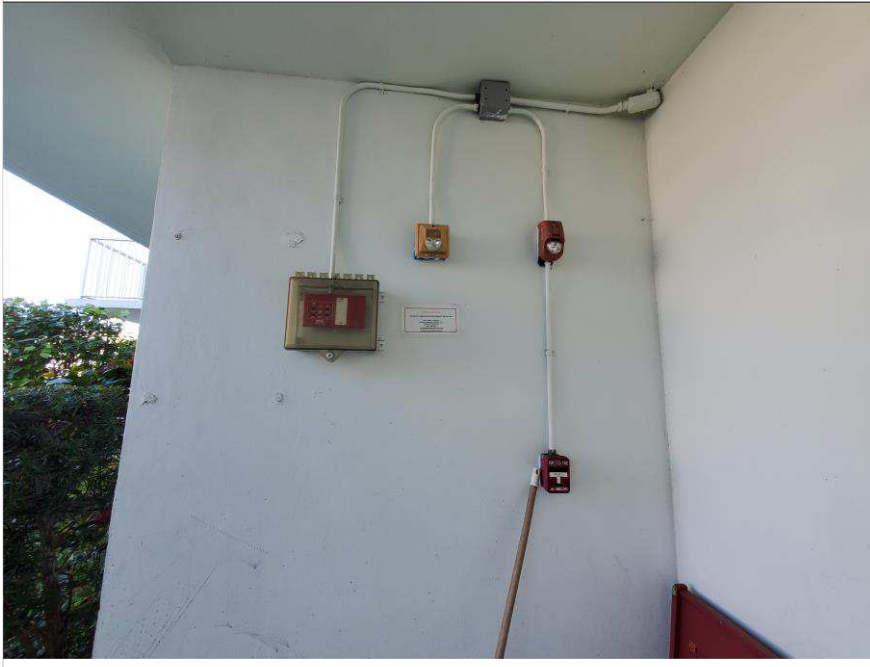
Photo 16 – Village of Dadeland Condominium Association

Level 1
Fire Alarm - Old and Weathered
Fire Alarm Devices and Control
Center

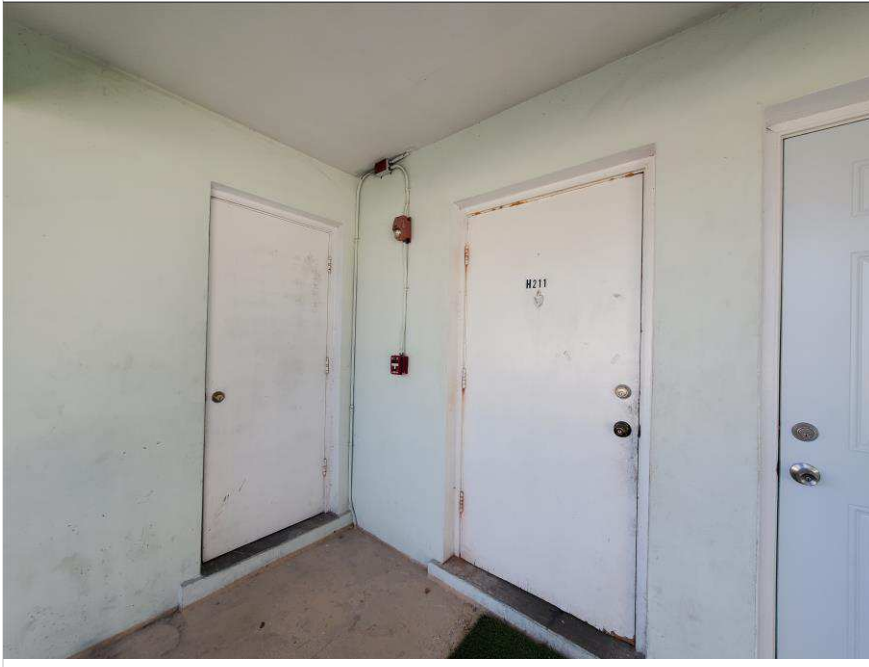
Photo 17 – Village of Dadeland Condominium Association

Level 2

Fire Alarm - Old and Weathered
Fire Alarm Devices and Control
Center

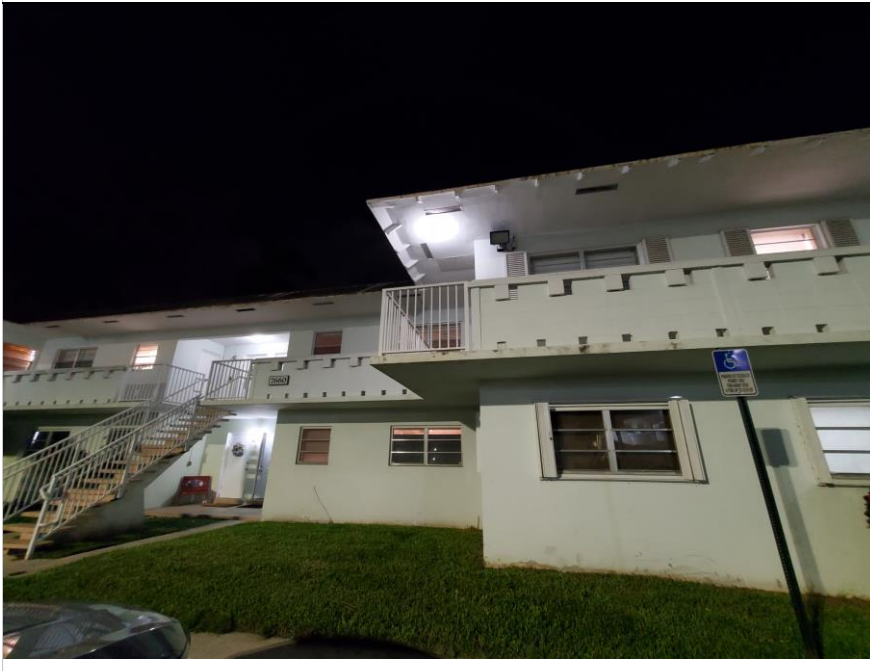
Photo 19 – Village of Dadeland Condominium Association

Egress Components
Poorly illuminated Catwalks and
Points of Egress.
Exterior lights not functional.

Insufficient illumination at Stairs
sidewalk, and Catwalks.

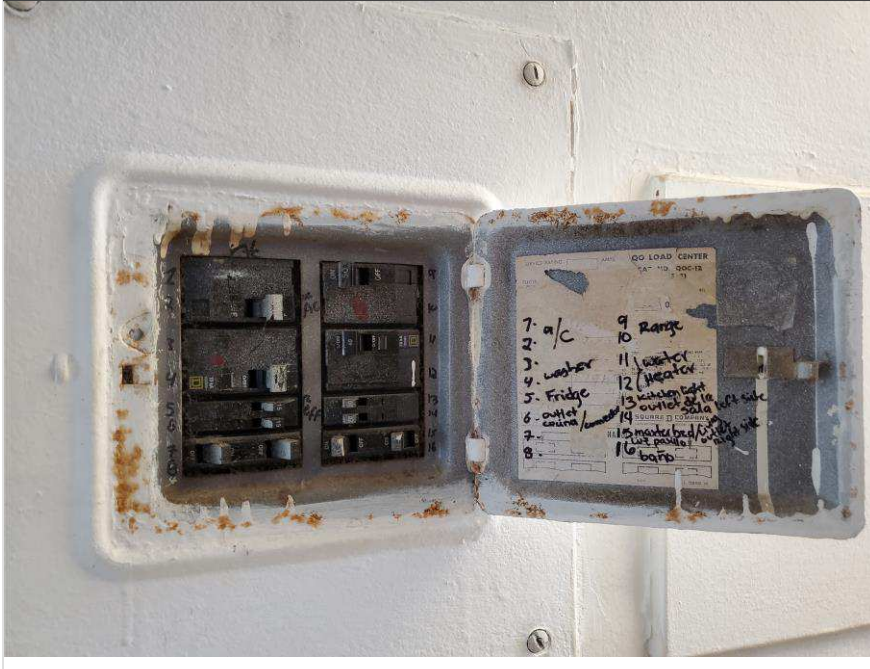
Photo 23 – Village of Dadeland Condominium Association

Apartments - Old Electrical Panels

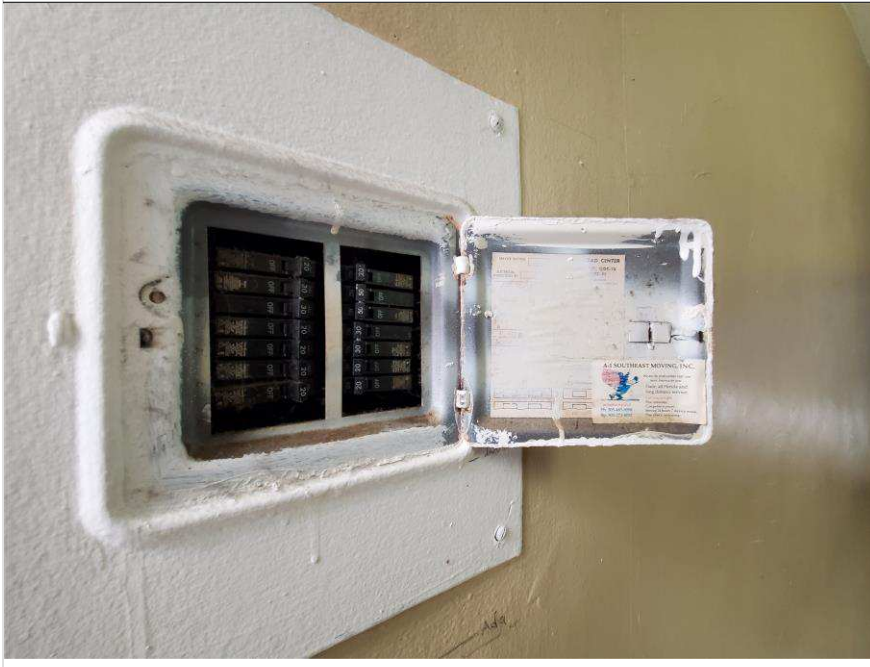
Photo 24 – Village of Dadeland Condominium Association

Apartments - Old Electrical Panels

Panel cover and panel box are not set properly leaving excessive space around breakers.

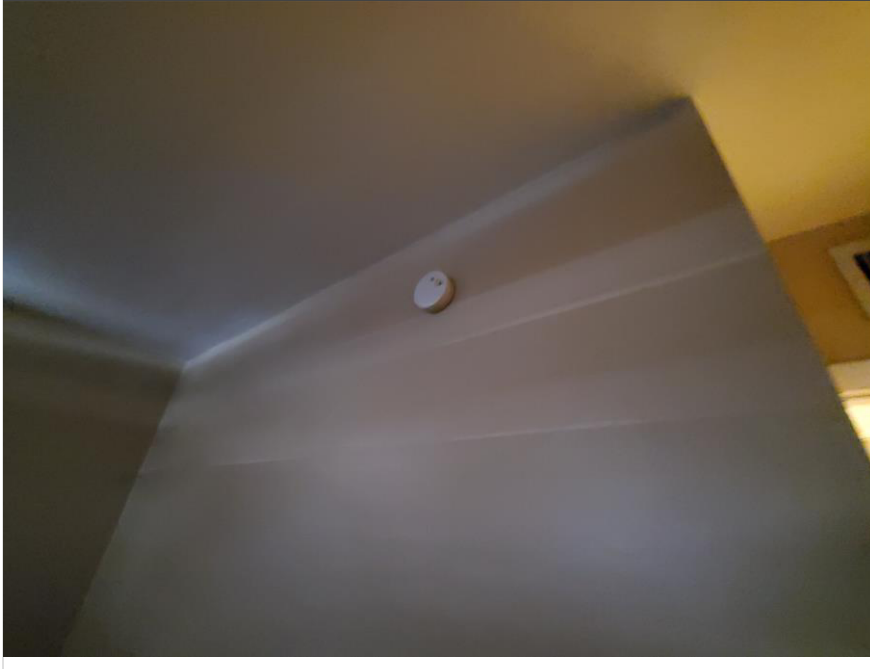
Photo 27 – Village of Dadeland Condominium Association

Apartments - Old Smoke
Detectors

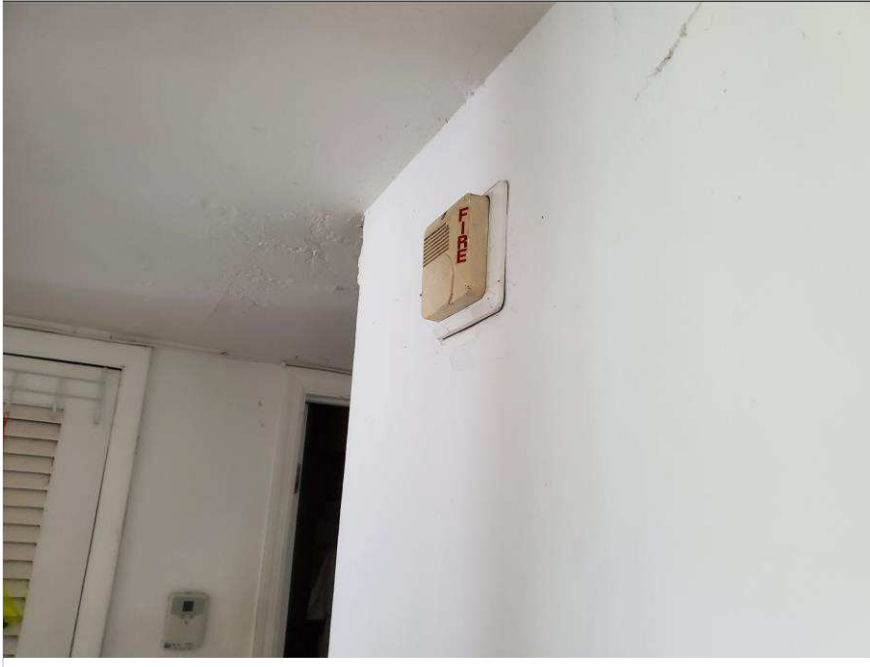
Photo 28 – Village of Dadeland Condominium Association

Apartments - Fire Alarm System

Old Devices exceeding useful
life.

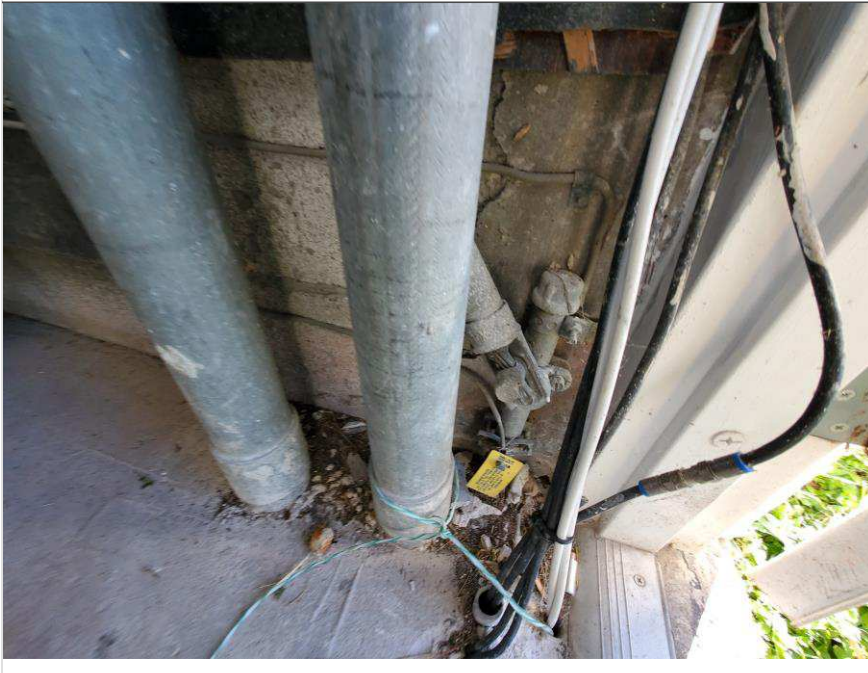
Photo 11 – Village of Dadeland Condominium Association

Existing Electrical Room - 1st FL
Main Service - Grounding

Grounding resistance to be tested to determine if repairs and/or maintenance are required.

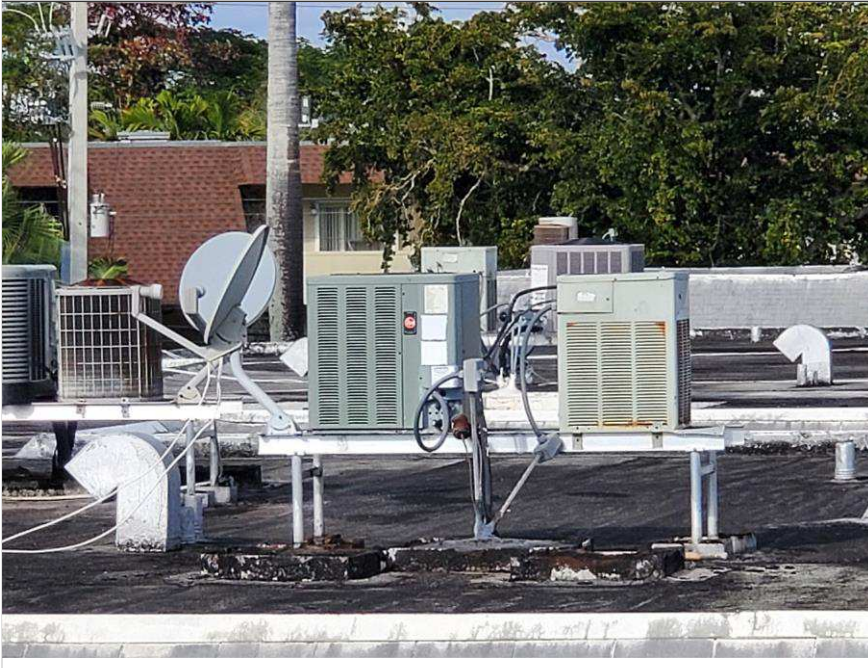
Photo 12 – Village of Dadeland Condominium Association

Rooftop
Rooftop Condenser Units

Junction boxes not properly supported.

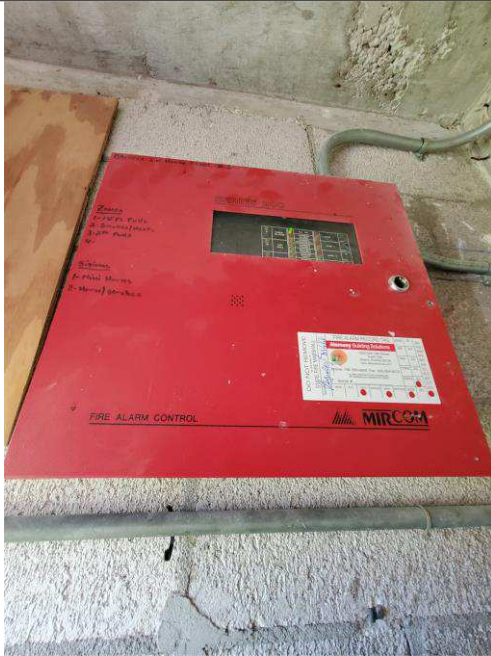
Photo 13 – Village of Dadeland Condominium Association

Existing Electrical Room - 1st FL
Fire Alarm Panel

All penetrations or openings in
walls are to be fire caulked.

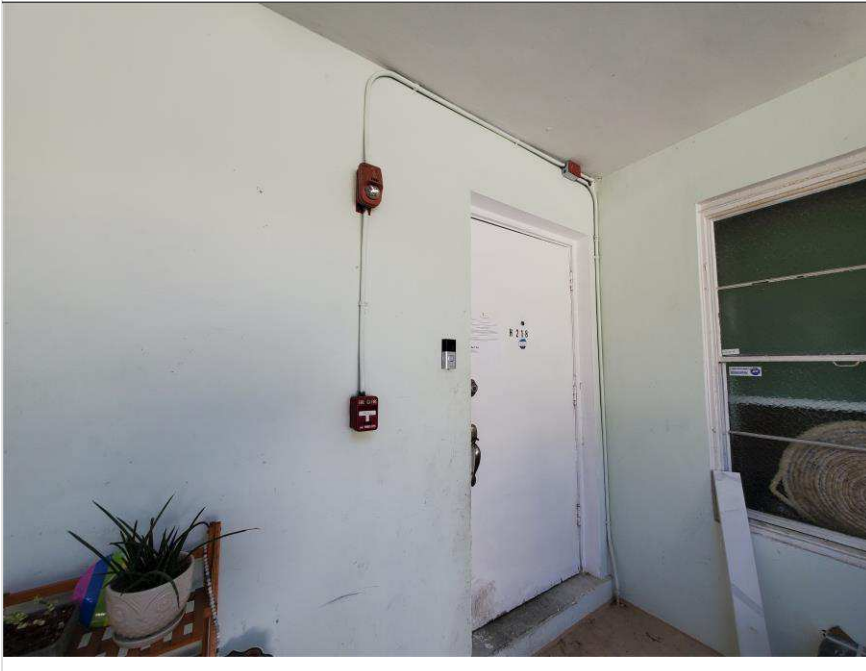
Photo 15 – Village of Dadeland Condominium Association

Level 2

Fire Alarm - Old and Weathered
Fire Alarm Devices and Control
Center

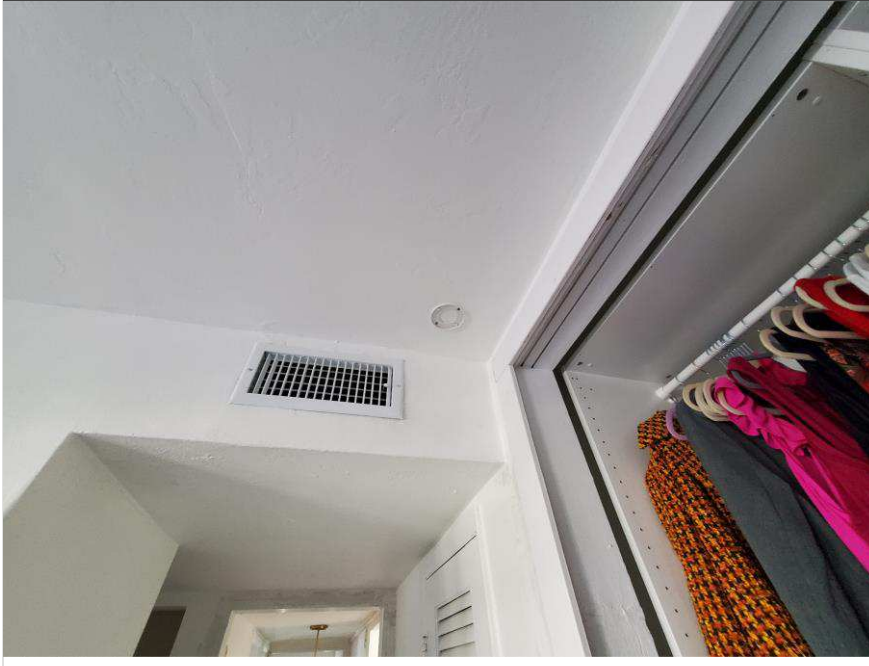
Photo 21 – Village of Dadeland Condominium Association

Apartments - Missing Smoke Detectors

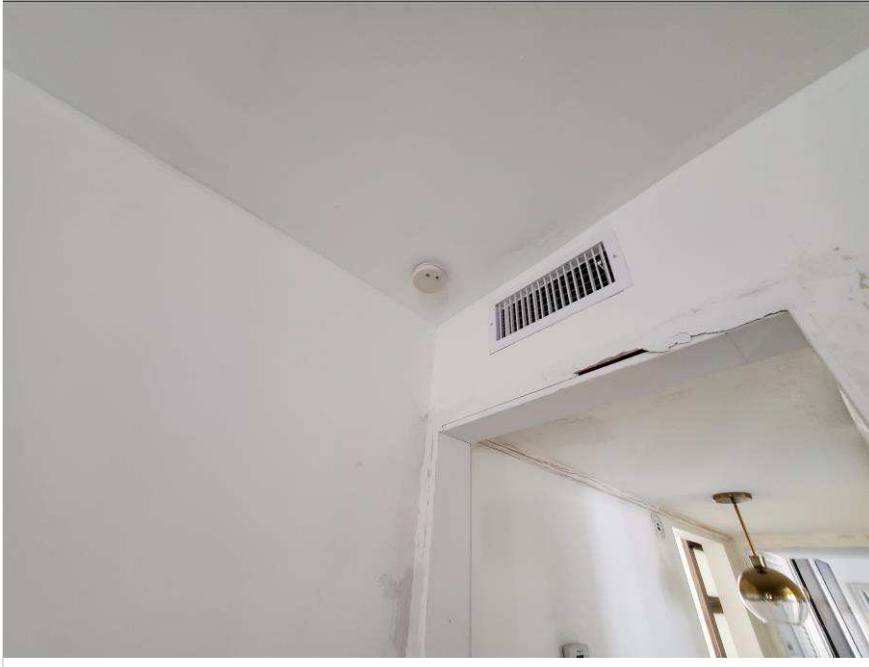
Photo 22 – Village of Dadeland Condominium Association

Apartments - Old Smoke or CO₂ detectors to be replaced.

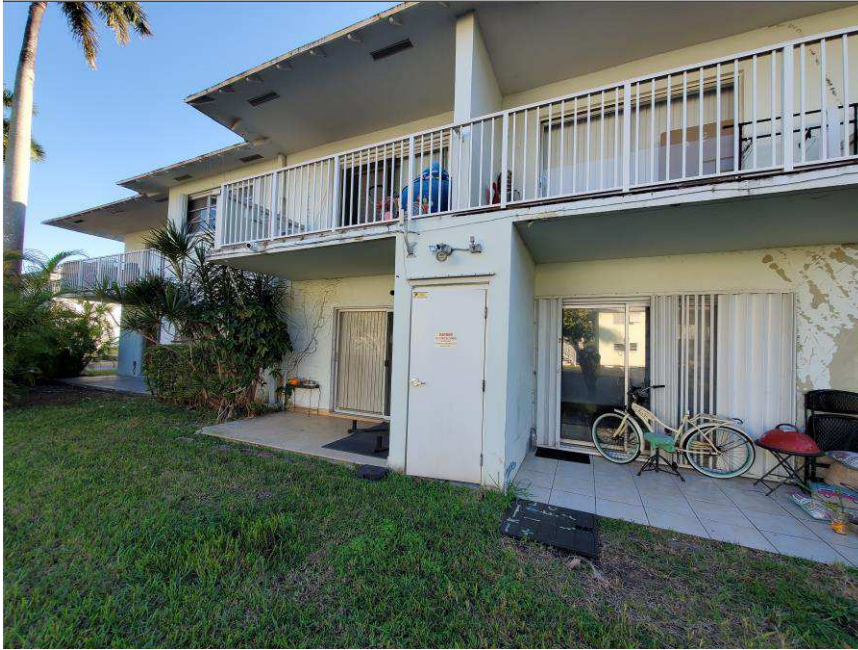
Photo 1 – Village of Dadeland Condominium Association

Existing Electrical Room – 1st FL
No Storage Permitted

Missing sign with room name
and building number.

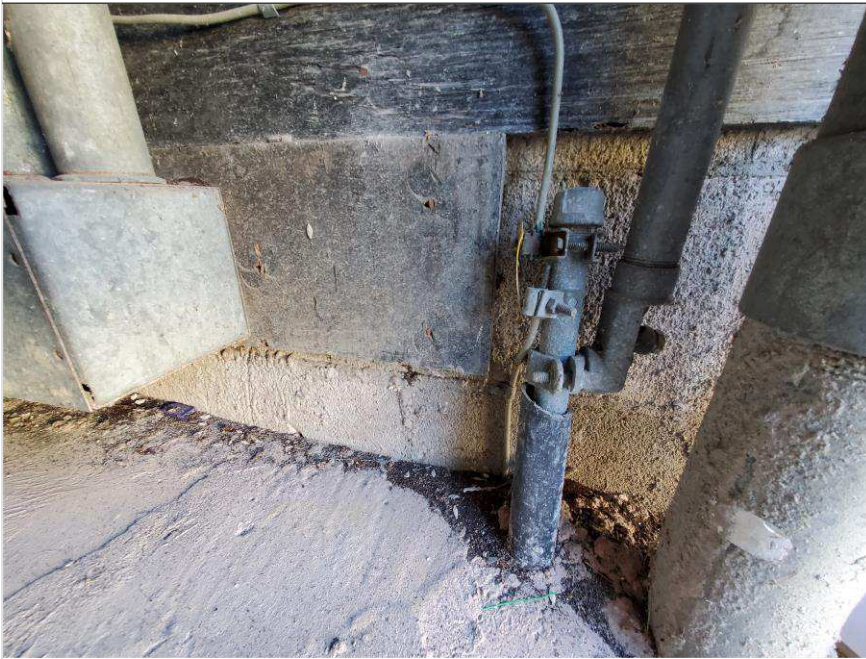
Photo 10 – Village of Dadeland Condominium Association

Existing Electrical Room – 1st FL
Main Service – Grounding

Grounding resistance to be
tested to determine if repairs
and/or maintenance are
required.

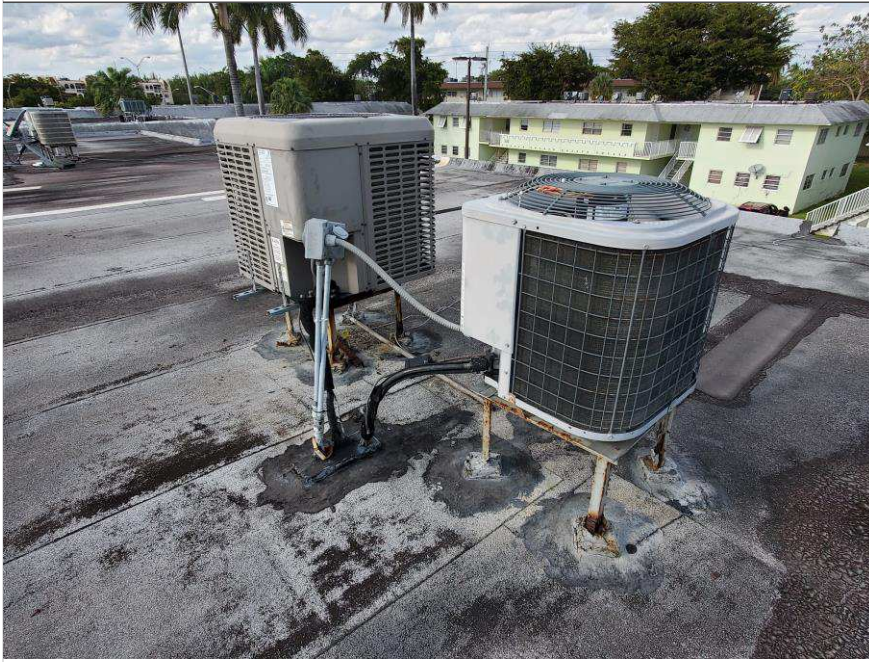
Photo 11 – Village of Dadeland Condominium Association

Rooftop Condenser Units

Improperly supported switches.

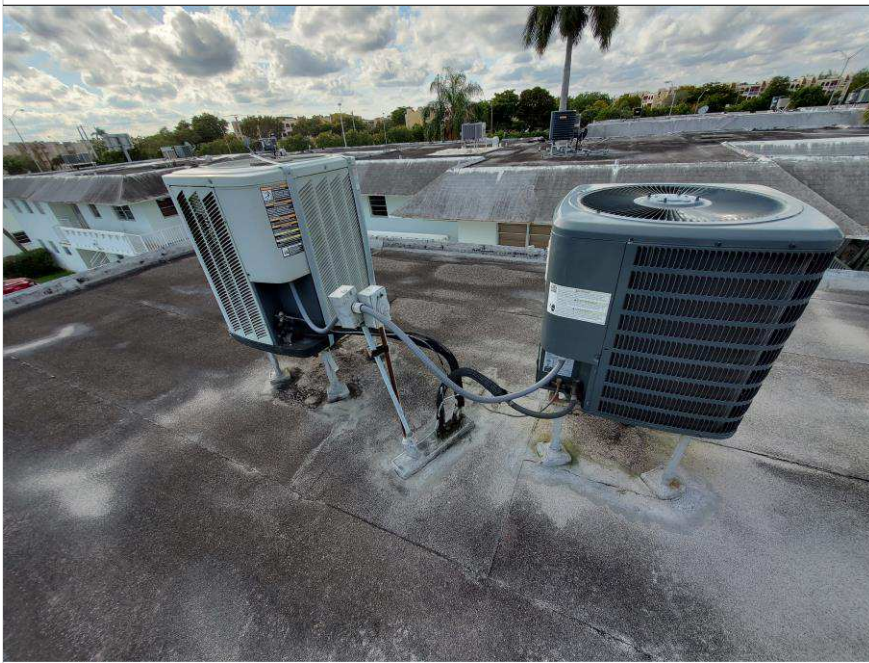
Photo 12 – Village of Dadeland Condominium Association

Rooftop Condenser Units

Oxidized junction boxes and conduits.

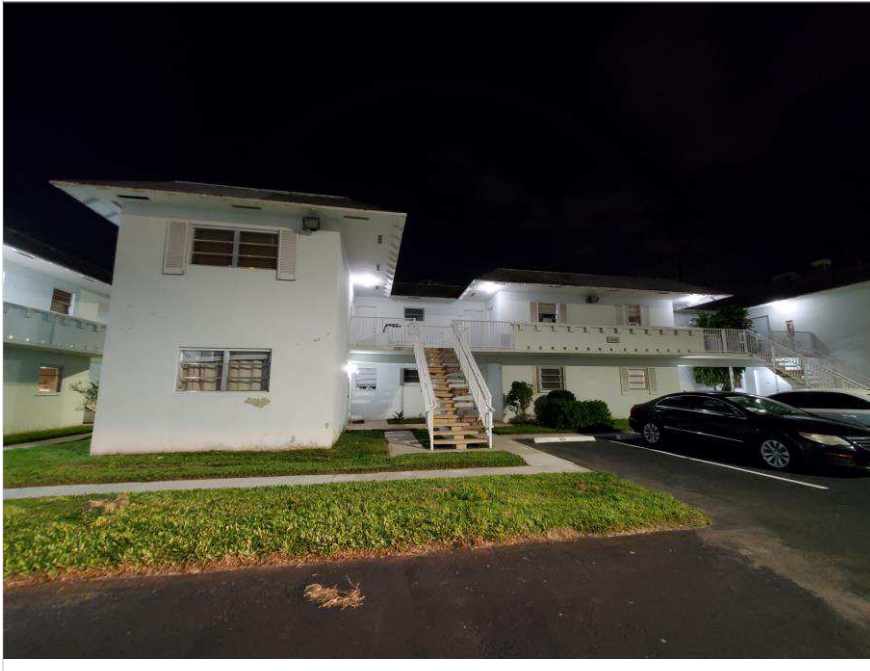
Photo 13 – Village of Dadeland Condominium Association

Parking and Catwalks –
Poorly illuminated sidewalks and
stairs.

Exterior light not functional.

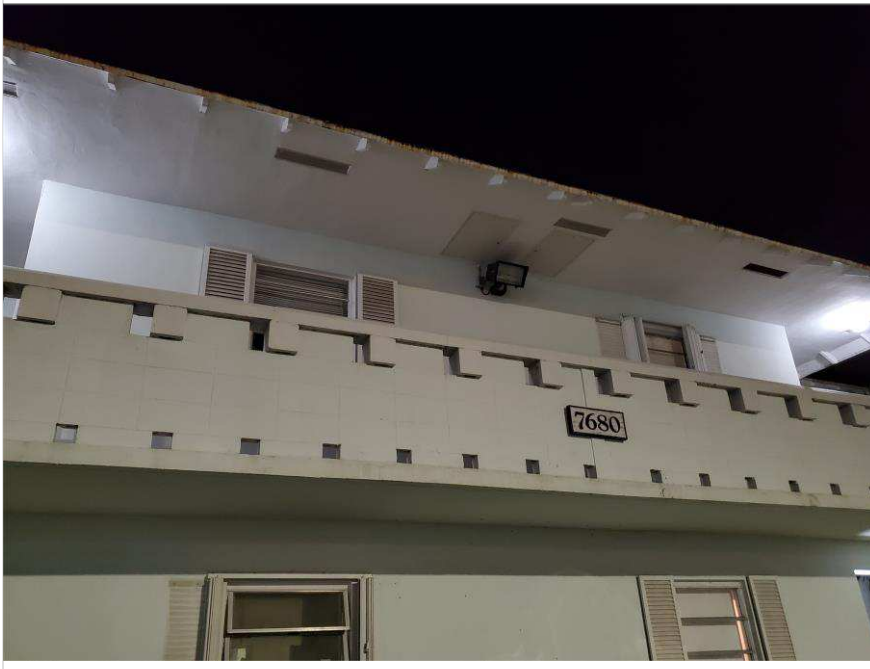
Photo 14 – Village of Dadeland Condominium Association

Parking and Catwalks –
Poorly illuminated sidewalks and
stairs.

Exterior lights not functional.

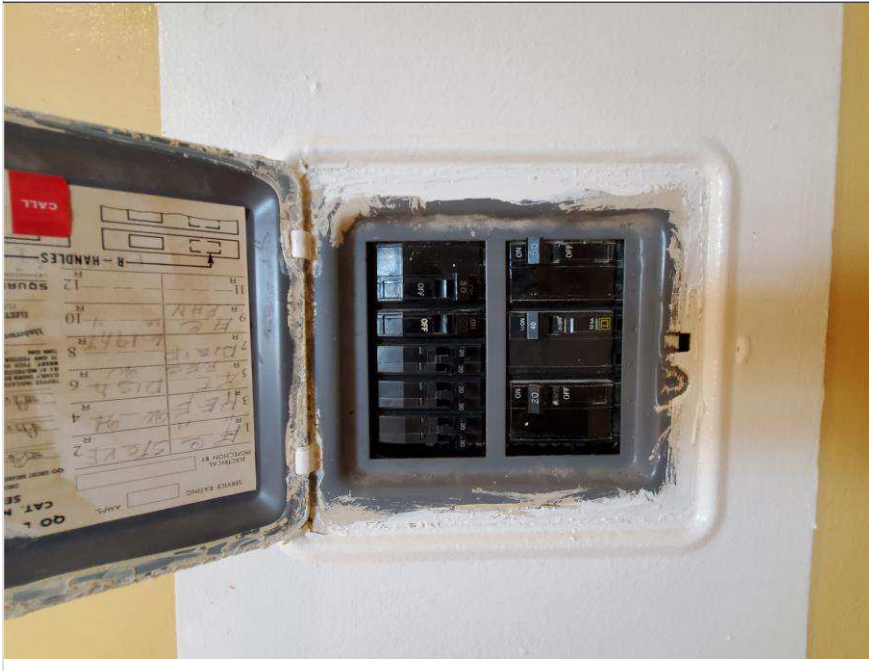
Photo 15 – Village of Dadeland Condominium Association

Apartments – Old Electrical Panels

Panel cover is not properly installed leaving large gaps around breakers.

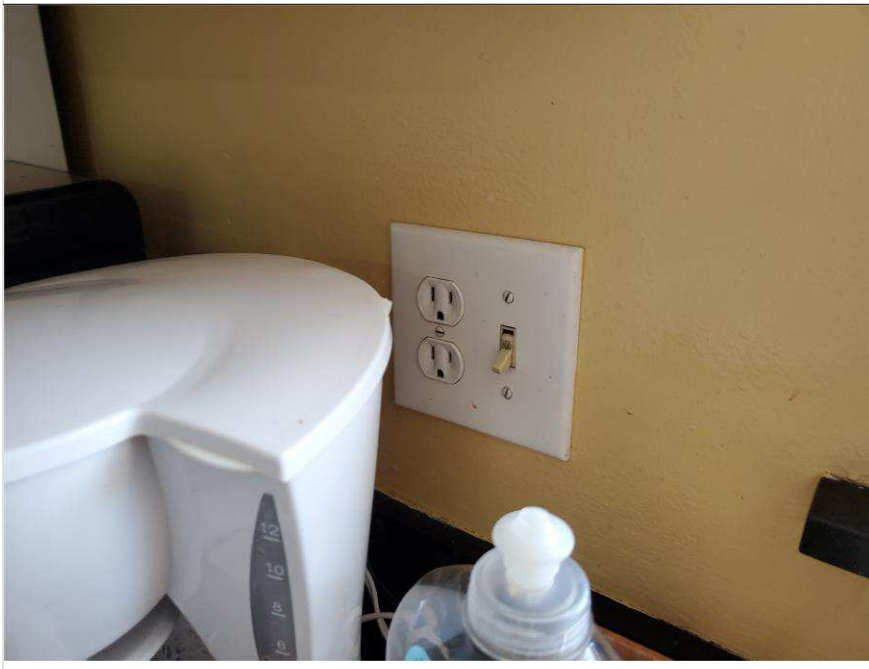
Photo 16 – Village of Dadeland Condominium Association

Apartments – Kitchen outlets are not GFCI type.

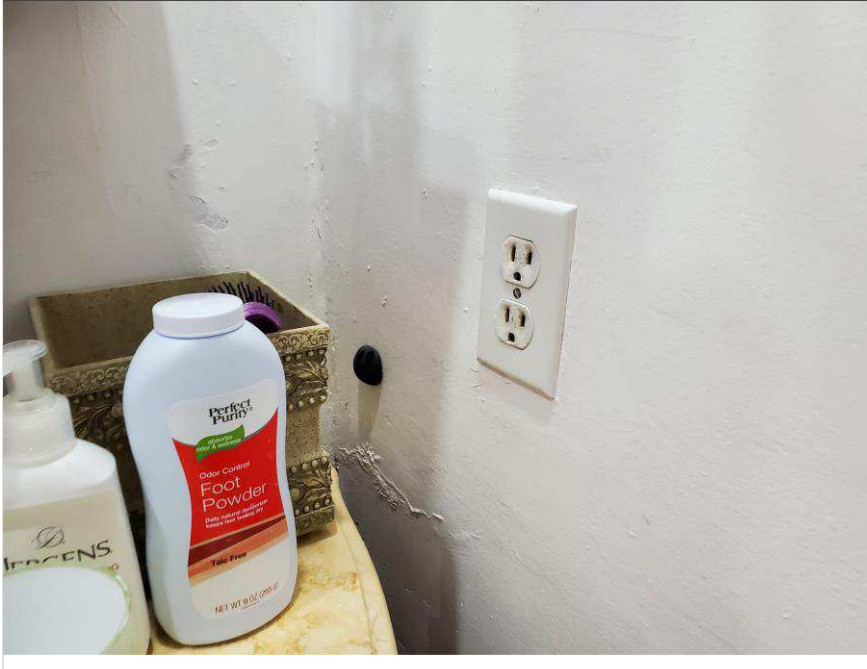
Photo 17 – Village of Dadeland Condominium Association

Apartments – Bathroom outlets are not GFCI type.

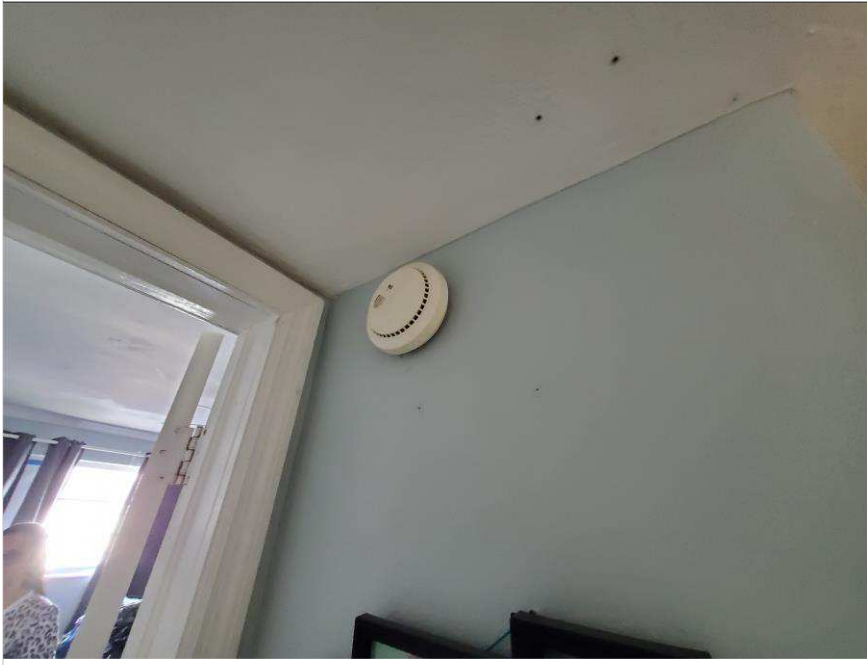
Photo 18 – Village of Dadeland Condominium Association

Apartments – Old Smoke Detectors

Old Smoke or CO₂ detectors to be replaced.

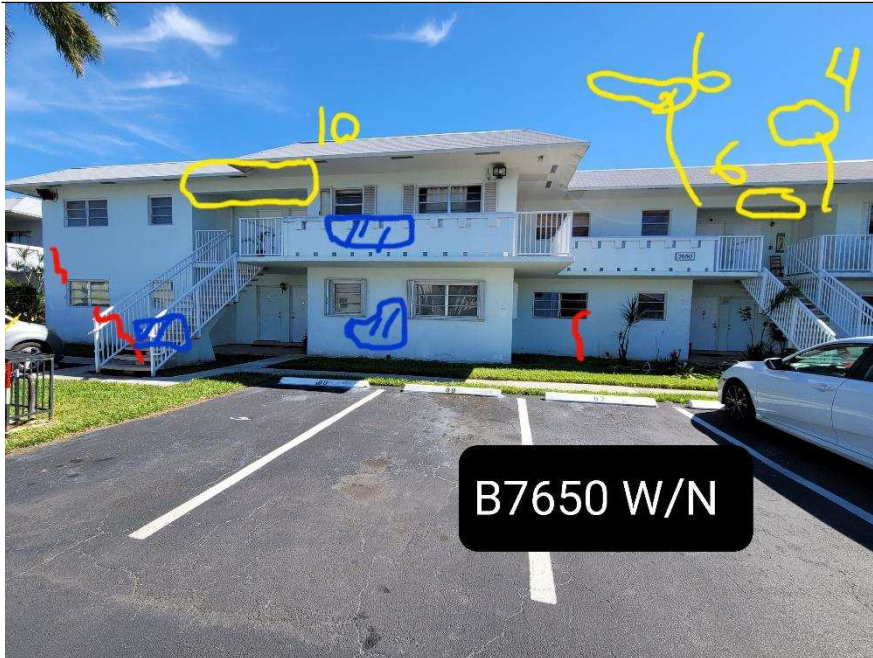
Photo #1:

The stuccoed envelope requires maintenance of the stucco exterior surfaces at many locations. Unsound stucco surfaces and surface cracks discovered at many areas of the exterior envelope.

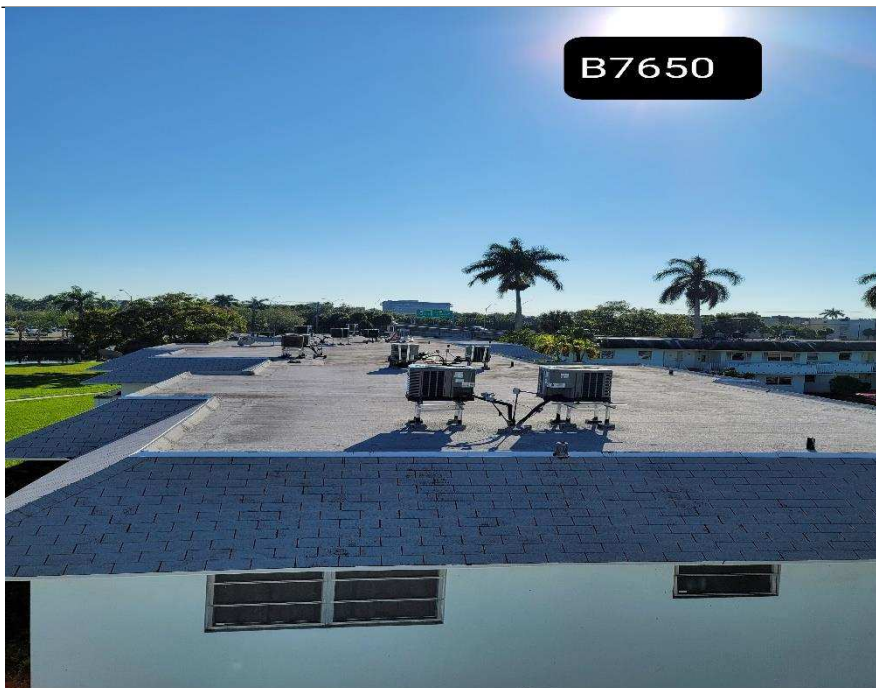
Photo #2:

Water ponding stains observed on the roof.

The bituminous roof membrane was deemed to be in fair/good condition with signs of weathering/distress at various locations.

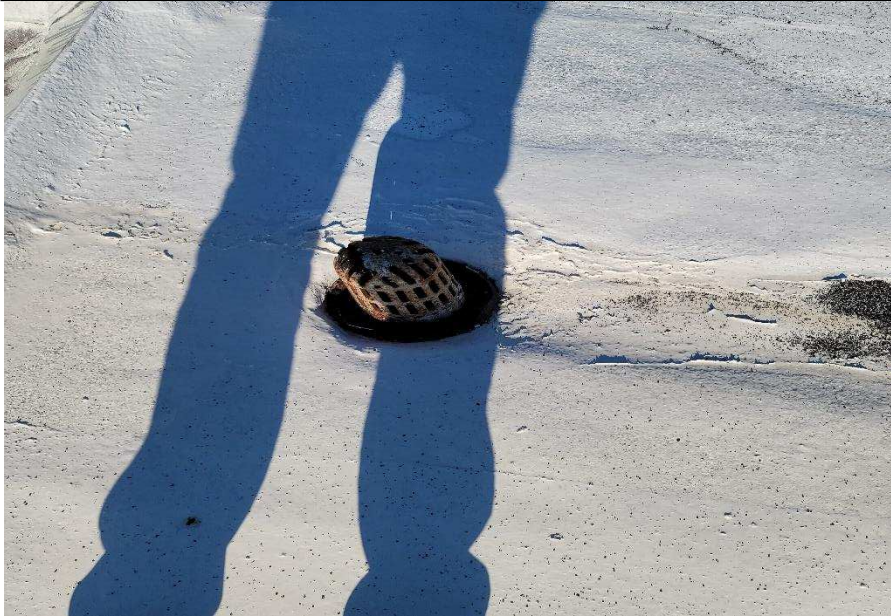
Photo #3:

The strainers for the interior drain lines were found to be rusted or non-functional since many of them are missing or not in their proper position. Others need maintenance to remove debris.

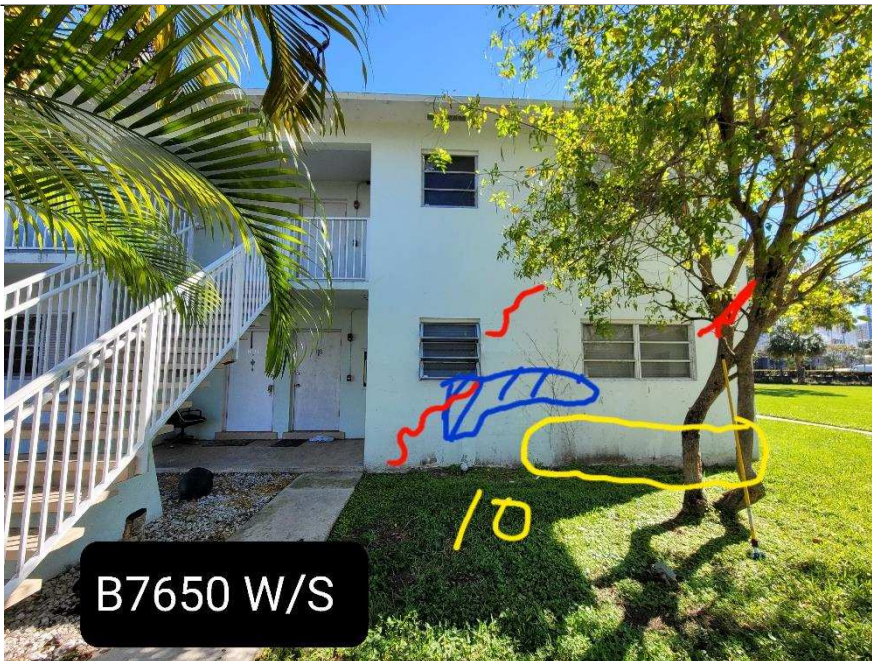
Photo #4:

The stuccoed envelope requires maintenance of the stucco exterior surfaces throughout the building. Fine horizontal and steps cracks observed sporadically. Most cracks located near the corners of the buildings or at the top/bottom corners of the wall openings.
