DEPARTMENT OF REGULATORY
AND ECONOMIC RESOURCES

MINIMUM INSPECTION PROCEDURAL GUIDELINES
FOR BUILDING ELECTRICAL RECERTIFICATION

- a. Name on Title: Village at Dadeland Condominiums (H)
- b. Street Address: 7650 SW 82nd St. Miami, Florida 33143
- c. Legal Description: Village at Dadeland Condominiums
- d. Owner's Name: Village at Dadeland Condominiums
- e. Owner's Mailing Address: 7650 SW 82nd St. Miami, Florida 33143
- f. Folio Number of Property on which Building is Located: 30-4035-047-XXXX
- g. Building Code Occupancy Classification: R2 - Residential
- h. Present Use: Condominium, Residential
- i. General Description, Type of Construction, Size, Number of Stories, and Special Features

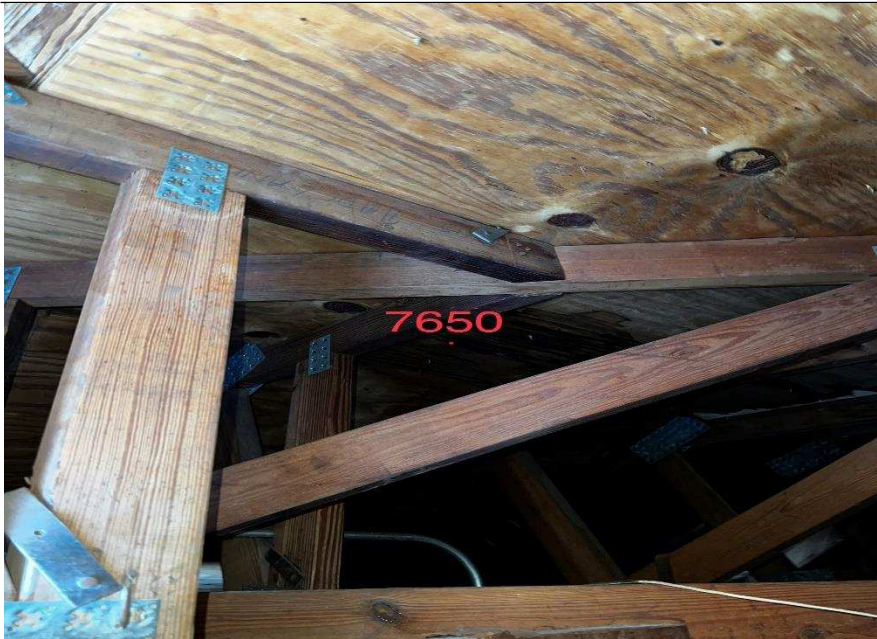
Photo #5:

Where accessible the roof structure was observed and found to be in fair condition.

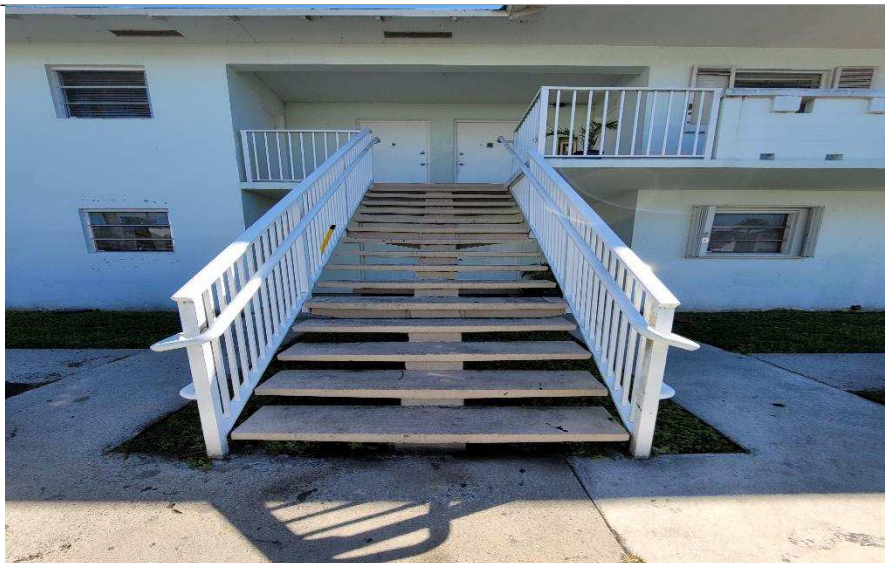
Photo #6:

The railings were deemed to be in fair/good condition.

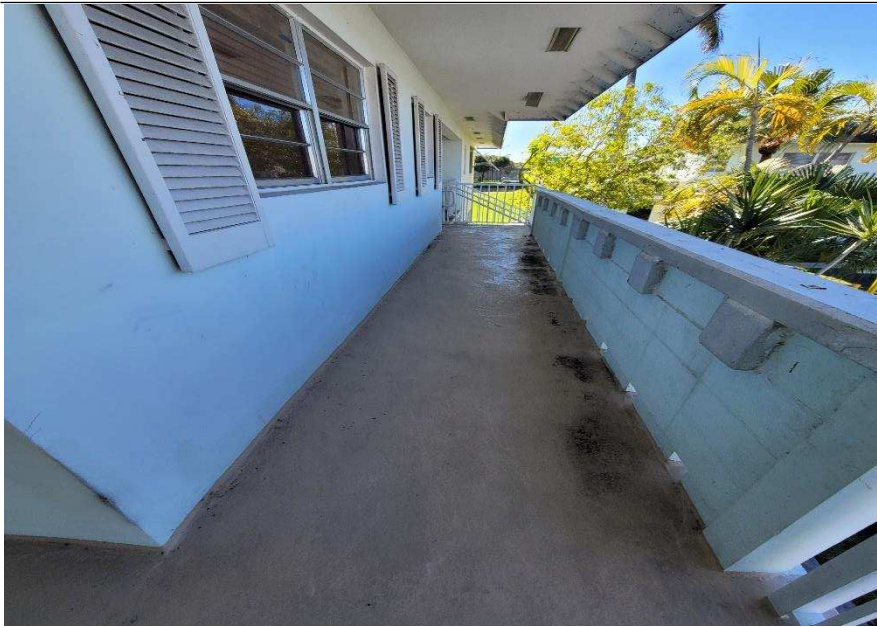
Photo #7:

The top wearing surface of the catwalks are stained or weathered and require maintenance.

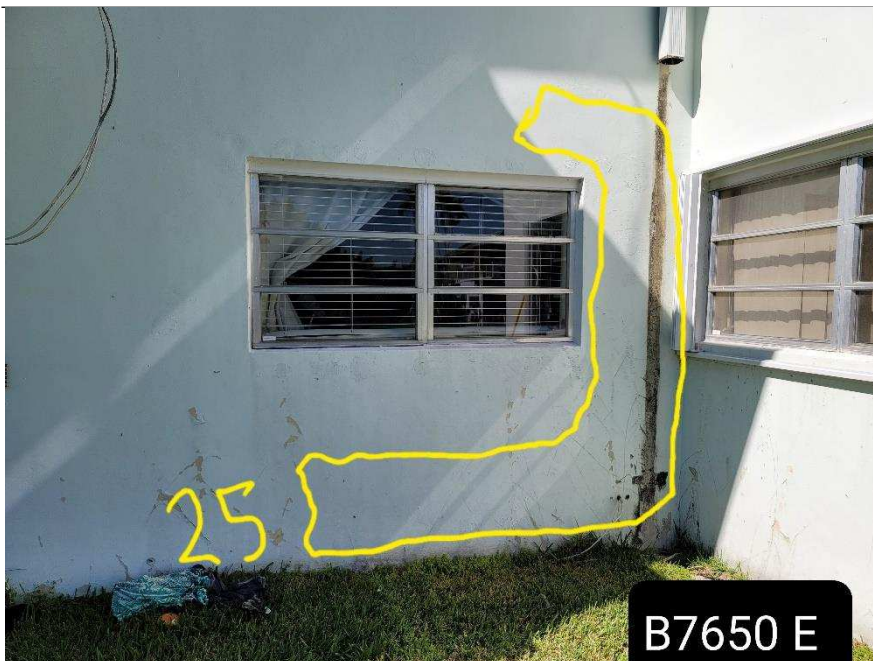
Photo #8:

Miscellaneous wall penetrations should be properly sealed to prevent water infiltration into the building and/or surface decay of the stucco membrane in the vicinity of the penetration.

No downspout diverters observed allowing water to accumulate near the base of the walls. The water accumulation has allowed vegetation growth and decay of the base of the walls.

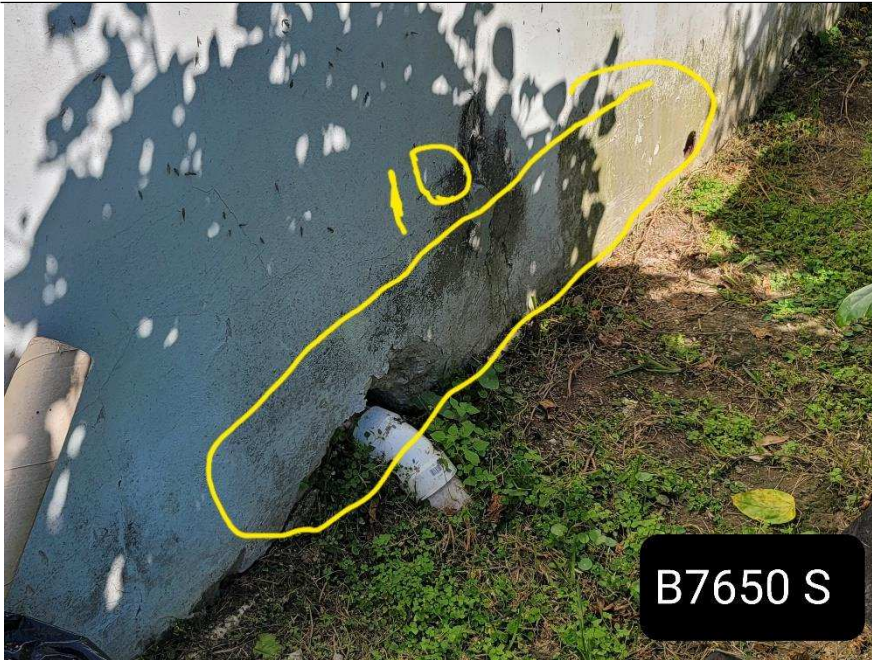
Photo #9:

Miscellaneous wall penetrations should be properly sealed to prevent water infiltration into the building, and/or surface decay of the stucco membrane in the vicinity of the penetration.

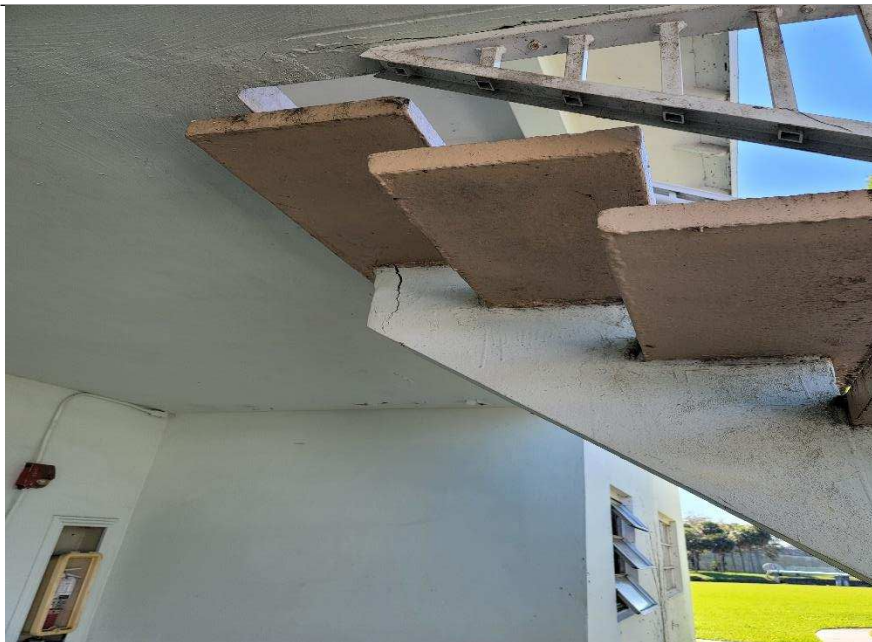
Photo #8:

Spalled and cracked surfaces observed at the stair walls/beams.

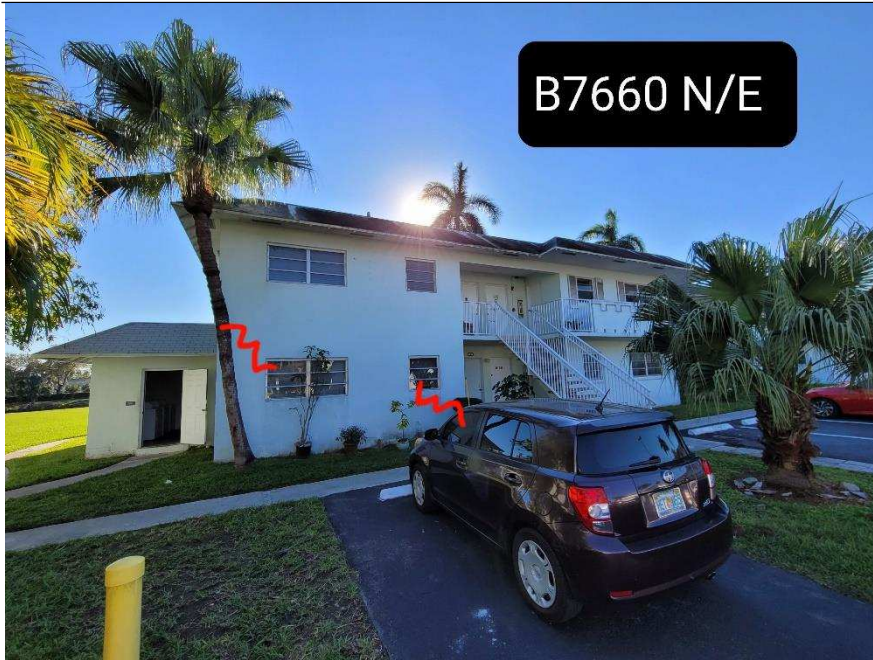
Photo #1:

The stuccoed envelope requires maintenance of the stucco exterior surfaces at many locations. Unsound stucco surfaces and surface cracks discovered at many areas of the exterior envelope.

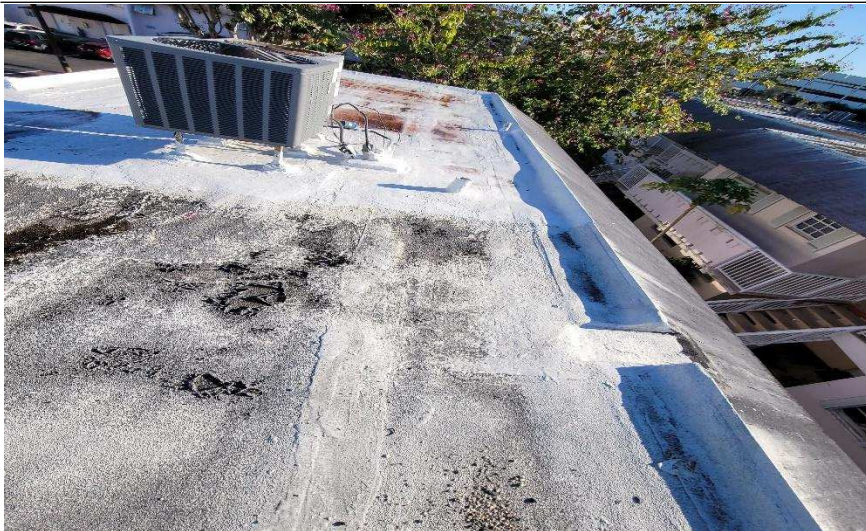
Photo #2:

Water ponding stains observed on the roof.

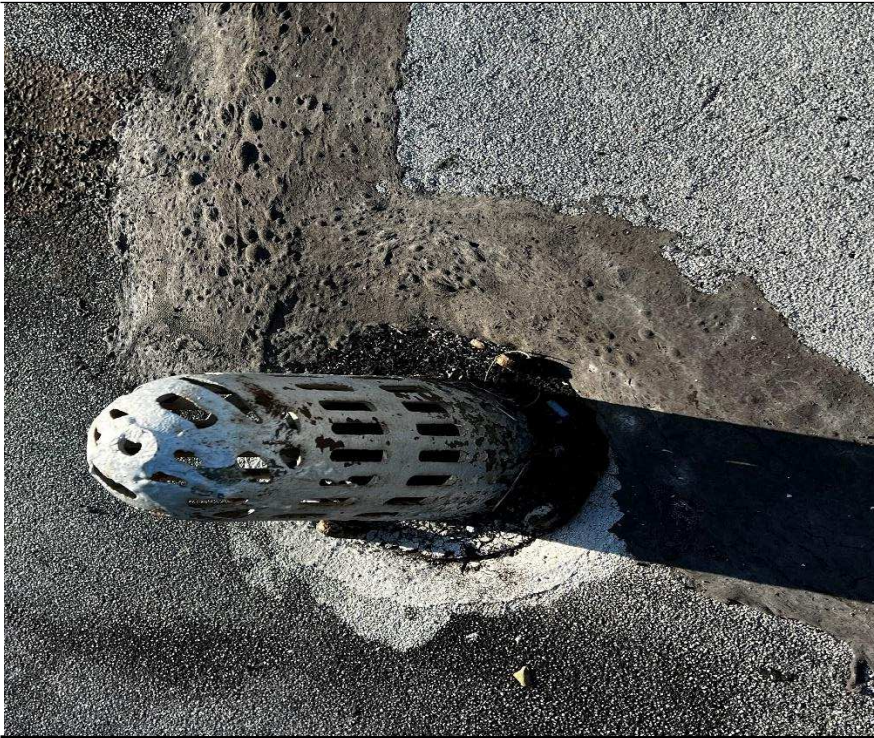
Photo #3:

The strainers for the interior drain lines were found to be rusted or non-functional since many of them are missing or not in their proper position. Others need maintenance to remove debris.

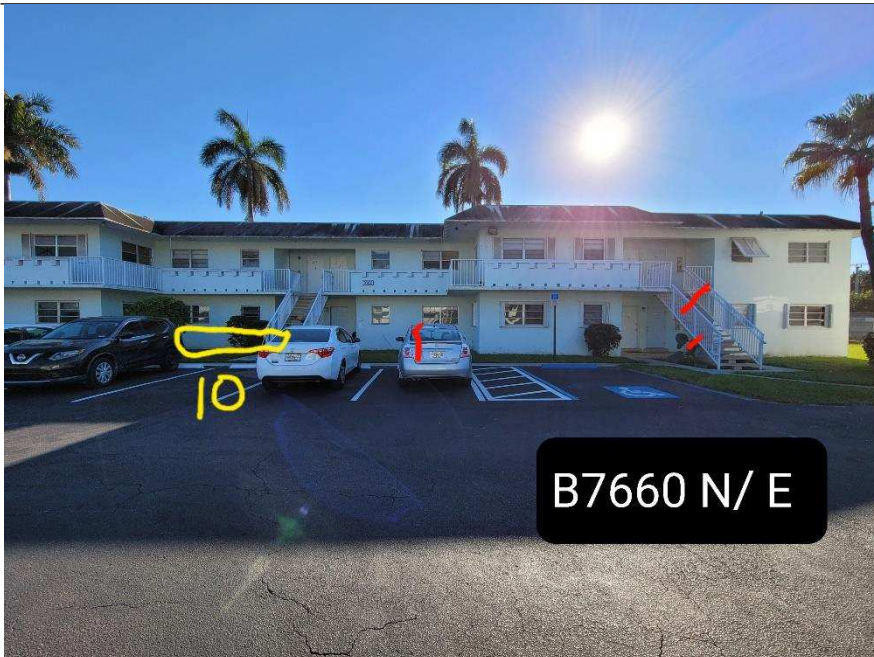
Photo #4:

The stuccoed envelope requires maintenance of the stucco exterior surfaces throughout the building. Fine horizontal and steps cracks observed sporadically. Most cracks located near the corners of the buildings or at the top/bottom corners of the wall openings.

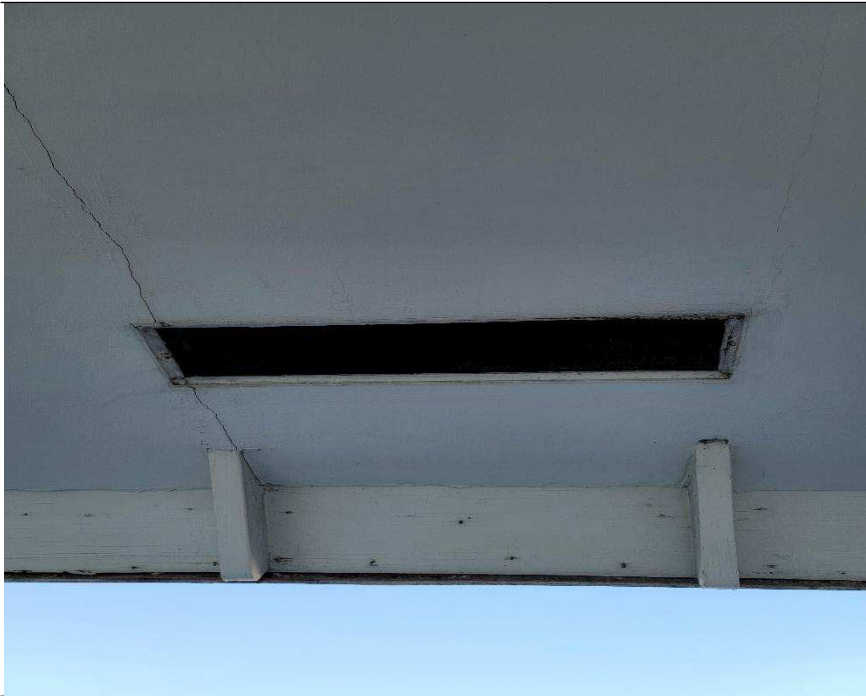
Photo #5:

The exterior finish of the wood soffit was observed to be cracked.

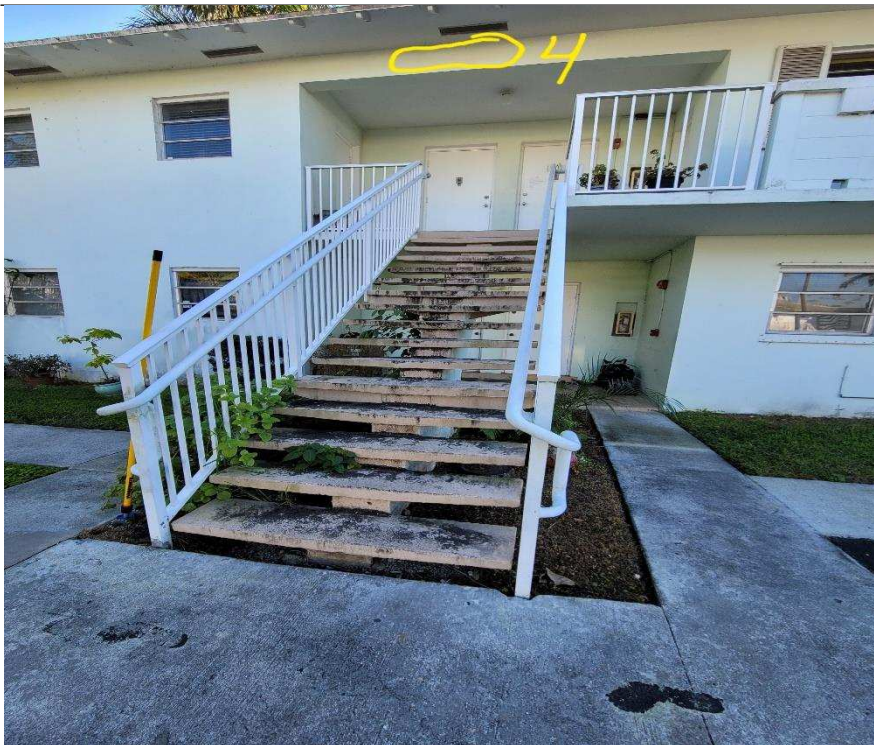
Photo #6:

The railings were deemed to be in fair/good condition.

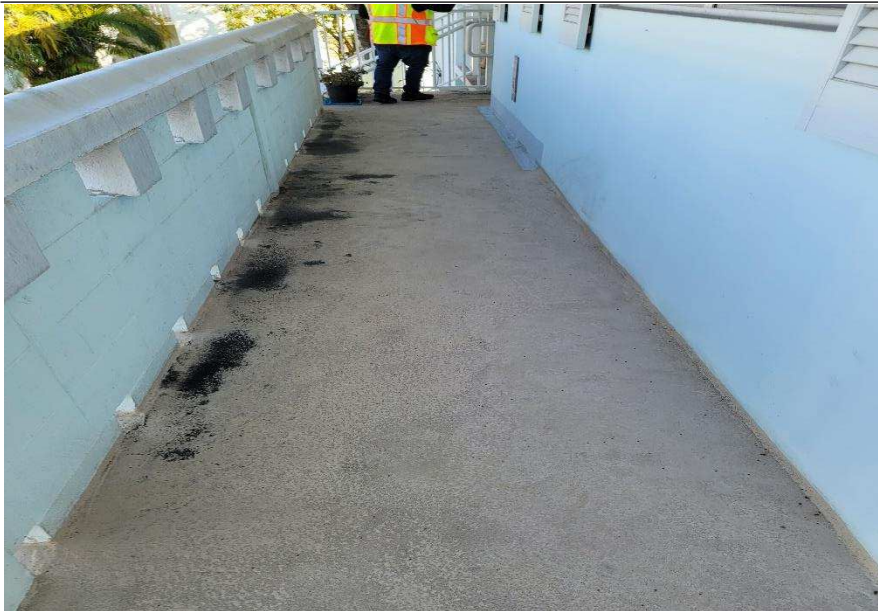
Photo #7:

The top wearing surface of the catwalks are stained or weathered and require maintenance.

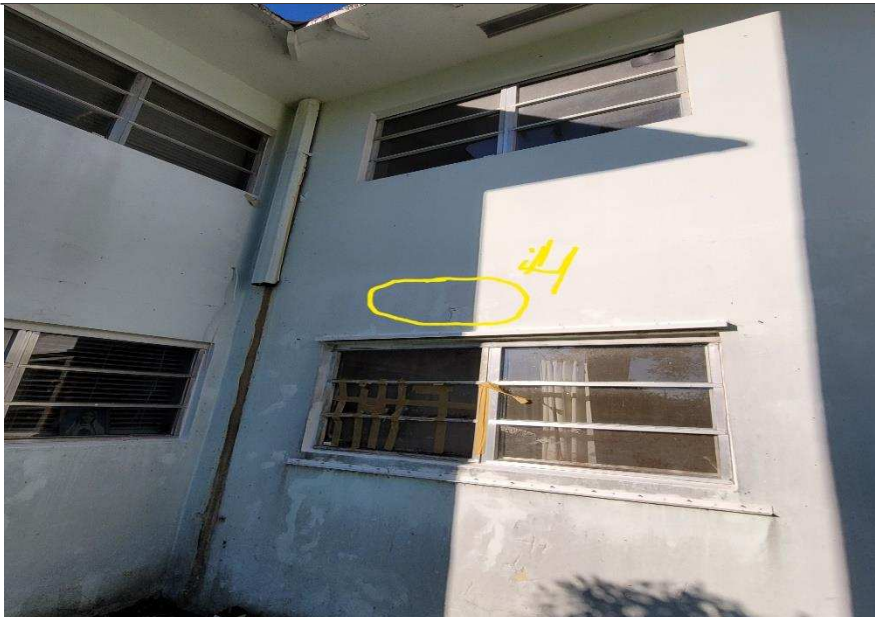
Photo #8:

No downspout diverters observed allowing water to accumulate near the base of the walls. The water accumulation has allowed vegetation growth and decay of the base of the walls.

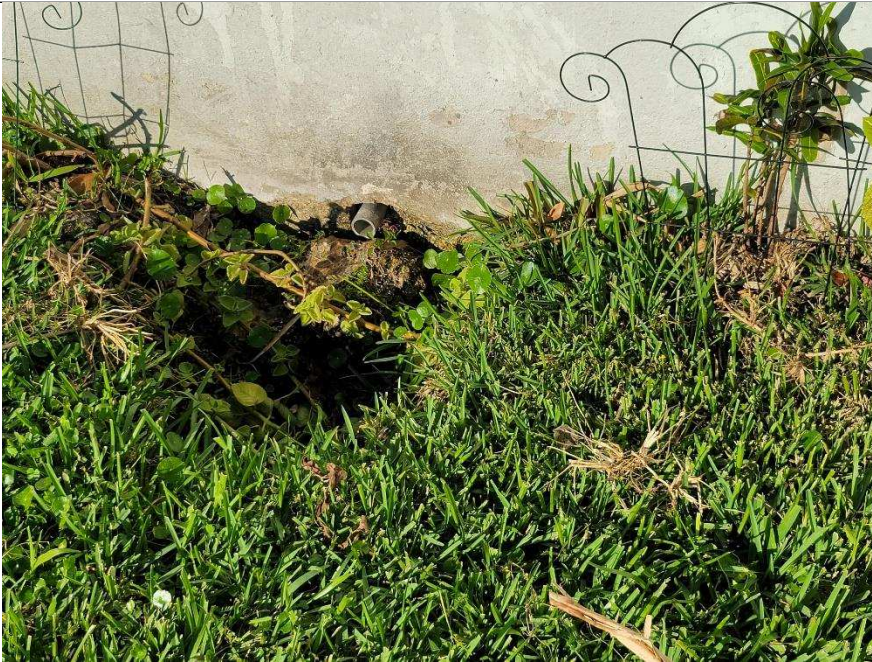
Photo #9:

Miscellaneous wall penetrations should be properly sealed to prevent water infiltration into the building, and/or surface decay of the stucco membrane in the vicinity of the penetration.

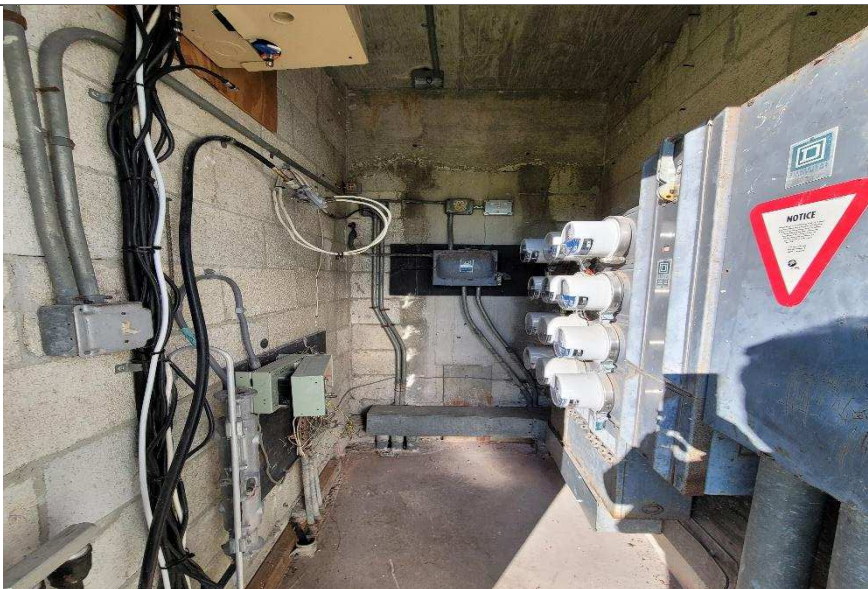
Photo #8:

The mechanical room was observed to be in good condition. Wall/ceiling penetration should be sealed.

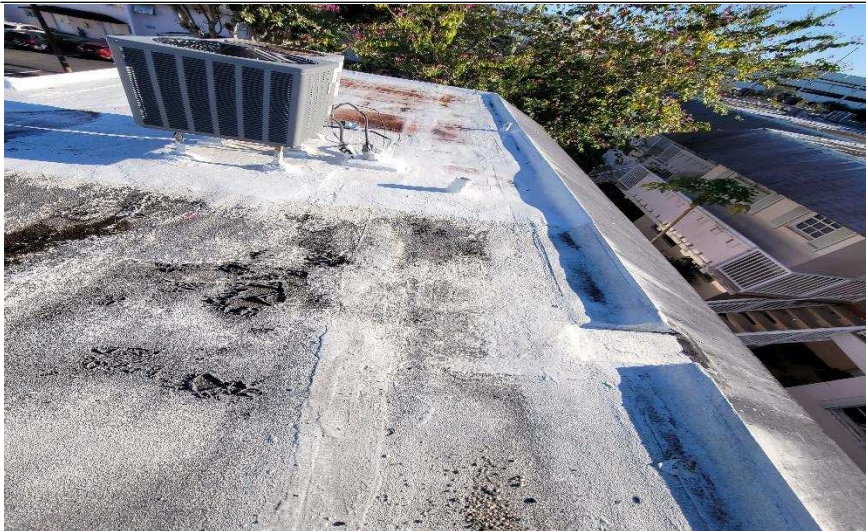
Photo #2:

Water ponding stains observed on the roof.

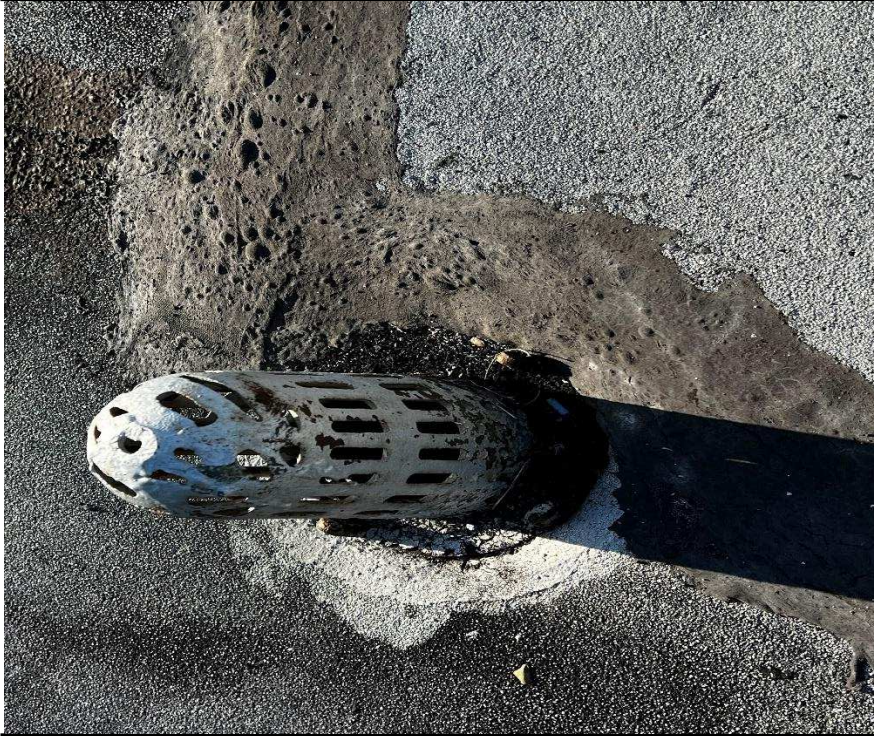
Photo #3:

The strainers for the interior drain lines were found to be rusted or non-functional since many of them are missing or not in their proper position. Others need maintenance to remove debris.

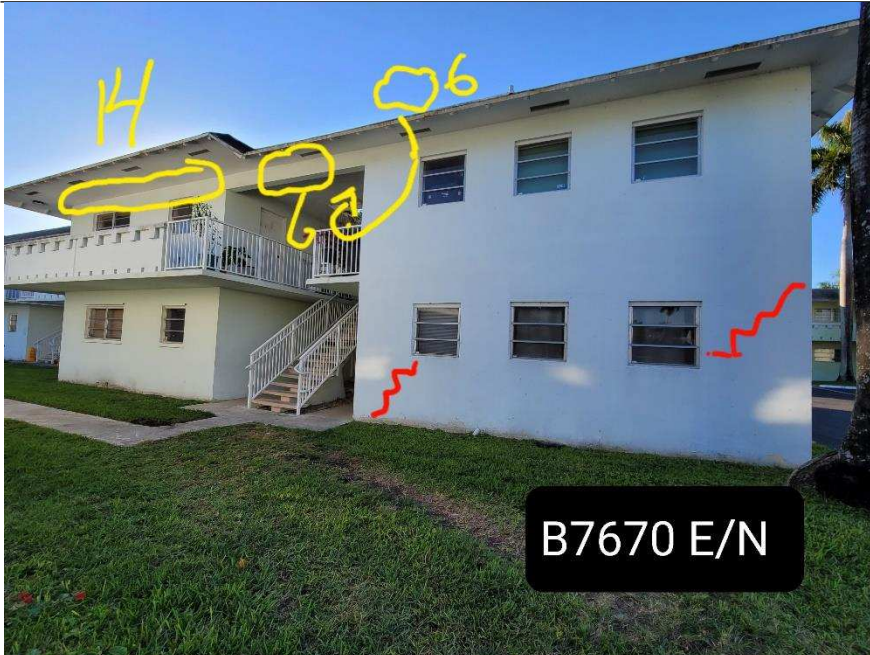
Photo #4:

The stuccoed envelope requires maintenance of the stucco exterior surfaces throughout the building. Fine horizontal and steps cracks observed sporadically.

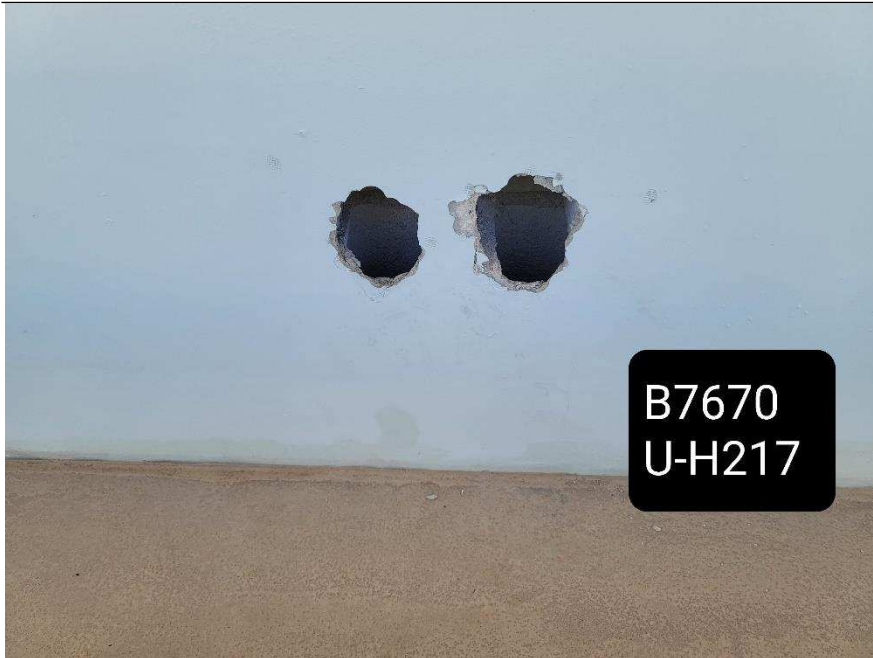
Photo #5:

Wall openings observed on the exterior wall allowing water and debris to enter into the wall cavities.

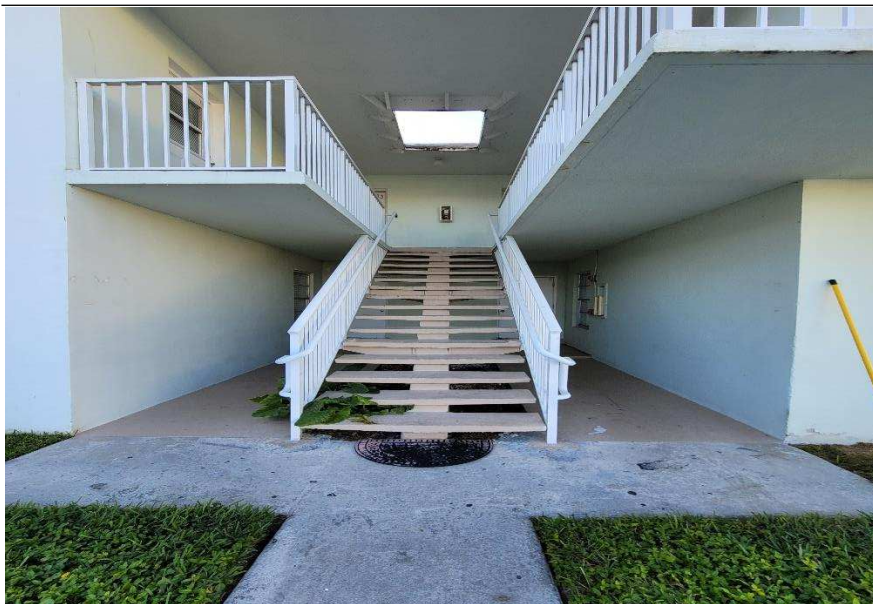
Photo #6:

The railings were deemed to be in fair/good condition.

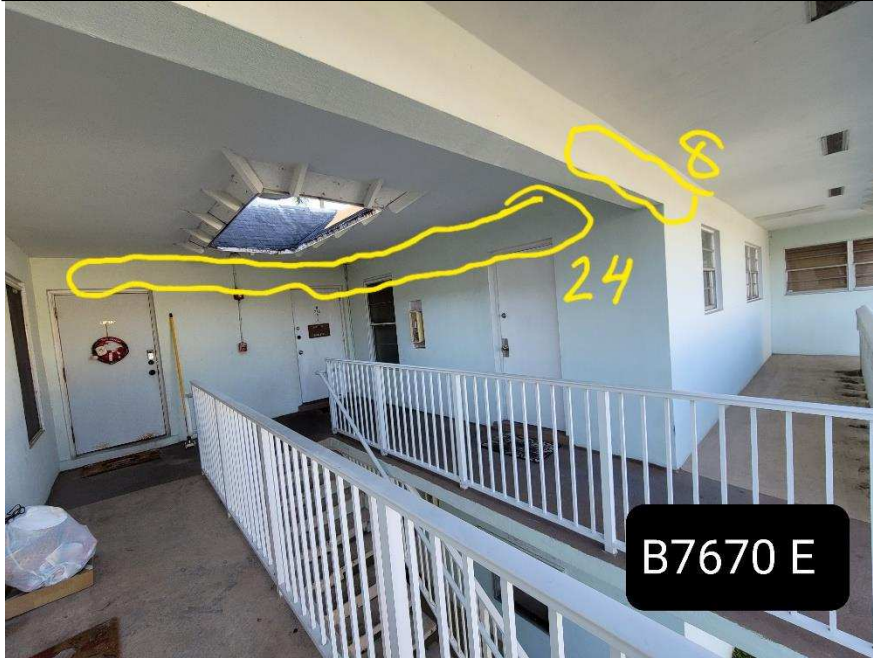
Photo #7:

The top wearing surface of the catwalks are stained or weathered and require maintenance.

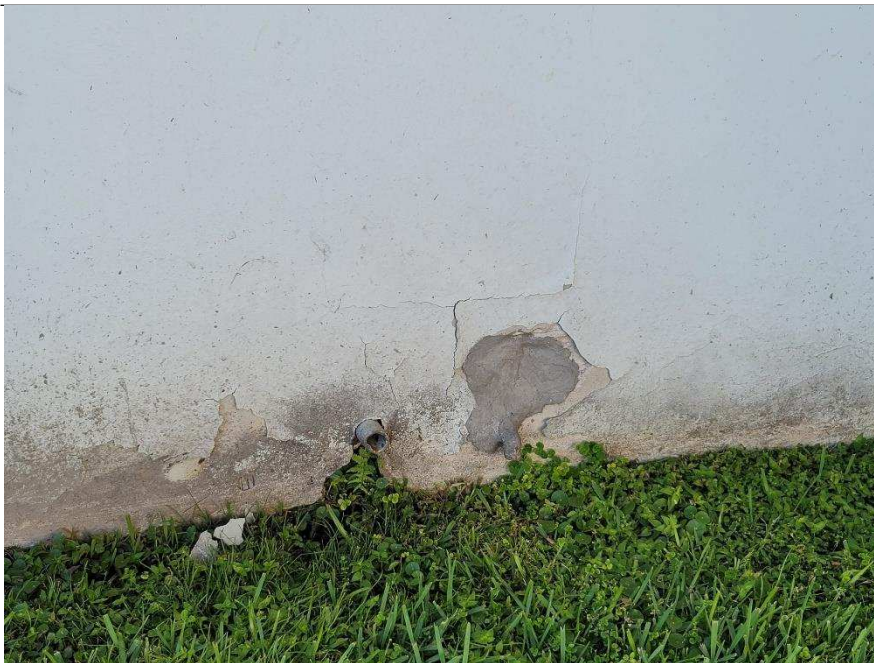
Photo #8:

Miscellaneous wall penetrations should be properly sealed to prevent water infiltration into the building, and/or surface decay of the stucco membrane in the vicinity of the penetration.

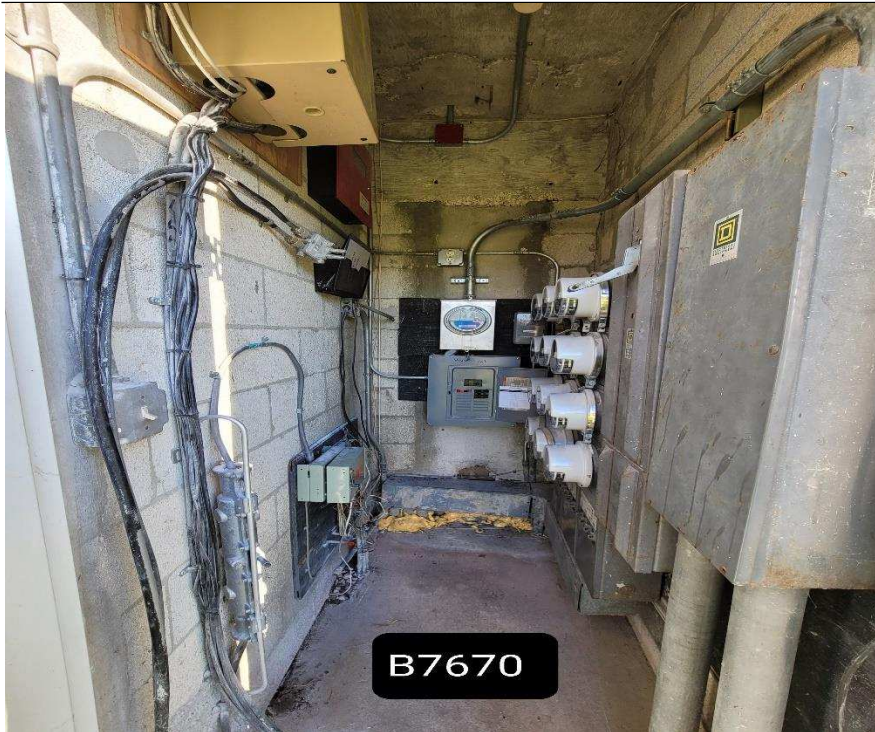
Photo #9:

The mechanical room was observed to be in good condition. Wall/ceiling penetration should be sealed.

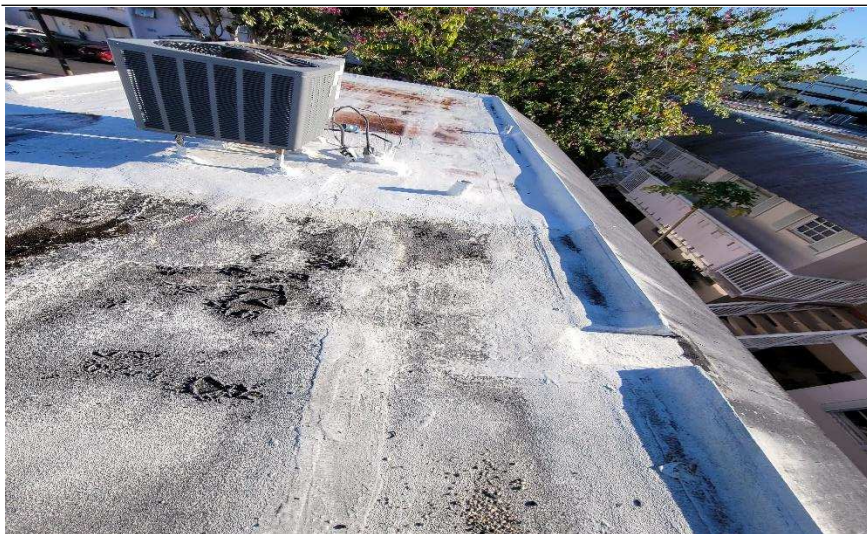
Photo #2:

Water ponding stains observed on the roof.

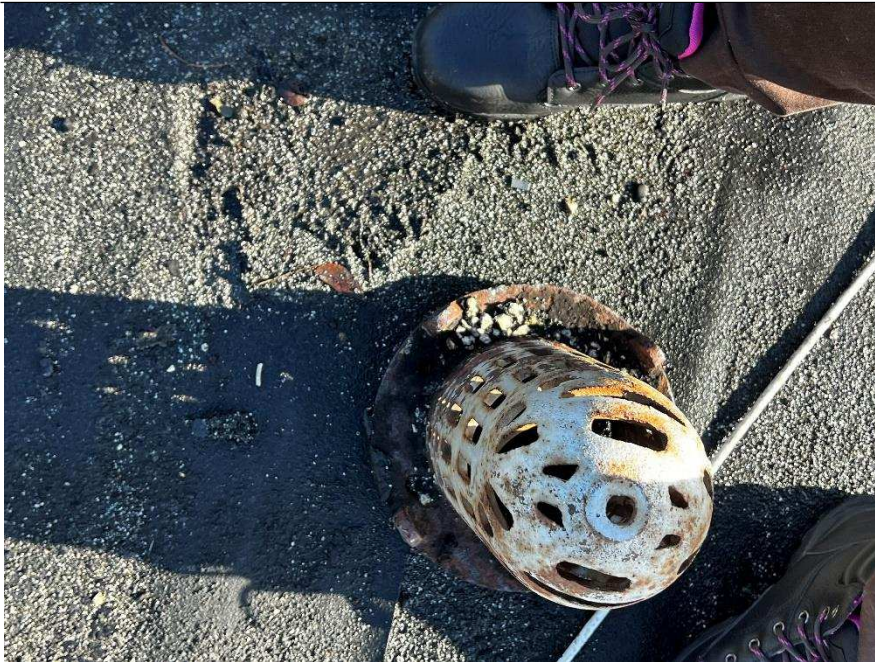
Photo #3:

The strainers for the interior drain lines were found to be rusted or non-functional since many of them are missing or not in their proper position. Others need maintenance to remove debris.

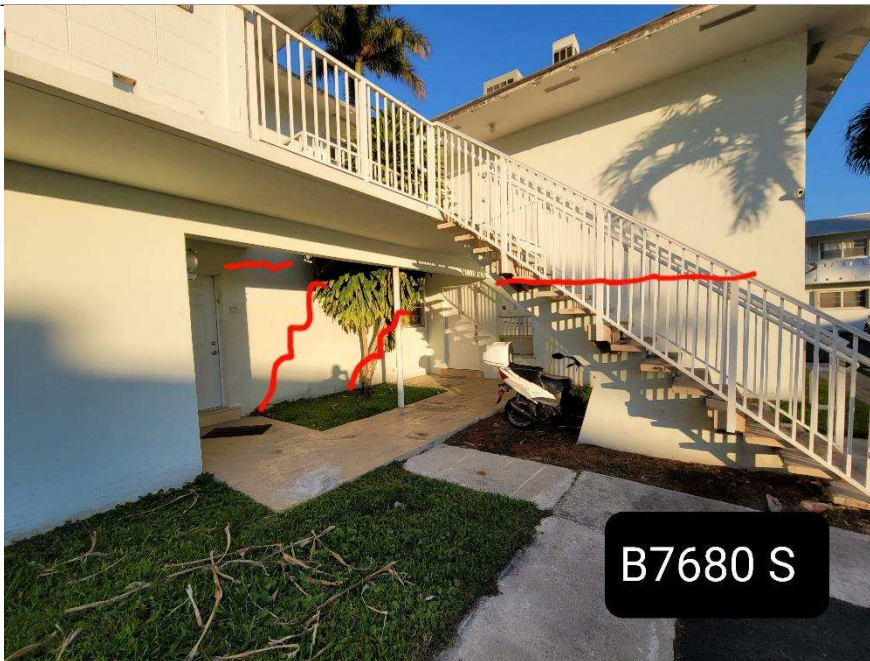
Photo #4:

The stuccoed envelope requires maintenance of the stucco exterior surfaces throughout the building. Fine horizontal and steps cracks observed sporadically.

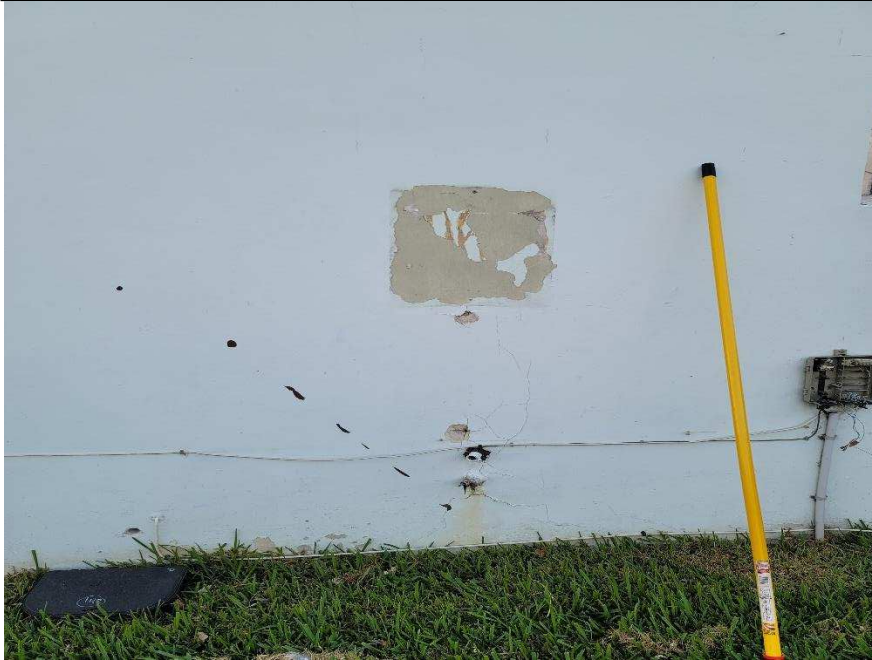
Photo #5:

Miscellaneous wall penetrations should be properly sealed to prevent water infiltration into the building, and/or surface decay of the stucco membrane in the vicinity of the penetration.

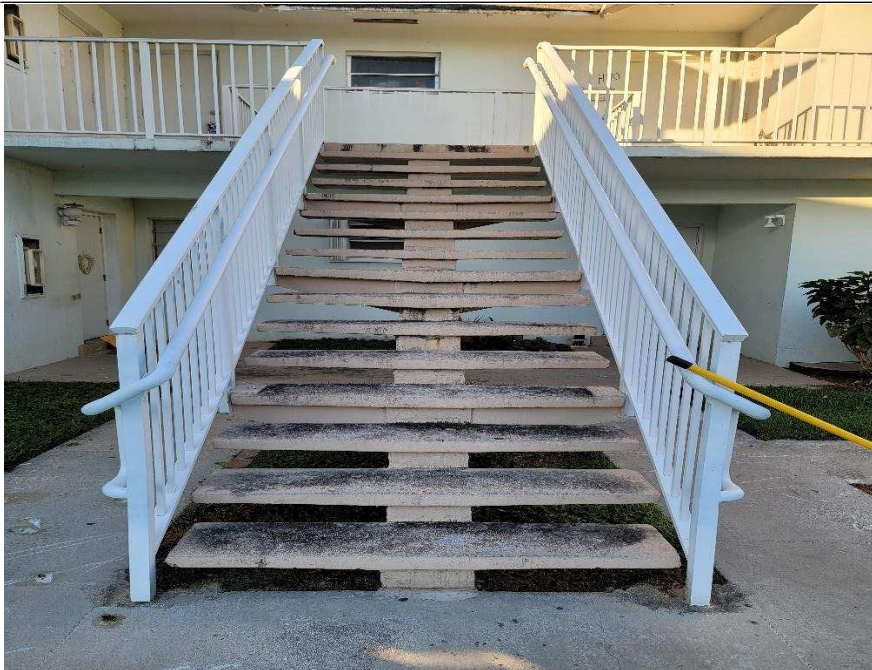
Photo #6:

The railings were deemed to be in fair/good condition.
