SAGUACHE CREEK DIVERSION INFRASTRUCTURE INVENTORY

Structure Name: HAWKINS D

HAWKINS DITCH

Saguache Creek Stream Management Plan

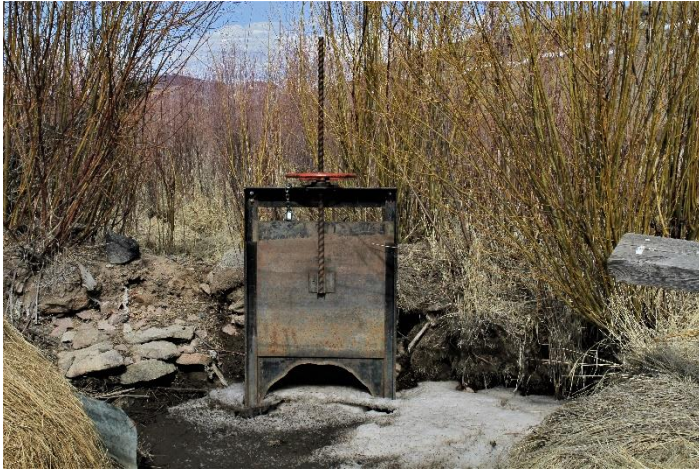
Headgate looking downstream

Repair(s) or Improvement(s) Currently Needed: The diversion dam should be improved to reduce debris accumulation and bank erosion as well as improve function for the ditch. Future improvements to the diversion dam should consider fish passage and riparian restoration. Bank stabilization is needed to protect the headgate. The headwall has been damaged and could use repair.

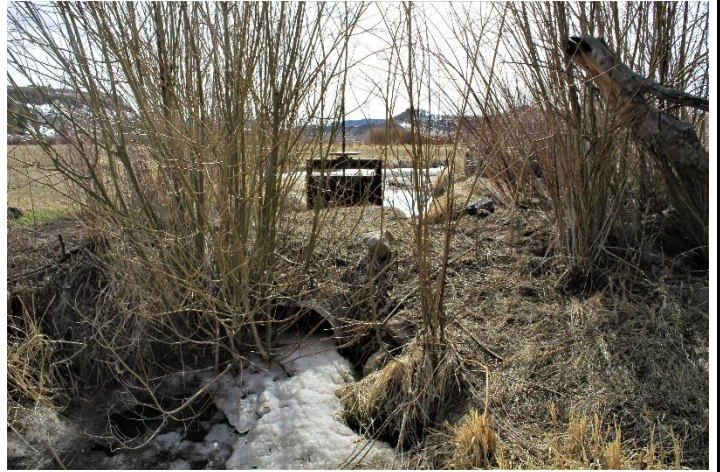
Headgate outlet

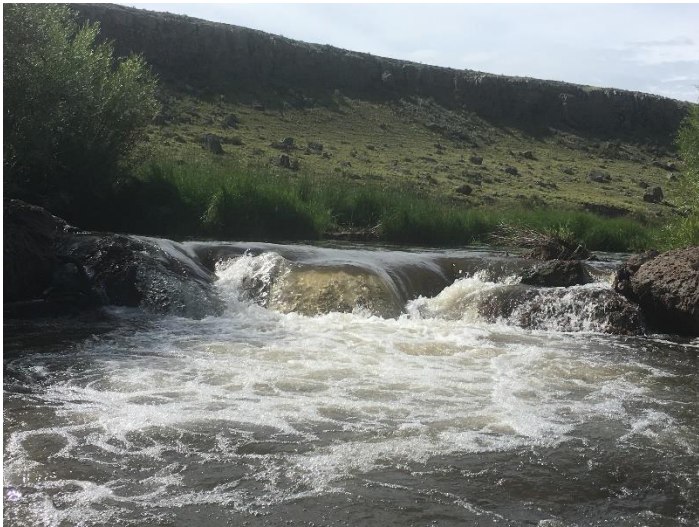
Structure Description: This ditch is located at the apex of a meander and the bank is experiencing erosion upstream of the headgate. The diversion dam is made up of large boulders and debris and is often supplemented with large hay bales. The headgate is located on the east bank of the river. A new flume was installed in 2019.

Diversion dam looking upstream

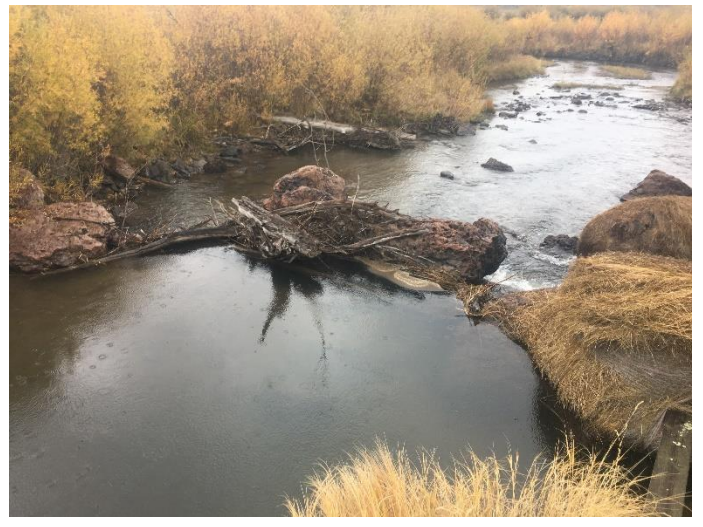
Diversion dam looking downstream

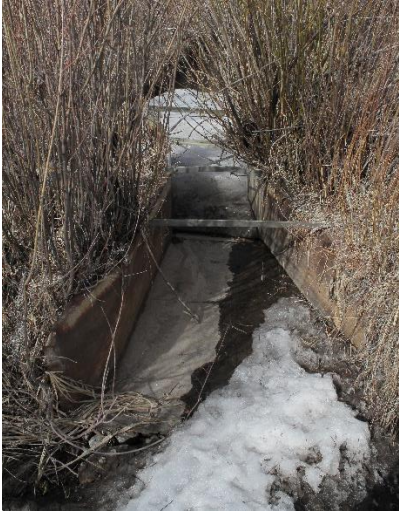
Flume looking downstream

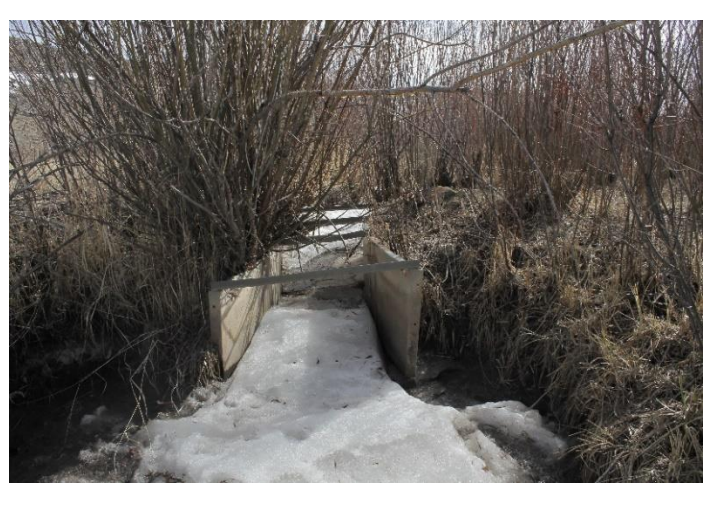
Flume looking upstream
