**RE: Village at Dadeland Condominium Association**  
**7440 SW 82nd St, Miami, FL 33143**  
**Electrical Repairs for Building Recertification**  
**Folio #: 30-4035-047-XXXX**

MINIMUM INSPECTION PROCEDURAL GUIDELINES  
FOR BUILDING ELECTRICAL RECERTIFICATION

a. Name on Title: Village at Dadeland Condominium (Club House)

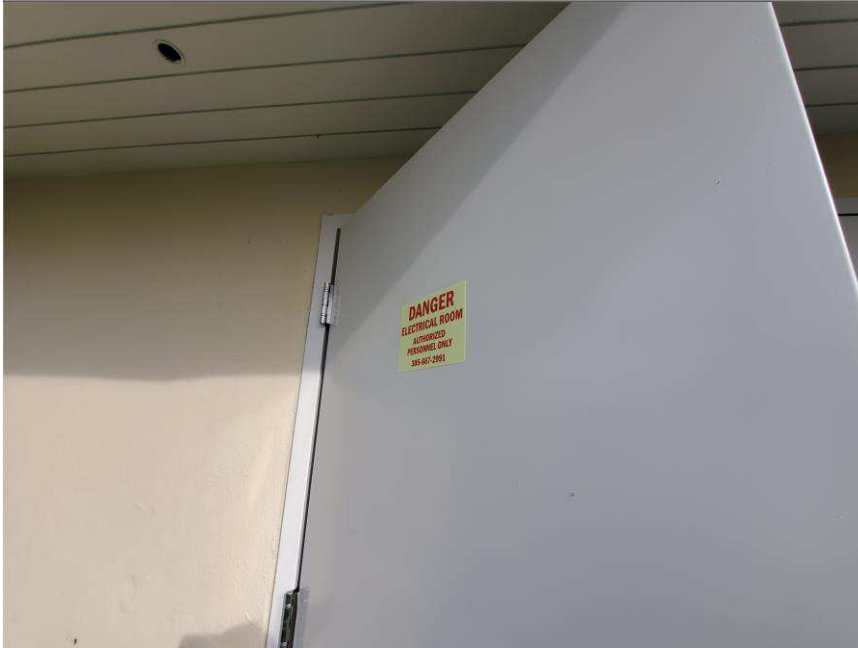
Photo 1 – Village at Dadeland Condominium Association

Existing Electrical Room - 1st FL  
No Storage Permitted

Building Number sign is missing.

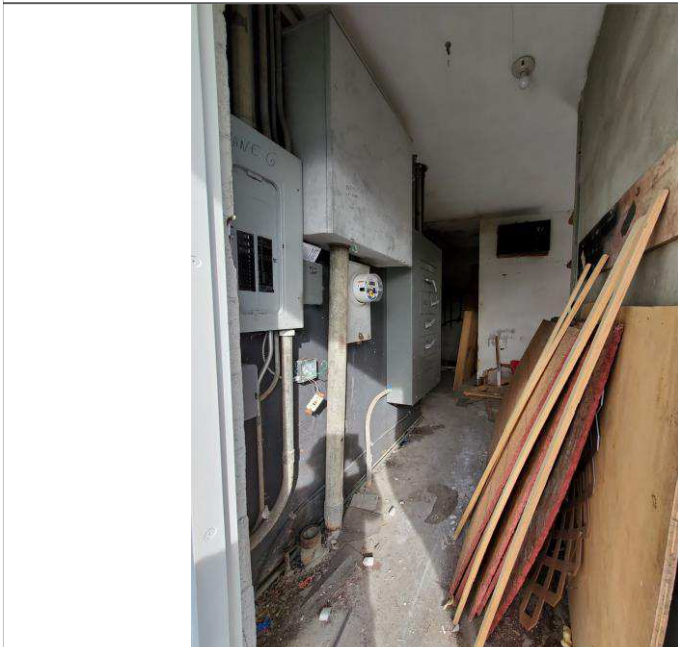
Photo 2 – Village at Dadeland Condominium Association

Existing Electrical Room - 1<sup>st</sup> FL  
Main Switches, Meters, House  
Main Switch, Fire Alarm Panel,  
and Gutters.

No Storage Permitted

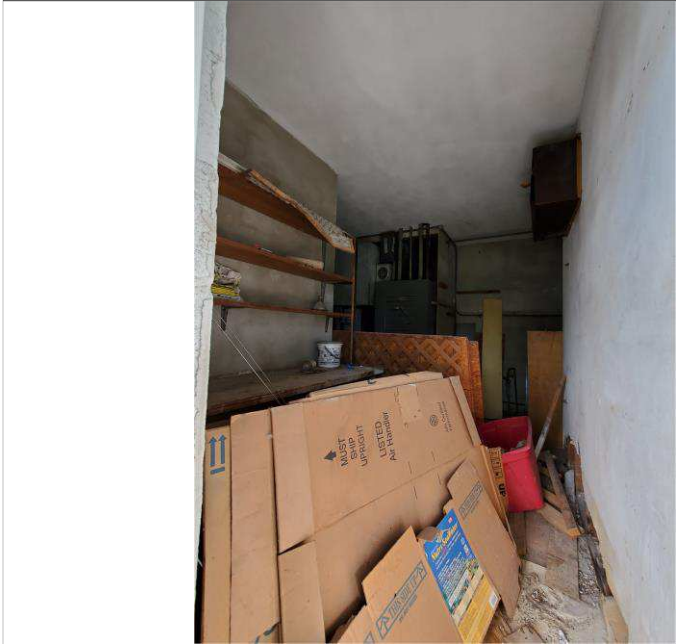
Photo 3 – Village at Dadeland Condominium Association

Existing Electrical Room - 1<sup>st</sup> FL  
Main Switches, Meters, House  
Main Switch, Fire Alarm Panel,  
and Gutters.

No Storage Permitted

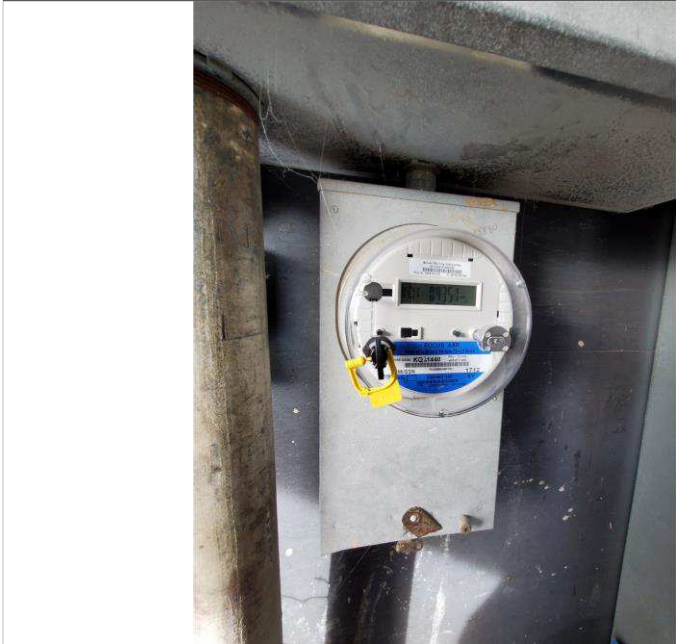
Photo 4 – Village at Dadeland Condominium Association

Existing Electrical Room - 1st FL  
House Main Meter

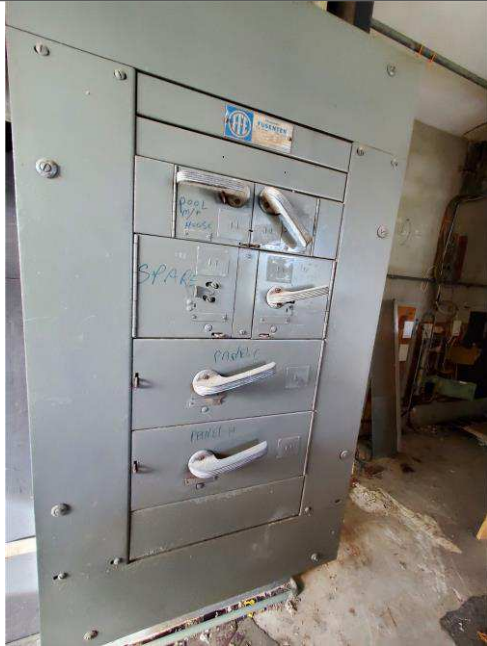
Photo 5 – Village at Dadeland Condominium Association

Existing Electrical Room - 1st FL House Panel Board is a 50 year old electrical component.

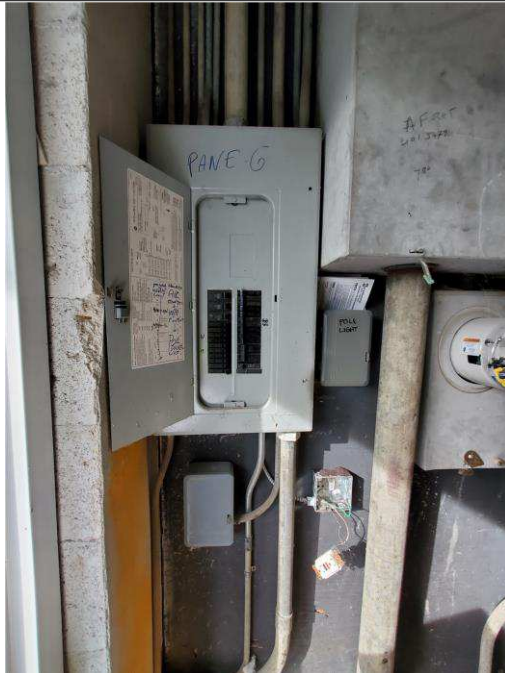
Photo 6 – Village at Dadeland Condominium Association

Existing Electrical Room - 1st FL House Main Panel 'G' is a 50 year old electrical component.

GFCI outlet need to be properly secure to electrical box

Incomplete panel directory.

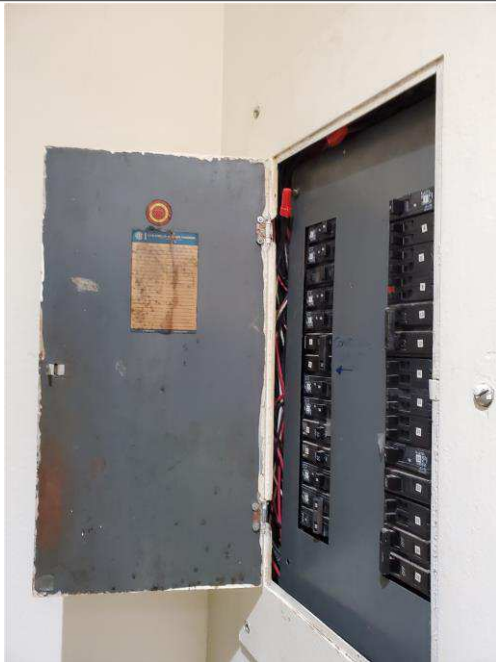
Photo 7 – Village at Dadeland Condominium Association

Existing Electrical Room - 1st FL  
House Main Panel 'H'  
is a 50 year old electrical  
component.

Old and oxidized panel.

Panel directory is missing.

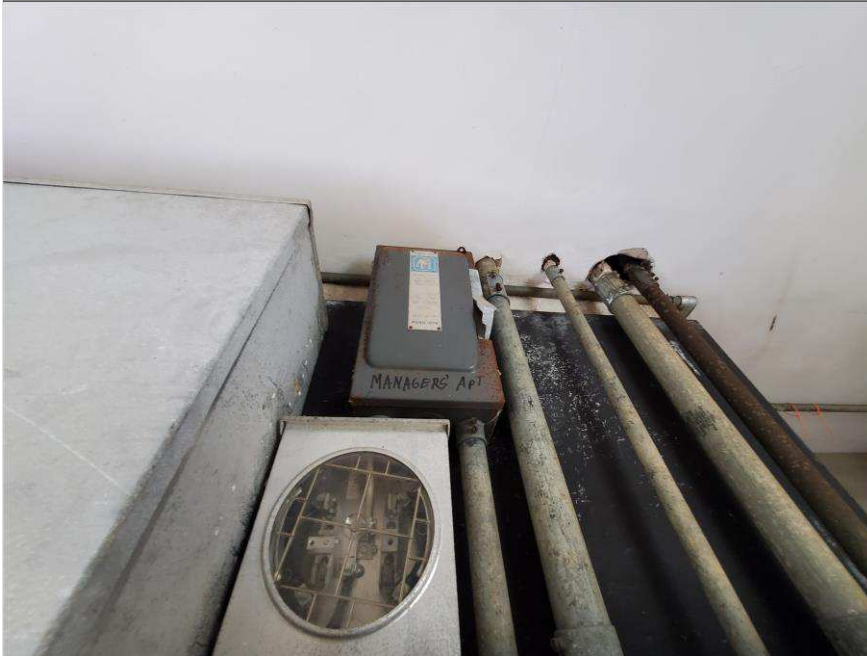
Photo 8 – Village at Dadeland Condominium Association

Existing Electrical Room - 1st FL  
Manager's Apartment Main  
Disconnect is a 50 year old  
electrical component.

Corroded disconnect switch.

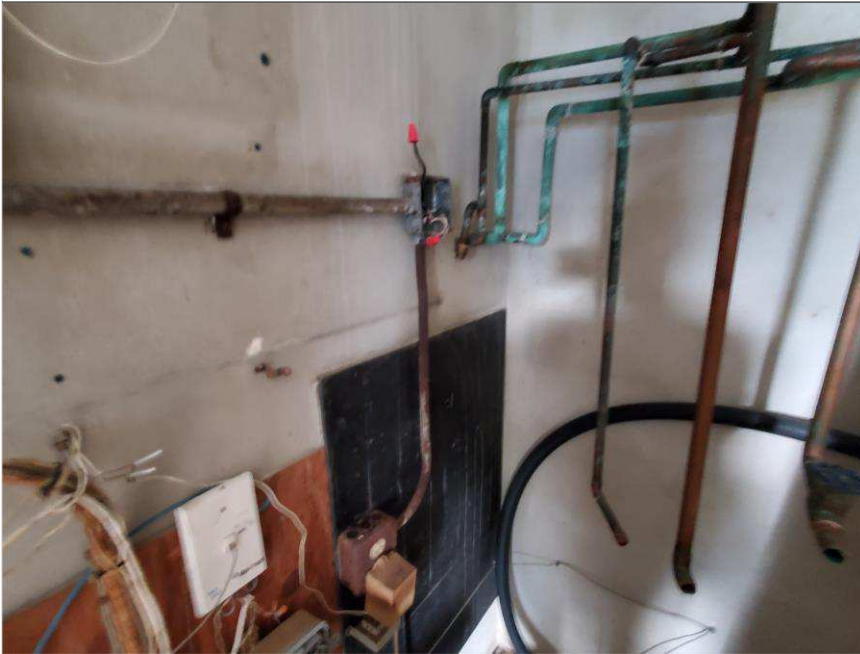
Photo 9 – Village at Dadeland Condominium Association

Existing Electrical Room - 1st FL

Corroded conduits, junction boxes, and outlets.

Open junction boxes.

| 9. All open outlets, switches, and junction boxes are to be closed. |

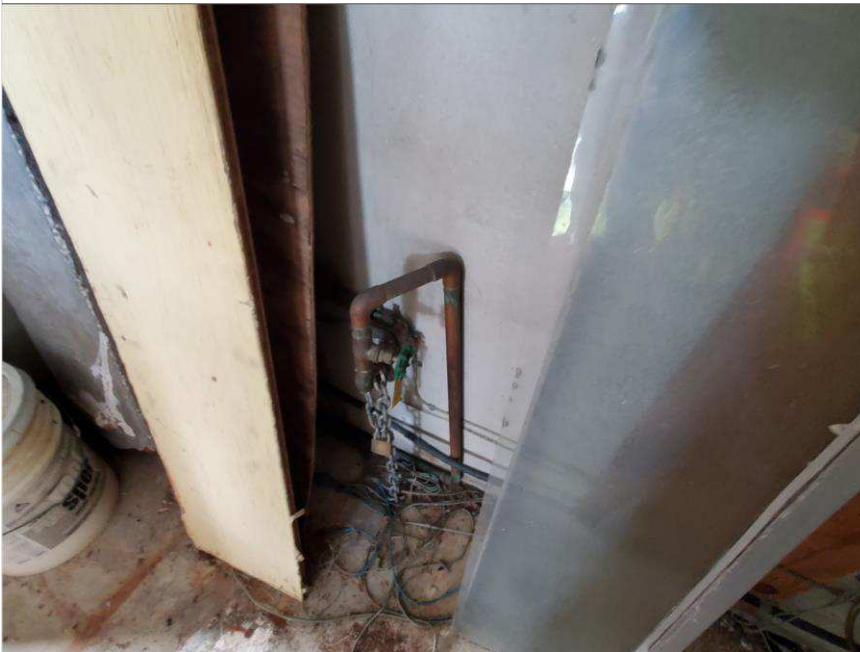
Photo 10 – Village at Dadeland Condominium Association

Existing Electrical Room - 1st FL

Plumbing lines and valves contained within electrical room.

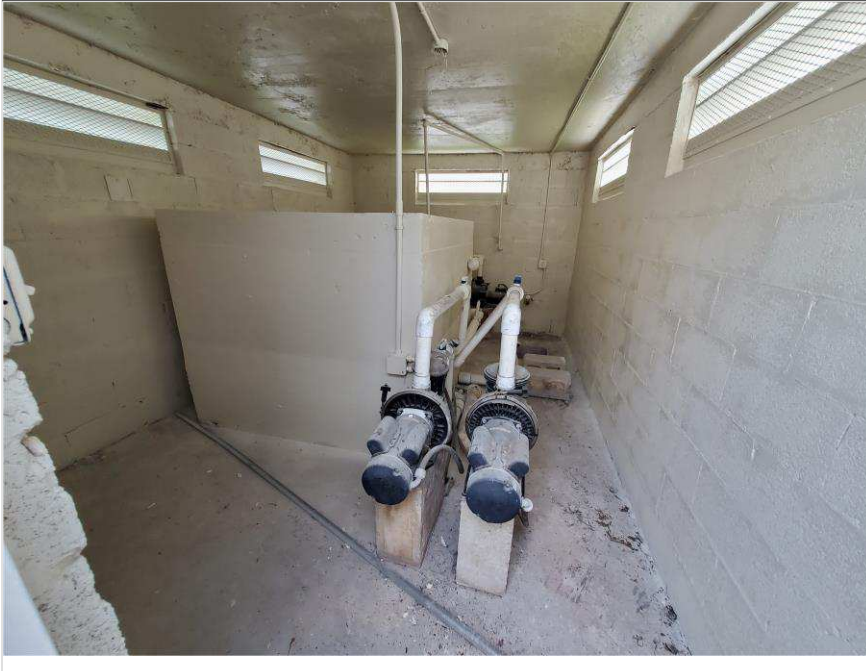
Photo 11 – Village at Dadeland Condominium Association

Main Pool - Pump Room -

Missing light fixture

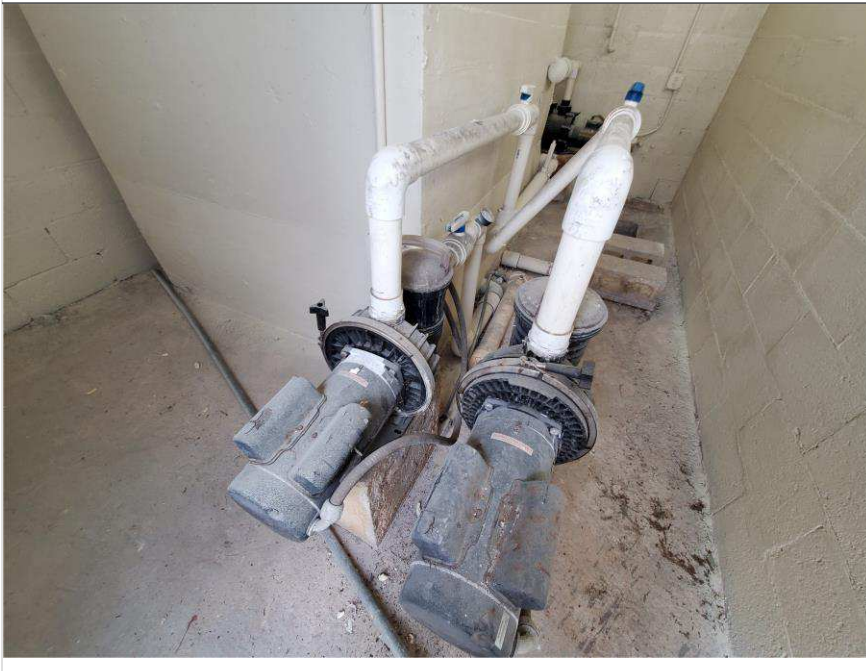
Photo 12 – Village at Dadeland Condominium Association

Main Pool - Pump Room -

Old pumps with corrosion.

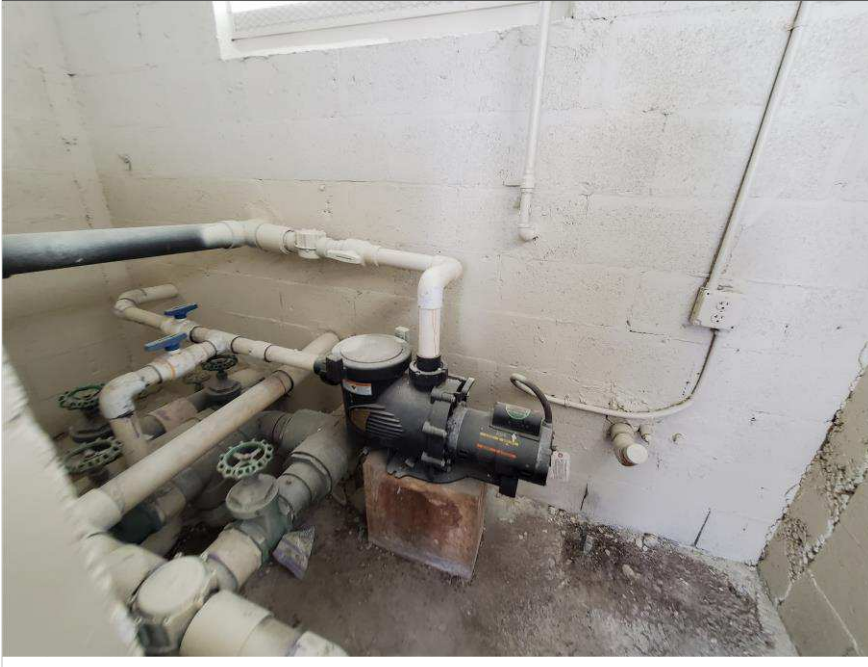
Photo 13 – Village at Dadeland Condominium Association

Main Pool - Pump Room -

Outlets are not GFCI type.

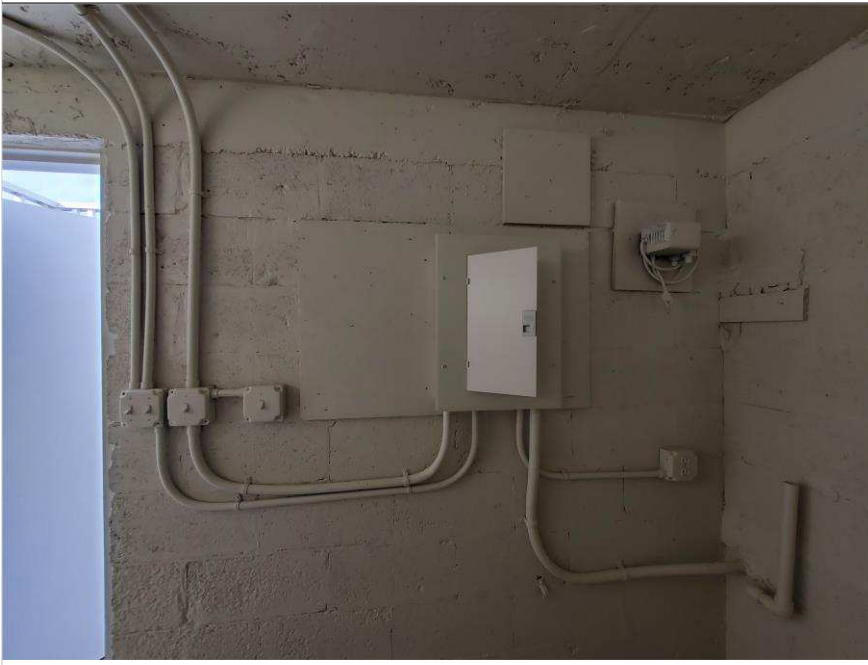
Photo 14 – Village at Dadeland Condominium Association

Main Pool - Pump Room -

Pool Electric Panel –  
Not properly identified.

Outlets are not GFCI type.

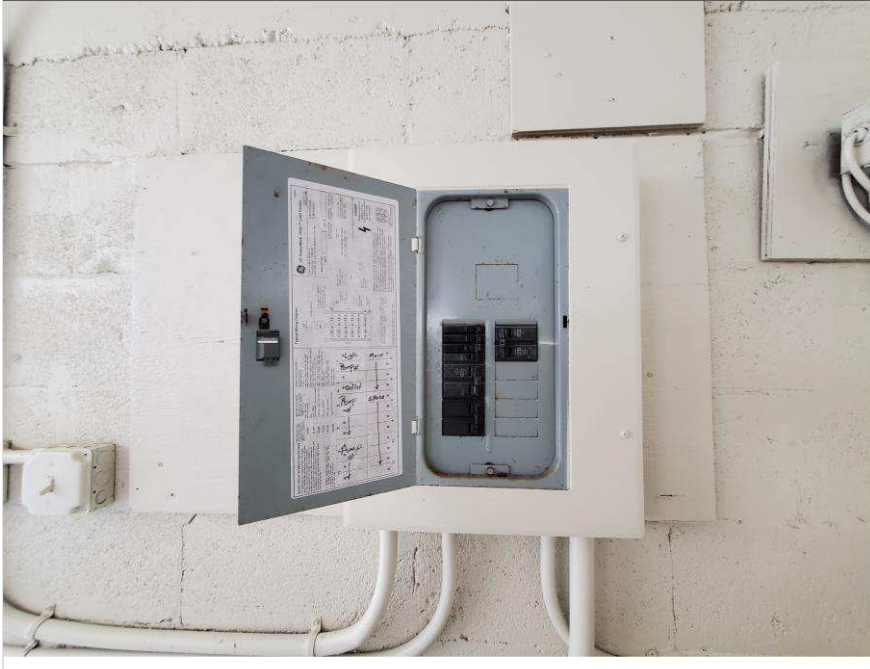
Photo 15 – Village at Dadeland Condominium Association

Main Pool - Pump Room -

Pool Electric Panel –  
Not properly identified.

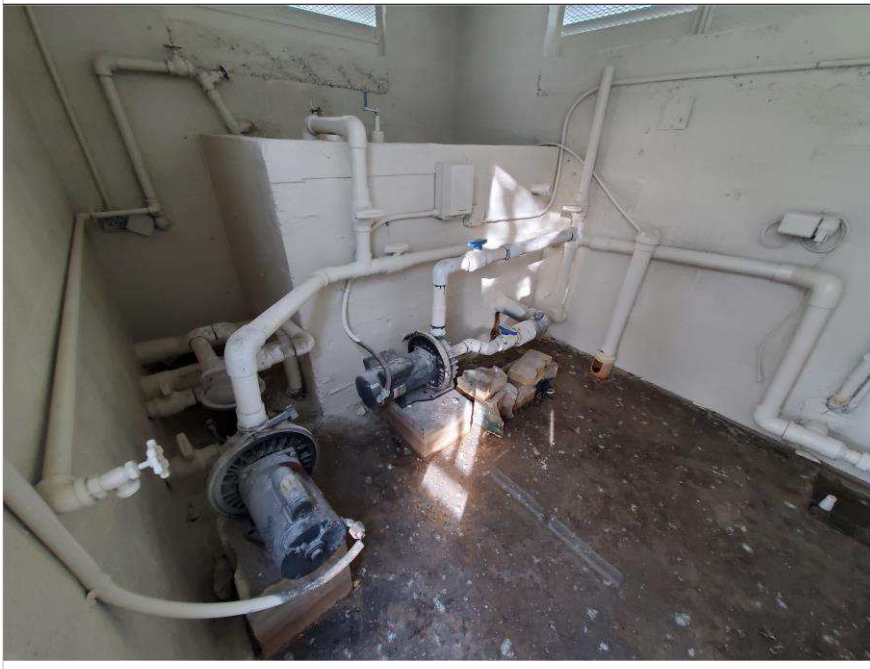
Photo 16 – Village at Dadeland Condominium Association

Pool #2 - Pump Room -

Old pumps with corrosion.

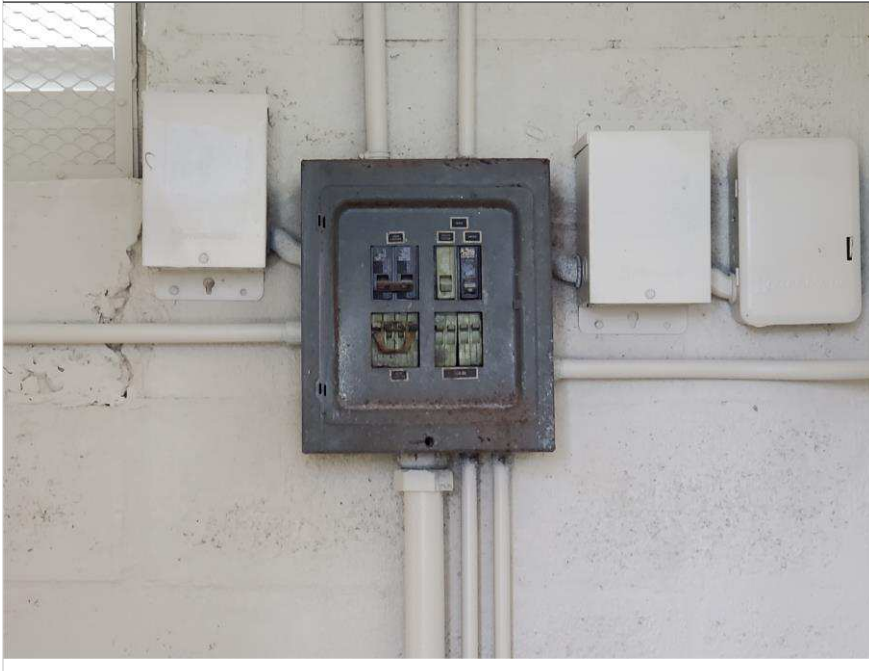
Photo 17 – Village at Dadeland Condominium Association

Pool #2 - Pump Room -

Pool Electric Panel –  
Not properly identified.

Old and corroded electrical  
component.

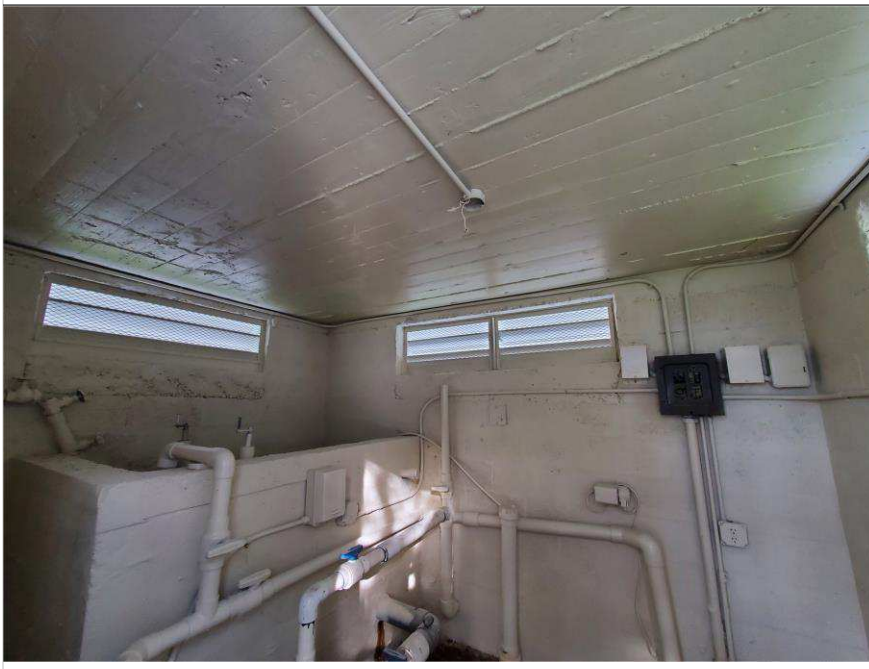
Photo 18 – Village at Dadeland Condominium Association

Pool #2 - Pump Room -

Missing light fixture.

Outlets are not GFCI type.

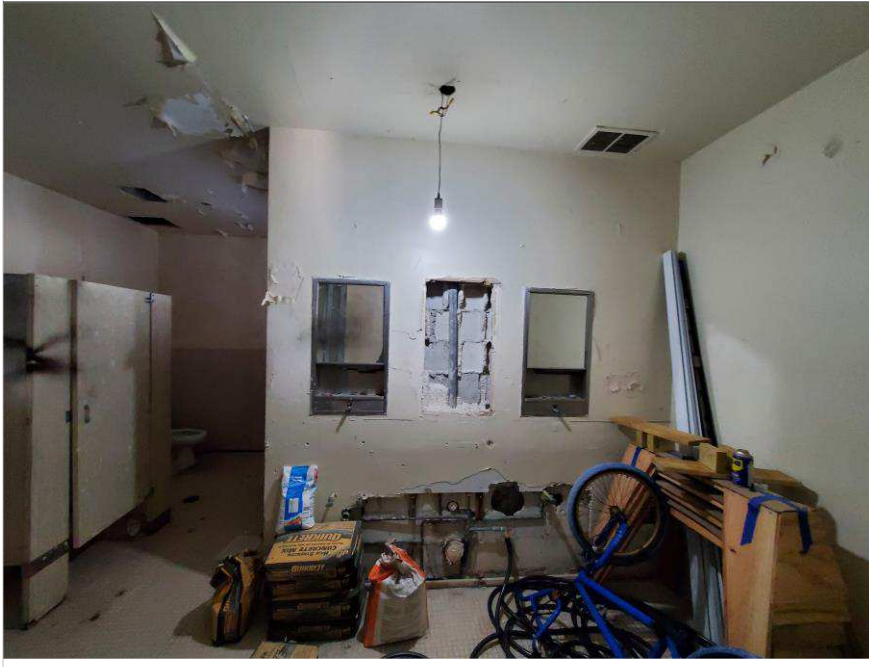
Photo 19 – Village at Dadeland Condominium Association

Clubhouse –  
Bathrooms/Showers

No Fire Alarm, Smoke Alarm, or  
Emergency Lights present.

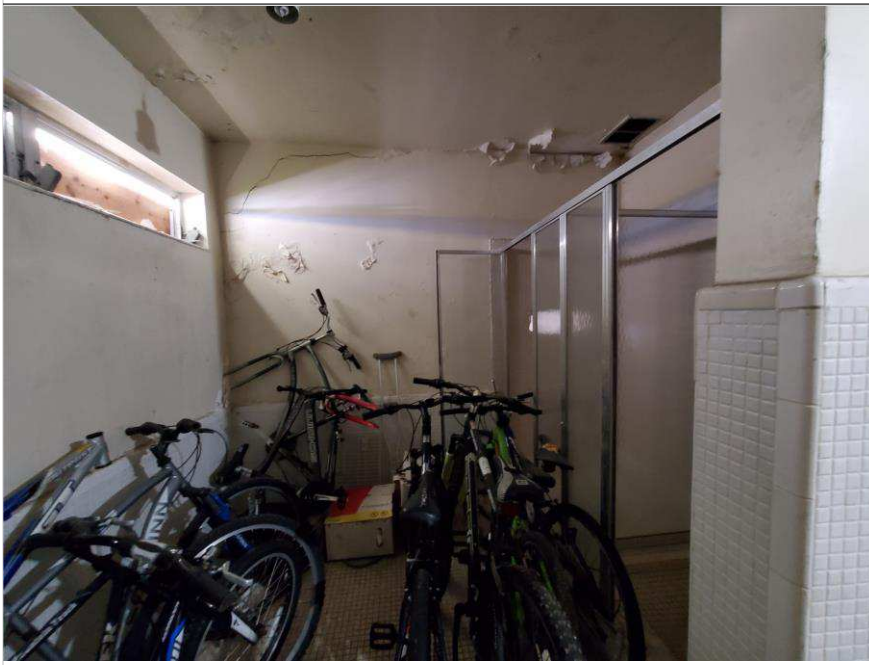
Photo 20 – Village at Dadeland Condominium Association

Clubhouse –  
Bathrooms/Showers

No Fire Alarm, Smoke Alarm, or  
Emergency Lights present.

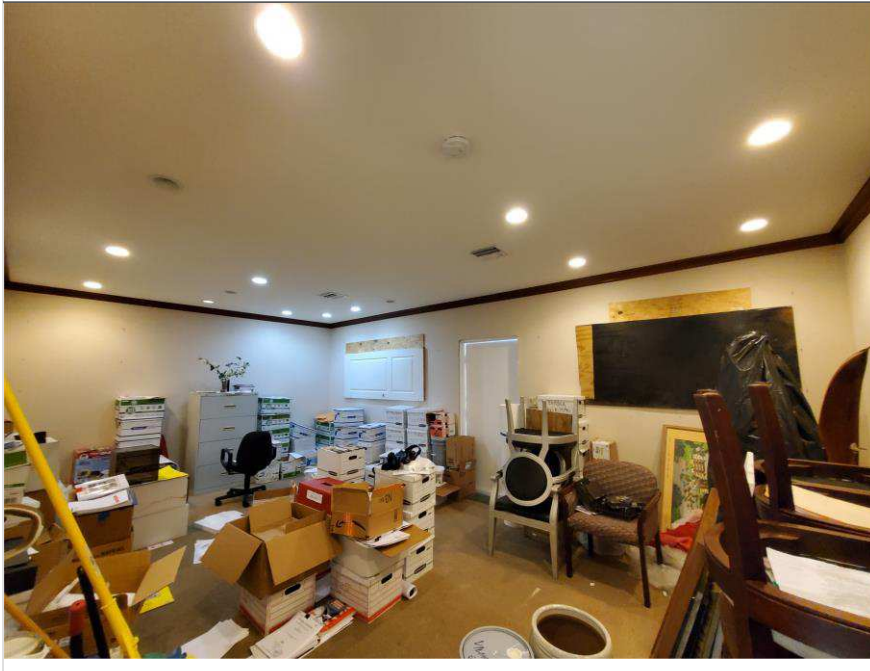
Photo 21 – Village at Dadeland Condominium Association

Clubhouse – Meeting Rooms

No Fire Alarm or Emergency  
Lights present.

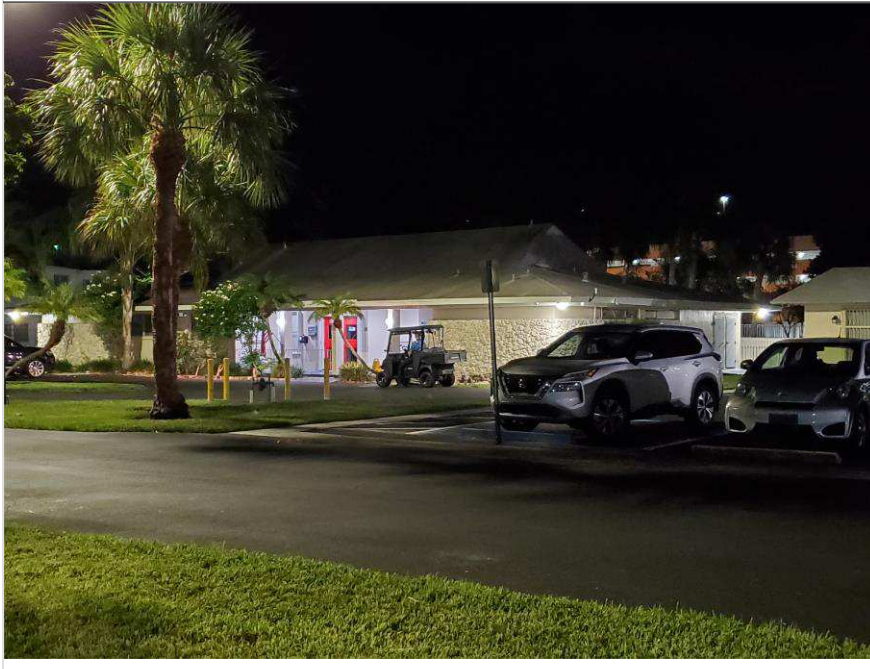
Photo 22 – Village at Dadeland Condominium Association

Comments: Open parking areas have low illumination levels creating unsafe conditions and security concerns. Additional lighting is required to illuminate the parking walking surfaces for safety and security purposes. Parking light mounted on building is out - Repairs Required.

Clubhouse Parking -  
Poorly illuminated sidewalks &  
Parking Areas.
