Home Inspection Report

738 Maple Row, North Harbor, NY 12020

Report Number:

01172512

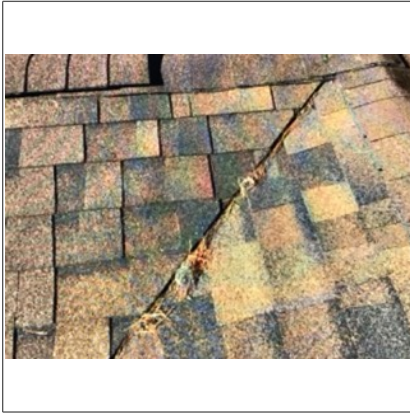
Sloped •Improve: Debris should be removed from the roofing to reduce risk of leaks and early roof wear.

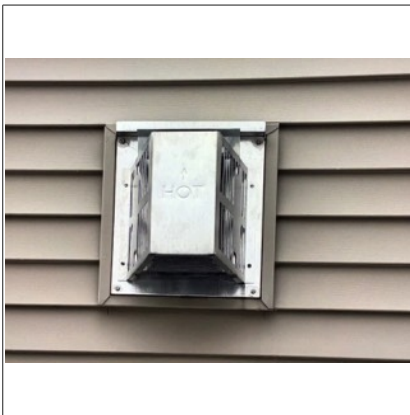
•Repair: The metal chimney should be cleaned to help assure safe and functional operation.

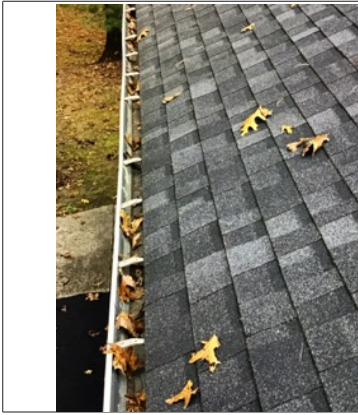
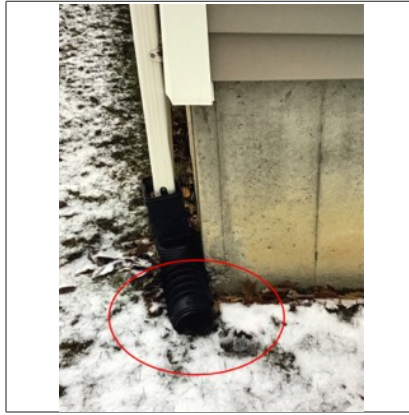
•The gutters require cleaning to avoid spilling roof runoff around the building - a potential source of water entry or water damage.

•Repair: The downspout(s) should discharge water at least five (5) feet from the house. Storm water should be encouraged to flow away from the building at the point of discharge.

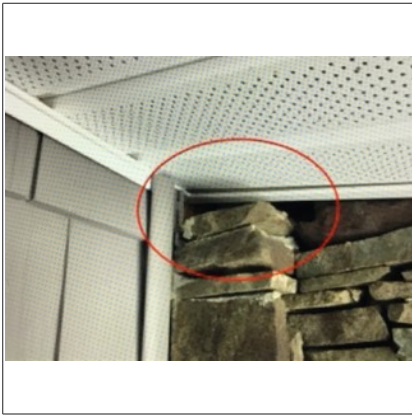
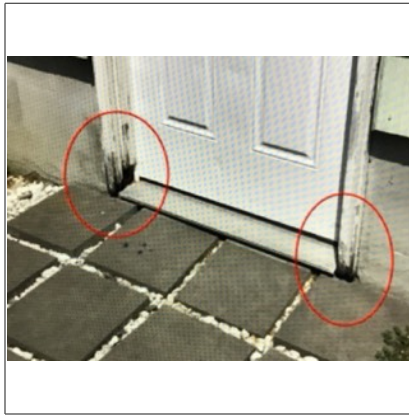
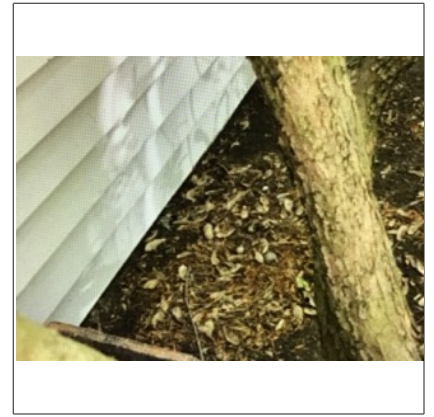
- Ext. walls**
- Repair: The exterior stonework should be re-pointed (replacement of the mortar between the masonry) to prevent further deterioration.
 - Siding to soil contact should be avoided to help prevent moisture and or insect activity.
 - The openings in the siding should be sealed and secured as needed to avoid moisture, insect and or wind damage.
 - Localized rot was observed in the wood trim. Following repair of the damaged areas (which should be combined with exterior painting/maintenance) proper maintenance of the trim and control of water from roof or surface runoff can avoid further damage.
 - Repair: The wood trim should be painted to preserve the building.

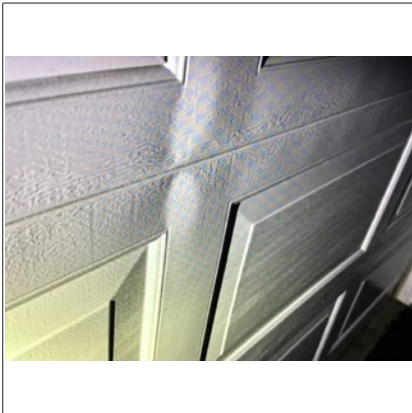
•The left side overhead garage doors is dented. This condition does not prevent the door from operating.

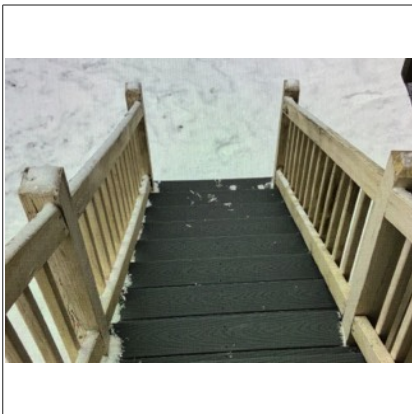
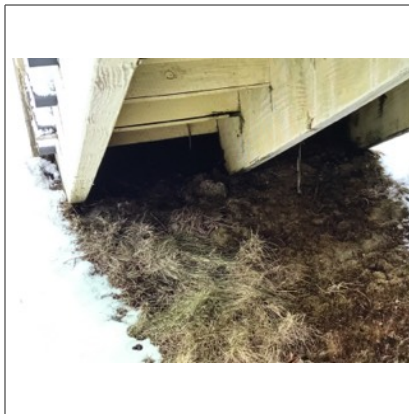
•Repair: As there is a danger of falling, a graspable hand railing, should be provided for all stairs and steps.
•Soil contact should be avoided on the stairs of the deck.

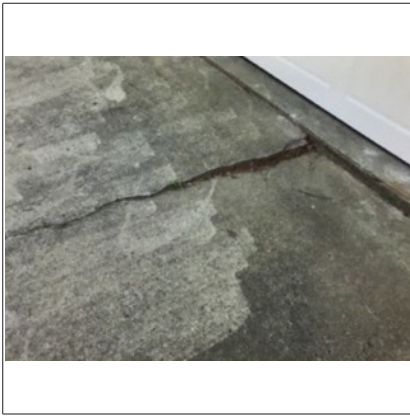
•The driveway shows evidence of cracking and heaving. Re-surfacing of the driveway would be a logical improvement.

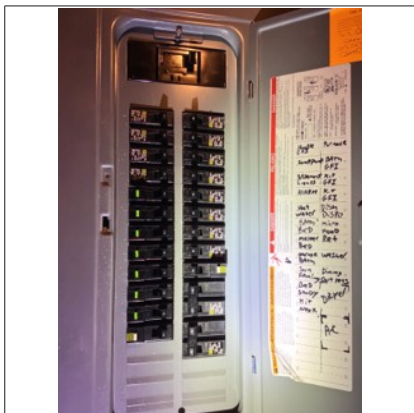
Service / entrance •Improve: The grounding of the electrical service should also be grounded to main water supply.
Main panel

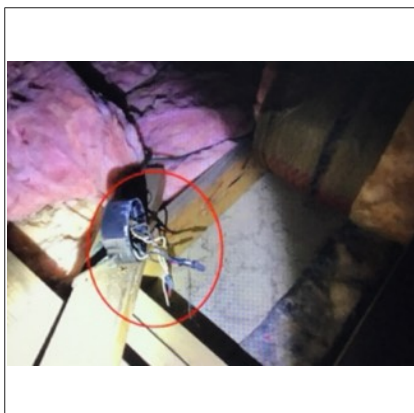
Distribution wires •Repair: Extension cords (in the garage serving the opener) should not be used as permanent wiring. This wiring should be replaced as needed.
•Repair: Improper electrical connections should be repaired. All electrical connections should be made inside junction boxes. All junction boxes should be fitted with cover plates, in order to protect the wire connections.
•Wiring: Touching Ducts/Pipes, exposed on exterior and or interior finishes should be relocated or protected by a rigid conduit.

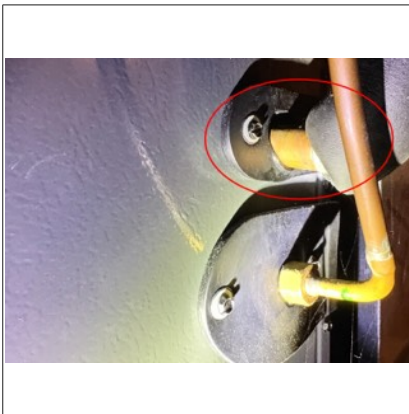
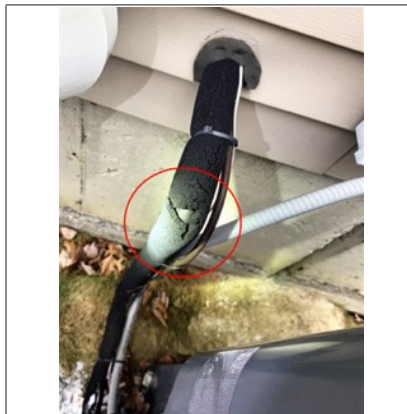
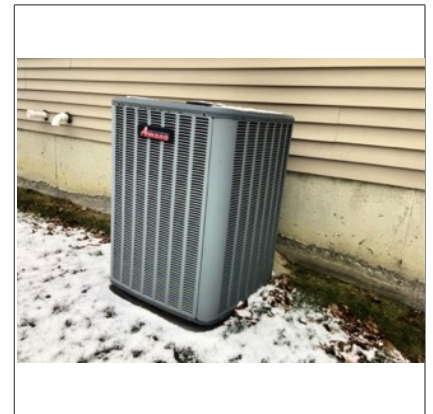
- Central air conditioning**
- Damaged and or missing insulation on refrigerant lines should be repaired. These lines should be insulated from the evaporator case all the way to the compressor unit to prevent condensation moisture damage and possibly a loss of temperature in the lines.

- Repair: The outdoor unit of the air conditioning system is out of level. This should be improved.
- AC Maintenance**
- The air conditioning system requires servicing frequently. This should be a regular maintenance item ideally performed in spring months to ensure efficient and reliable AC.

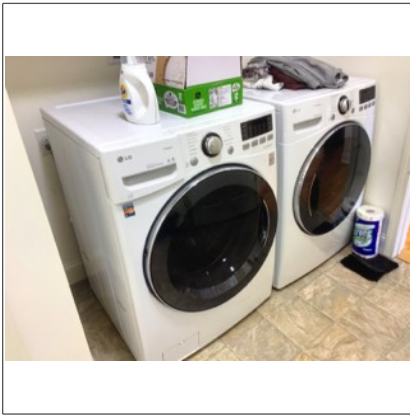
- The use of an overflow pan and the installation of burst free hoses is recommended on the washing machine of this home to protect against overflow or hose failures.
- The discharge of the dehumidifier into the sump pit should be improved, for a host of reasons. Primarily, it may provide the basement leakage measurements a false level of moisture.
- It may also be prudent to consider a back up style pump (sump jet) that will still work in the event of a power interruption.
