SAGUACHE CREEK DIVERSION INFRASTRUCTURE INVENTORY

Structure Name: MOUNTFIELD D

Date: April 11, 2019

Saguache Creek Stream
Management Plan

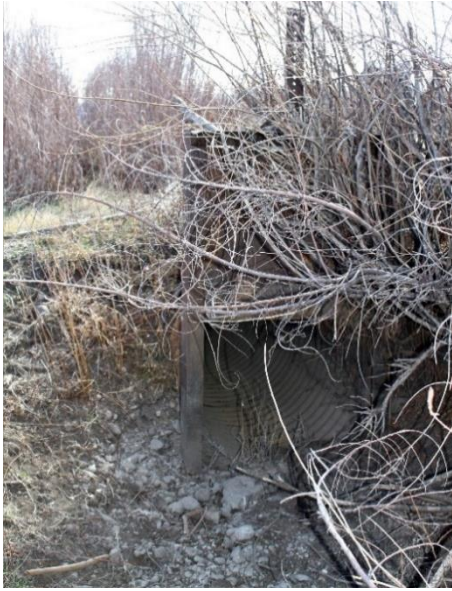
Headgate looking downstream

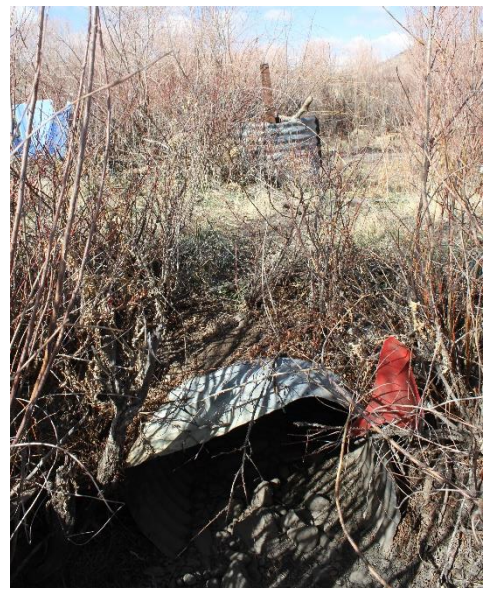
Headgate outlet

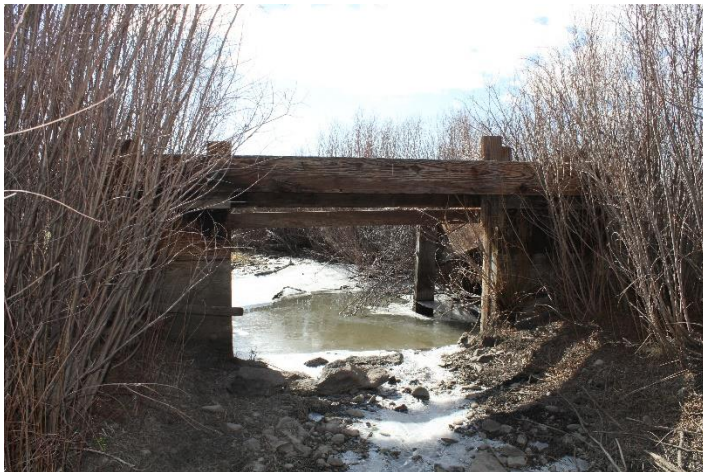
Diversion dam looking downstream

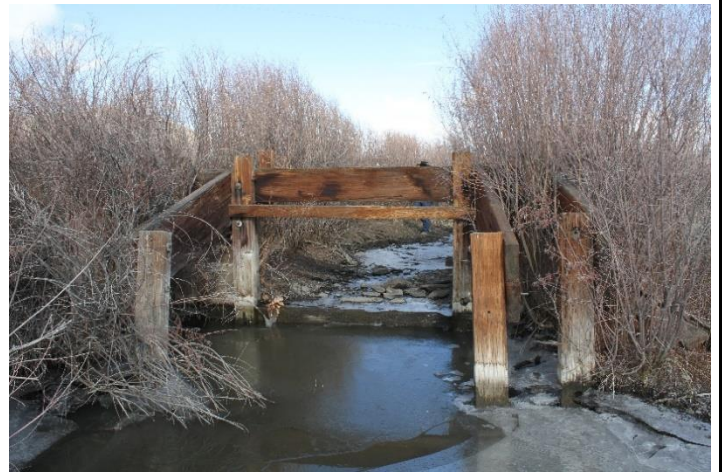
Diversion dam looking upstream

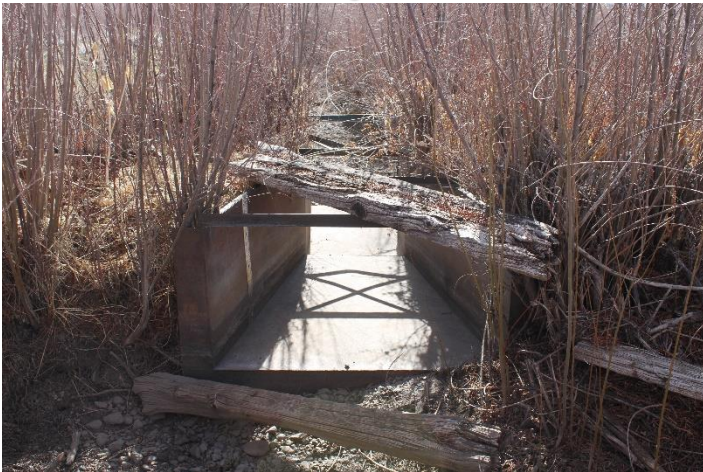
Flume looking downstream

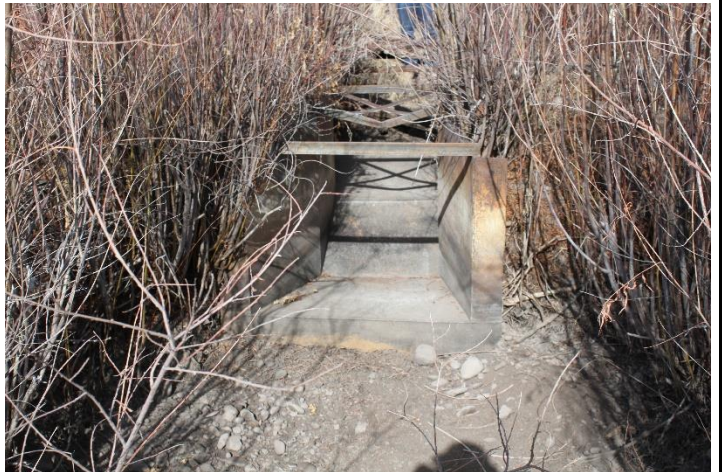
Flume looking upstream
