Inspection Report

Sample Report
123 Anywhere Street
San Luis Obispo, CA 93401

Inspected by: **Gregory S. Terry**

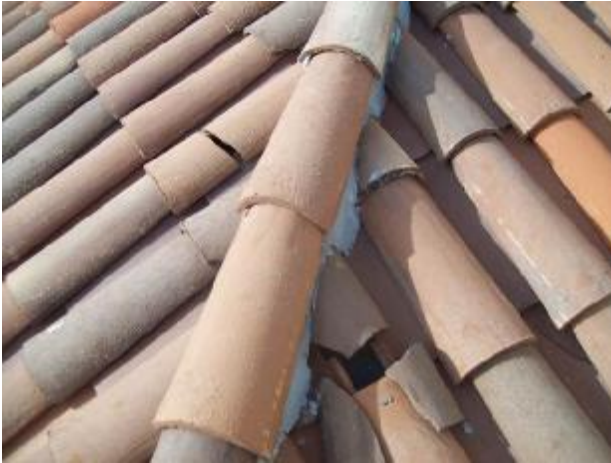
R

1.) There are several cracked and displaced roof tiles at the hip above the NW corner of the garage.

Cracked and displaced roof tiles at the hip above the garage.

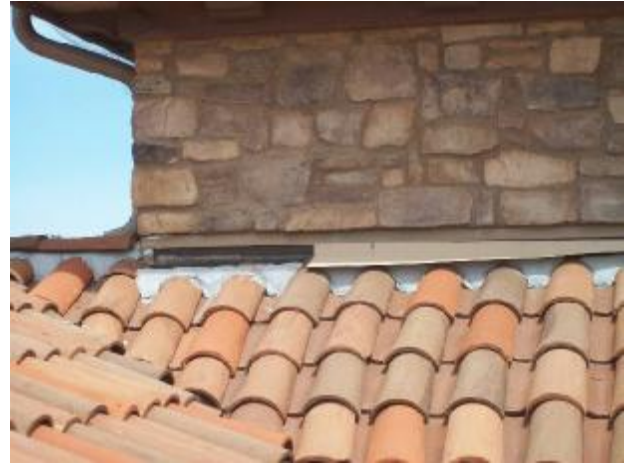
R

2.) The roof-to-wall flashing above the east side of the garage is partly missing and partly damaged.

Partly damaged and partly missing roof-to-wall flashing above the garage.

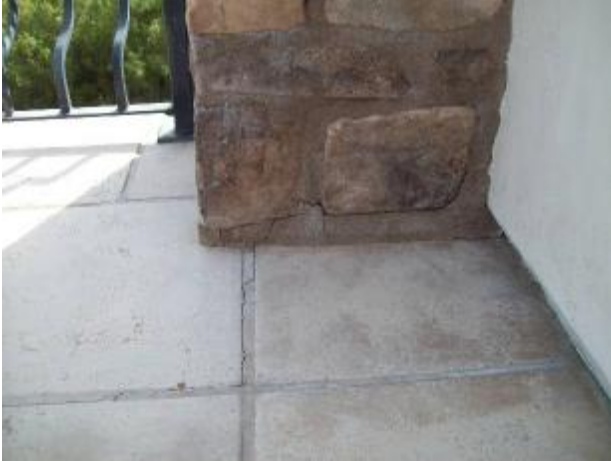
EX

1.) There is a differential crack in the stucco at the east end of the second story north side balcony. There are also cracks at the base of both of the the masonry railing columns above this area. This appears to have been caused by settlement of the load bearing column at the NE corner of the balcony. Recommend further evaluation of this condition by a qualified and licensed Structural Engineer prior to close of escrow.

Cracks at the base of the NE handrail column at the balcony.

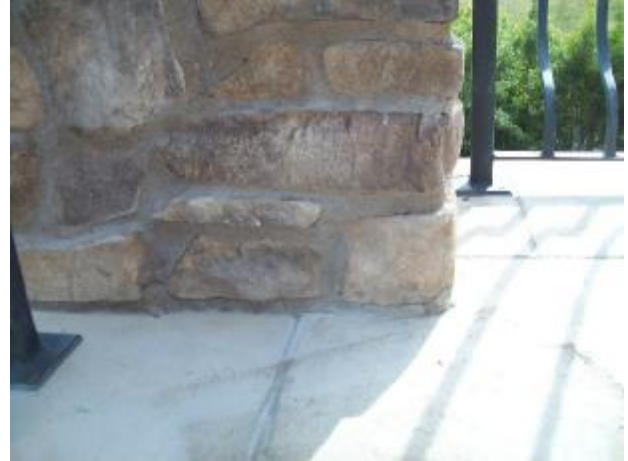
EX

Cracks at the base of the SE handrail column at the balcony.

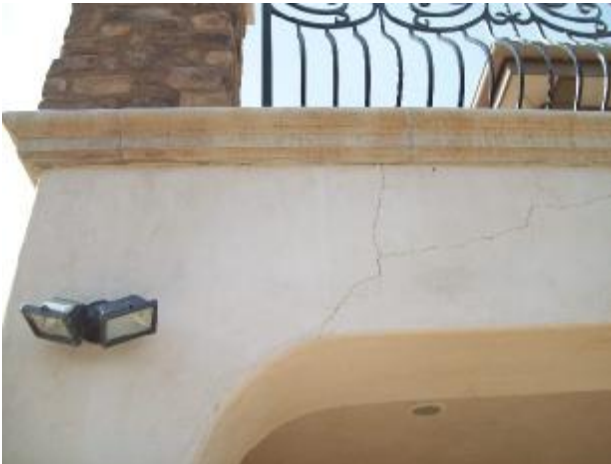
EX

Differential crack in the stucco at the NE corner of the second story north side balcony.

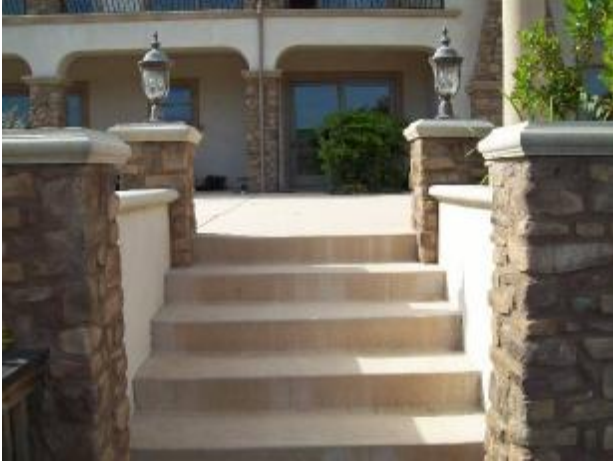
GD

Safety Hazard Note: There are no hand rails installed for both of the concrete stairs that lead from the backyard concrete patio to the lower wood decks.

Hand railing is needed at the concrete stairs at the backyard patio area.

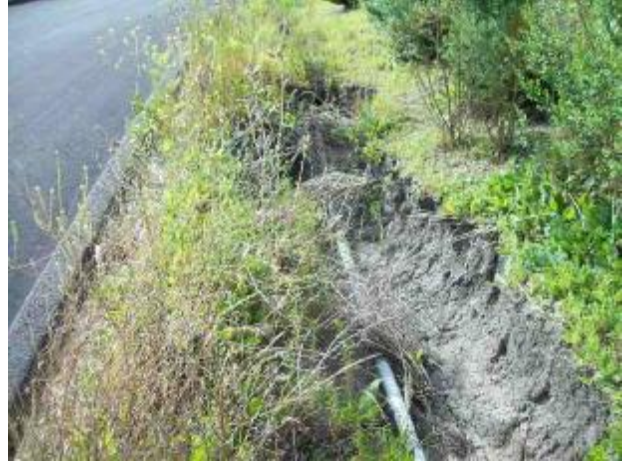
GD

Erosion control is needed at the trench along the east property line.

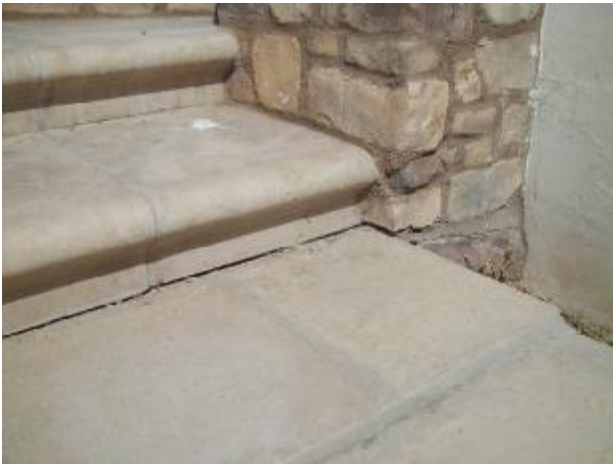
GD

Settlement observed at the concrete patio at the east side of the front entry area.

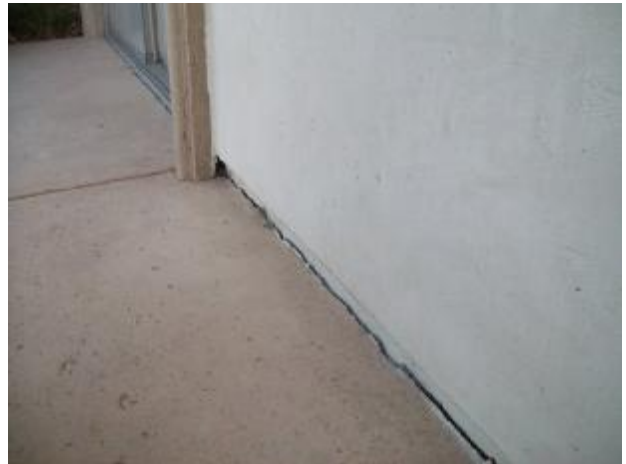
GD

The concrete patio at the north side of the master suite has settled and pulled away from the home.

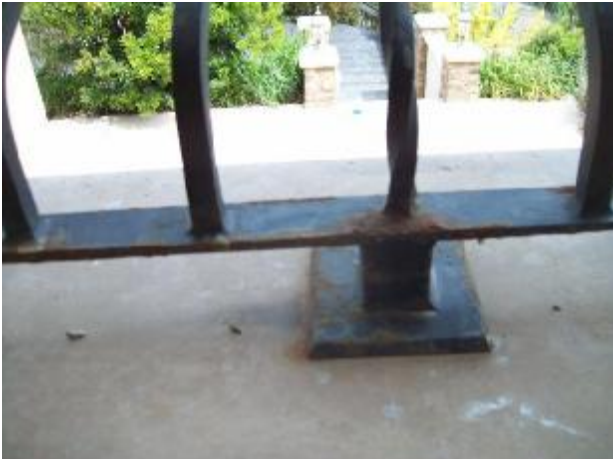
GD

Example of some of the rusting at the wrought iron railings around the second story balconies.

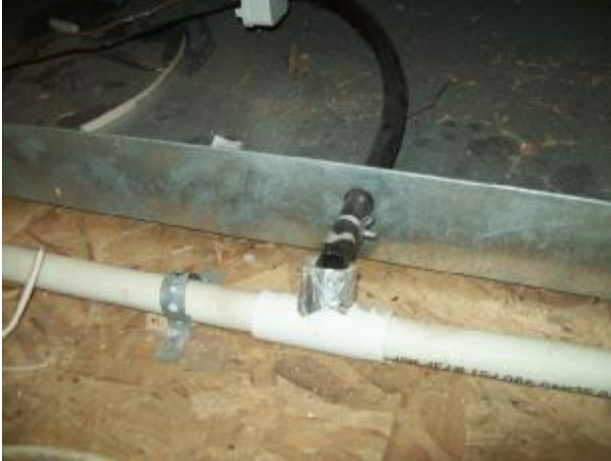
HC

1.) There is a substandard connection of the furnace condensate drain line to the primary A/C drain line at the unit installed in the second story east attic. This connection is subject to leakage.

Substandard connection for the FAU condensate drain line to the A/C primary drain line.

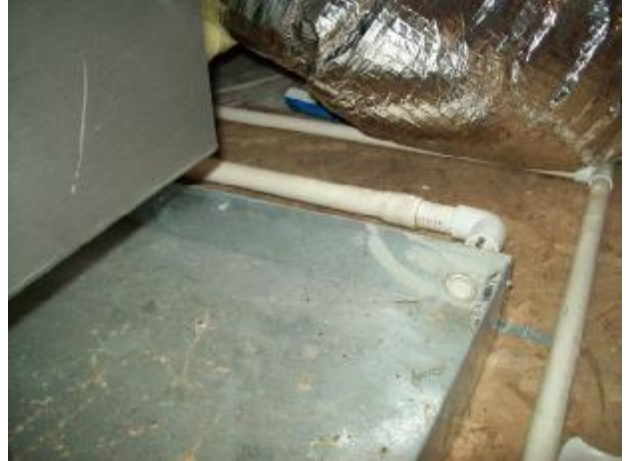
HC

Fire Safety Hazard Note: The propane pans below both of the horizontal furnaces in the attics spaces on the east side of the home are improperly installed. The drain lines are required to be a minimum of two inches in diameter (They are installed with one inch lines) and the drain lines have an inadequate slope to drain. Additionally, the drain lines are not installed flush with the base of the pans.

Improper installation of the propane pans below the furnaces in the attic.

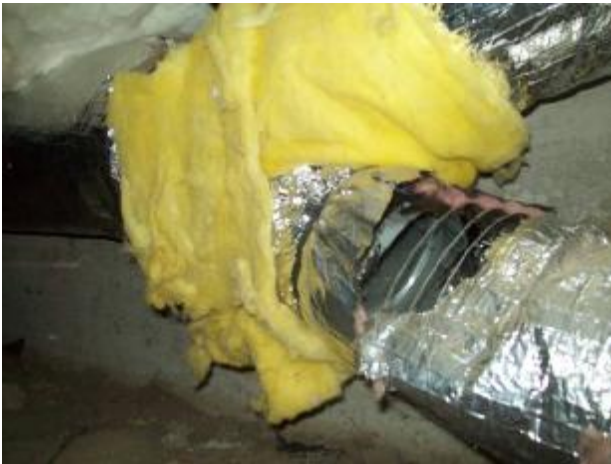
HC

7.) There is a damaged HVAC duct in the substructure area below the east hallway.

Damaged HVAC duct in the substructure area.

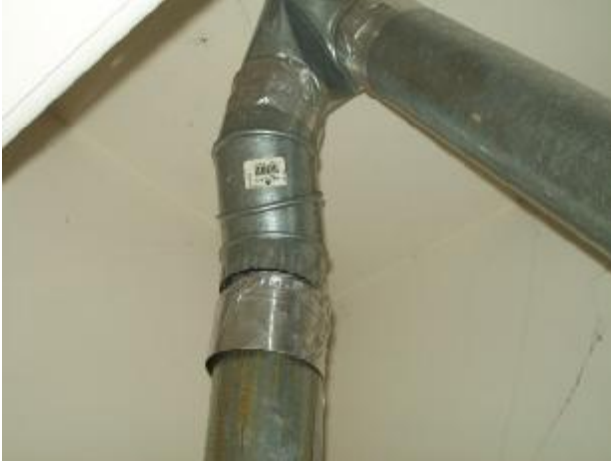
P

Safety Hazard Note: One of the exhaust vent flues for the water heater in the garage has separated. This can allow the products of combustion to vent into the interior of the garage.

One of the exhaust vent flues is separated above the water heater in the garage.

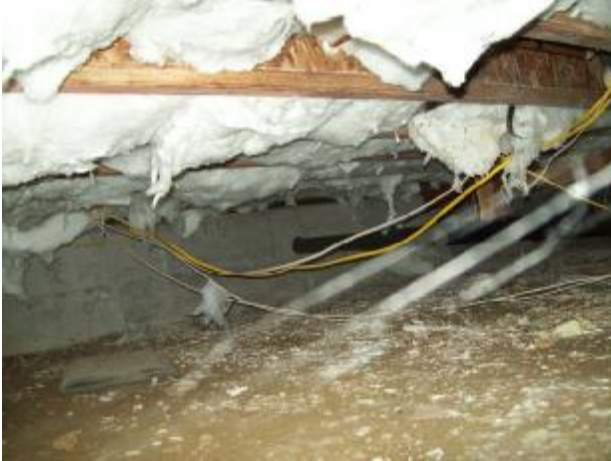
EL

Unsecured wiring in the substructure area.

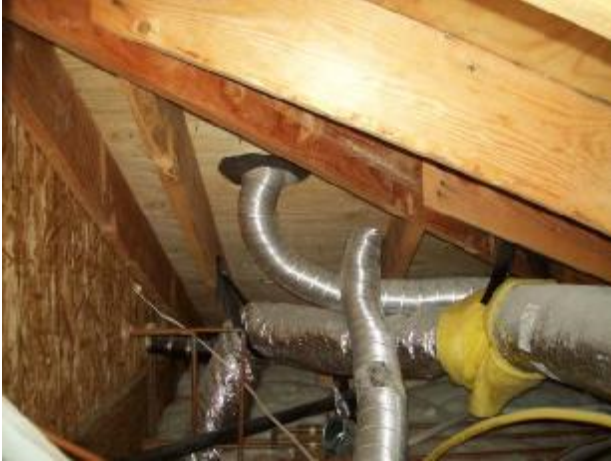
B

The vent flue for the ceiling exhaust fan in the upstairs east hall bath terminates in the attic.

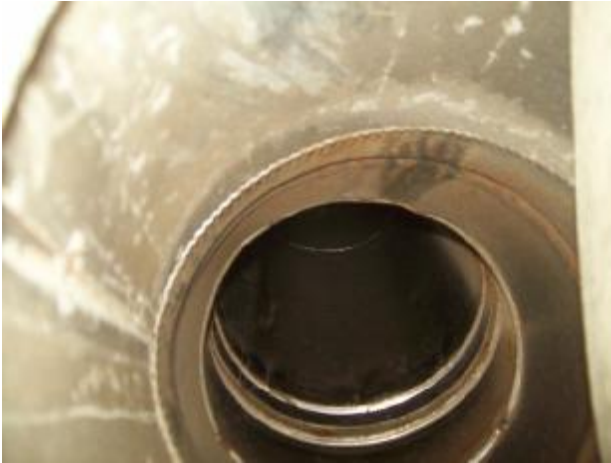
IR

Gaps observed where the metal chimney attaches to the top of the firebox in the outdoor fire place.

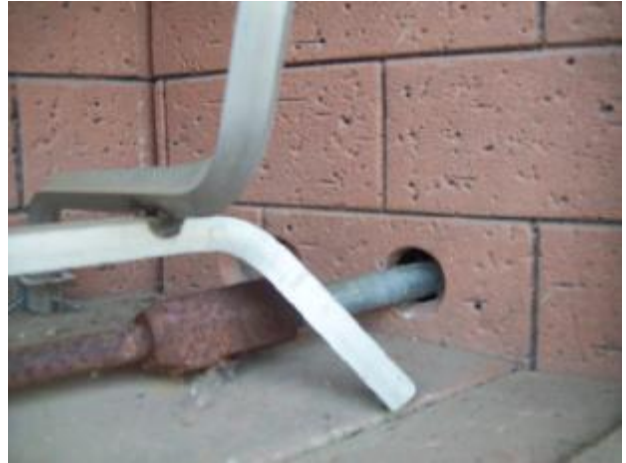
IR

Noncombustible caulking is needed where the gas line penetrates the refractory plate in the outdoor F/Pl.
