SAGUACHE CREEK DIVERSION INFRASTRUCTURE INVENTORY

Structure Name: TAYLOR A ASHLEY D

Date: April 3, 2019

Saguache Creek Stream Management Plan

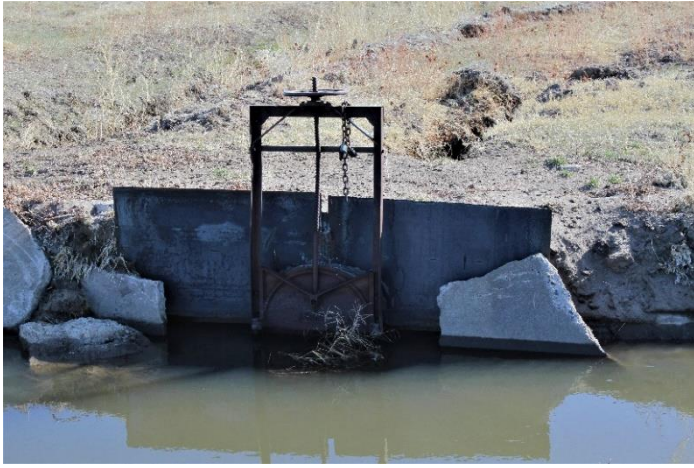
Headgate looking downstream

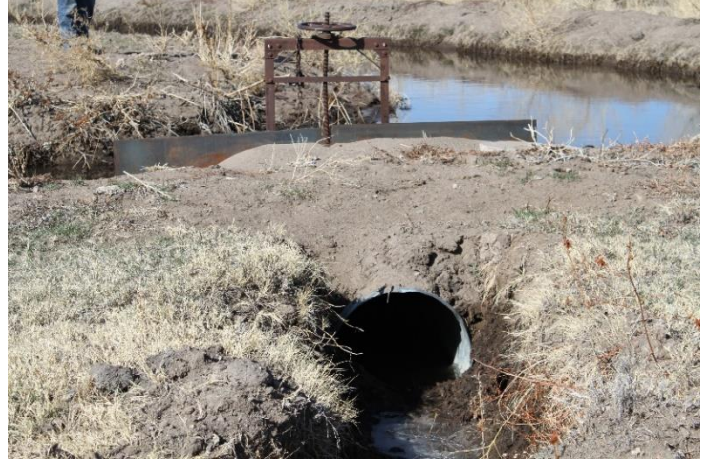
Headgate outlet

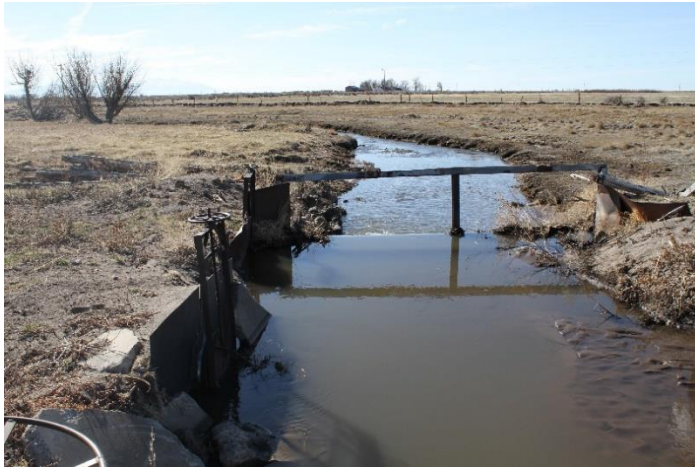
Headgate and diversion dam

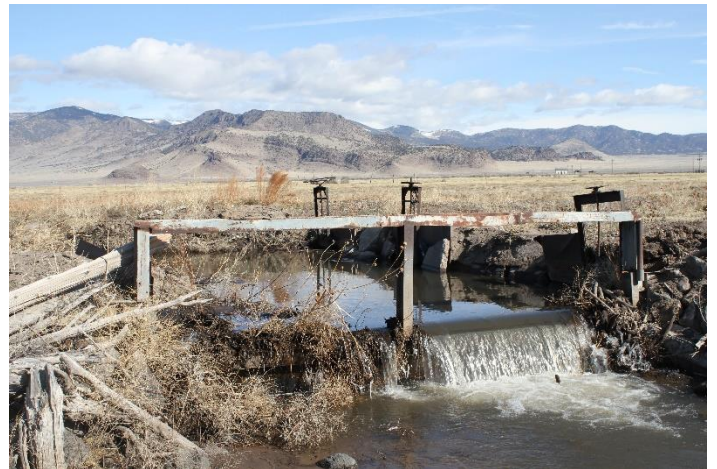
Diversion dam looking upstream

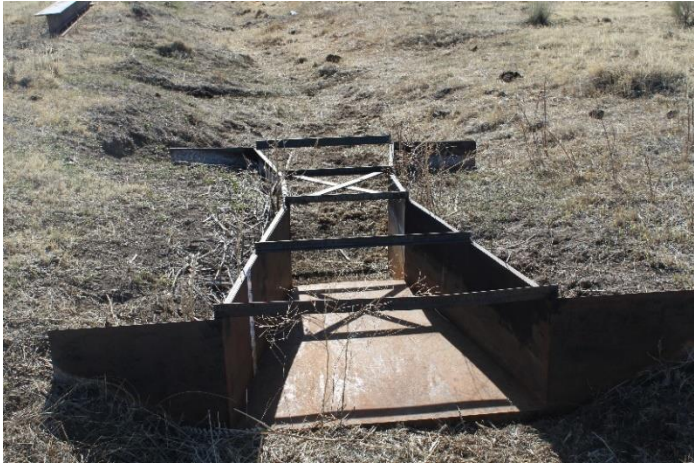
Flume looking downstream

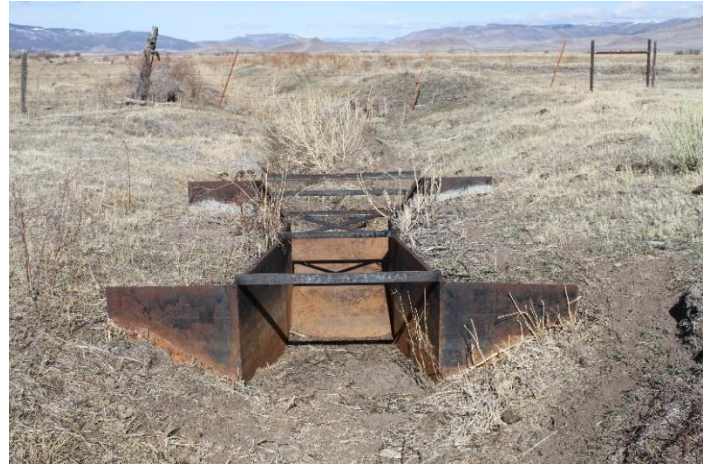
Flume looking upstream
