SAGUACHE CREEK DIVERSION INFRASTRUCTURE INVENTORY

Structure Name: MALONE SULLIVAN COMMUNITY D

Date: April 3, 2019

Saguache Creek Stream
Management Plan

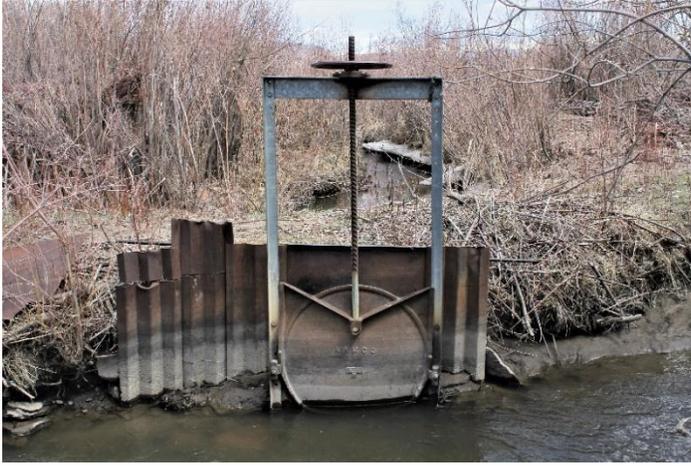
Headgate looking downstream

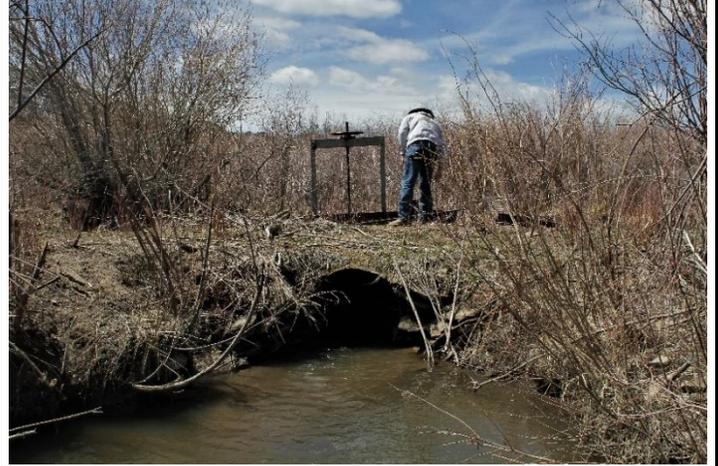
Headgate outlet

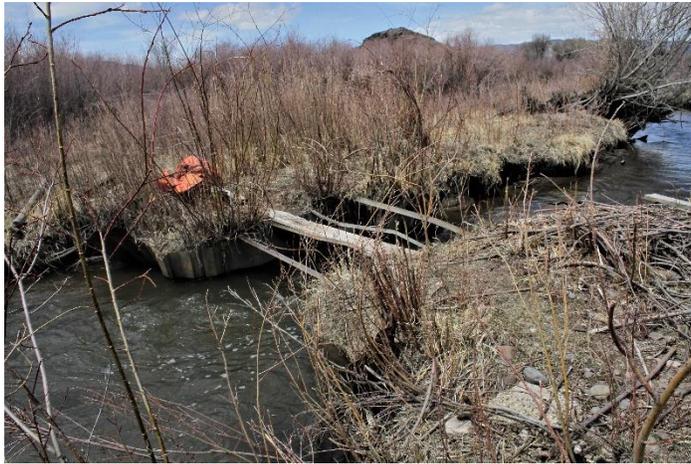
Diversion dam looking upstream

Repair(s) or Improvement(s) Currently Needed: The diversion dam needs to be repaired to prevent further degradation. It could also be elevated to improve the ditch's access to its full decree at low flows. The flume does not consistently measure accurately, but functions moderately well. Fish passage and riparian restoration should be considered as part of any future repairs or improvements.

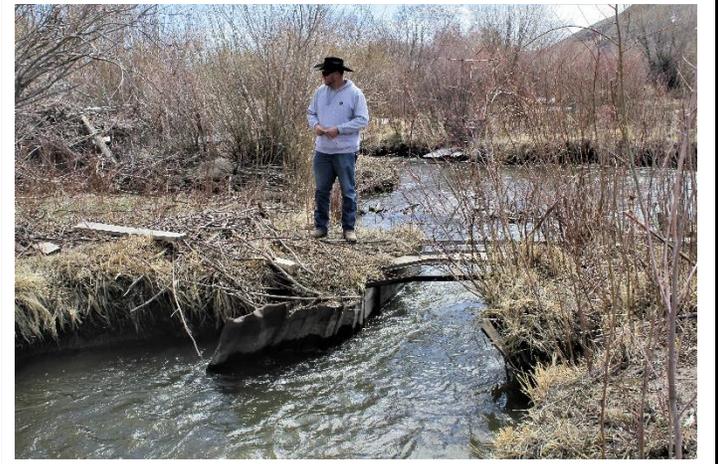
Diversion dam looking downstream

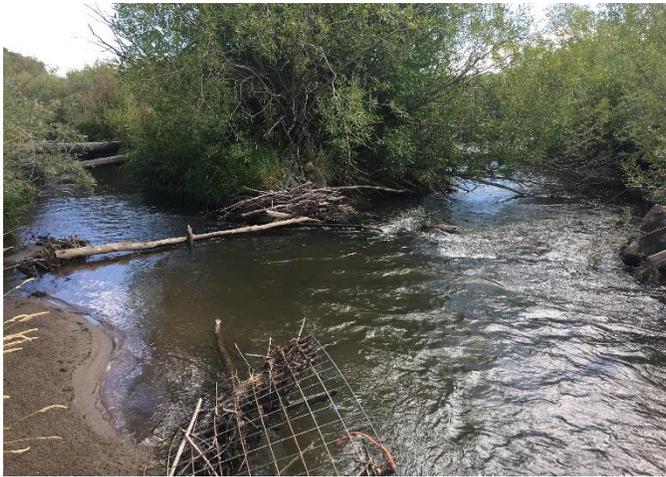
Diversion off main channel looking downstream

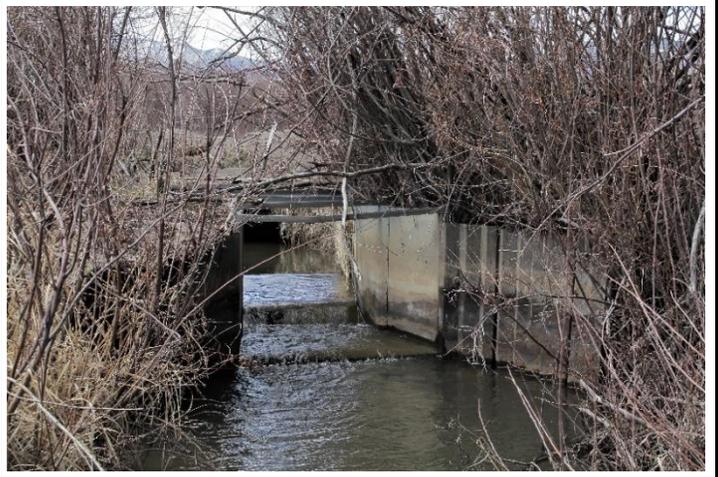
Flume looking upstream
