SAGUACHE CREEK DIVERSION INFRASTRUCTURE INVENTORY

Structure Name: RUSSELL D 4

Date: April 4, 2019

Saguache Creek Stream
Management Plan

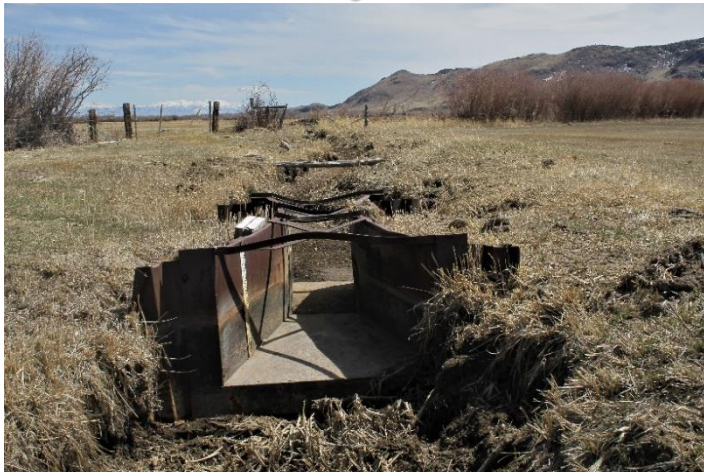
Flume looking downstream

Repair(s) or Improvement(s) Currently Needed: Bank stabilization is recommended upstream of the diversion dam. The headgate and flume could both be reset. Fish passage and riparian restoration should be considered as part of any future repairs or improvements.

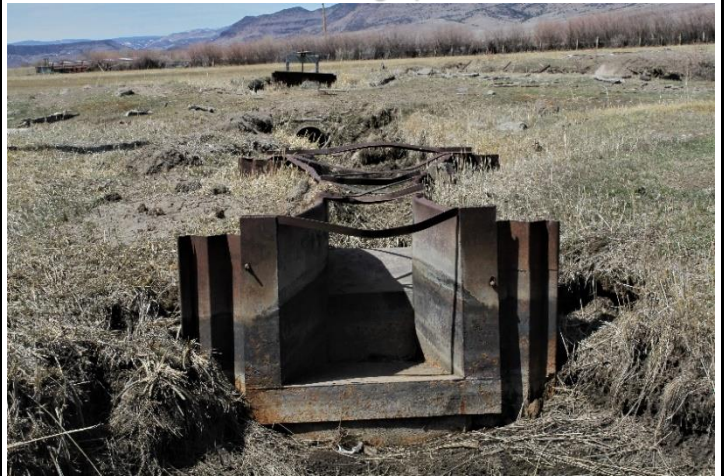
Flume looking upstream
