SAGUACHE CREEK DIVERSION INFRASTRUCTURE INVENTORY

Structure Name: IRWIN D

Date: April 11, 2019

Saguache Creek Stream Management Plan

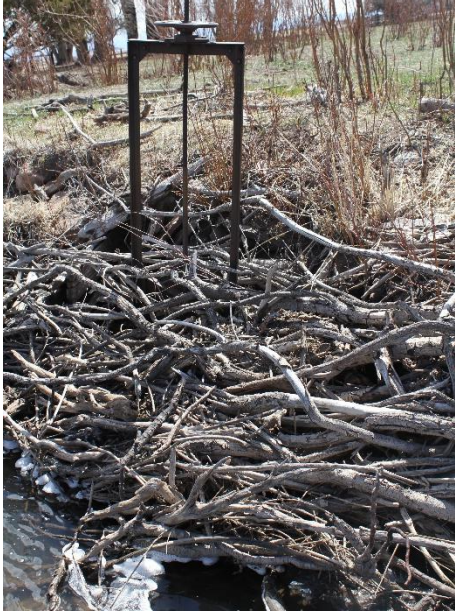
Headgate looking downstream

Repair(s) or Improvement(s) Currently Needed: Debris accumulation needs to be mitigated at the headgate with a trash rack or by relocating the structure. The flume needs to be reset to improve its accuracy. Existing fish passage should be maintained and riparian restoration should be considered as part of any future repairs or improvements.

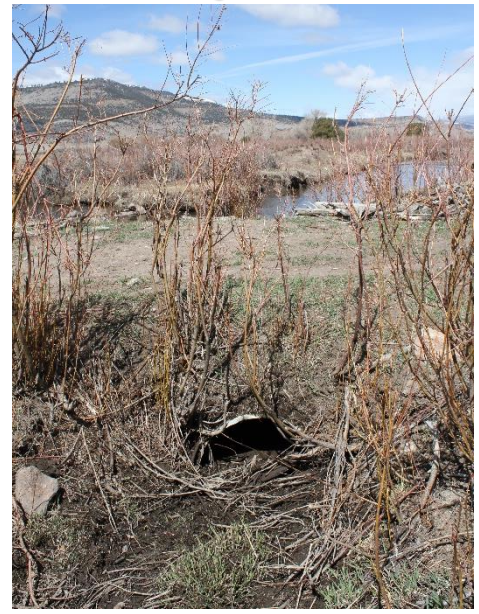
Headgate outlet

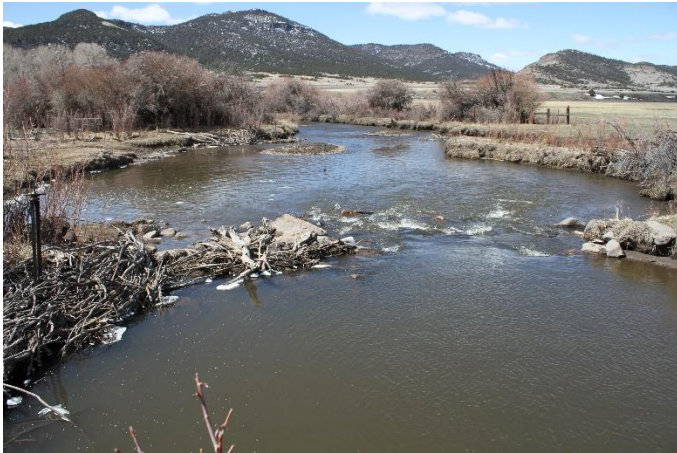
Headgate and diversion dam

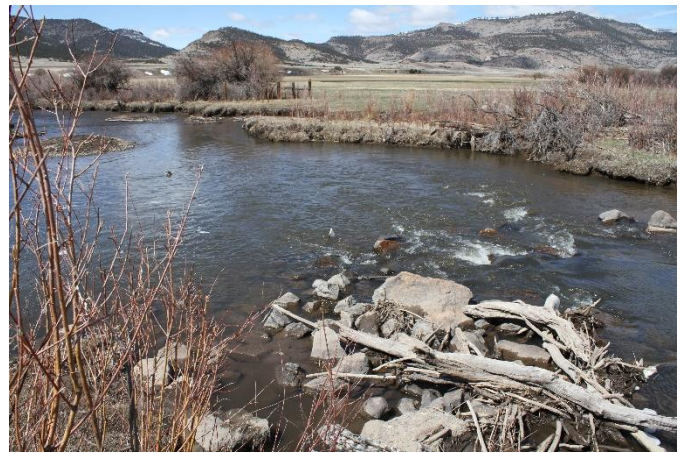
Diversion dam

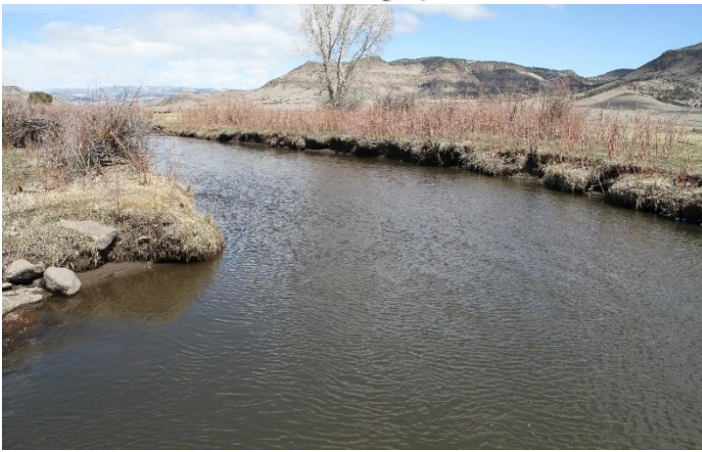
Channel looking upstream

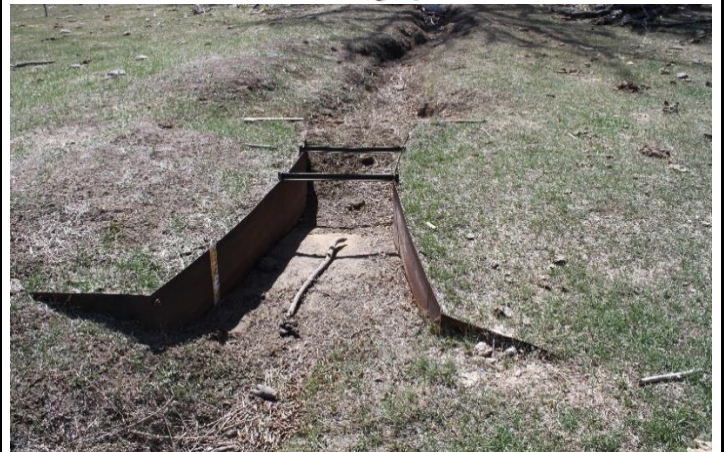
Structure Description: The ditch is located at the apex of a meander. The channel here is relatively stable. A stacked rock diversion dam directs water to the headgate on the north bank of the river. Woody debris accumulates at the headgate. Sediment accumulates at the headgate as well as in the ditch at County Rd Z because of the ditch's low gradient. The flume is sunken and does not measure accurately.

Flume looking upstream
