Engineering Report

Strength of Spiral Seam Elbows – Collapse Testing

Client: Jinwwong Technology Ltd.
Date: January 27, 2012

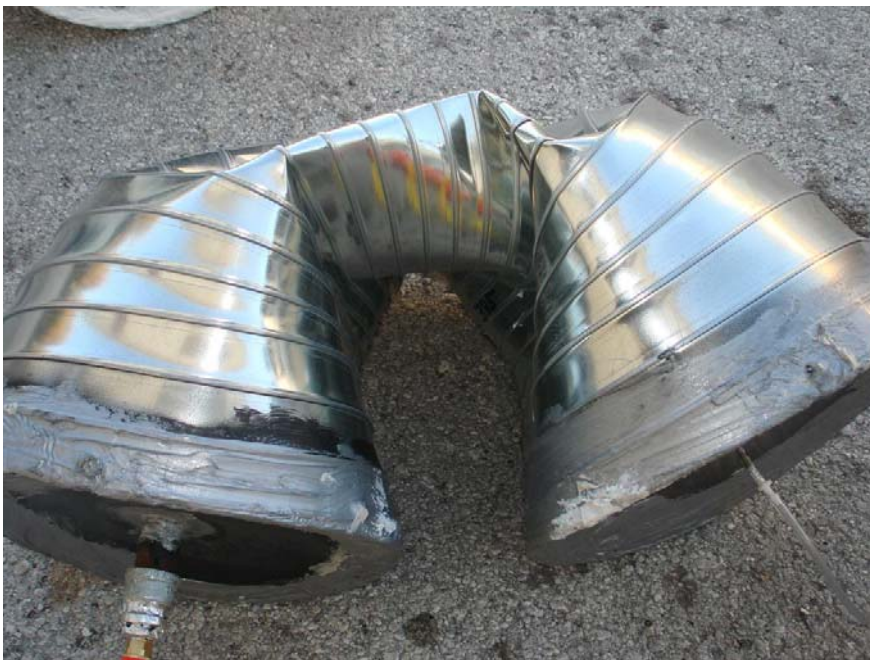
Figure 4

Elbow Size (inches)	Collapse Pressure (in.wg.)
3.6	Did not collapse at - 396
5.7	Did not collapse at - 356
9.6	Did not collapse at - 384
15.6	- 214
19.3	- 131

Elbow Size (mm)	Collapse Pressure (kPa)
92	Did not collapse at - 98.6
145	Did not collapse at - 88.6
245	Did not collapse at - 95.6
395	- 53.3
490	- 32.6

Picture of 15.6-inch (395 mm) Elbow after Collapsing

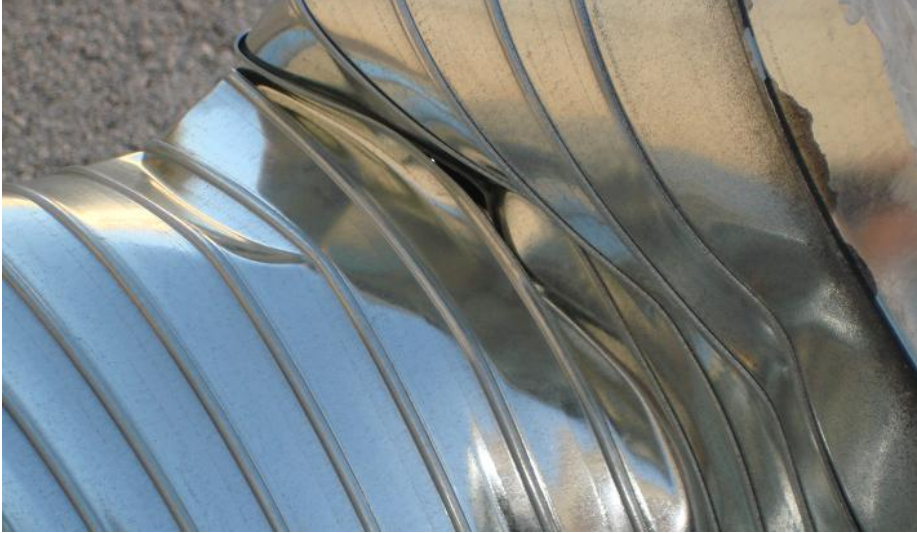
Figure 5

Picture of 15.6-inch (395 mm) Elbow after Collapsing

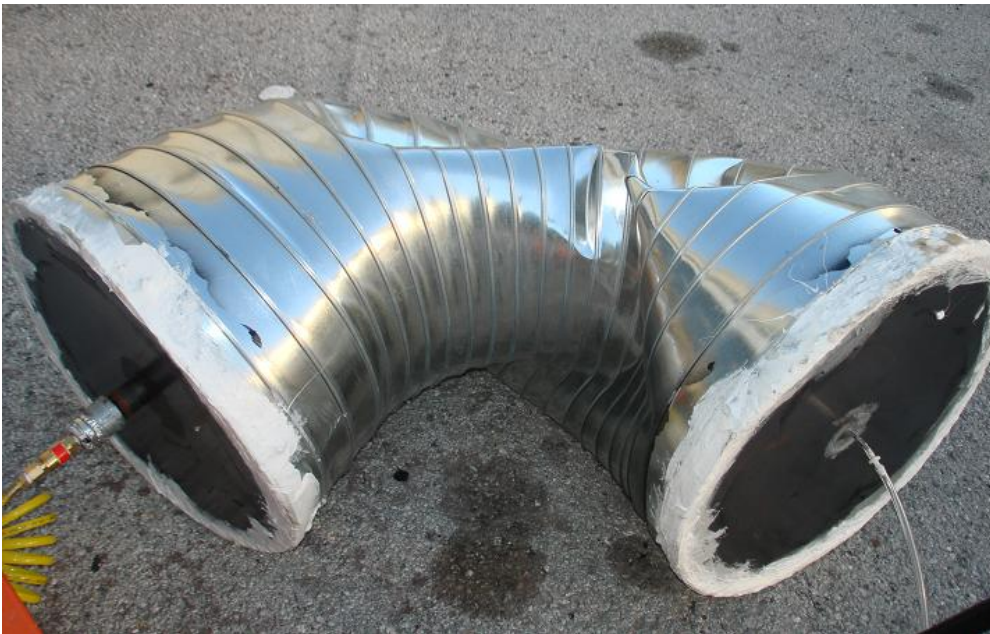
Figure 6

Picture of 19.3-inch (490 mm) Elbow after Collapsing

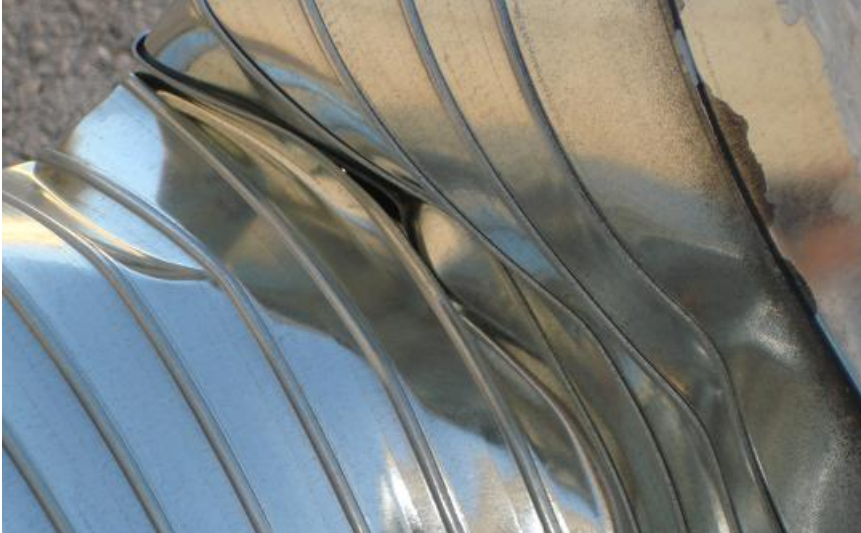
Figure 7

Picture of 19.3-inch (490 mm) Elbow after Collapsing
