CCR Unit: SCA #2 Ash Landfill

Owner: Sunnyside Cogeneration Associates

Annual Inspection: January 2025

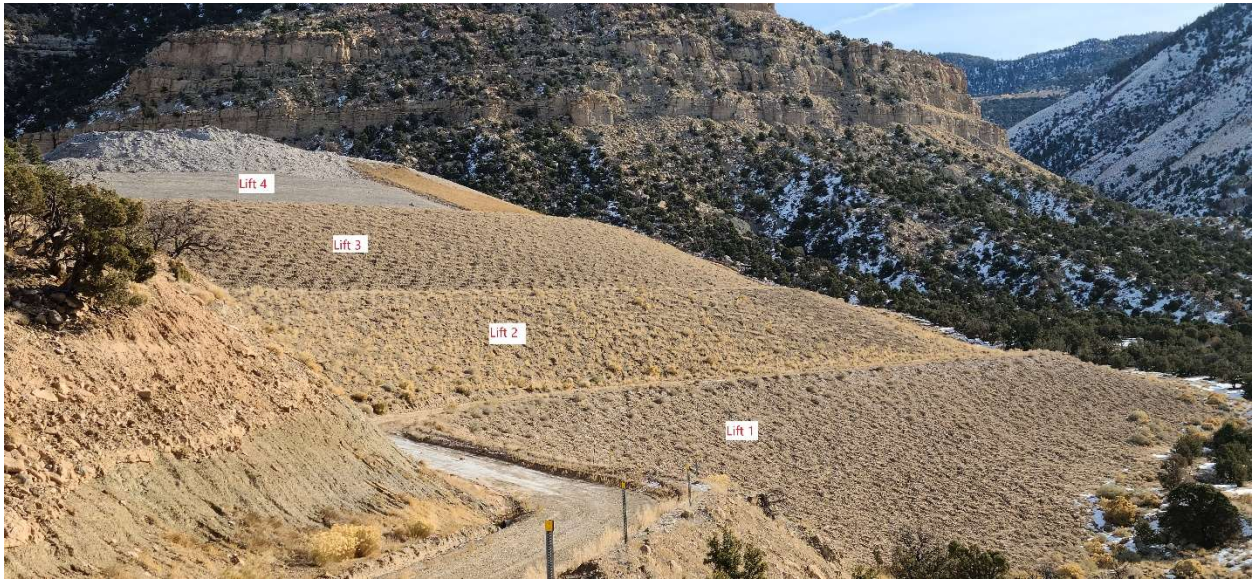
SCA#2 Ash Landfill –looking southeasterly

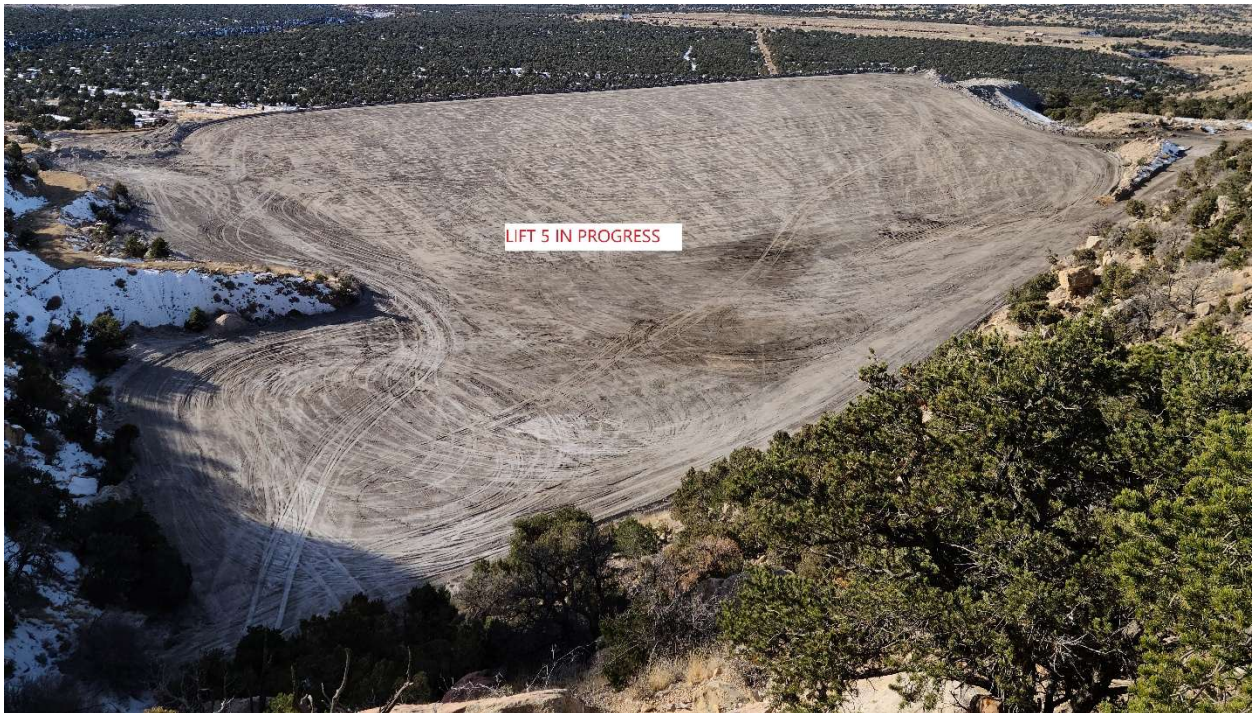
SCA#2 Ash Landfill – looking westerly
Lift #5 in progress

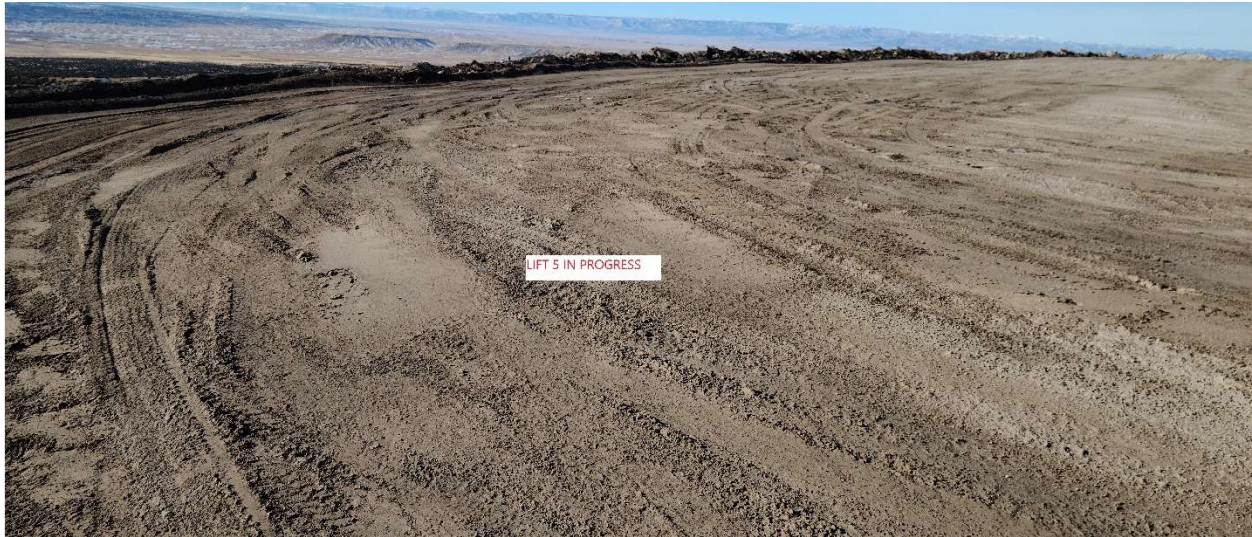
Lift #5 – in process – photo looking northwest

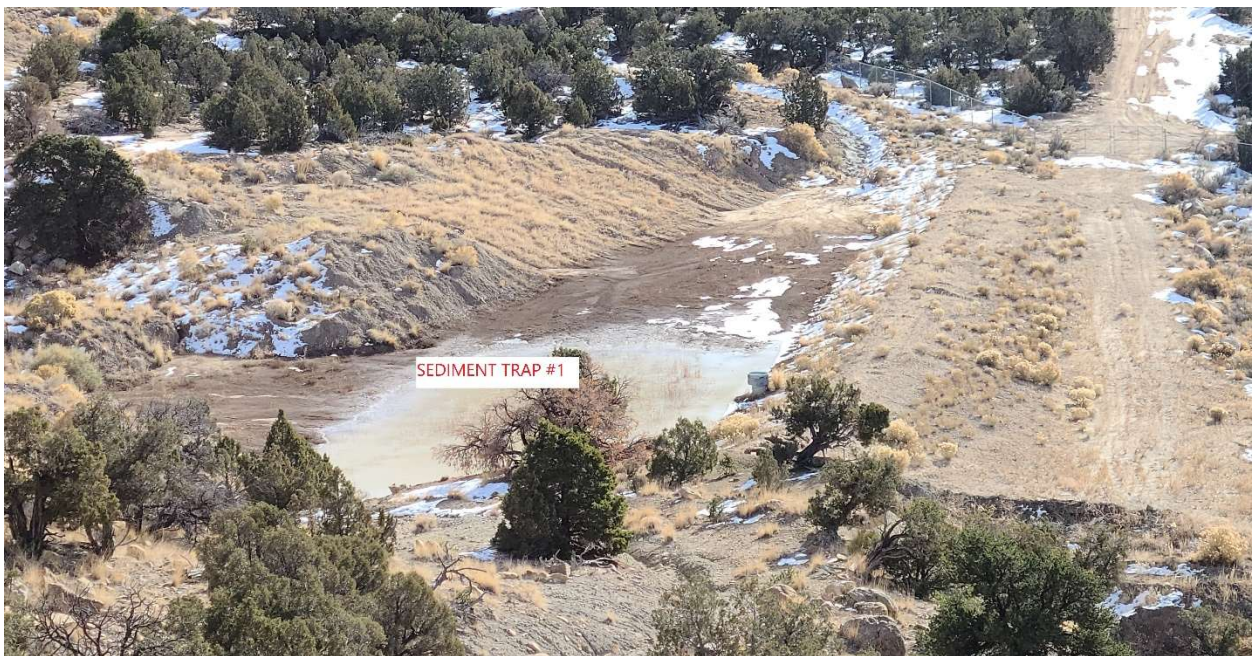
- iv. Sediment Trap #1 and Sediment Pond 018 are in operation west (downhill) of the landfill. No discharge recorded in 2024. Both had some water and ice in it at time of inspection.

Sediment Trap #1 is has some water/ice
water flows from trap #1 to pond 018 in normal open condition

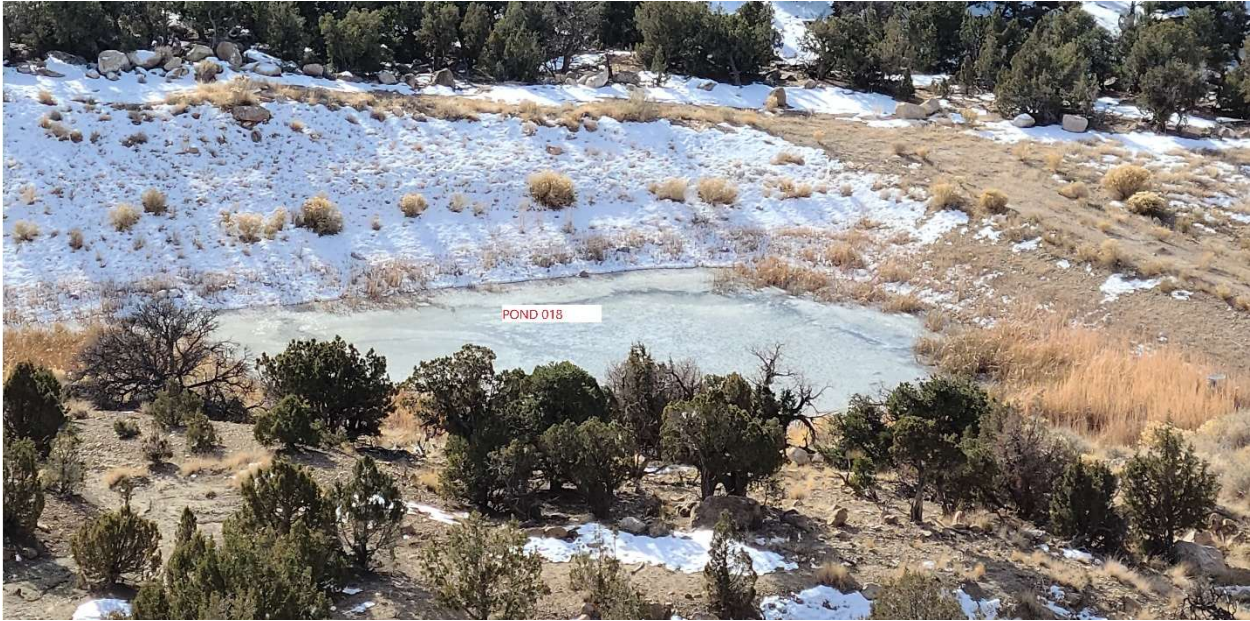
Sediment Pond 018, located west of Sed Trap #1 – photo looking southerly
Pond has some water.
No discharge in 2024
