Re: Preliminary Reserve Study – Next Steps in the Process  
Colonial Acres Phase V  
South Lyon, Michigan

Colonial Acres Phase V  
South Lyon, Michigan

Commencing First Fiscal Year: January 1, 2026 to December 31, 2026

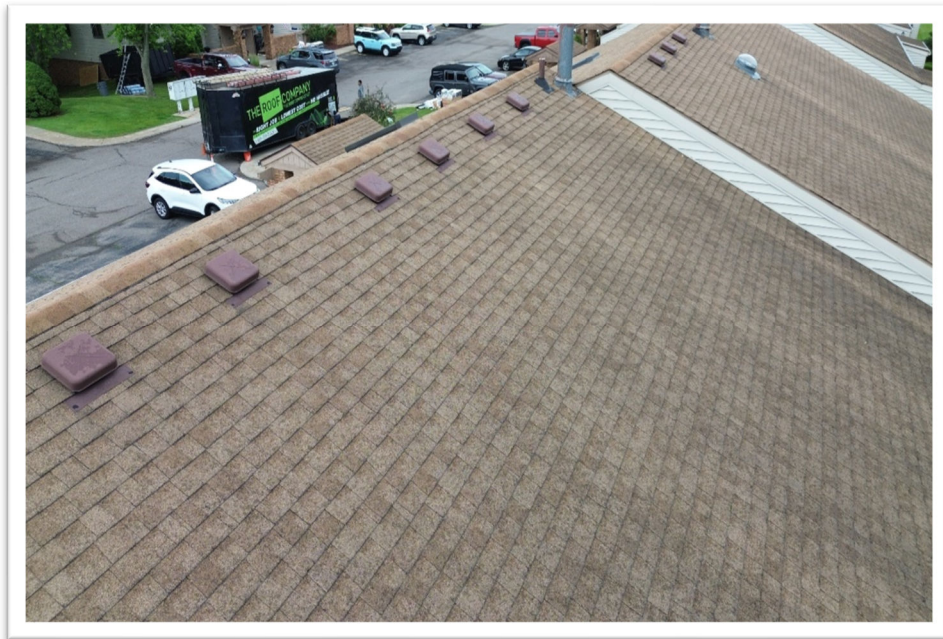
Photograph 7: Typical view of asphalt roof shingles

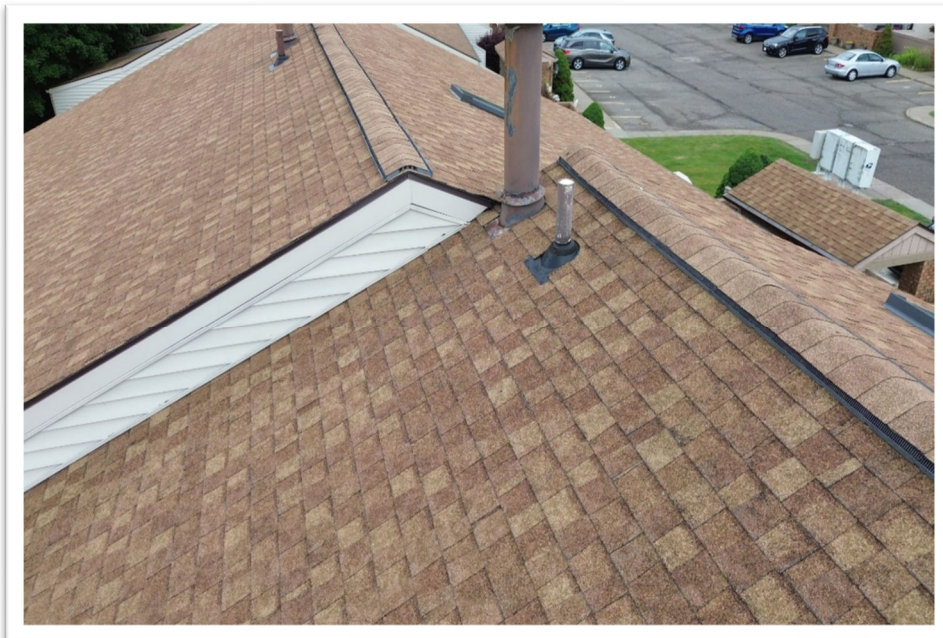
Photograph 8: Typical view of asphalt roof shingles

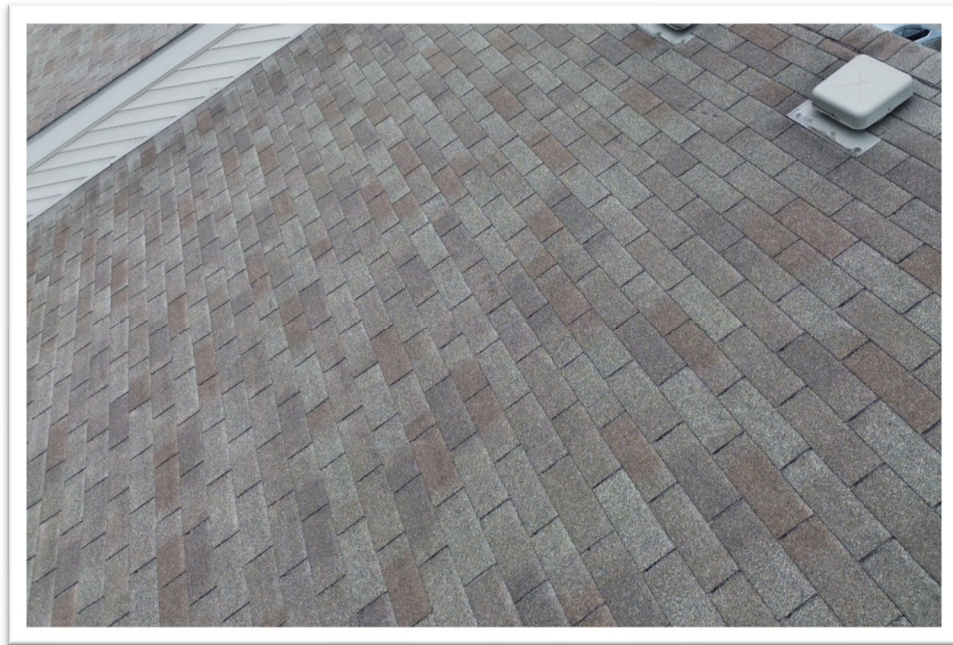
Photograph 9: Typical view of asphalt roof shingles

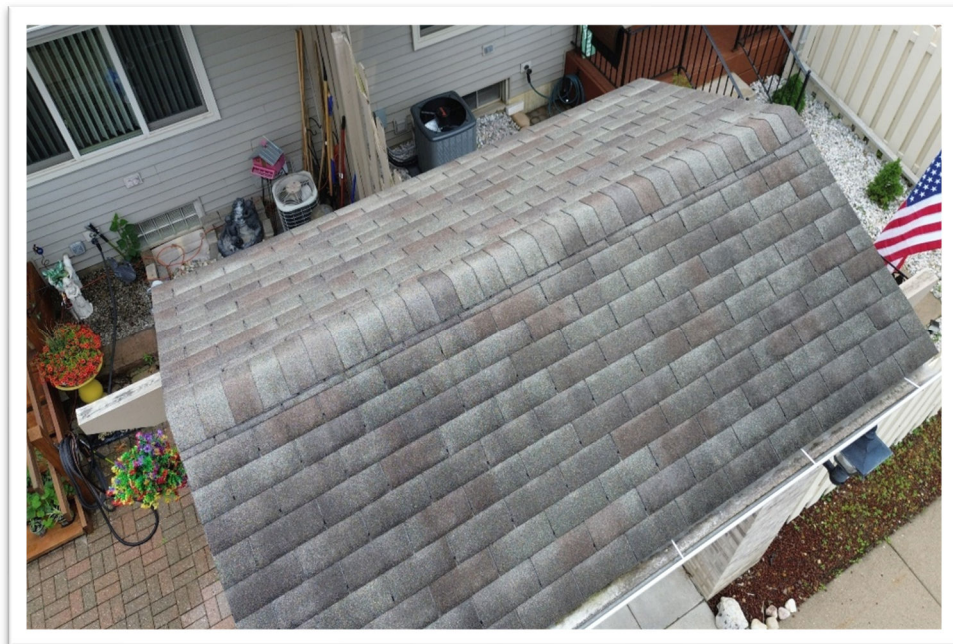
Photograph 10: Typical view of asphalt roof shingles – Bus stop

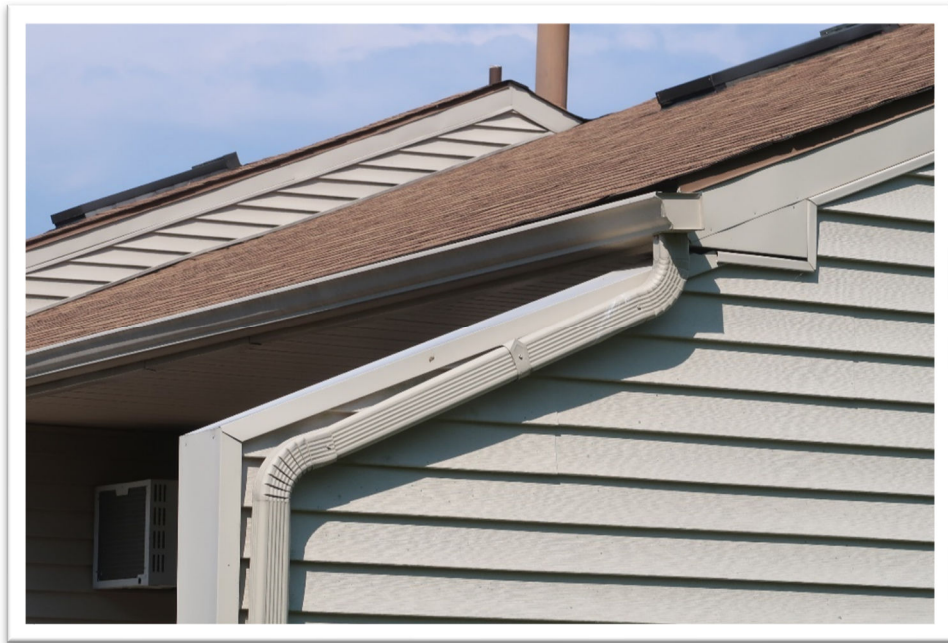
Photograph 11: Typical view of aluminum gutters & downspout – Older model

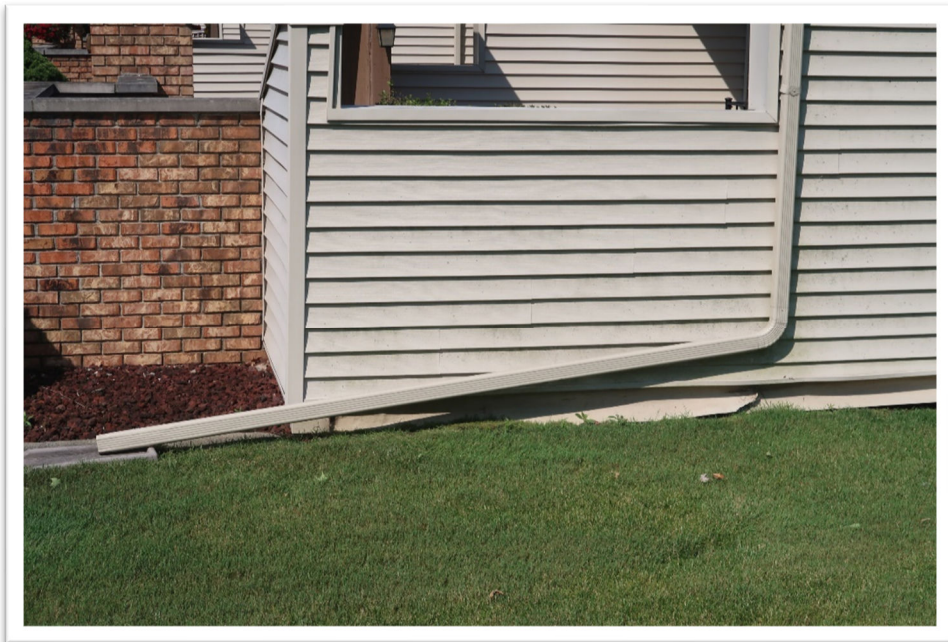
Photograph 12: Typical view of downspout – Older model

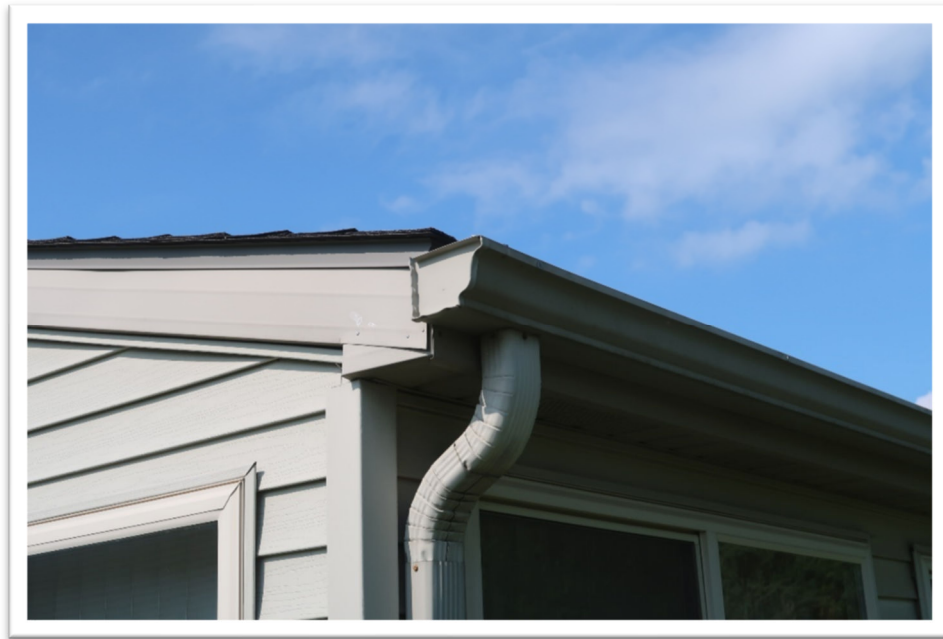
Photograph 13: Typical view of aluminum gutters & downspout – Newer model

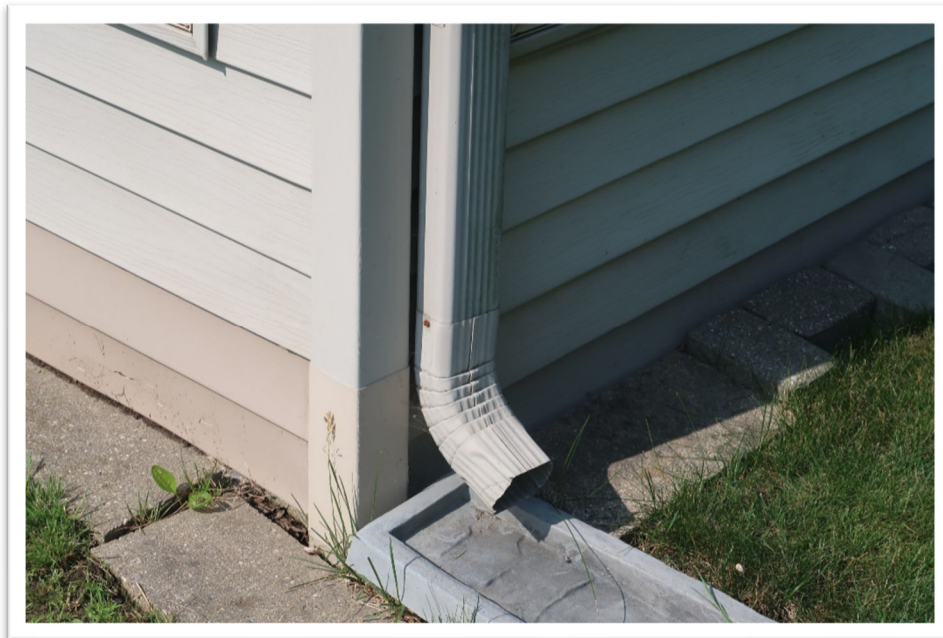
Photograph 14: Typical view of downspout – Newer model

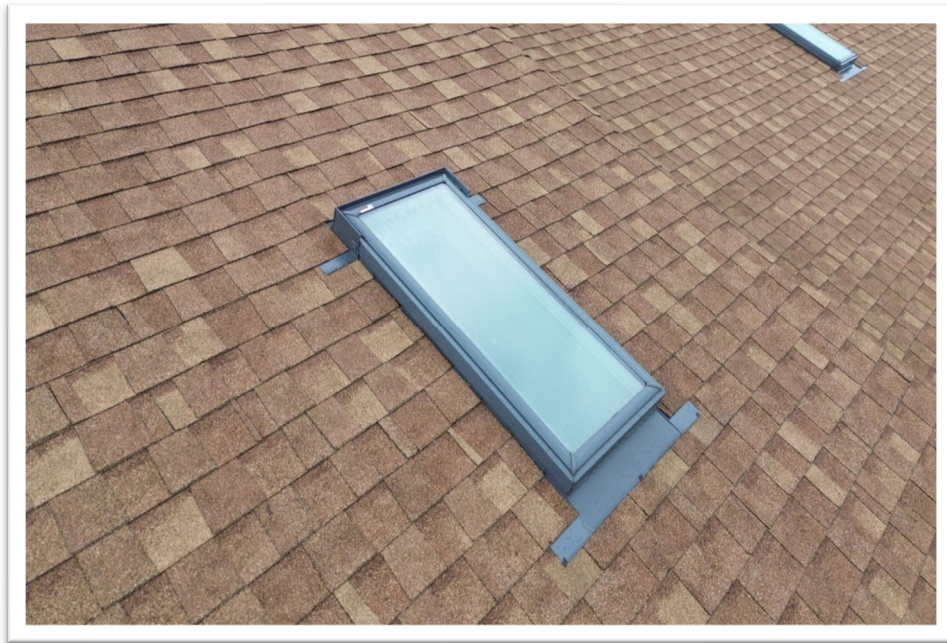
Photograph 15: Typical view of skylight

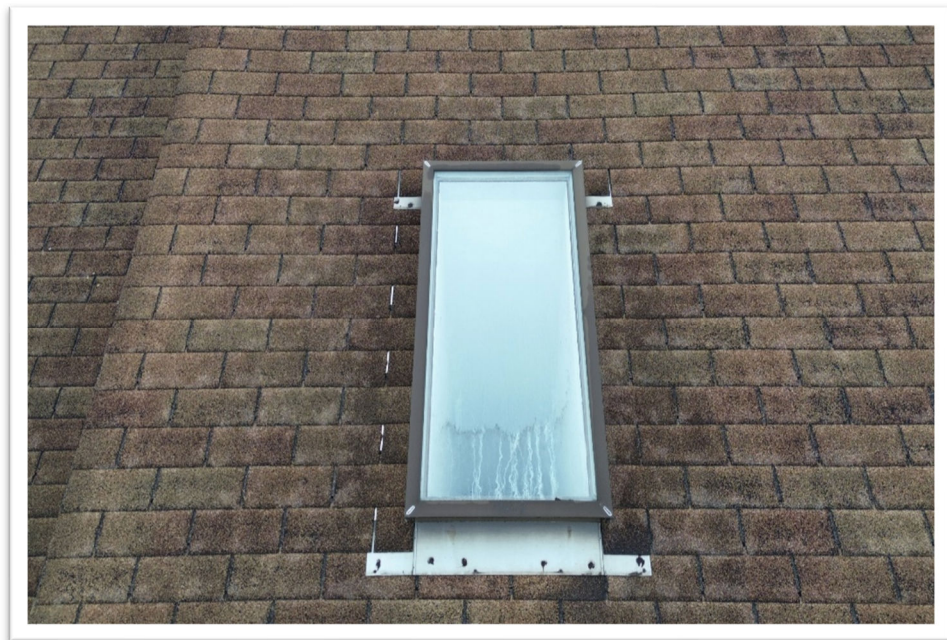
Photograph 16: Typical view of skylight

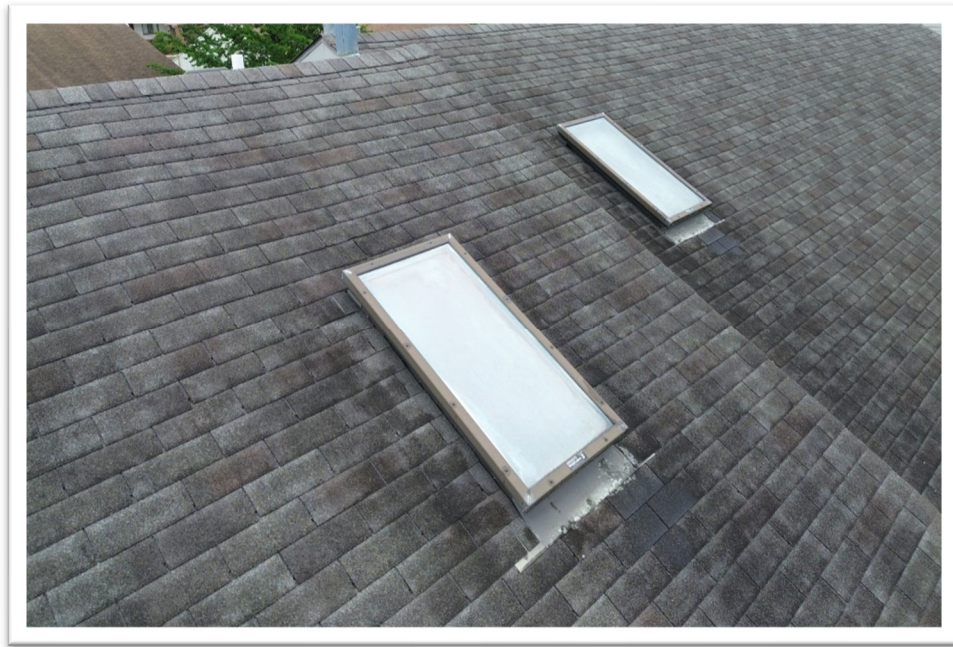
Photograph 17: Typical view of skylights

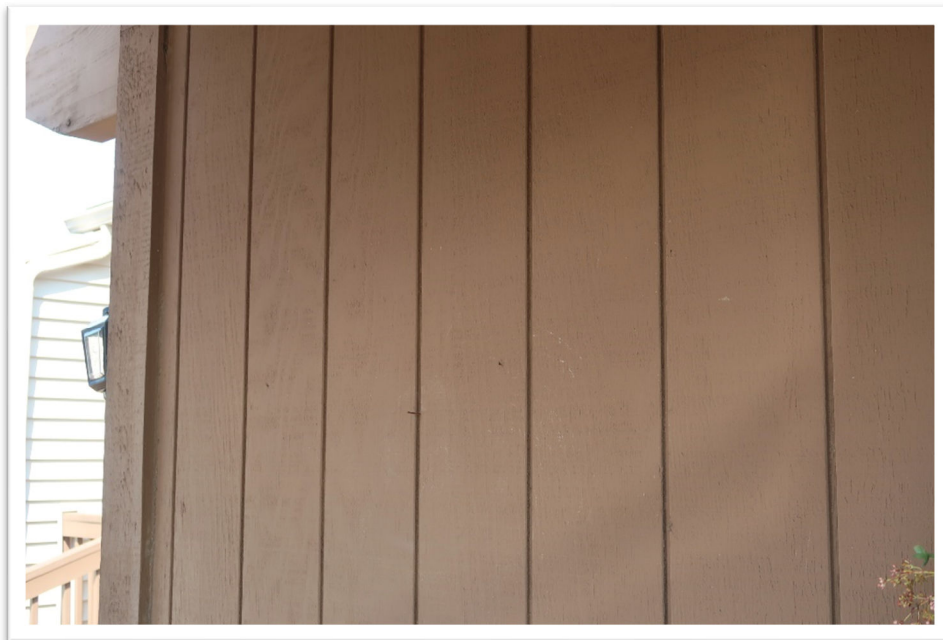
Photograph 18: Typical view of bus stop wood siding

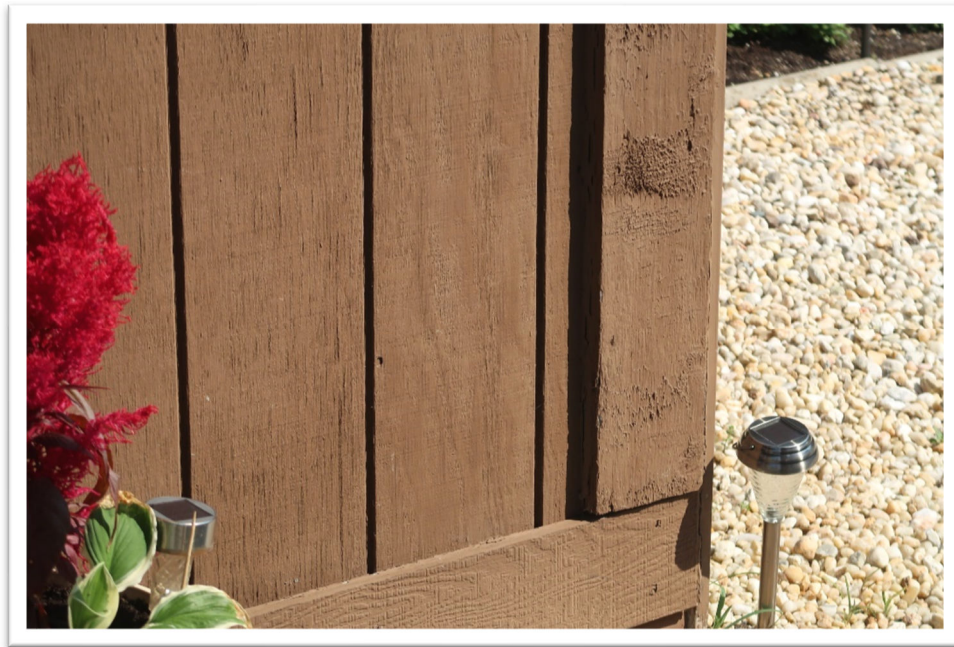
Photograph 19: Typical view of bus stop wood siding

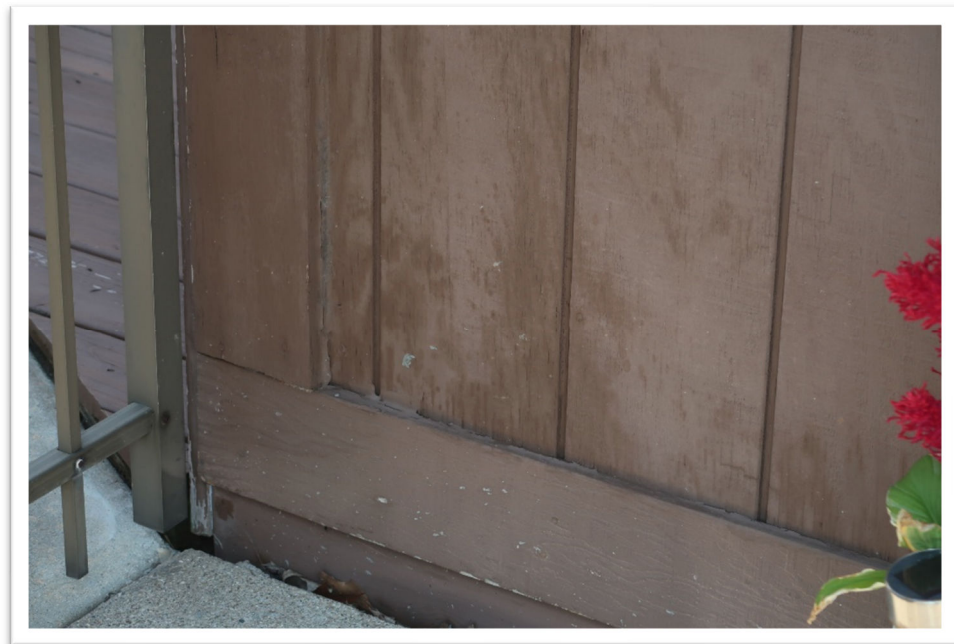
Photograph 20: Typical view of bus stop wood siding

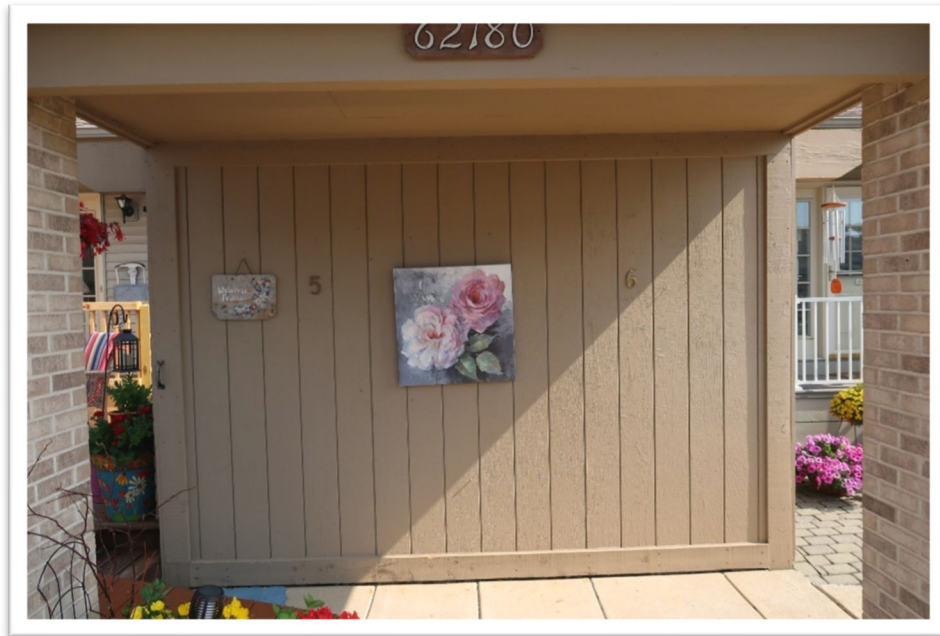
Photograph 21: Typical view of bus stop wood siding

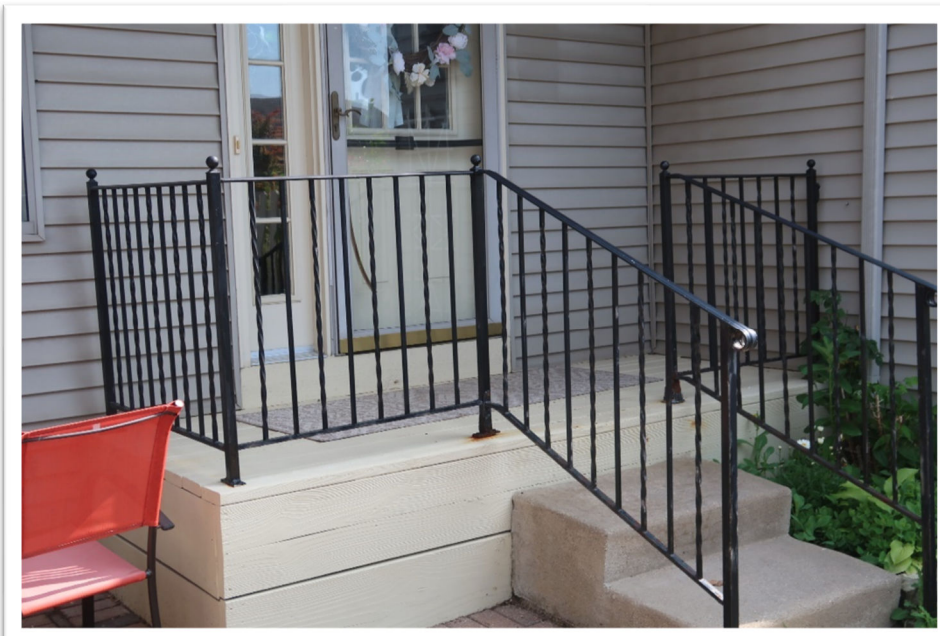
Photograph 22: Typical view of wood porch

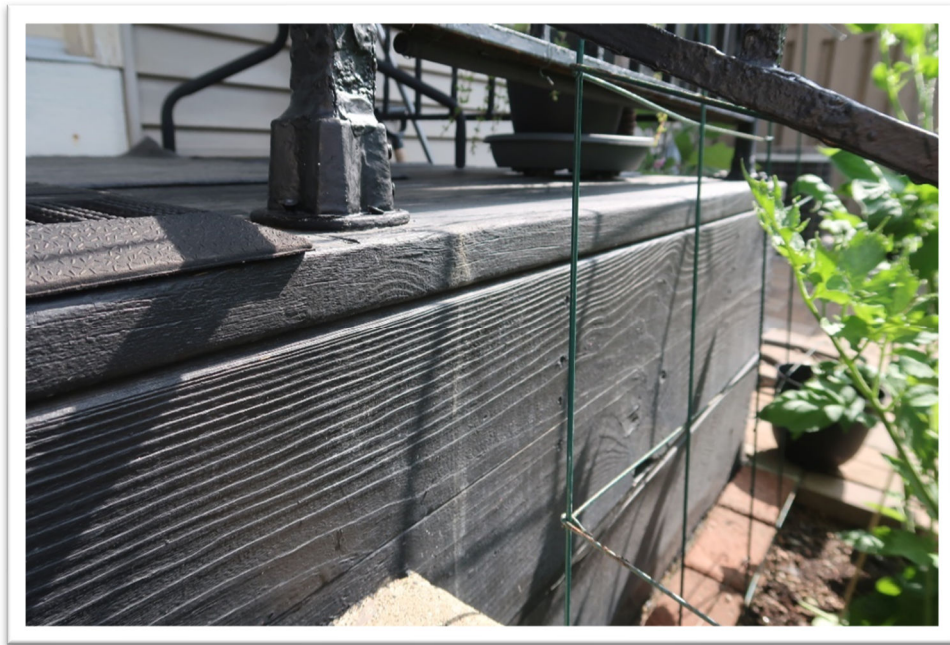
Photograph 23: Typical view of wood porch

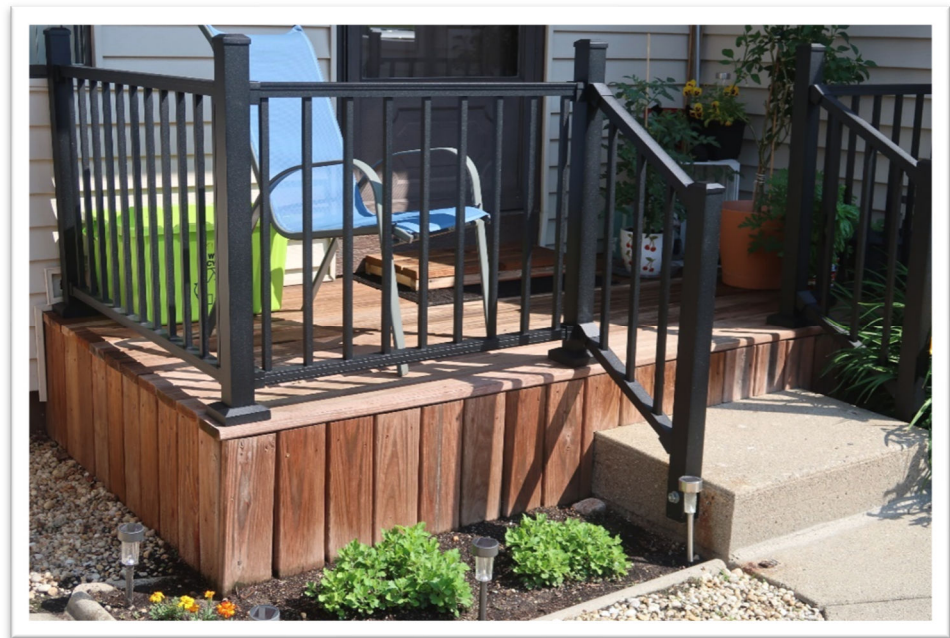
Photograph 24: Typical view of wood porch

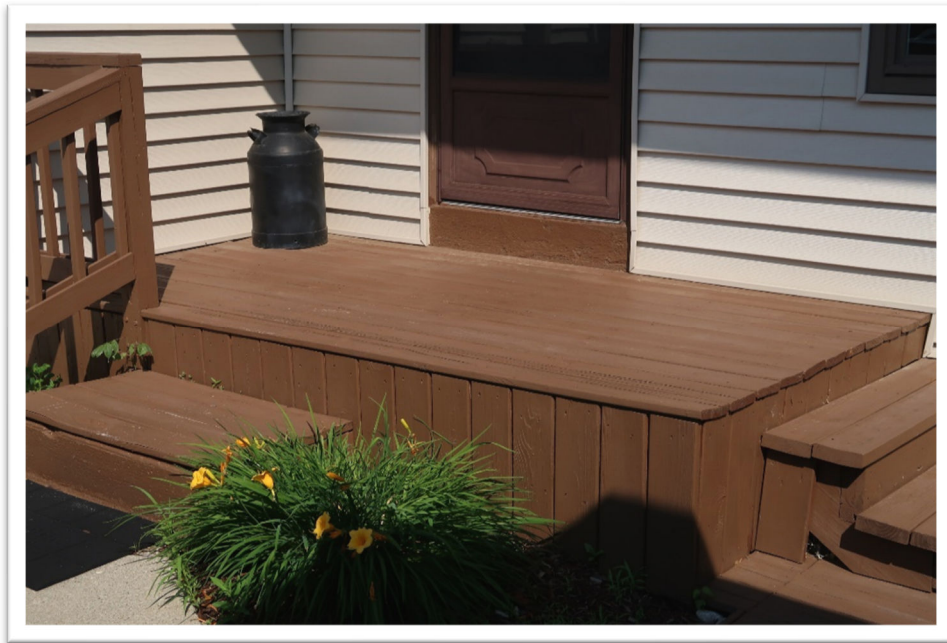
Photograph 25: Typical view of wood porch

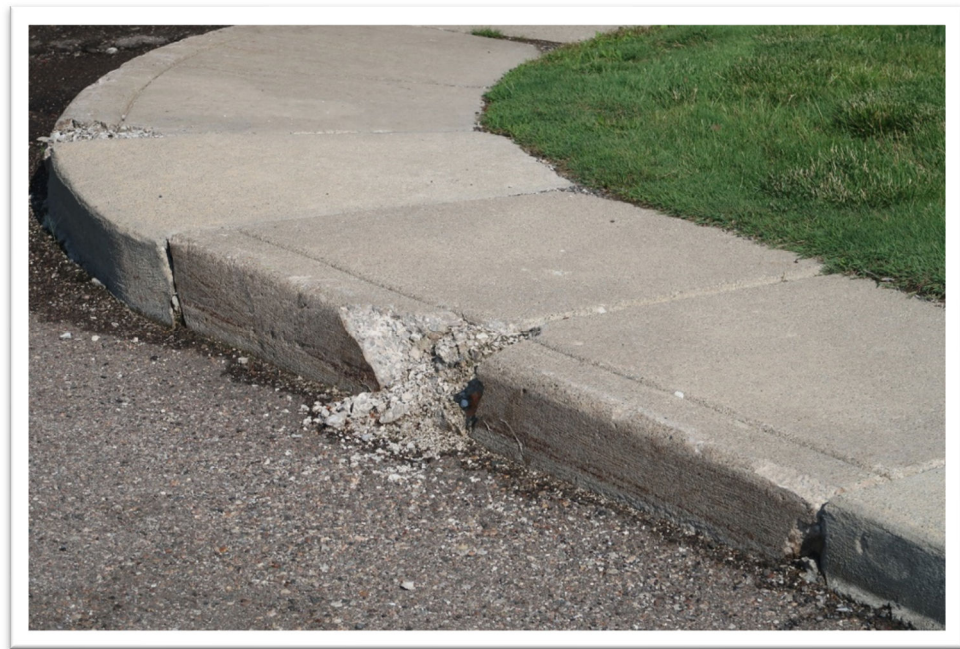
Photograph 28: Typical view of concrete sidewalk

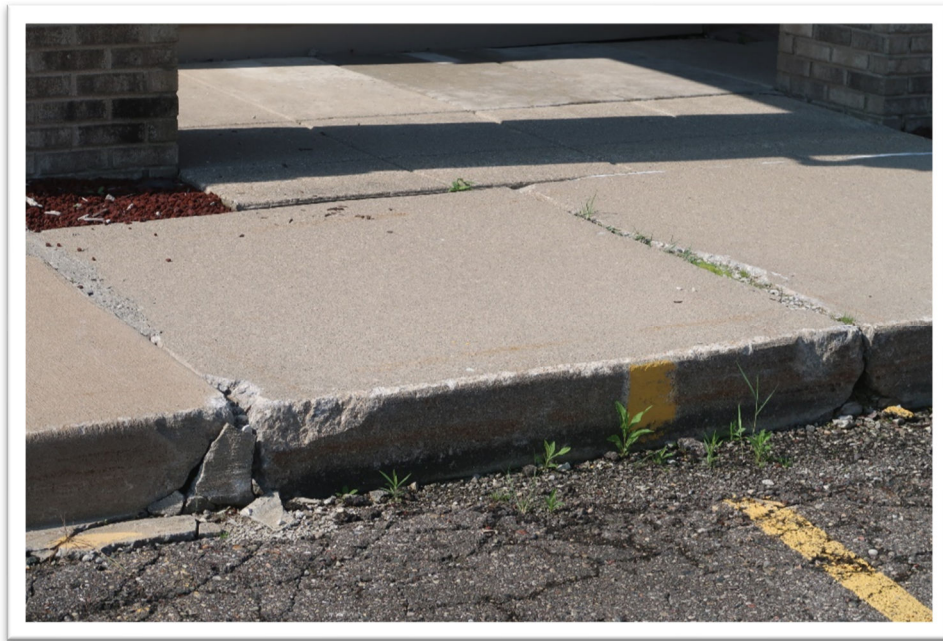
Photograph 29: Typical view of concrete sidewalk

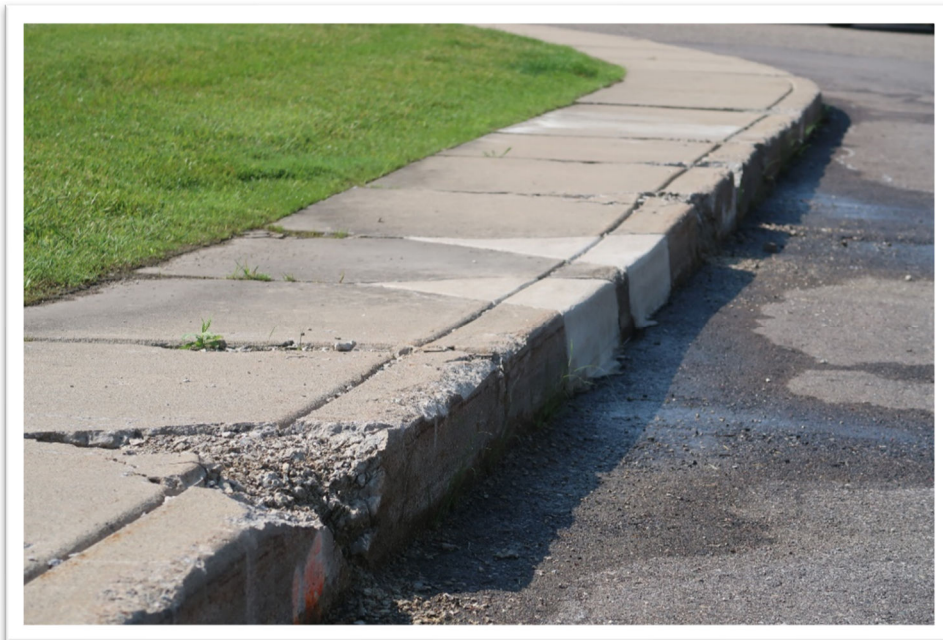
Photograph 30: Typical view of concrete sidewalk

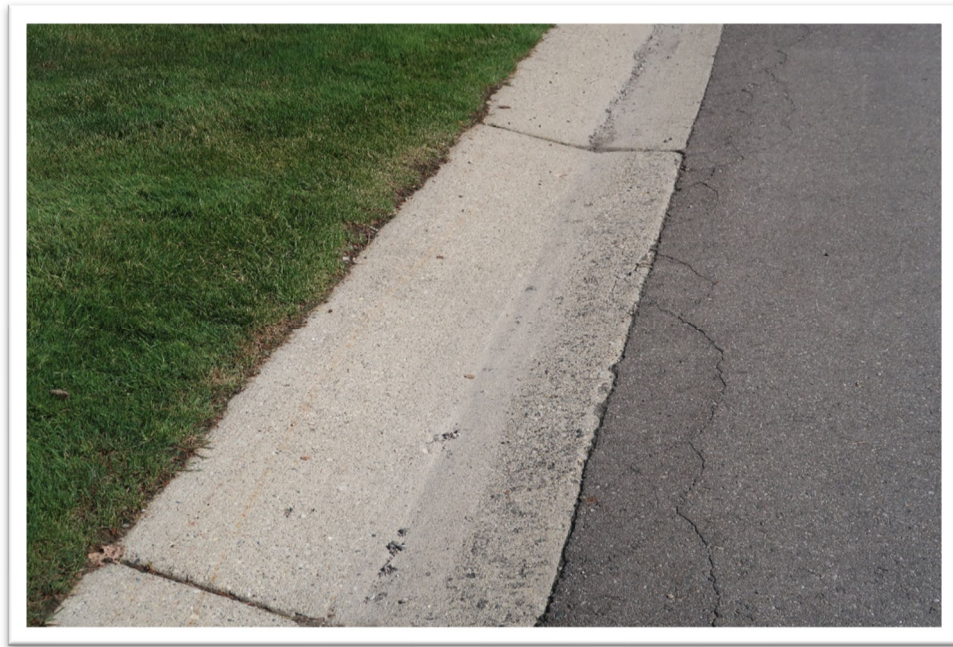
Photograph 31: Typical view of concrete curb

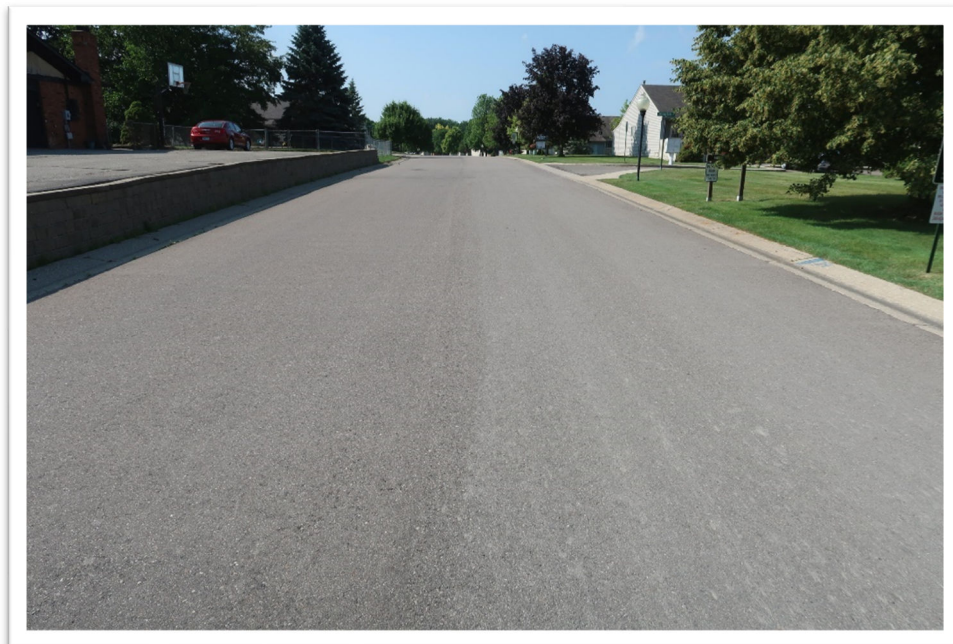
Photograph 32: Typical view of asphalt street – Heritage Boulevard

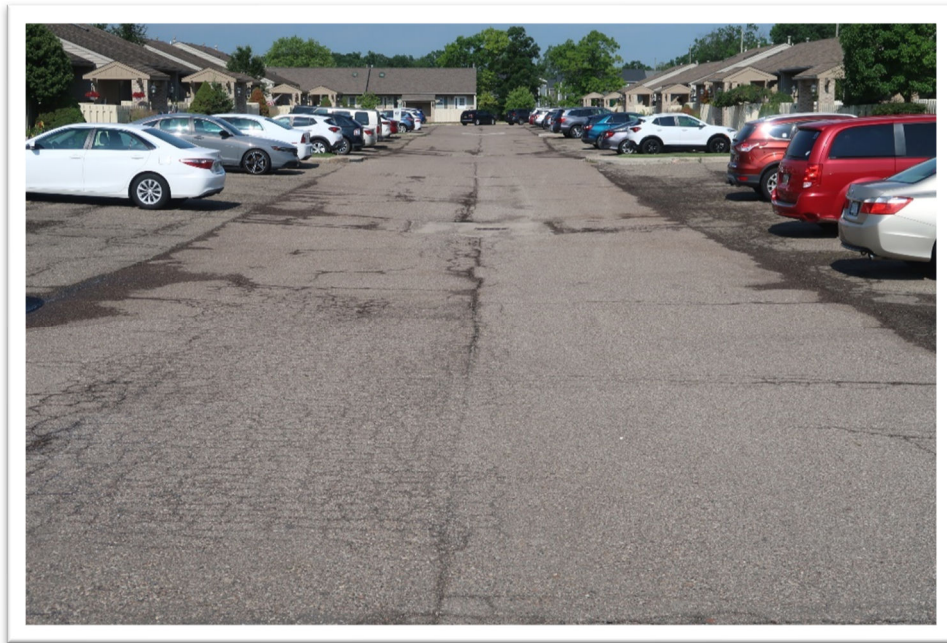
Photograph 33: Typical view of asphalt street – Arlington Circle

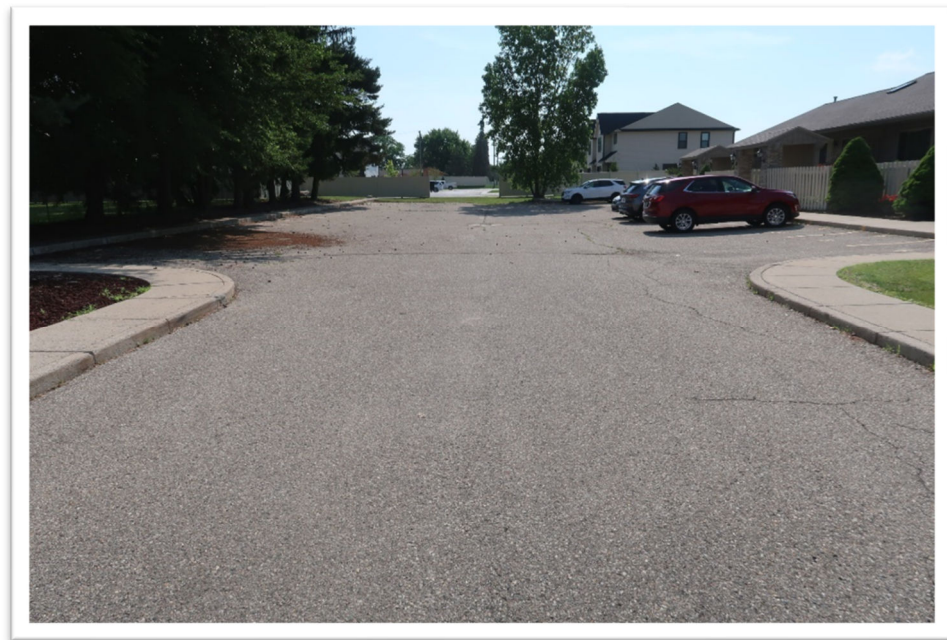
Photograph 34: Typical view of asphalt streets – Alexandria Court

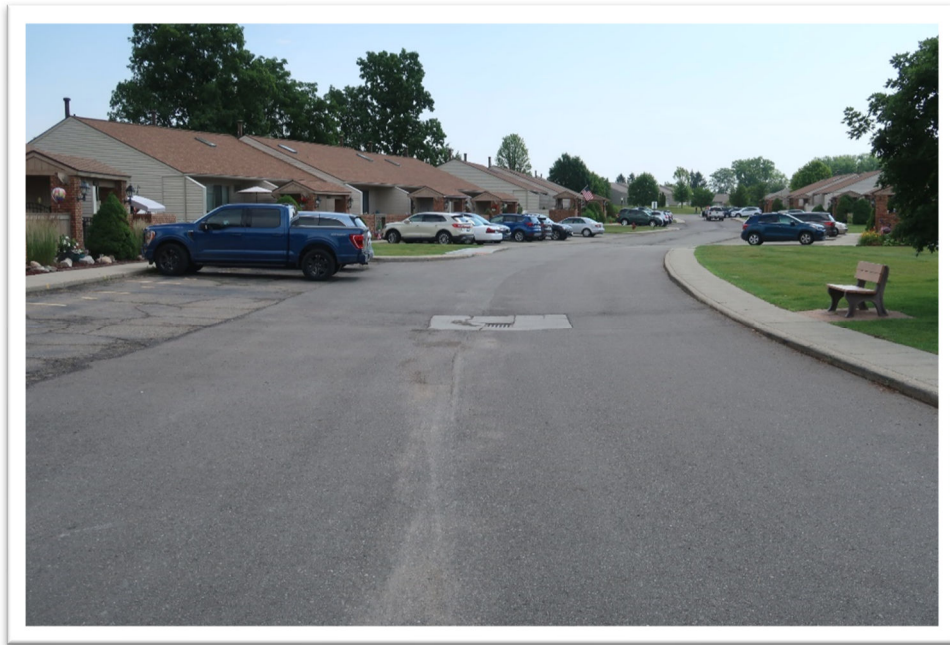
Photograph 35: Typical view of asphalt streets – Yorktown Drive

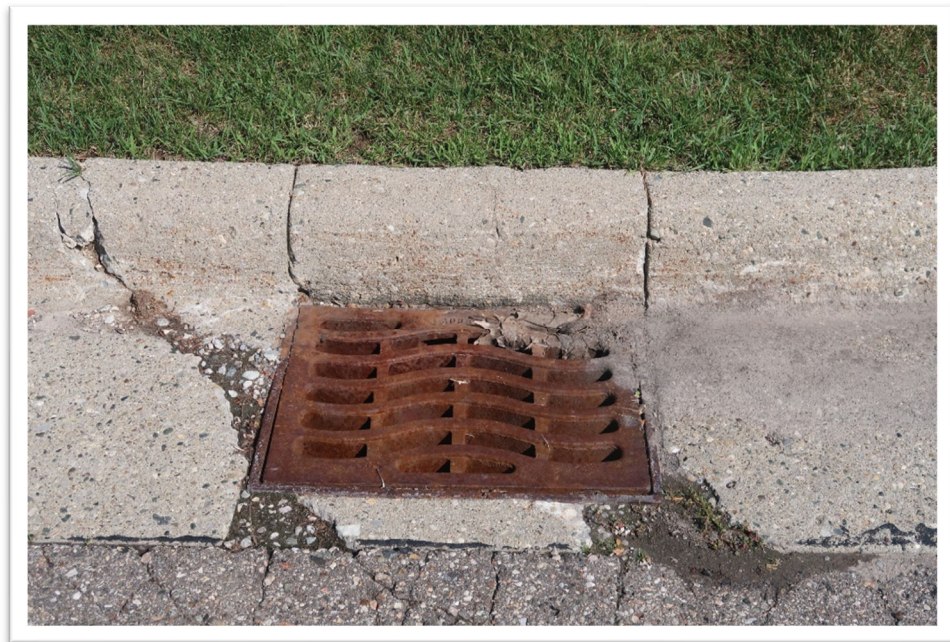
Photograph 36: Typical view of catch basin

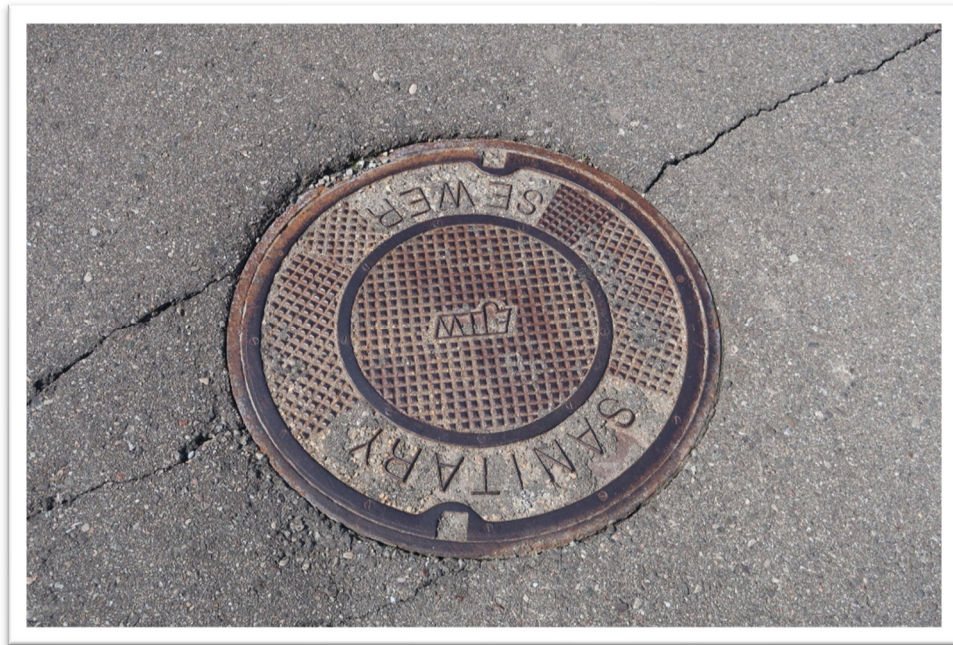
Photograph 37: Typical view of manhole

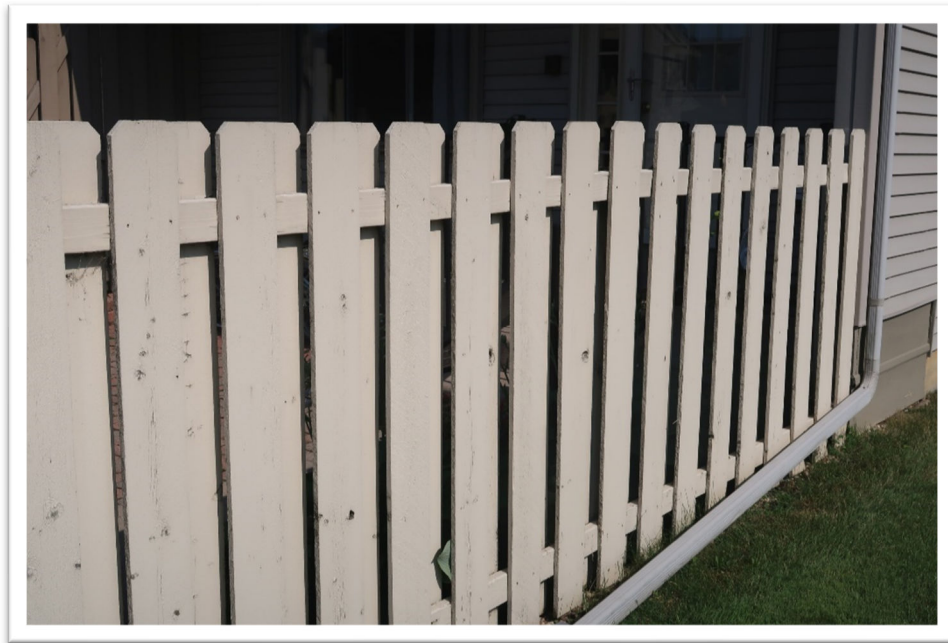
Photograph 41: Typical view of wood board privacy fence

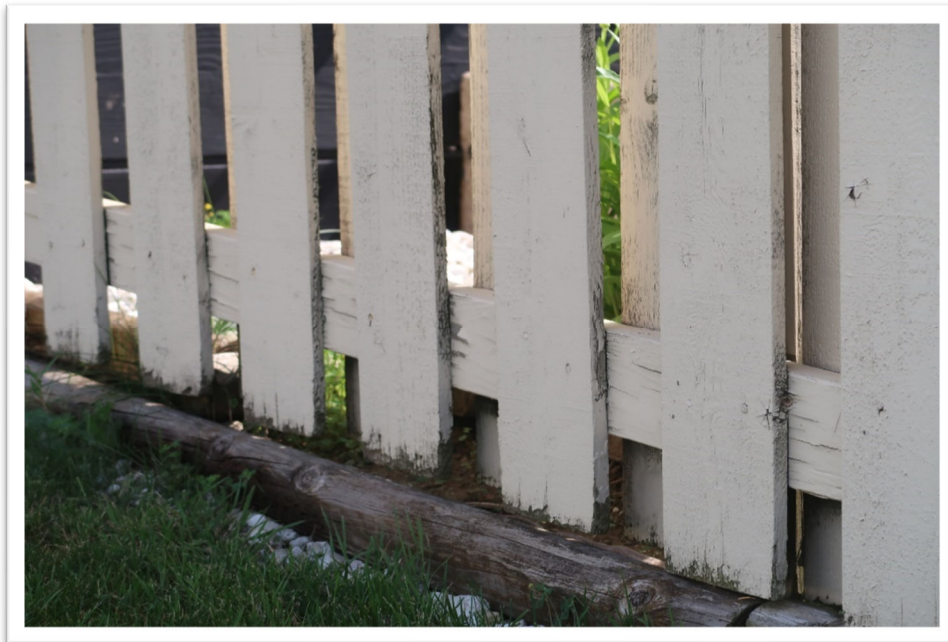
Photograph 42: Typical view of wood board privacy fence

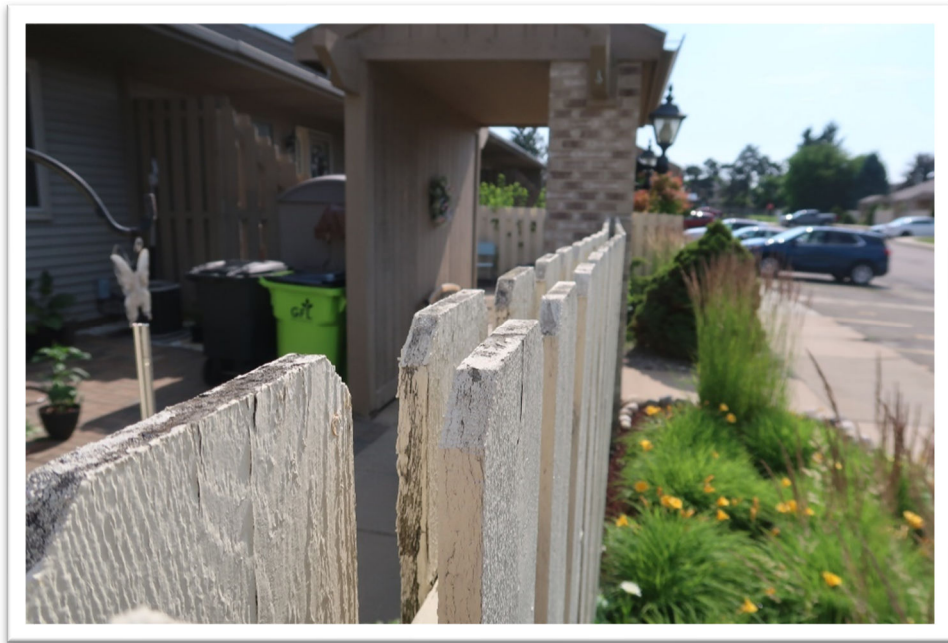
Photograph 43: Typical view of wood board privacy fence

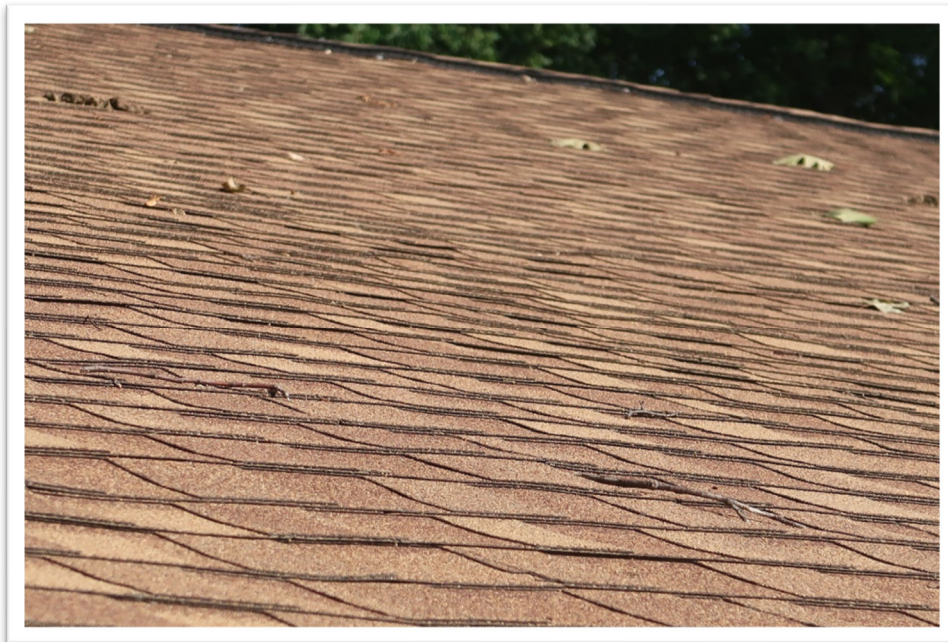
Photograph 48: Typical view of clubhouse asphalt roof shingles

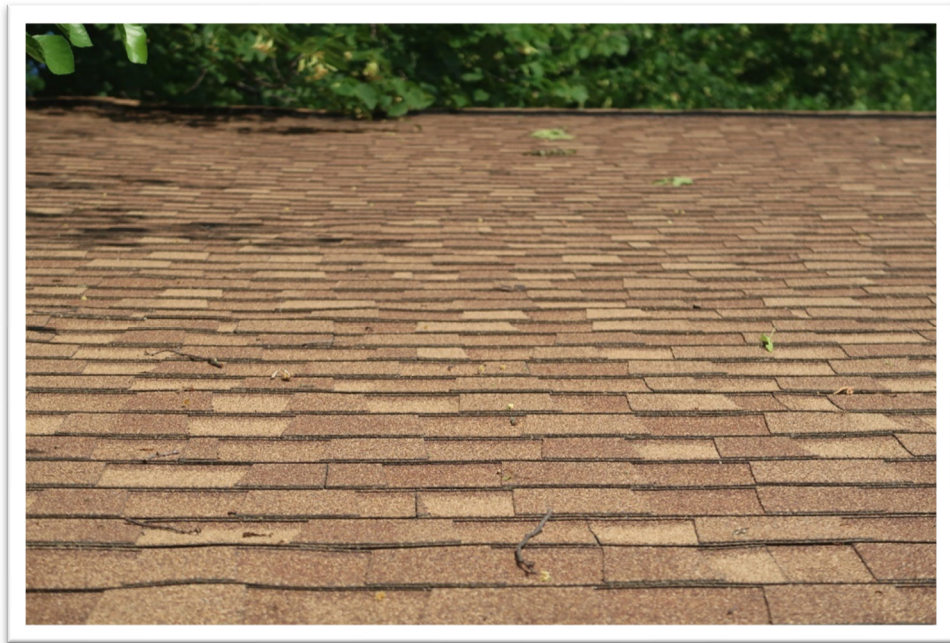
Photograph 49: Typical view of clubhouse asphalt roof shingles

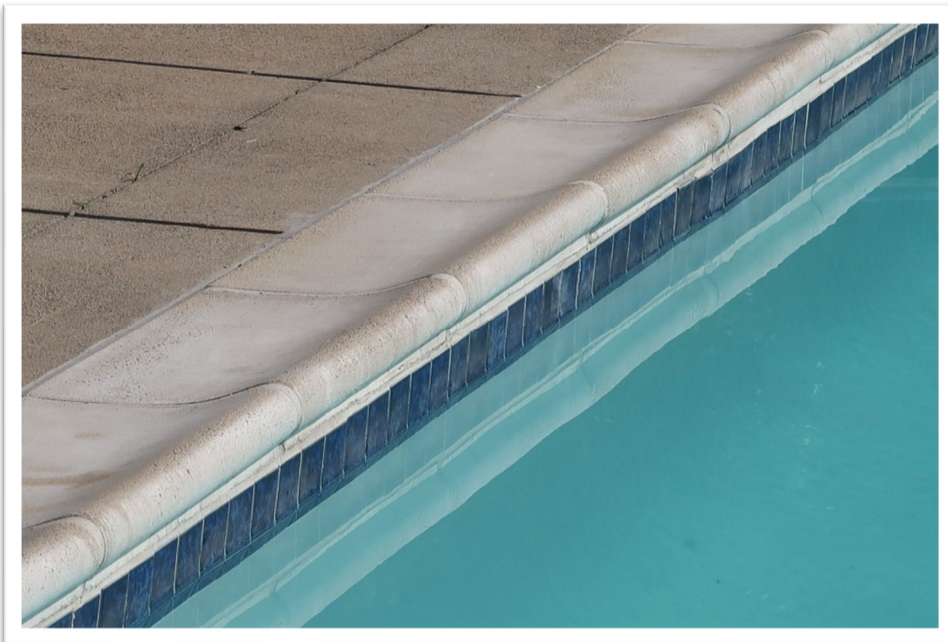
Photograph 56: Typical view of pool coping and tile
