"Full" Reserve Study

Casa del Cielo HOA Scottsdale, AZ

Report #: 34714-0
For Period Beginning: January 1, 2019
Expires: December 31, 2019

Date Prepared: October 9, 2018

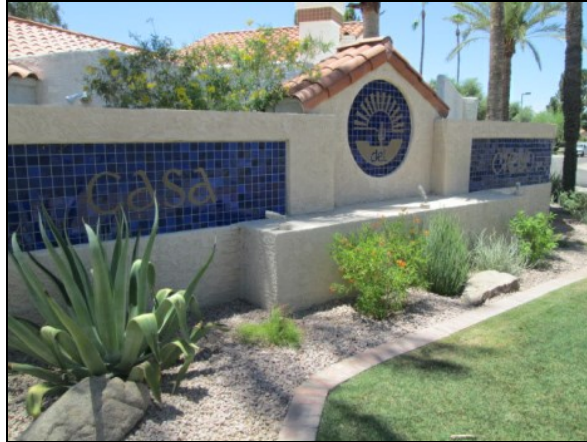
Useful Life:
30 years

Remaining Life:
0 years

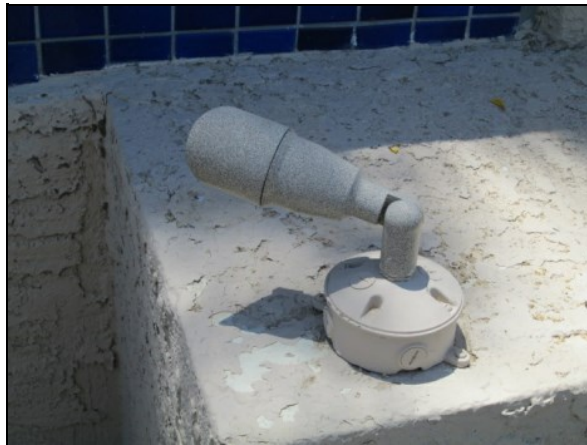
Comp #: 110 Monument Lights - Replace

Useful Life:
15 years

Remaining Life:
0 years

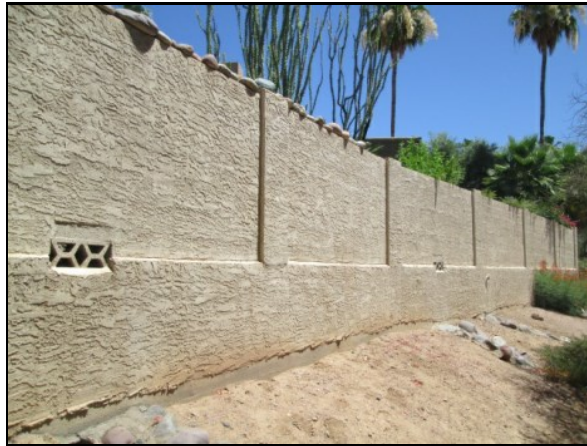
Comp #: 501 Stucco Walls - Repair

Useful Life:
24 years

Remaining Life:
12 years

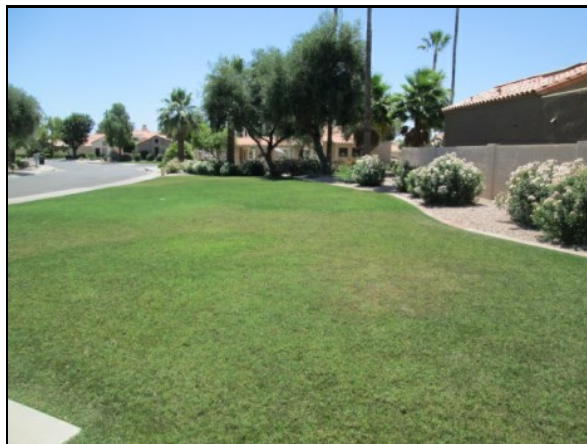
Comp #: 600 Irrigation System - Replace

History: Replaced during 2013 thru 2016 for ~\$60,000

Useful Life:
30 years

Remaining Life:
25 years
