RIO GRANDE DIVERSION INFRASTRUCTURE INVENTORY

Structure Name: MEADOWN OVERFLOW D

Date: April 11, 2019

Rio Grande Stream
Management Plan

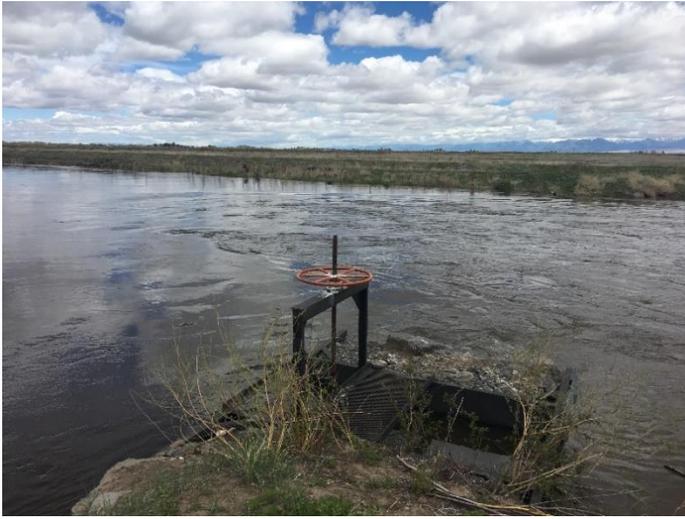
Structure Description: A "U-shaped" rock and debris diversion dam directs water to a feeder channel, ~550 ft long, located on the south bank of the river. A sluice gate at the entrance to the feeder channel helps transport sediment downstream. The diversion dam functions well. At the end of the feeder ditch, a small pool has formed and water is pumped out of the river via a permanently installed, metered lift pump. Alternatively, water can be delivered to the ditch via the original headgate, which is adjacent to the lift pump. There is a cutthroat flume just below the headgate. Any flow not pumped or diverted returns to the river via two small culverts leading to a return flow channel.

Diversion dam and sluice gate

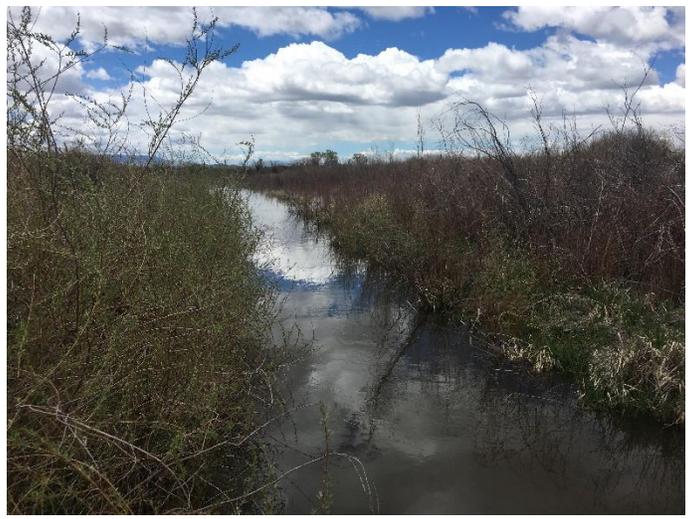
Feeder ditch looking downstream

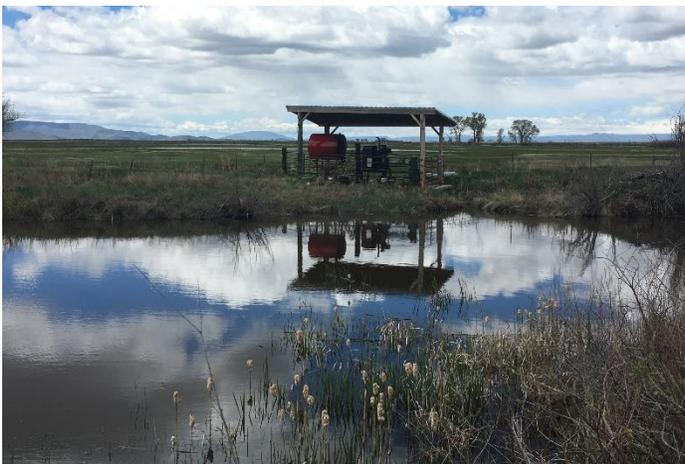
Pump used for irrigating adjacent field

Repair(s) or Improvement(s) Currently Needed: The headgate should be repaired or replaced. The lift pump does not function very well for the water user and could be improved. Channel and bank restoration work should be implemented in this reach to reconnect the river with its floodplain and to restore native riparian vegetation. Restoration work would improve the function of the river by slowing and dispersing water during high flow events and improving channel conditions for riparian vegetation recruitment. The flume does not measure accurately and needs to be replaced. Any future improvements should maintain existing boat and fish passage.

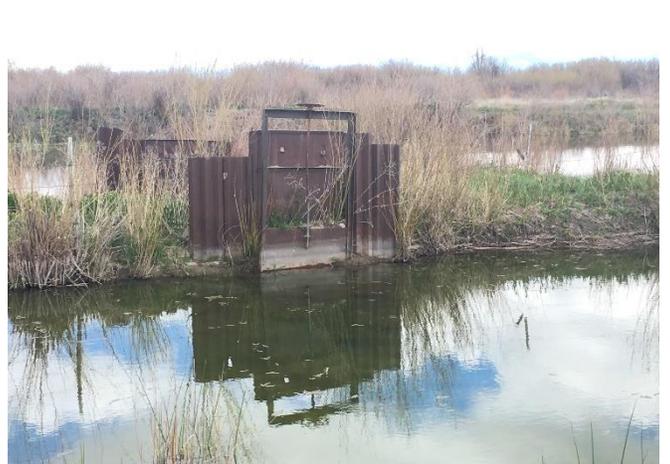
Headgate looking downstream

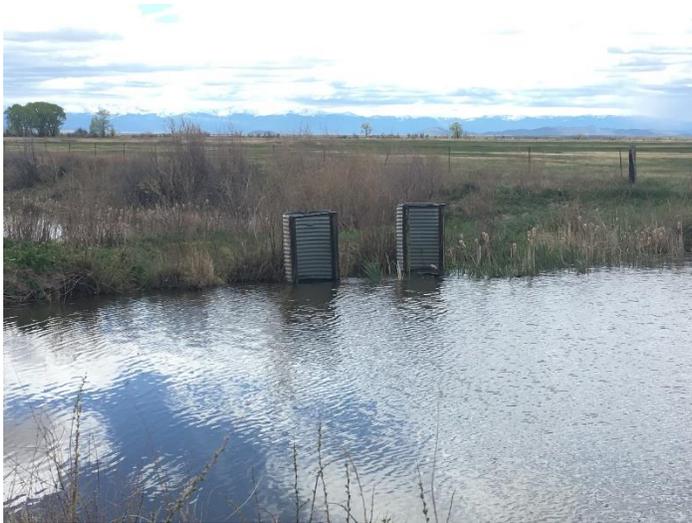
Return flow structures

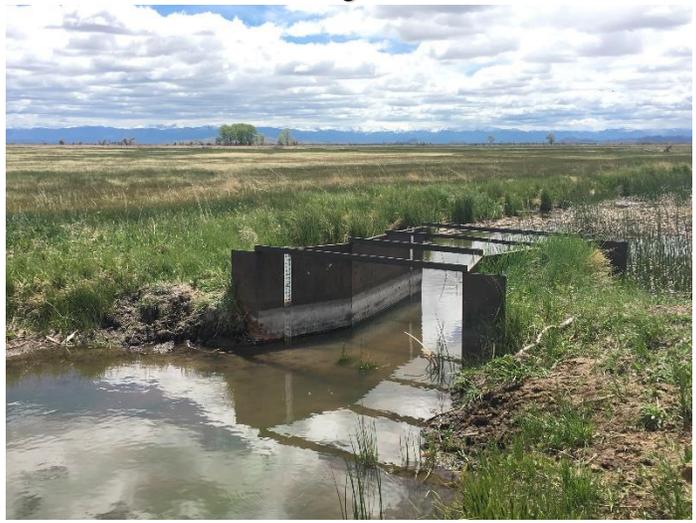
Flume looking downstream
