Mar 13th, 2024

48 N. Temple, Indianapolis, IN, 46201

Home Inspection Report

Kyle Pfeifer / Pfeifer Home Inspection

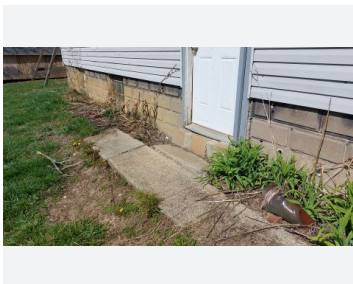
1.1 GRADING

The grading has a negative slope and water is pooling against the foundation in several areas. A qualified contractor will need to evaluate to determine the proper repair.

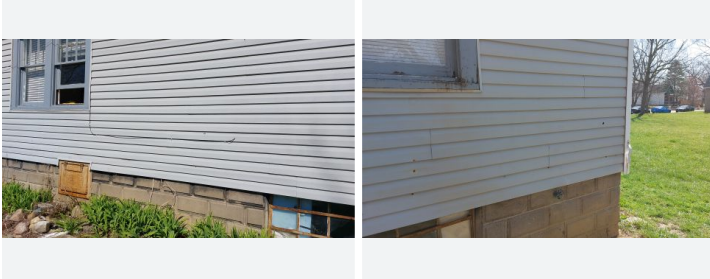
2.1 EXTERIOR SIDING

Maintenance

A few small cracks/holes were observed in the vinyl siding as we reviewed the exterior of the property. A qualified contractor will need to repair/replace all the damaged siding.

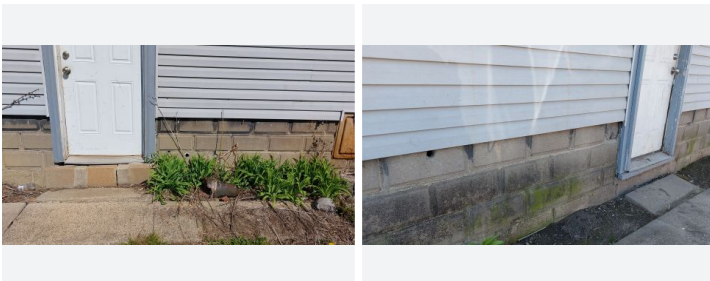
2.2 FOUNDATION

Maintenance

Several small holes were found in the cement block foundation. They appear to be old holes for gas and electrical lines. If desired, the holes could be filled with mortar.

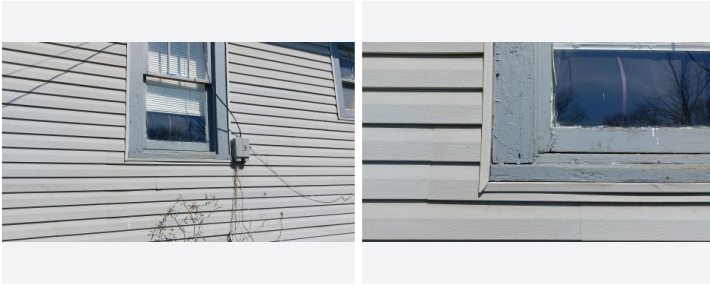
2.3 EXTERIOR TRIM

Maintenance

We recommend painting the exterior trim. We found several small cracks in the trim that will allow water in slowly rotting the boards over time.

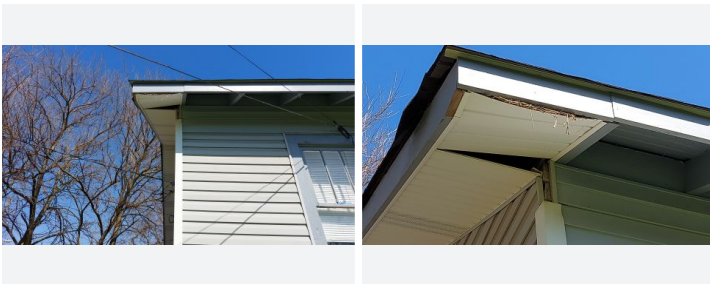
2.4 SOFFITS

Maintenance

A few minor repairs will be needed to the pictured soffit box. The corner of the soffit box will need re-attached if desired.

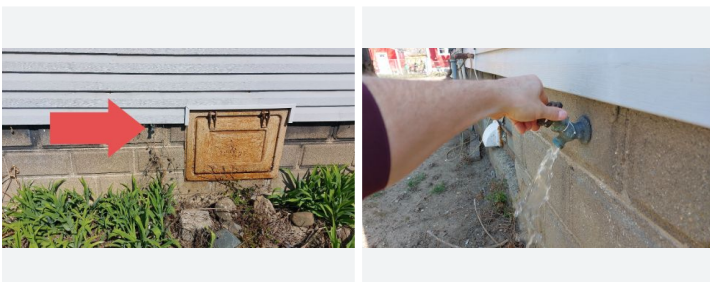
2.5 HOSE BIBS

Maintenance

One of the hose bibbs on the side yard is missing a handle. A new handle will need to be installed. If a new handle cannot be installed the hose bibb will need to be replaced by a qualified contractor.

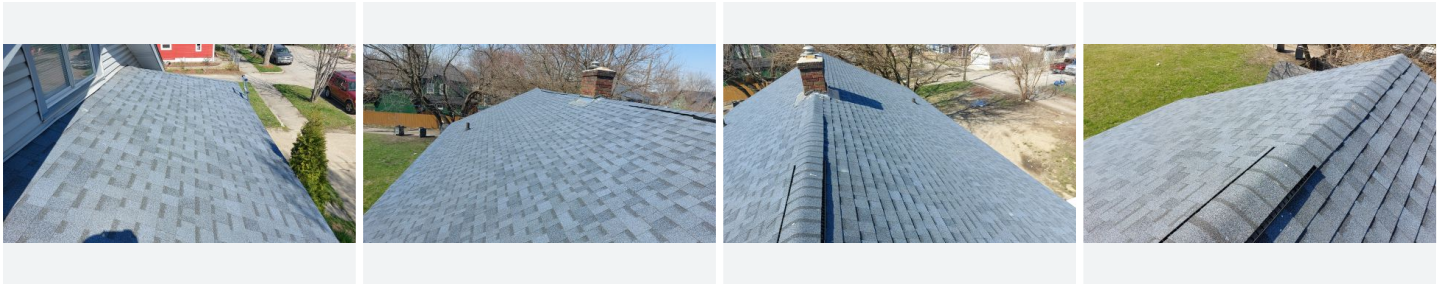
3.1 ROOFING MATERIAL

Acceptable

After walking the roof, it was obvious the roof was only a few years old. Minor deterioration was noted around the outside of the shingles. No obvious water entry was found anywhere. Water is properly being shed down to the gutters and away from the foundation as expected. All of the roofing/plumbing vents were installed correctly and leak free.

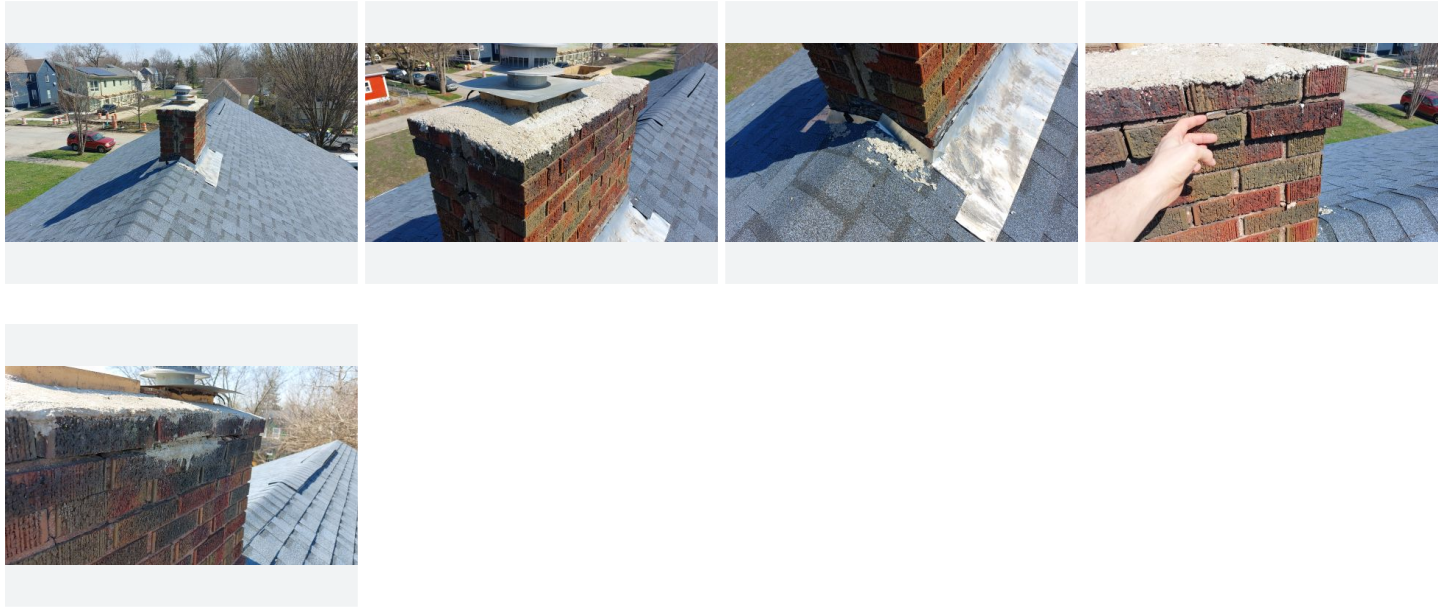
3.3 CHIMNEY

Marginal

Overall, the brick chimney is not in bad shape for its age. The chimney is structurally sound and not leaning inward or outward. The mortar between the brick has deteriorated and falling apart in certain areas. No issues were observed with the chimney crown or cap. A qualified contractor will need to review.

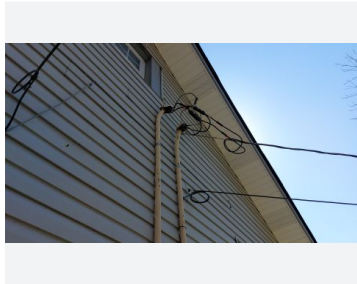
4.1 ELECTRICAL SERVICE ENTRANCE

Acceptable

The service entrance is in good condition with no major imperfections. We did not observe any signs that water is entering the meter.

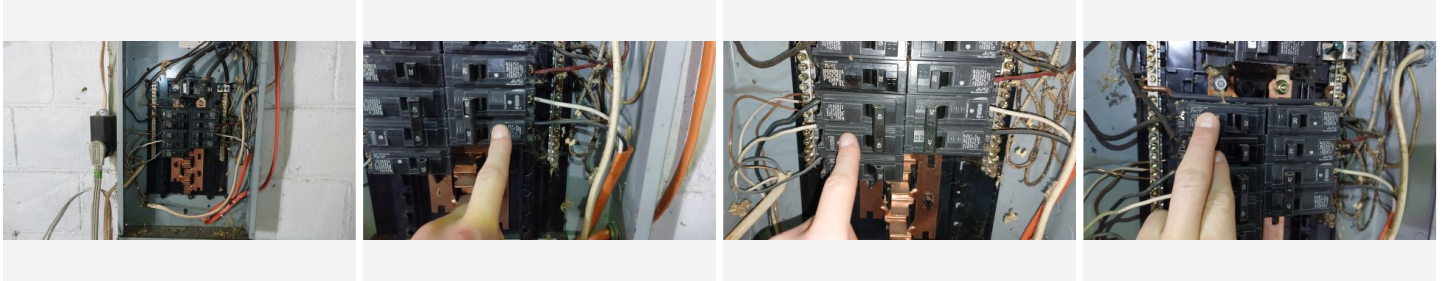
4.2 ELECTRICAL PANEL

Defective

We reviewed the pictured electrical panel we found several breakers that are over fused and attached to the wrong wire. No other issues were found. A qualified contractor will need to review the panel.

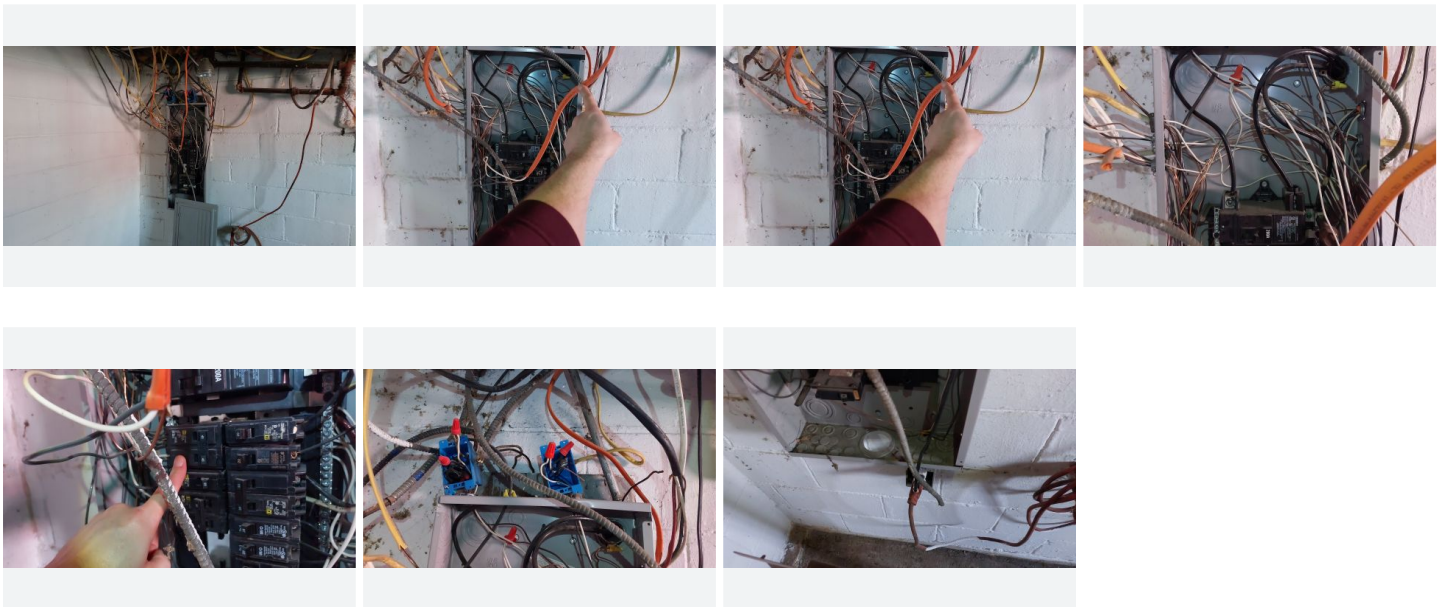
5.1 ELECTRICAL PANEL

Defective

We reviewed the pictured electrical panel we found several issues needing reviewed by a qualified contractor. A few electrical circuits were not installed correctly. The wiring was not installed through the top or side of the panel. As such the cover for the panel can not be installed. Directly, above the panel we found two junction boxes needing covered and attached. The over fused 40amp breaker needs to be removed. Lastly, all loose/abandoned wiring needs addressed as well.

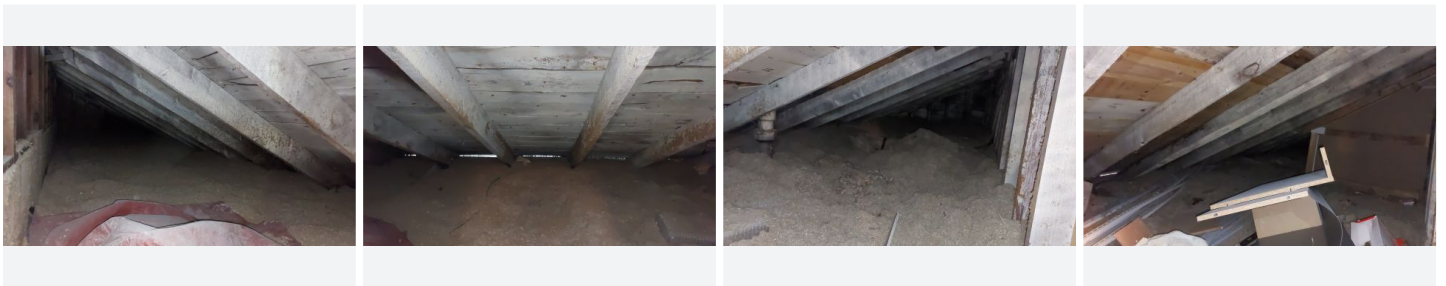
6.1 ROOF FRAMING

Acceptable

Overall, the structure in the main attic is in good condition with no major structural imperfections. The home is a 'stick built' house, meaning each 2x6 rafter was individually cut to fit together. No active signs of water entry were found. A satisfactory amount of blown in insulation was found throughout the attic.

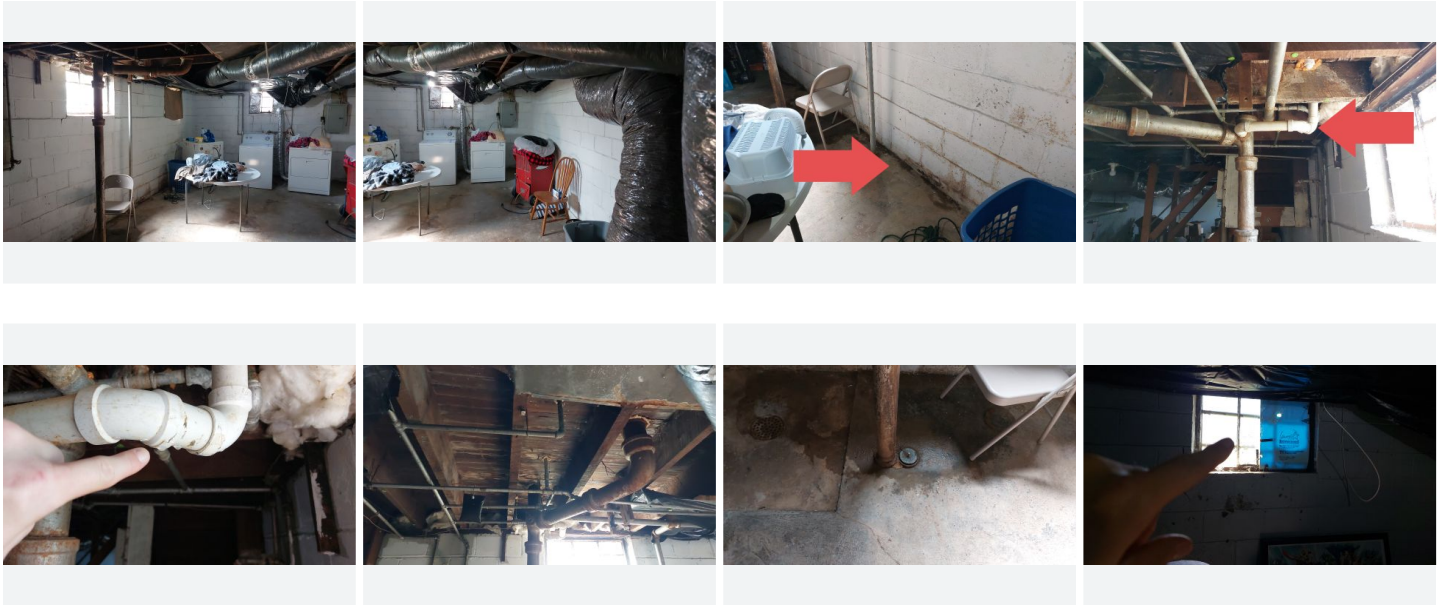
7.1 WALLS

Defective

The space downstairs was relatively dry with a little moisture present. With that said, we still recommend running a dehumidifier to alleviate any moisture issues that will build up. We did observe water entering from the outside and through the foundation walls. The grading and downspouts need to be reviewed to ensure they are draining away from the home. As a result, we observed a white substance that appears to be mold throughout the space. In pictures four and five we found an active leak coming from one of the drainage lines. We could not identify exactly where the leak was coming from. Several of the basement windows are cracked and need addressed. No major issues were observed with the wooden or cement block structure of the home. The main sewer line from the home to the street is cast iron. We recommend having the sewer line scoped to ensure it has not collapsed or has tree roots growing in it. A qualified contractor will need to review all issues.

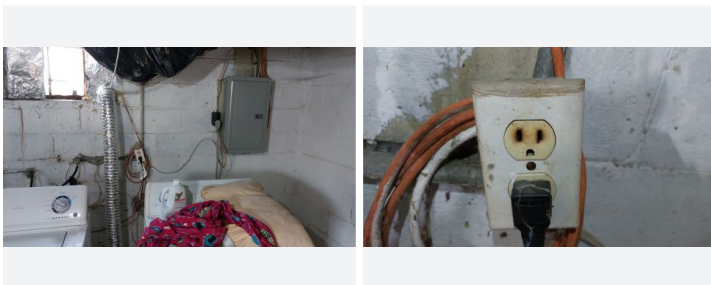
7.2 ELECTRICAL

The outlet in pictures one and two has 'shorted out' and needs to be replaced immediately. At one point the circuit 'arced' burning up the outlet and wiring. Further investigation is needed.

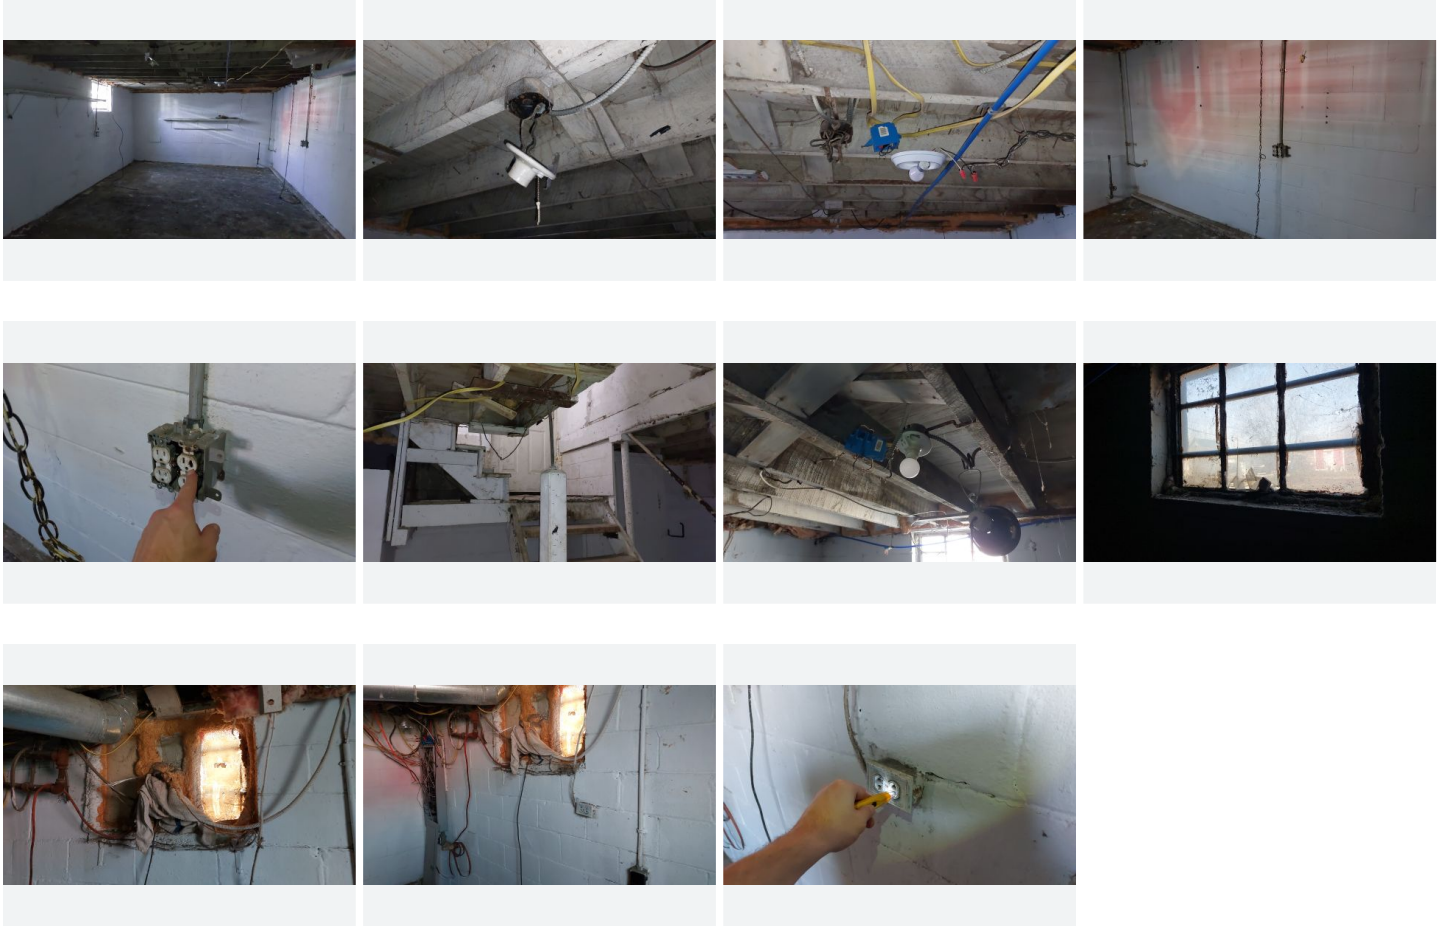
8.1 WALLS

The space downstairs was relatively dry with a little moisture present. With that said, we still recommend running a dehumidifier to alleviate any moisture issues that will build up. We did observe water entering from the outside and through the foundation walls. The grading and downspouts need to be reviewed to ensure they are draining

away from the home. All of the electrical wiring and junction boxes need reviewed for multiple reasons. In photos four and five we found an arced outlet needing replaced. Several of the basement windows are cracked and will need replaced. In photo six an adjustable flooring jack was used to support several flooring joists by the stairs. We recommend removing the jack and supporting this area in a different way. All open or abandoned plumbing lines need addressed. A qualified contractor will need to review all issues.

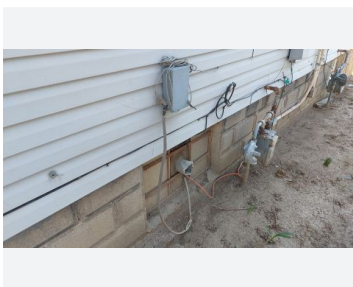
9.1 A/C SYSTEM OPERATION

Defective

Currently, no A/C unit is installed on the exterior of the home. It appears the way the refrigerant lines were cut the previous unit was stolen by someone. A qualified contractor will need to install a new unit with a cage to prevent theft.

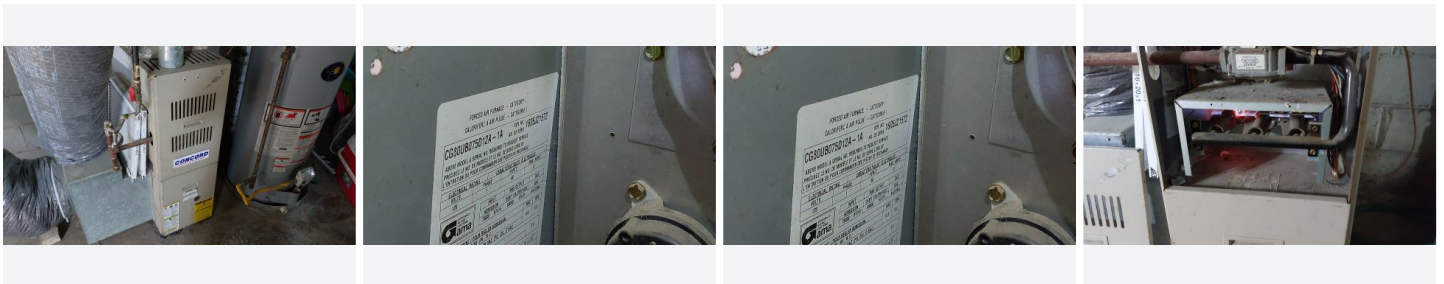
10.1 HEATING SYSTEM OPERATION

Marginal

The furnace was tested and in working order during our inspection. With that said, the unit is from 2005 and almost at the end of a typical life cycle. We recommend budgeting for a new unit.

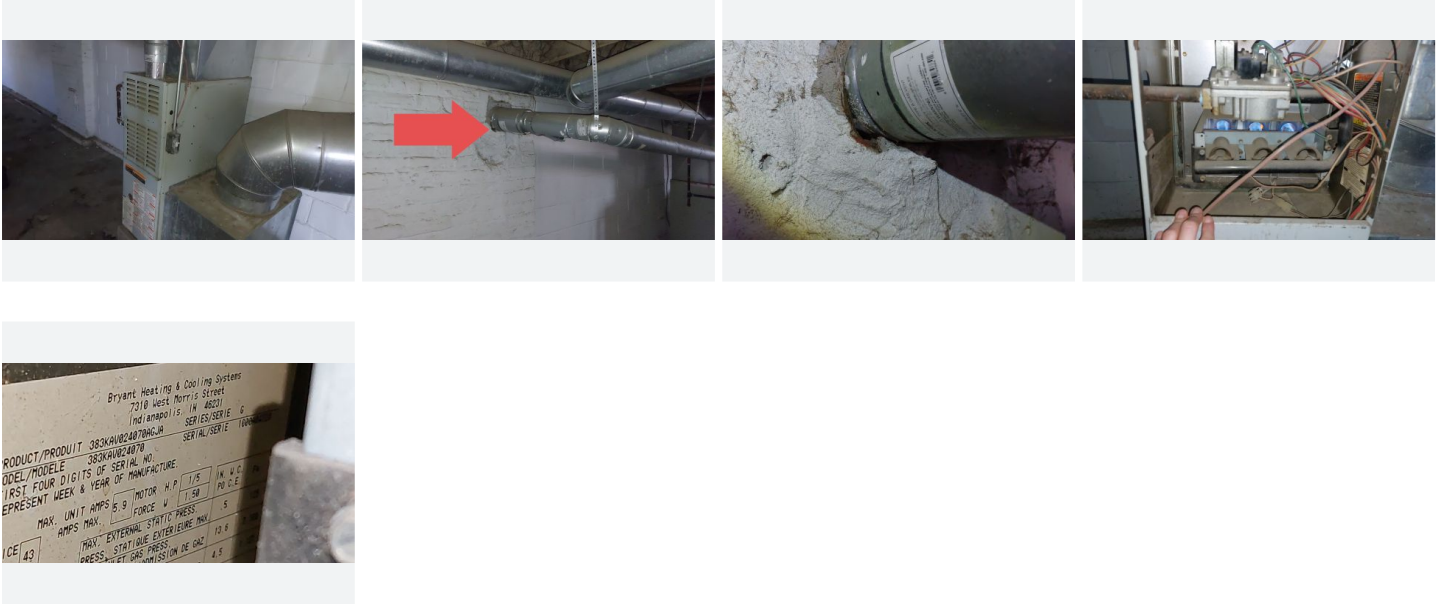
11.1 HEATING SYSTEM OPERATION

Defective

The furnace was tested and in working order during our inspection. With that said, the unit is from 2000 and almost at the end of a typical life cycle. In pictures two and three we found an opening around the exhaust line where it enters the chimney. This opening will need to be closed.

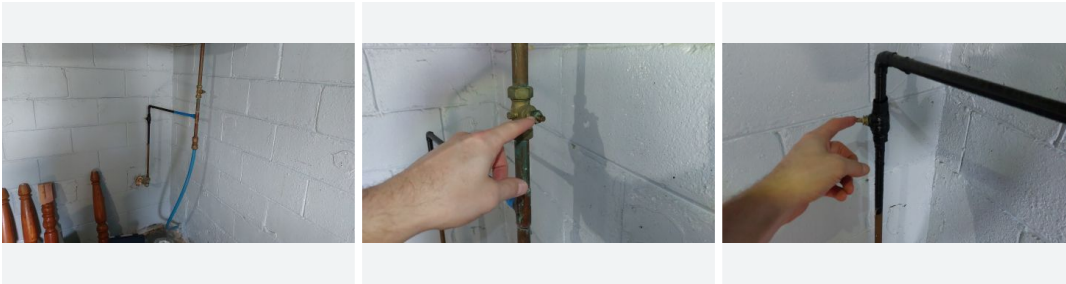
12.1 MAIN WATER SHUTOFF

Marginal

Two of the pictured shut off valves will need to have new handles installed as they are currently missing.

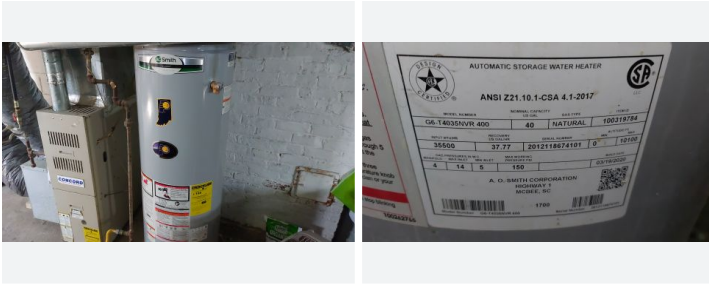
12.2 WATER HEATER OPERATION

Acceptable

This particular hot water heater was functioning properly during our inspection. Hot water was getting delivered to the appropriate places as expected. We recommend draining ten gallons from the tank to clean it out and wash any built up sediment out.

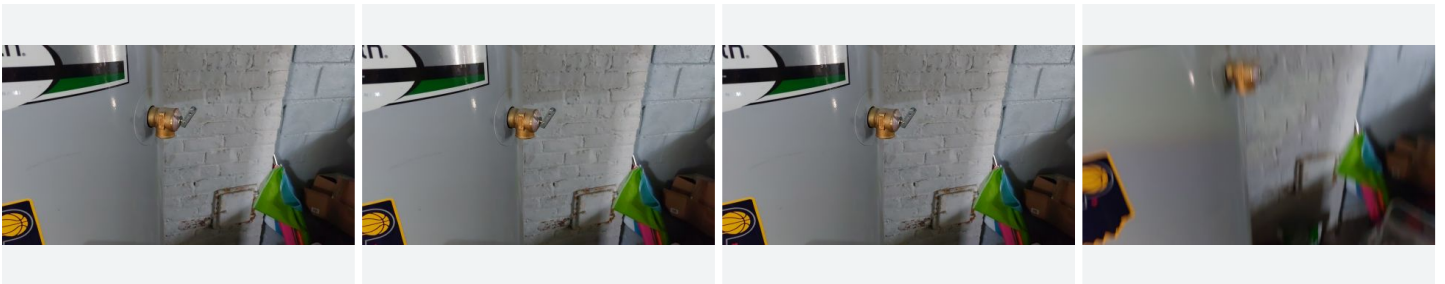
12.3 TPRV AND DRAIN TUBE

Maintenance

Per code, all hot water heaters are required to have a copper/CPVC drainage line piped between 6-24 inches of the floor. Here the pipe is missing. A qualified contractor will need to add an extension to the hot water heater.

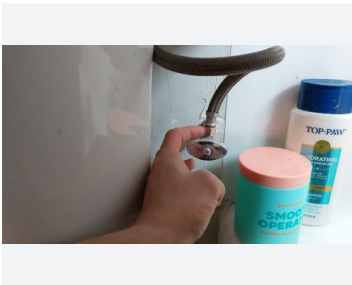
14.3 COLD WATER SUPPLY LINE

Defective

We found a slow leak where the cold-water supply connects to the shut off valve. A qualified contractor will need to review.

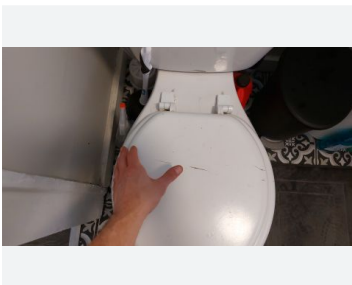
14.5 TOILETS

Maintenance

The base of the toilet is loose as we shifted the entire toilet during our review. We were able to shake the toilet from side to side. A qualified contractor will need to review for the correct repairs.

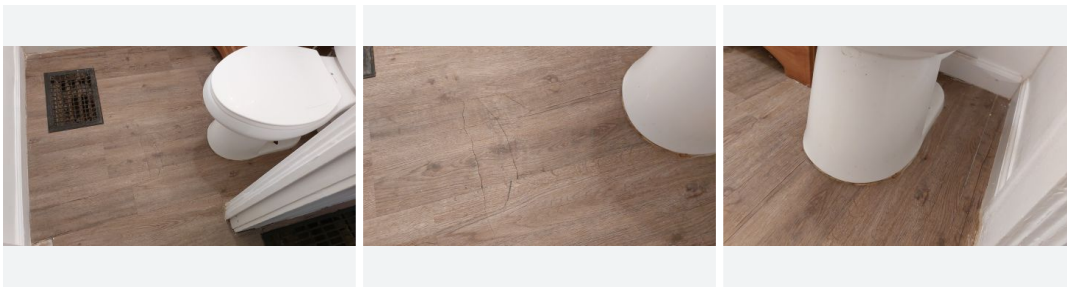
15.2 FLOOR

Marginal

Several soft areas in the subflooring were found around the toilet. Further evaluation is needed to determine the proper repairs.

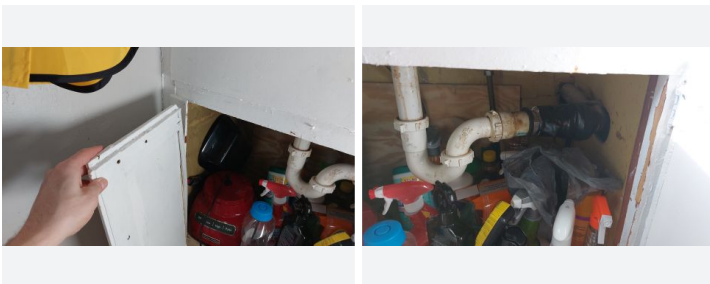
16.2 CABINETS

Marginal

The cabinet doors are loose and need to be re-attached. Furthermore, electrical tape is currently being used to hold the drainage line together. A qualified contractor will need to review.

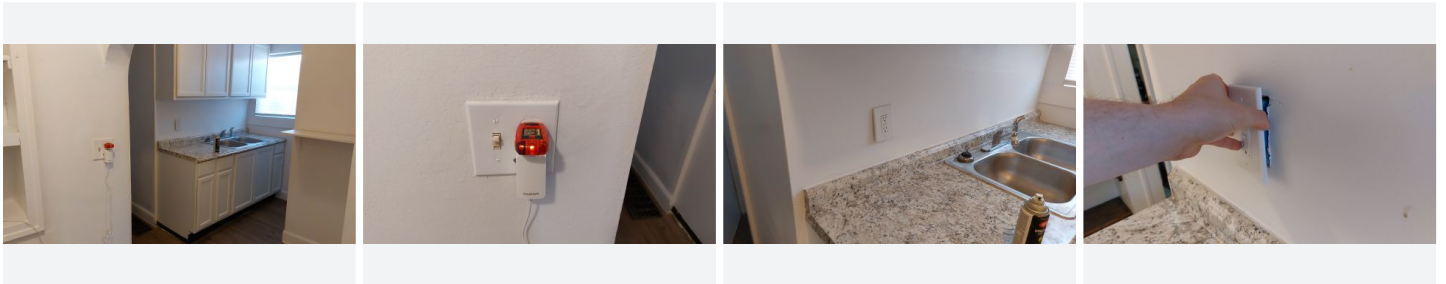
17.1 ELECTRICAL

Defective

The electrical outlet in pictures one and two is indicating 'reverse polarity.' Reverse polarity is when the hot and neutral wires are reversed. We also noticed a really loose outlet next to the sink. A qualified contractor will need to review for the correct repair.

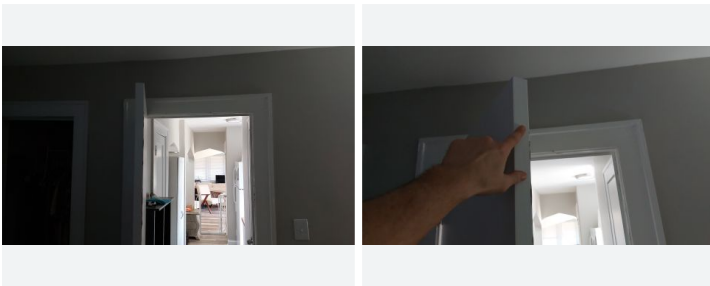
The entry door will not completely shut. The door will not close all the way as the latch is just missing the strike plate. A qualified contractor will need to review for the proper repairs.

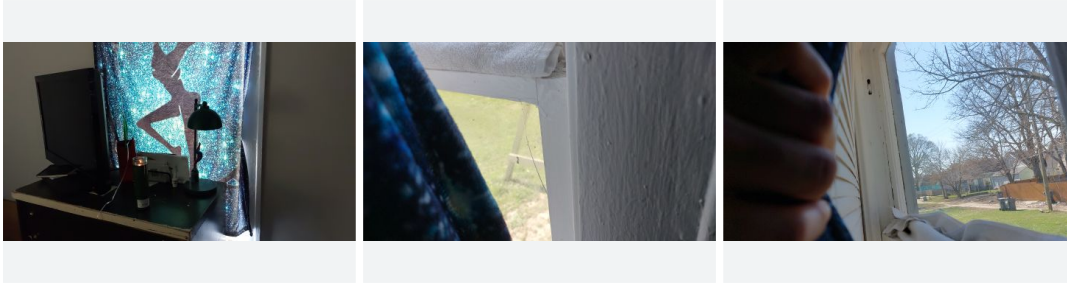
18.3 WINDOWS

Defective

One of the windows in this room is cracked and needs to be addressed. Furthermore, several of the sash cords are missing. A qualified contractor will need to remove and replace any damaged glass.

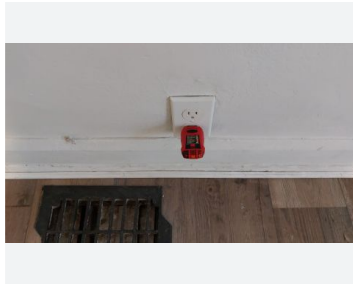
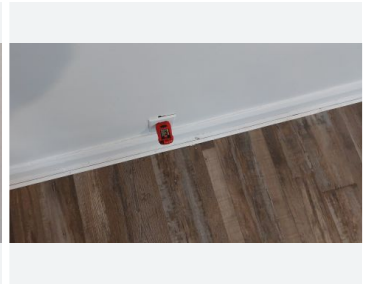
Defective

We attempted to test the pictured outlets; however, they were not working. A qualified contractor will need to review for the correct repair.

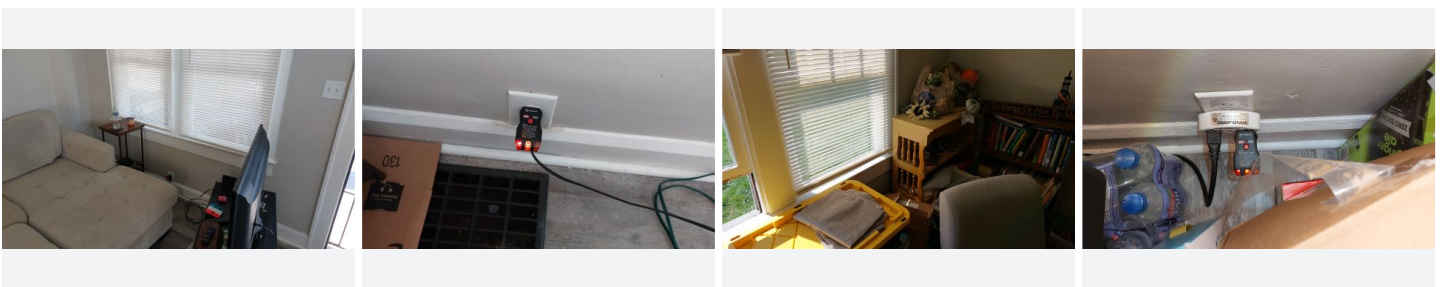
Defective

Several of the electrical outlets in this room are indicating 'reverse polarity.' Reverse polarity is when the hot and neutral wires are reversed. A qualified contractor will need to review for the correct repairs.

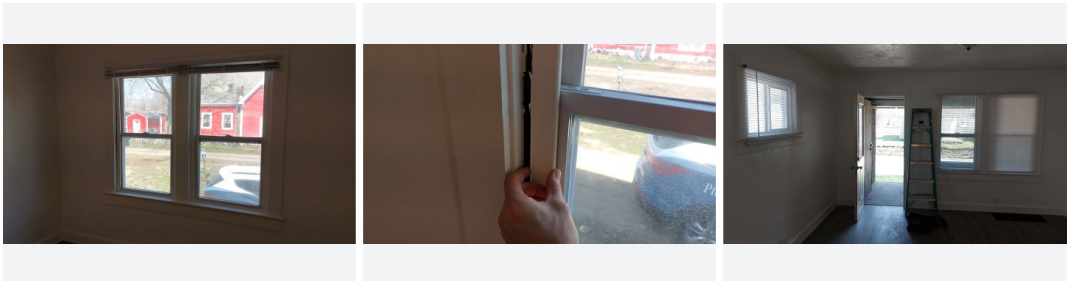
21.2 WINDOWS

The sash cords are missing/damaged for several of the single hung windows in this room. We attempted to open the window, however were unable as they fell down immediately. A qualified contractor will need to review for the proper repairs.

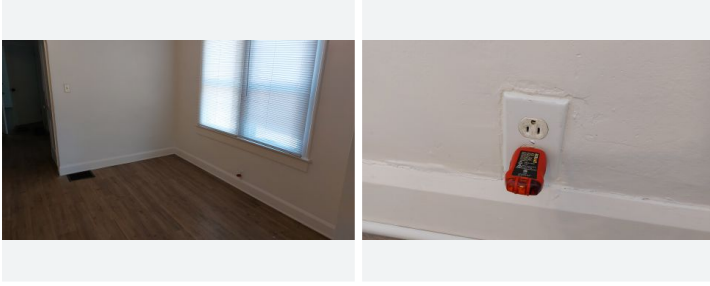
21.3 ELECTRICAL

Defective

We attempted to test the pictured outlet, however it was not working. A qualified contractor will need to review for the correct repair.

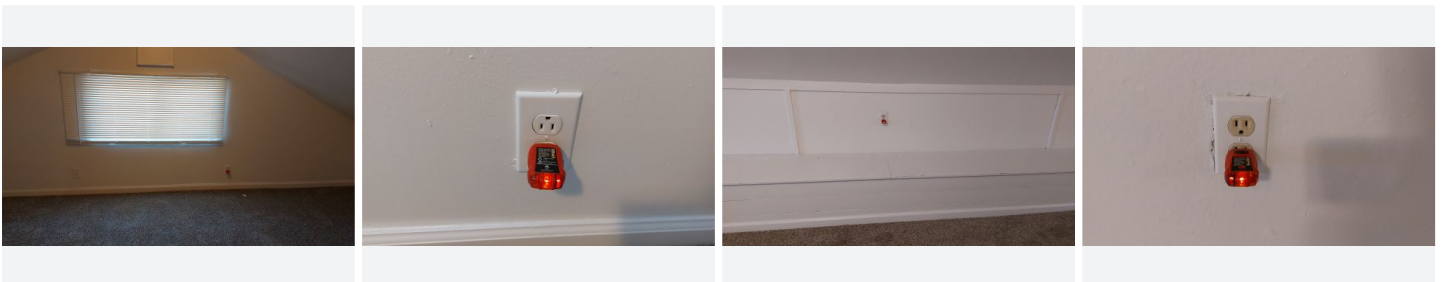
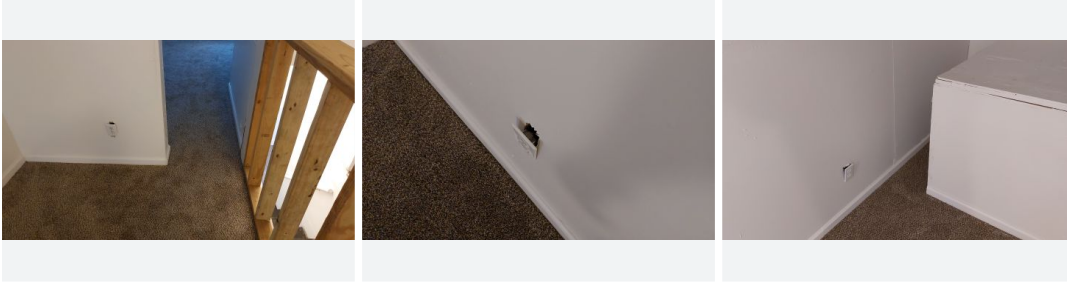
■ Defective

Several of the outlets in this room are indicating 'reverse polarity.' Reverse polarity is when the hot and neutral wires are reversed. Additionally, several outlets are loose and need to be re-attached. A qualified contractor will need to review for the correct repair.

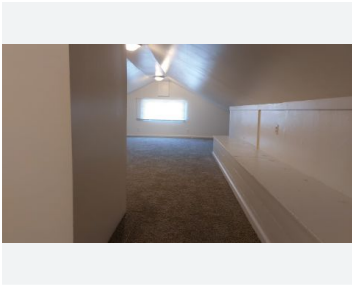
22.3 HVAC SOURCE

Defective

We did not see a return line connected to the HVAC system in the finished attic. Currently, air is not being exchanged between floors. Further evaluation is needed.
