RIO GRANDE DIVERSION INFRASTRUCTURE INVENTORY

Structure Name: NEW DITCH

Date: April 11, 2019

Rio Grande Stream Management Plan

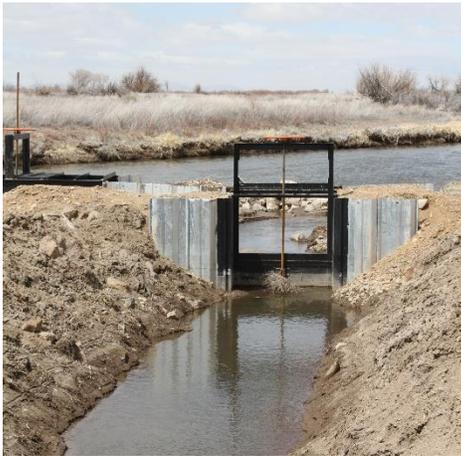
Headgate outlet
