Wheel Separations

by Mark Bailey MASc, PEng, PE

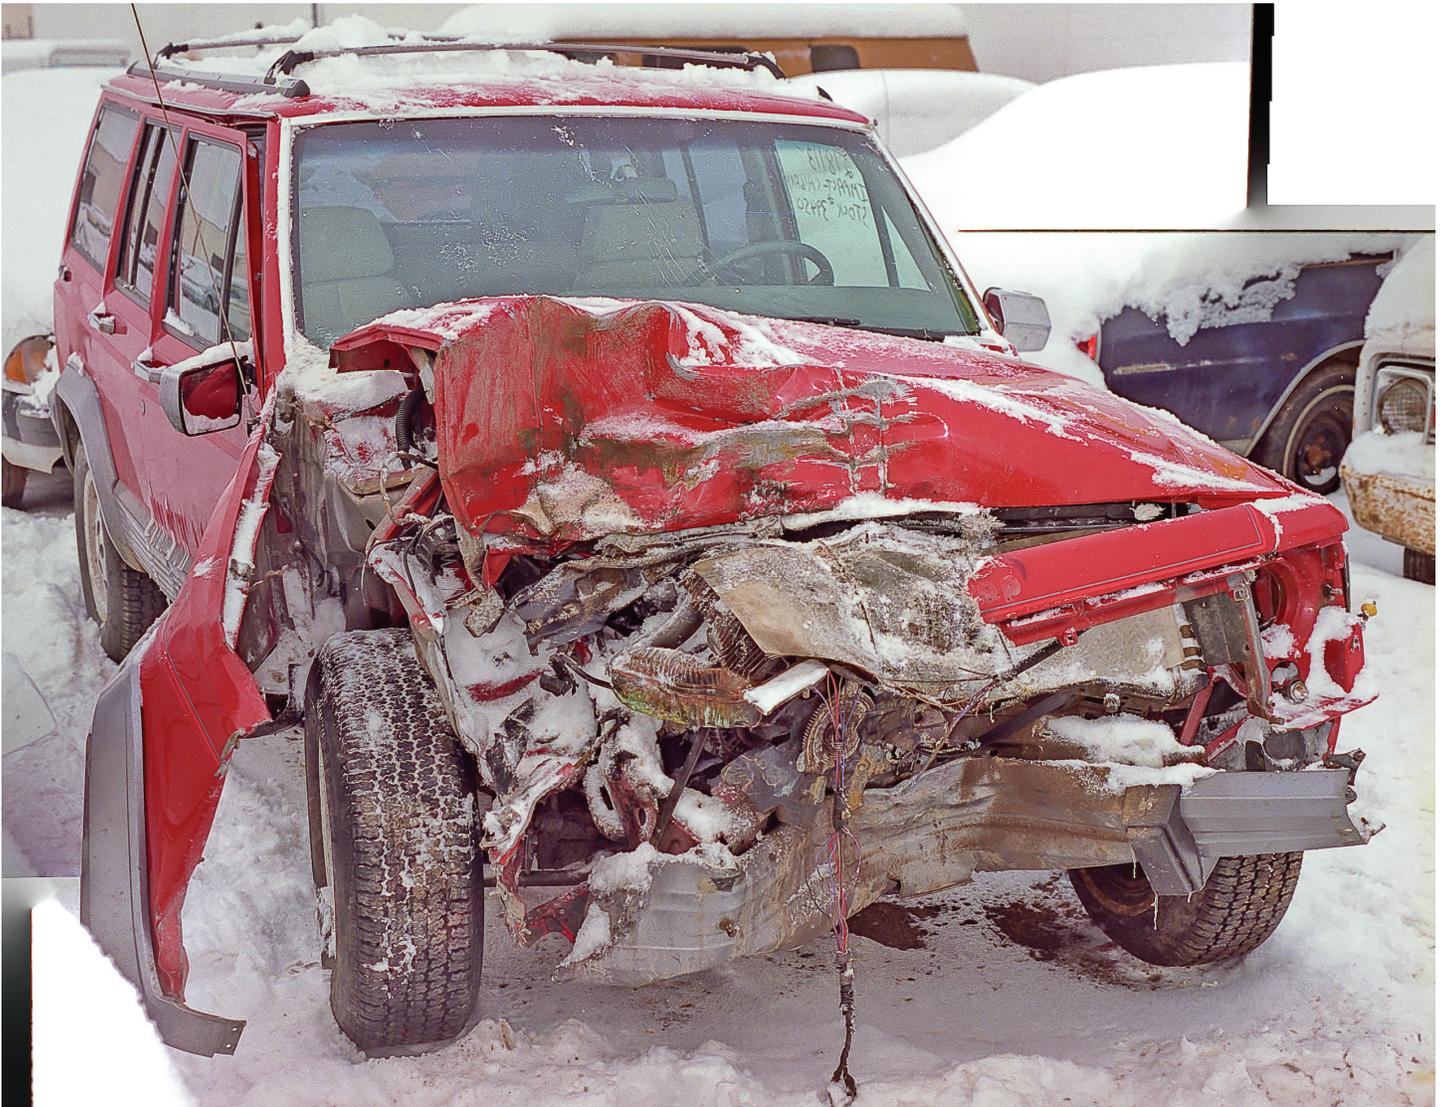
Figure 1. Front-end damage from head-on impact with separated dual heavy truck wheels.

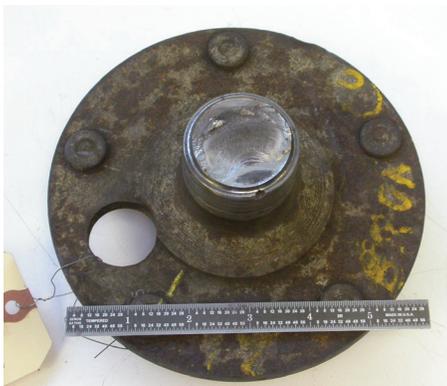
Figure 2. The end of a Ford Bronco axle broke off one month after it was serviced. During the service an axle bearing was carelessly removed with a cutting torch, which metallurgically altered the axle and led to a catastrophic fatigue fracture.

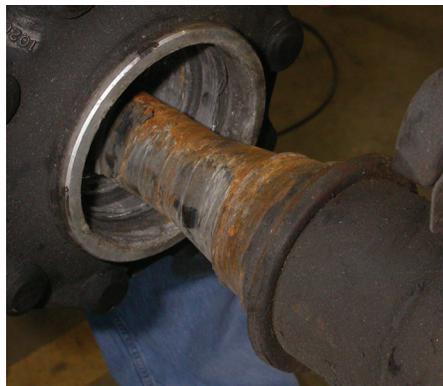
Figure 3. A heavy truck hub had a bearing failure and the consequent friction destroyed the hub and allowed it to come off the end of its axle.

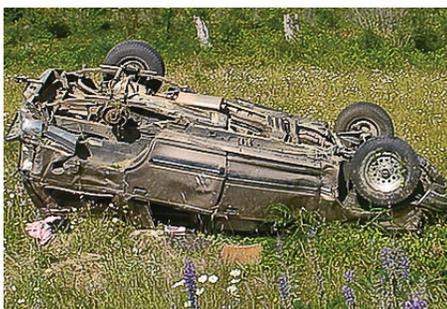
Figure 4. Eyewitnesses observed the left rear wheel separate from this SUV before it lost control and rolled. All five nuts were missing from the wheel studs of the left rear wheel.

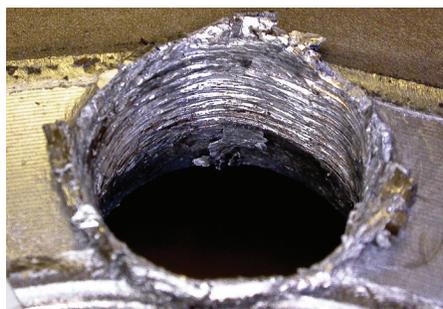
Figure 5 shows a wheel stud and the hole of the left wheel that it was in. The nut has spun off the stud and was never found. The

stud threads left an imprint in the aluminum wheel and there is aluminum embedded in the stud threads. The stud is not broken.

Figure 5. This stud (right) and wheel hole damage (above) is from a left-side wheel separation that occurred 21 days after the wheel was installed.

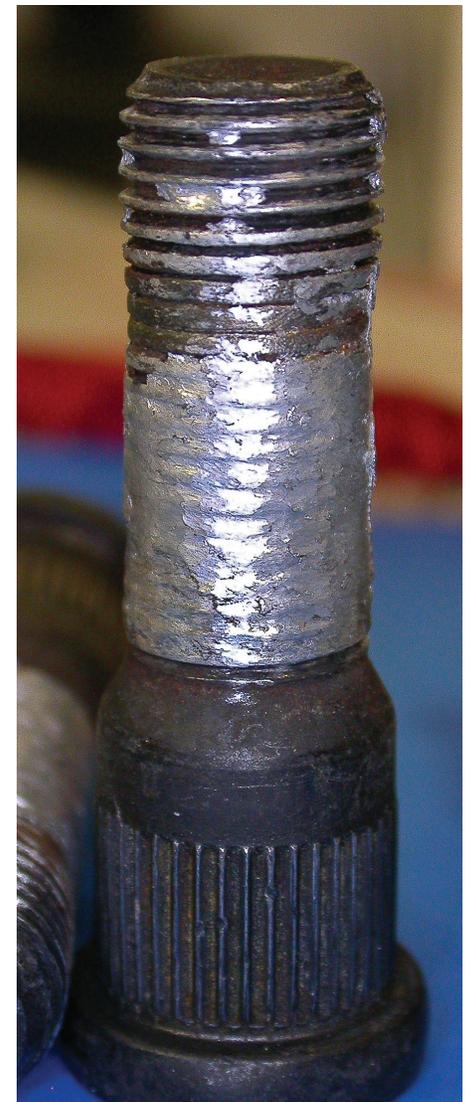
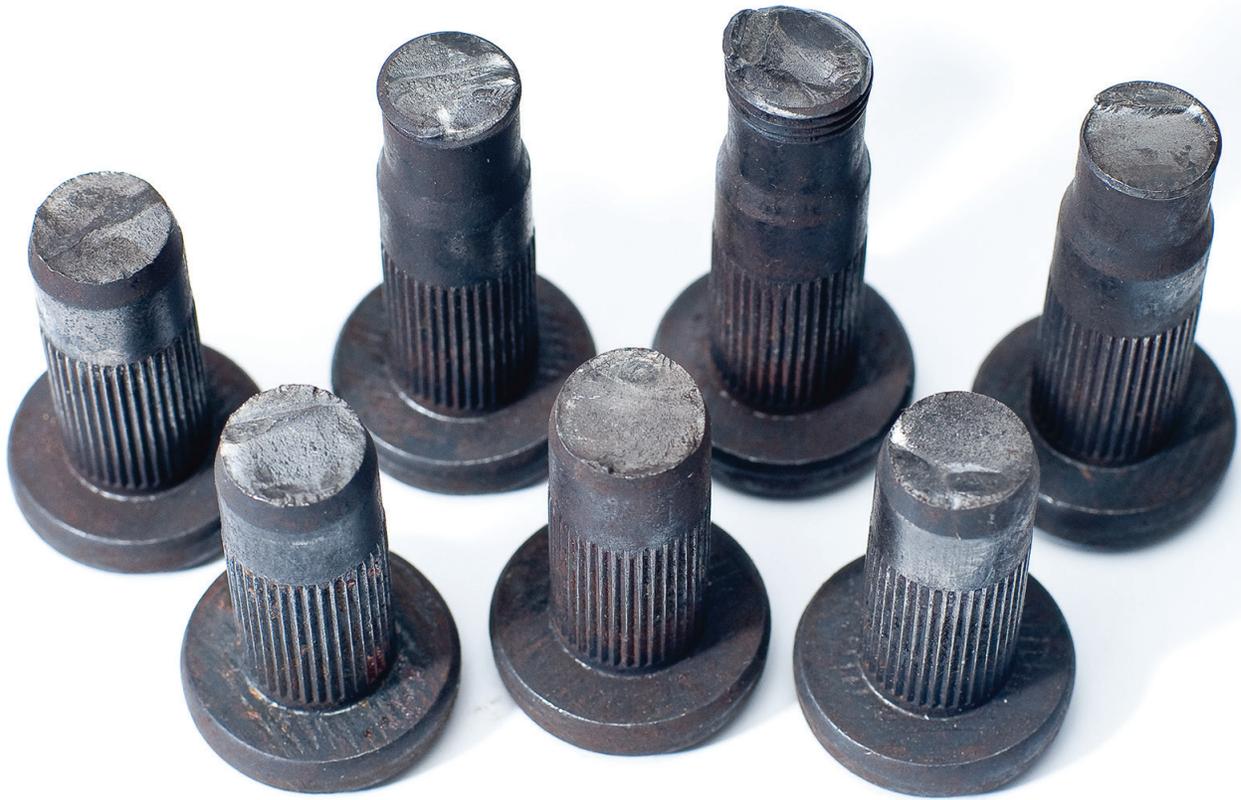
Figures 6 and 7 show broken right side wheel studs. These are the portions of the studs that were in the wheel hub. The parts of the stud that broke off, along with the nuts, were never found. The flat fractures with "beach marks" (fine curved parallel lines resembling an aerial view of a beach) on the fracture surface are typical of right-side stud fractures, and are classic examples of what engineers refer to as reversed bending fatigue.

Figure 6. Fatigue fractures on studs from a motor home right-side wheel after 2900 miles. Fatigue fractures are usually flat and transverse to the stud axis.

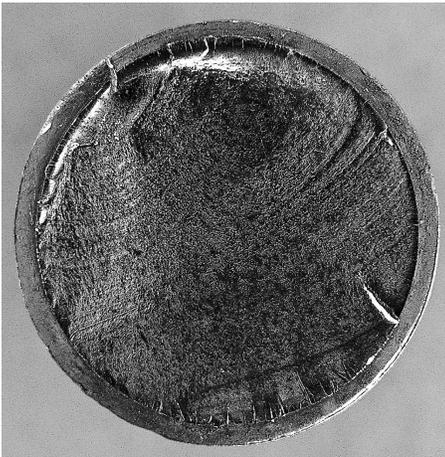
Figure 7. Beach marks on the fracture surface are clear signs that this stud from the right rear of a van failed from fatigue. Failure was less than 121 days since installation.

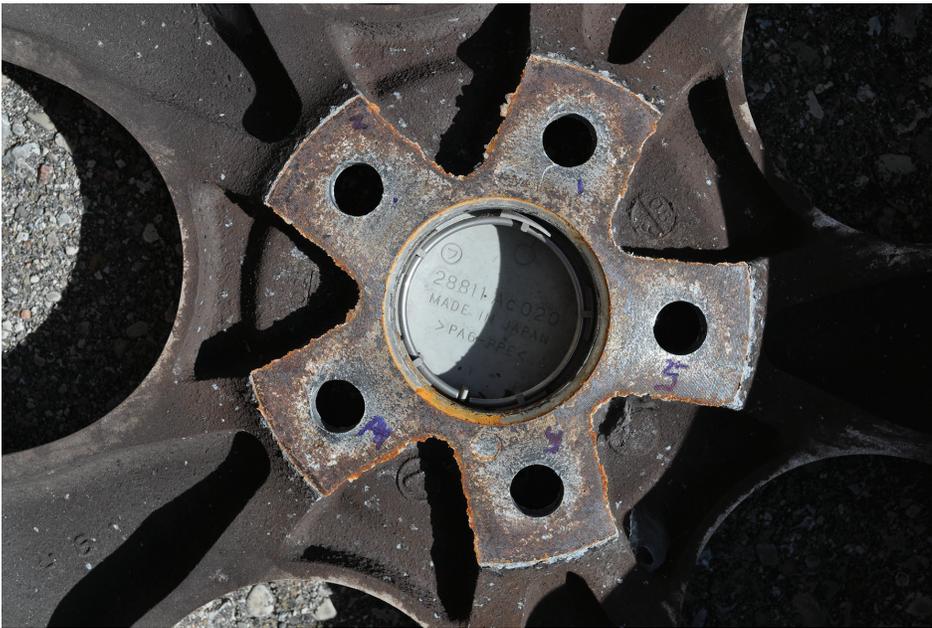
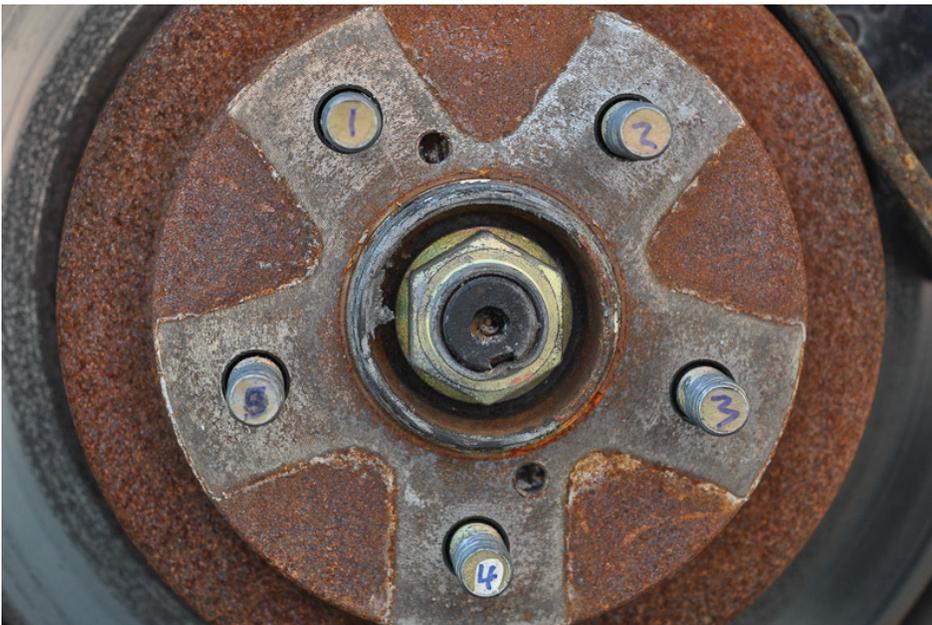
Figure 9. The minor rust deposits on the edges of the contact area of this aluminum wheel are normal, but the contact patch (five white arms outlined by rust) on the brake rotor must be clean.

Figure 9 shows an example of corrosion (visible as orange-brown iron oxide) from an iron brake rotor on a passenger car with aluminum (or "alloy") wheels. In this case the corrosion developed on the iron brake rotor in the exposed spaces where the aluminum wheel flange did not press on the rotor, leaving a clean contact patch or "footprint" of the wheel flange on the rotor. The corrosion is not problematic unless it develops on the clean footprint area. If the footprint was corroded instead of clean, as shown in Figure 10 for a steel wheel that separated, then the rust clamped between the wheel and rotor is thinned by crushing from driving, leading to lost clamping force. There are ample warnings for wheel installers to clean wheel surfaces before re-installing a wheel to prevent corrosion and dirt from imperiling the clamping force. Cleaning the wheel interfaces is normally done with a wire brush just before installation.

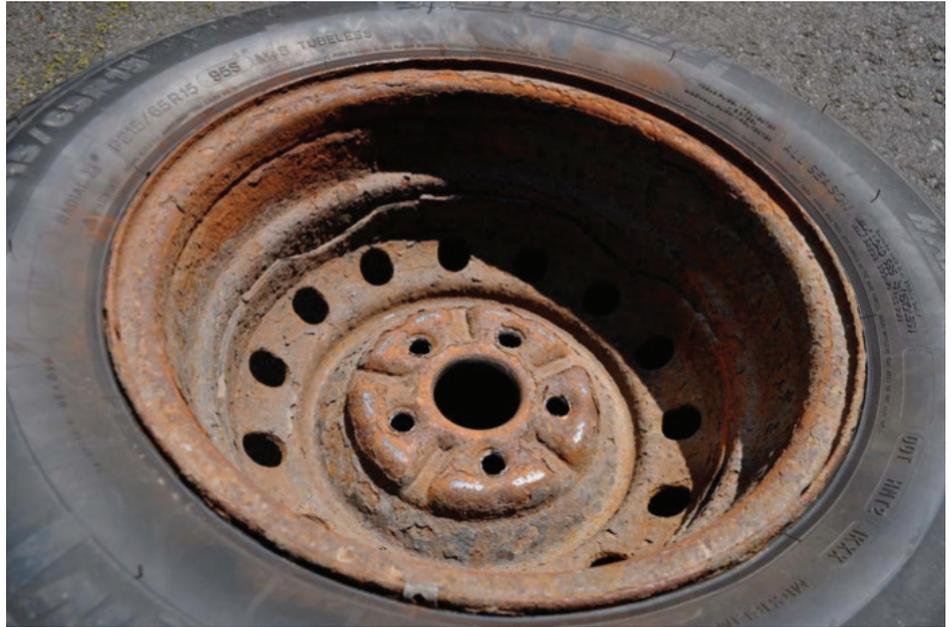
Figure 10. A badly corroded wheel separated because rust deposits were not cleaned off properly before it was installed.

The remedy to the wrong or lost clamping force is to have the wheel nuts re-torqued after a short driving distance. Although wheel separations are rare, they should be entirely preventable with re-torquing.
