TALCO
Home Inspection

Inspection Report

Property Address:
125 Crimea Drive
Nicholasville KY 40356

Date: 11/6/2018	Time: 10:00 AM till 02:00 PM	Report ID: 181106ANTHONY
Property: 125 Crimea Drive Nicholasville KY 40356	Customer: Ms. Sharon Anthony	Real Estate Professional:

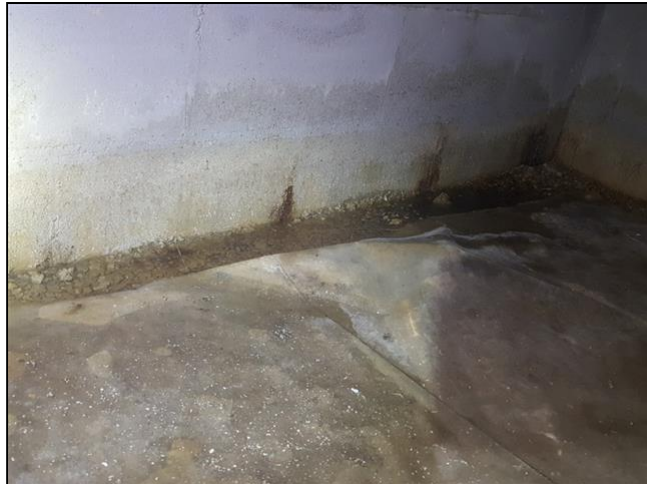
1.2 Item 1(Picture) rear right corner of home

1.2 Visible signs of water intrusion along the perimeter walls and standing water in the crawlspace was present at time of inspection. Water intrusion can lead to more costly repairs and increase damage if not corrected. Water intrusion if not corrected can lead to other problems including mold and cause excessive moisture to the floor system that can lead to deterioration and increased repair cost. Roof and Lot Drainage repairs or improvements should be addressed as a first step to controlling water entering in the crawl space. After corrections, recommend monitoring the crawlspace to see if additional steps are needed to prevent water intrusion.

Note: You may wish to consider installing a sump pump and drainage system in the crawlspace in removing the water. You may wish to seek an opinion from a qualified crawlspace contractor to further inspect crawlspace.

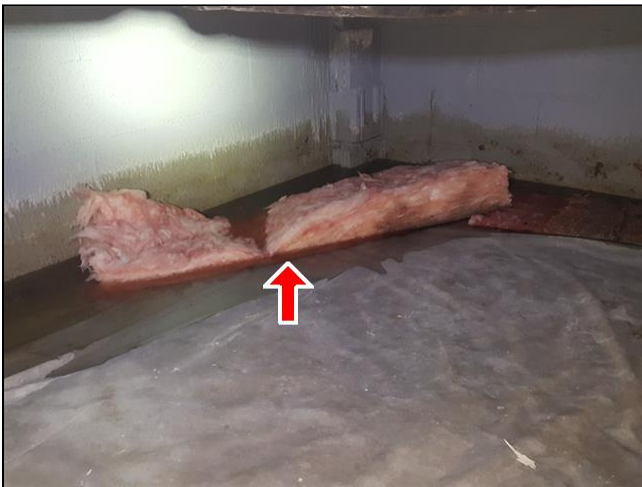
1.3 Item 3(Picture) under front entry

1.3 (1) All insulation and wood should be removed from the crawlspace floor. The insulation will hold moisture creating condensation and possible mold growth on the wooden structure in the crawlspace. Wood debris risks rotting and can attract wood eating insects into the crawlspace which can lead to more costly repairs later. Recommend all types of debris resting on the crawlspace floor be removed to prevent damage to the wood structure of the home.

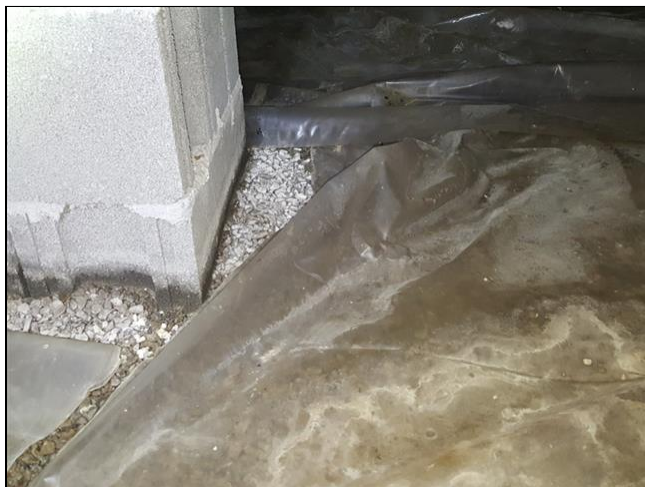
1.3 Item 7(Picture)

1.3 (3) The vapor barrier (plastic) on the crawlspace ground needs to be sealed at the joins to prevent water rising and pooling on top of the barrier in the crawlspace. Placing blocks or heavy weights at the joins is not recommended. A vapor barrier provides added protection to the floor system from moisture or dampness that can enter from ground. Recommend a general contractor repair as needed.

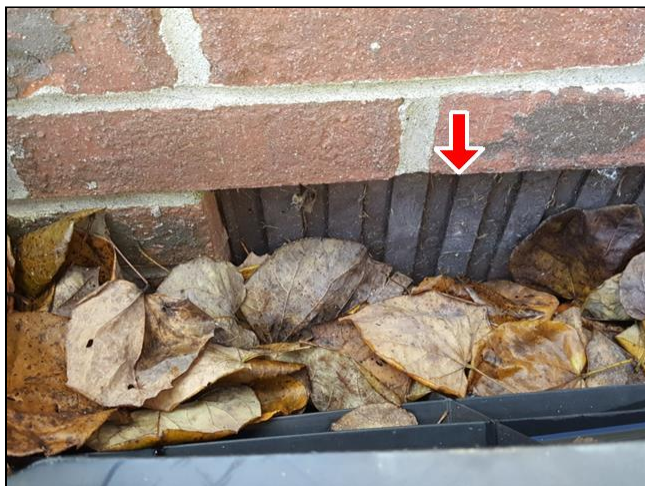
1.9 Item 1(Picture) right side of home

1.9 (1) The vents have been closed/sealed where indicated in the photos for the crawl space. However the crawlspace has not been prepared for encapsulation. Though there was no condensation noted at the time of the inspection. Proper ventilation will help control humidity and reduce the potential for wood rot and condensation forming in the crawlspace. It is recommended that One (1) square foot of free vent area should be provided for every 500 square feet of crawlspace. Recommend the vents be opened. [Information about venting or not venting a crawlspace](#)

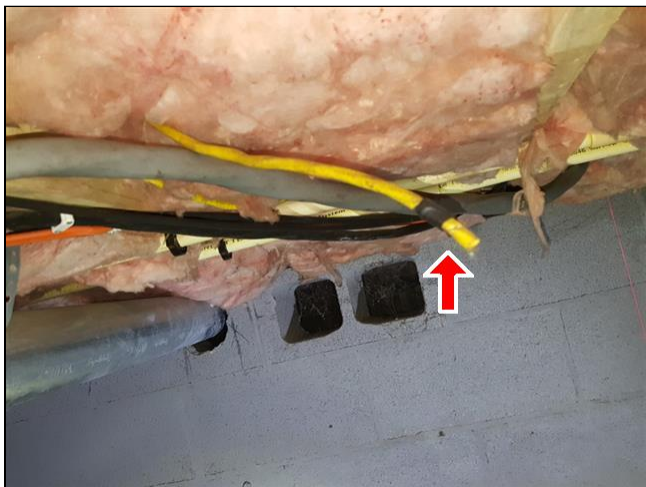
1.10 Item 1(Picture)

1.10 Exposed wires that are not in use in the crawlspace under the master bathroom area should be terminated with twist caps and placed in a junction box or completely removed if not in use. The wire was not energized at the time of the inspection, however it could be if a switch is turned on somewhere in the home. This is a potential safety issue. An electric shock can occur if touched and if a water leak develops above this it may cause a short resulting in a fire in the home if the wire becomes energized. Recommend a qualified electrician repair and correct for safety prior to moving in.

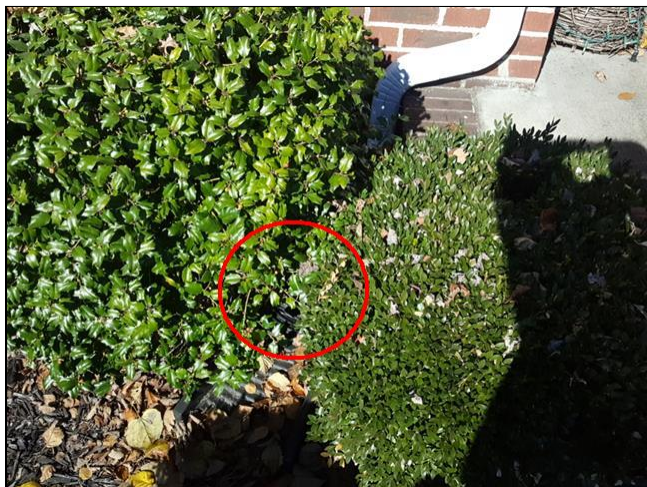
2.3 Item 8(Picture) front left corner of porch

2.3 (3) Recommend the downspouts where indicated in the photos be extended or corrected to ensure water is draining correctly after the brick border and walkway in the garden bed. This will ensure and prevent excess water not being trapped in the front garden bed which may cause leakage into the crawlspace and/or settlement of the foundation of the home. Repair as needed by a general contractor.

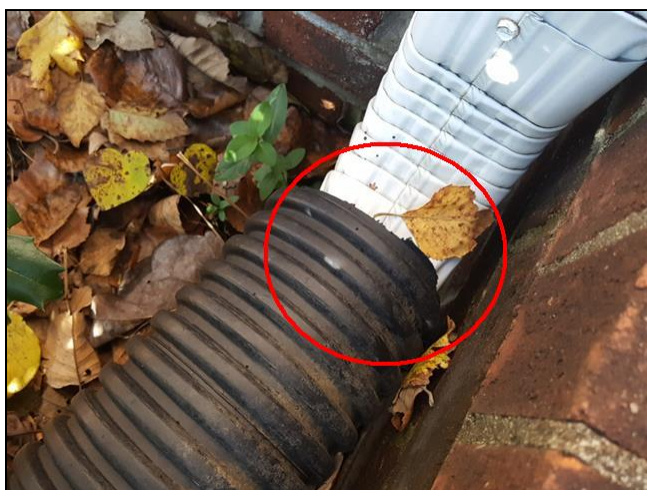
2.3 Item 10(Picture) front left corner of porch

2.3 (4) Recommend the downspout extension(s) be attached to the downspout where indicated in the photos by placing a screw at the top and bottom where it connects to the downspout to ensure the extension(s) does not pull away from the downspout(s). Failing to do this may create future problems to the foundation around the home due to soil erosion and water entering the crawlspace which may result in the foundation settlement if the extension detaches from the downspout.

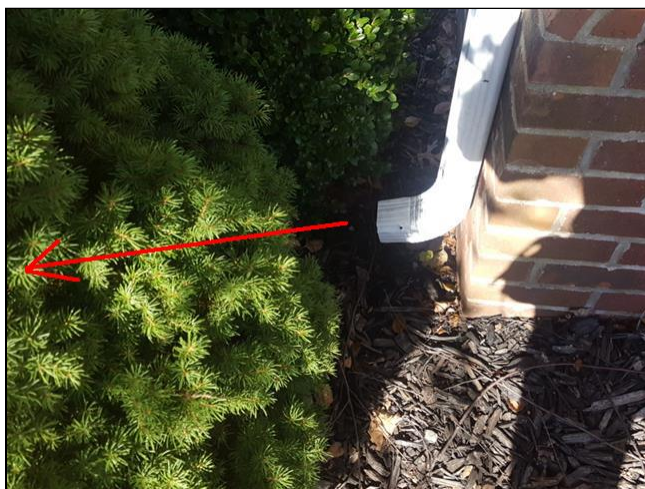
2.3 Item 12(Picture)

2.3 (5) The downspout at the front left corner of the home is missing a splashblock and is discharging on the ground next to the foundation of the home where indicated in the photos. The downspouts should discharge water through leaders then onto splash blocks at least 6 feet from the home. Storm water should be encouraged to flow away from the foundation/home at the point of discharge to prevent water entering the crawlspace and to prevent settlement of the foundation. Recommend repair and correcting as needed by a general contractor.

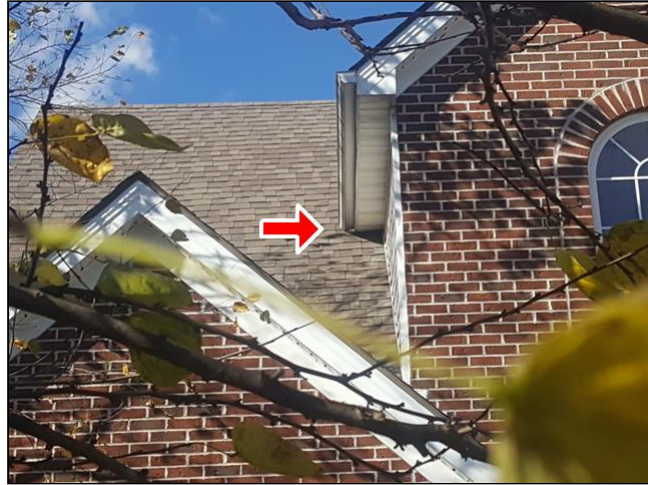
2.3 Item 13(Picture)

2.3 (6) Recommend the gutters(s) that discharge onto the roof have downspout extensions attached and be extended to discharge water directly into the gutter below. This condition, if left unattended, can result in premature deterioration and staining of the roofing material under the end of the gutter. The excessive discharge of storm water onto the roof also puts stress on building materials designed to prevent water entry into the structure of home. Recommend correcting as needed using a qualified gutter installer.

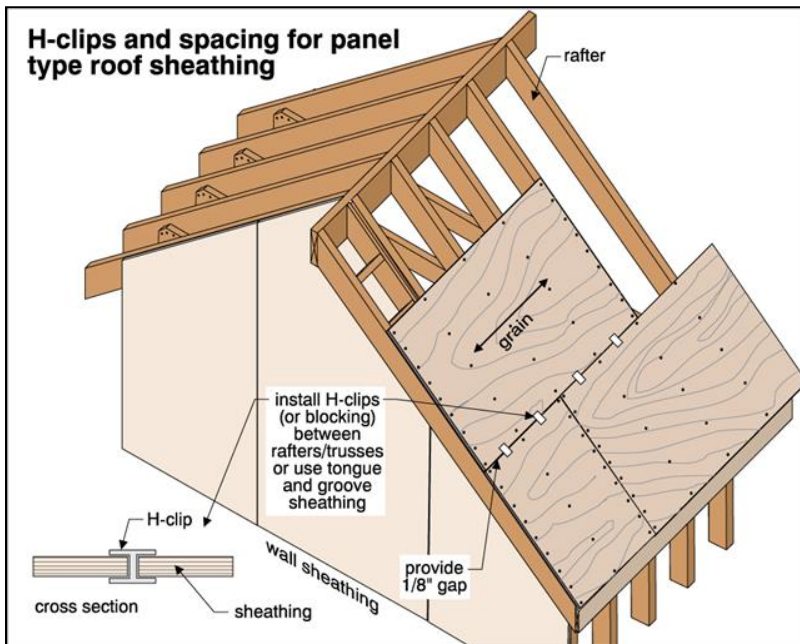
2.5 Item 2(Picture)

2.5 (1) There is no 1/8" spacing or ply clips at the ends, joins or sides of the roof sheathing as is recommended. Without this space the edges of the sheathing could raise if moisture enters and expands the sheathing. The raised areas could then be easily seen as the shingles conform to the surface of the roof sheathing on the outside. No problems were found at time of inspection. If this condition appears and is bothersome the shingles will need to be removed and the sheathing replaced or if possible a relief joint cut at the edges of the sheathing by a qualified roofing contractor. At the moment this is not a high priority. Strongly recommend that when a new roof is installed that this be done then.

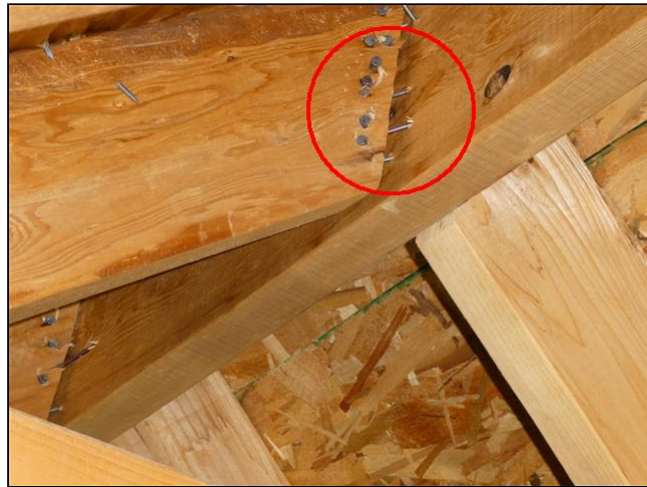
2.5 Item 3(Picture)

2.5 (2) Various rafters are pulling away at the joins in the attic. Repairs are needed to maintain the stability of the roof. Excess loads on the roof like snow can cause further separation if not reinforced. Recommend additional collar ties (horizontal members running between each rafter, near their mid span) or vertical supports to the rafters in the attic to add extra support to the roof structure and to resist rafters from separation in the future. Recommend a qualified framing roofing contractor further investigate and make any necessary improvements or repairs to the roof structure as needed and correct any other problems found prior to closing.

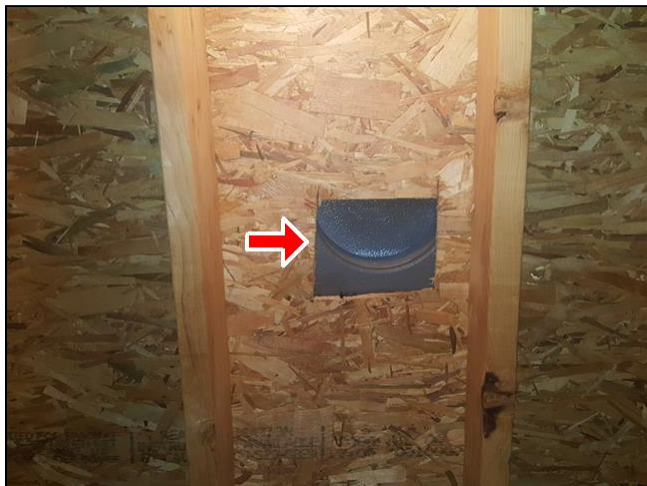
2.6 Item 1(Picture)

2.6 The roof sheathing was not cut open correctly when the passive exhaust vents were installed. The exhaust venting is partially blocked. This will prevent proper airflow through the roof space and provide proper ventilation of the attic. Proper ventilation will help to keep the house cooler during warm weather and extend the life of roofing materials. In the winter, it will help reduce the potential for ice dams on the roof and condensation within the attic. It doesn't warrant for corrections to be made now due to no real issues noted in the attic from this condition. However when the roof is replaced in the future, strongly recommend the roofing contractor repair as needed to allow for proper exhaust venting.

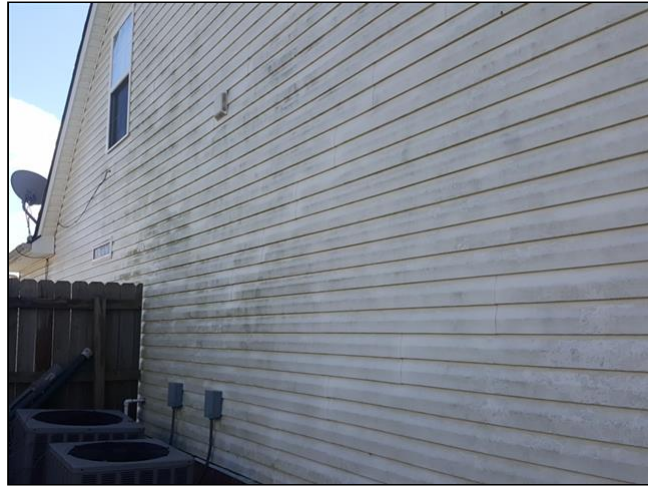
3.1 Item 1(Picture)

3.1 Algae was seen on the Vinyl siding on the right side of the home. This side of the home does not receive direct sunlight and this growth is common in shady areas. Recommend cleaning with soap and water and also removal of plants that are in contact with the wall siding as they attract moisture.

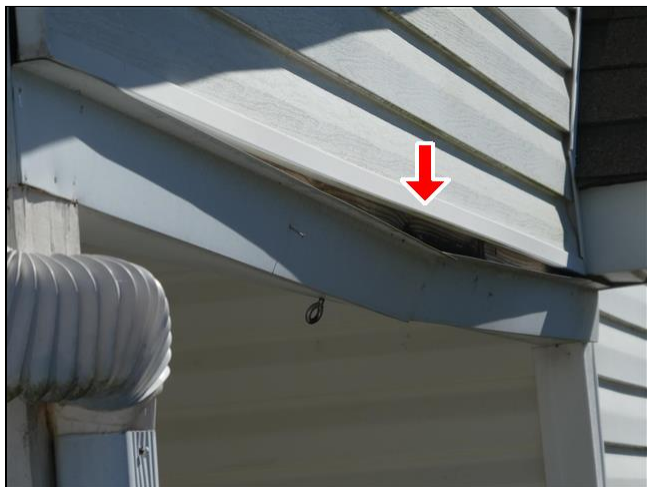
3.2 Item 1(Picture)

3.2 The fascia board at the right side of the patio roof where indicated in the photo(s) has a metal wrapping which is separated and hanging loose and is exposing the wood fascia to the weather. These areas need to be sealed/covered to prevent possible water intrusion which can cause the fascia to deteriorate leading to costly repairs if not corrected. Recommend a qualified contractor repair as needed.

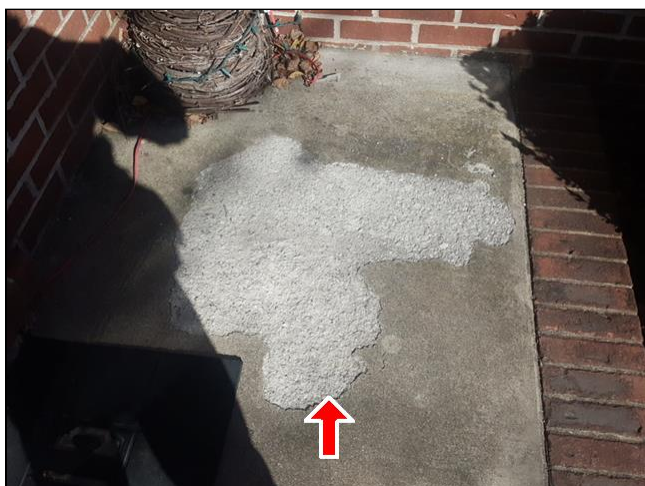
3.5 Item 1(Picture)

3.5 The concrete porch is pitted and chipped in various areas. Further deterioration of the porch can occur via water entry which could lead to possible cracking of concrete. Recommend these areas be repaired by a qualified masonry contractor.

Please Note: This may have been caused by placing salt on the front porch in winter to prevent ice occurring on the front porch. Salt eats away at the concrete surface.

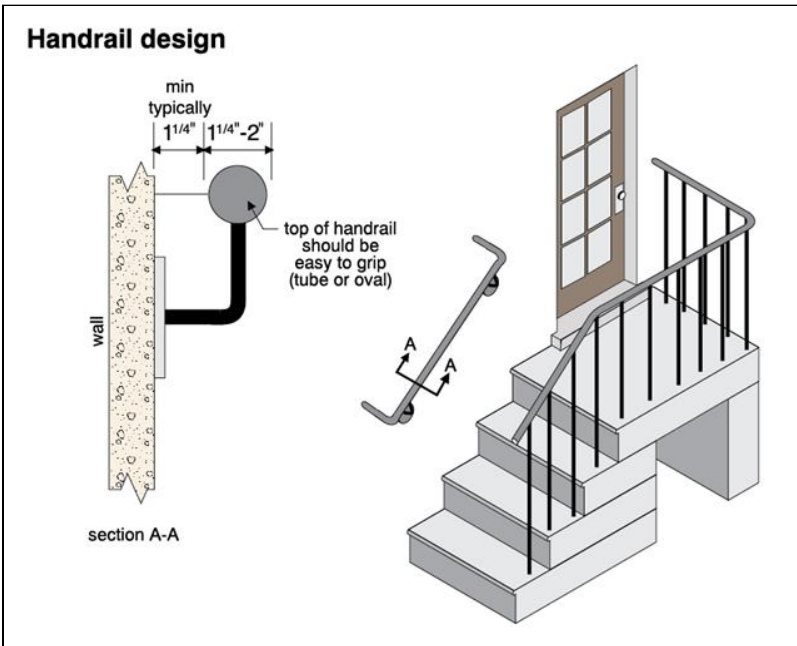
3.6 Item 2(Picture)

3.6 2x6s are installed for handrails for the deck staircase and are not considered "gripable" by industry standards. This is a safety issue and an injury could occur if not corrected. Recommend that a standard approved handrail be installed for safety by a general contractor.

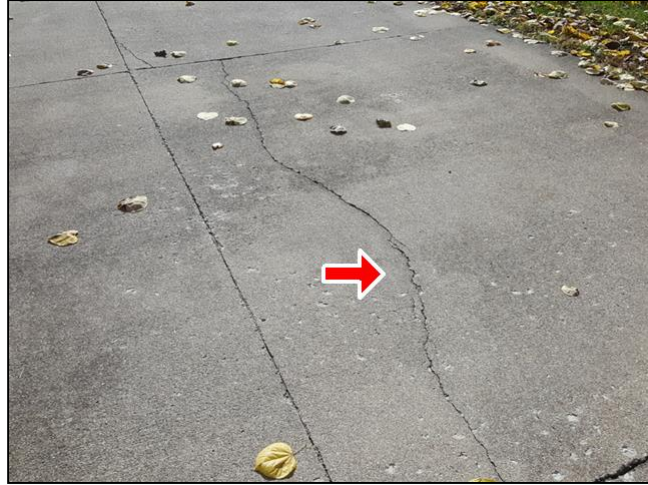
3.7 Item 1(Picture)

3.7 Common settlement crack(s) were noted at the concrete drive. This is not a tripping hazard as yet at this time. I also do not see these small cracks as an indication of a structural issue. Further deterioration and/or settlement can occur to the driveway/walkway via water intrusion if not repaired. Recommend repairs via a masonry caulk as needed then monitor annually. Here is a link for [Sealing Concrete Cracks](#)

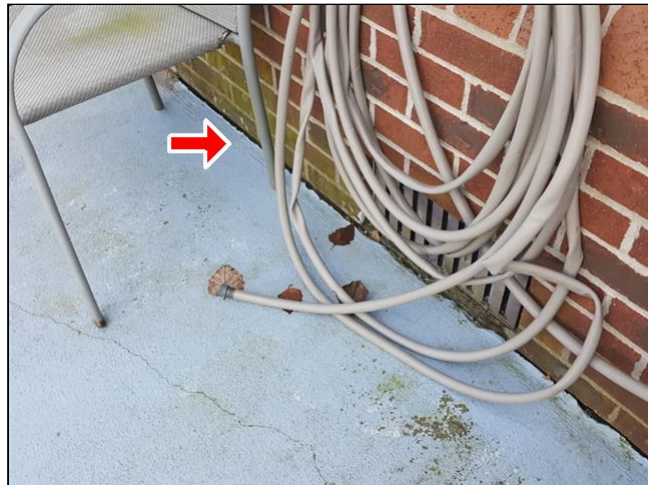
3.8 Item 1(Picture)

3.8 The gaps between the patio floor at the rear of home should be sealed where it meets the house to prevent water impingement against the foundation wall. This will avoid water intrusion in the crawlspace and possible settling of the foundation perimeter and patio slab of the home. Here is a link that can be helpful. [Foundation and Concrete Cracks Fillers](#)

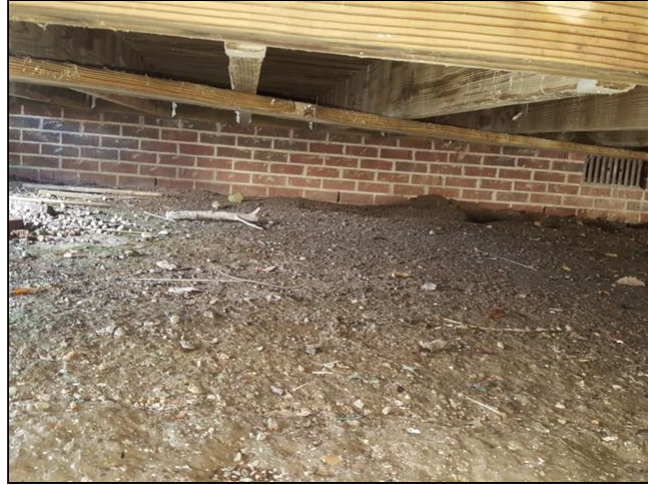
3.10 Item 1(Picture)

3.10 (1) Recommend installing a plastic sheet covering under the deck at the rear of the home at about 2 feet wide or entire underneath of the deck to prevent water entering the crawlspace. This improvement will prevent excess water draining into the soil along the foundation which can lead to water intrusion inside the crawlspace and prevent settlement of the deck post.

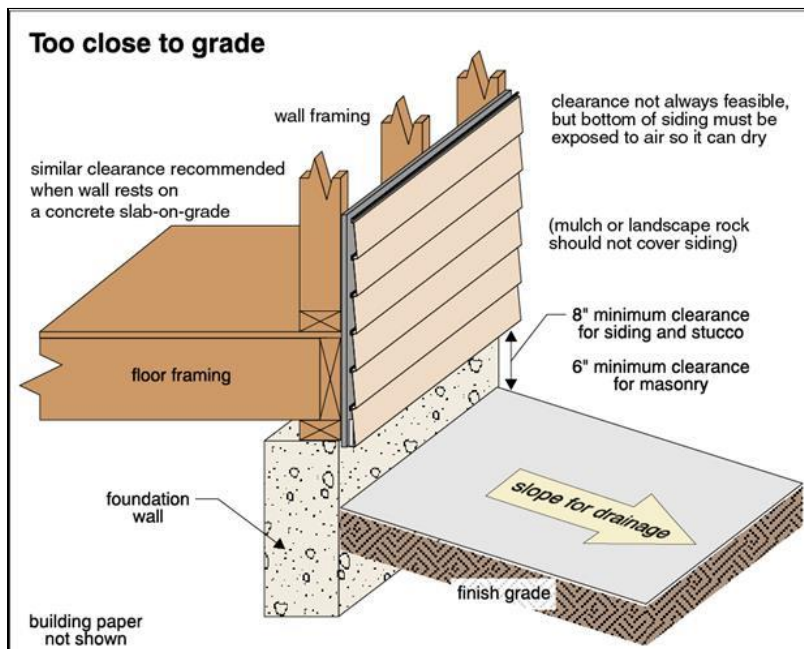
3.10 Item 4(Picture)

3.10 (2) There are depressions in the soil on the right side of the home near the heat pumps. Recommend filling all depressions and re-grading the soil so the soil slopes away from the home around the foundation to ensure water pooling does not occur in these areas. Water pooling could lead to crawlspace leakage and settlement of the heat pump platforms.

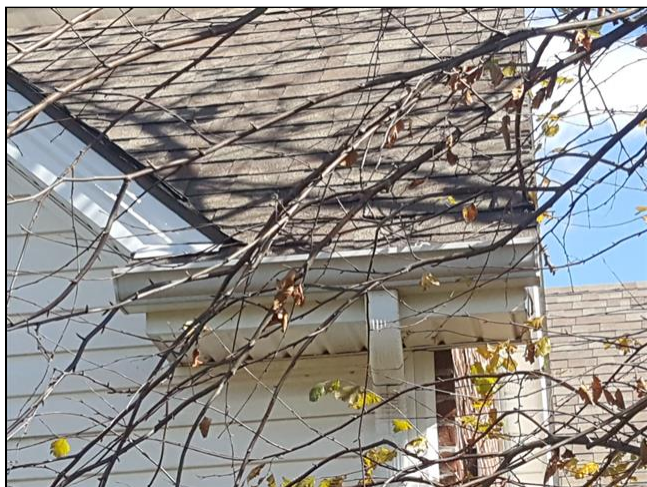
3.11 Item 1(Picture)

3.11 (2) The tree limbs that are in contact or hanging near the roof at the front left corner of the home should be trimmed to prevent damage to the shingles and from scraping on the roof surface. They will also clog gutters which will cause water run off problems around the home. Recommend cutting back tree branches as needed.

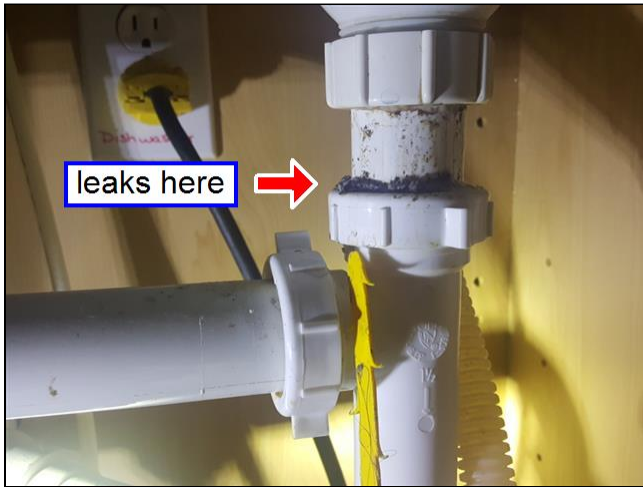
5.1 Item 1(Picture)

5.1 The waste line is leaking at the connection underneath the right sink in the kitchen. Repairs are needed to stop leaking water from damaging the cabinet bottom or to eliminate moisture that may contribute to fungi growth. A qualified licensed plumber is recommended for repairs as needed.

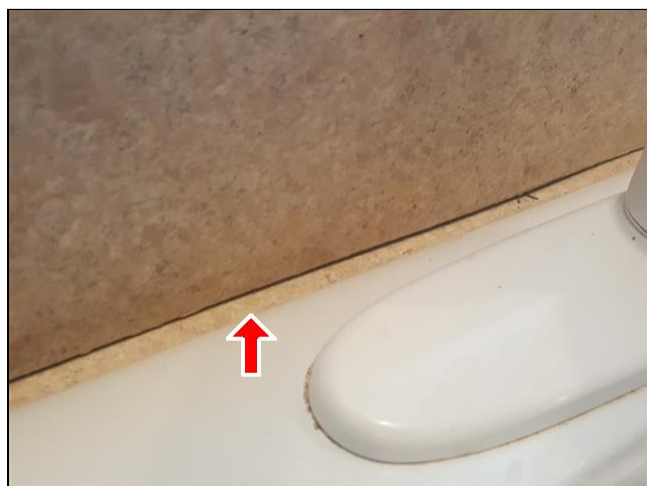
5.8 Item 1(Picture)

5.8 Recommend better sealing between the laminated counter and trim. This will prevent water entering which may cause damage to the counter top near the sink area and then may result in possible mold forming. Repair using a quality caulk that is resistant to moisture and is expandable. Repair as needed.

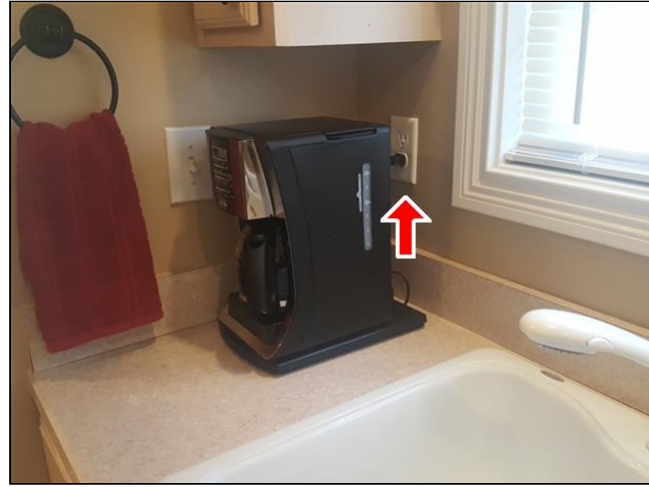
5.9 Item 1(Picture)

5.9 (2) The outlets in the kitchen where indicated in the photo(s) are not GFCI protected. GFCI (Ground fault circuit interrupters) outlets should be considered for installation as a safety upgrade in all locations where water is present if the outlets are not presently connected to a GFCI. They are now required in all bathrooms, kitchen, unfinished basements, garages, exterior outlets, or other locations within 6' of a water source or sink. GFCI outlets may not have been required when this house was built but should be considered for safety. Recommend a licensed electrician replace as needed.

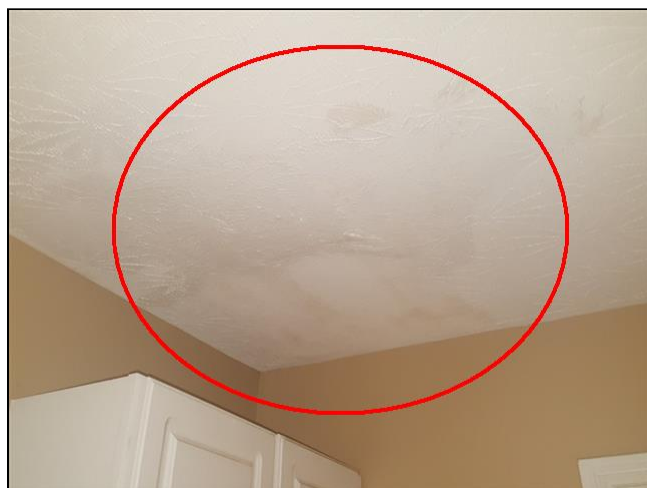
6.0 Item 1(Picture)

6.0 (1) The drywall on the ceiling is sagged and has minor water stains in some areas in the washer dryer room and shows signs of a previous repair. It is positioned directly above the 2nd bathroom area under the bath tub. The area tested dry at the time of the inspection. Although there was no leaking or elevated moisture content found at this time, cannot determine how this has occurred. Perhaps ask the owner of the home to explain damage. Inspections are limited and destructive inspections are excluded. Recommend monitoring this area to see if a water leak is active and if leak does exist recommend further investigation and repair as needed. The repair work will likely involve the removal of covering in order to determine where the leak is coming from and if it still exists. The extent of damage cannot be realized until the covering is removed.

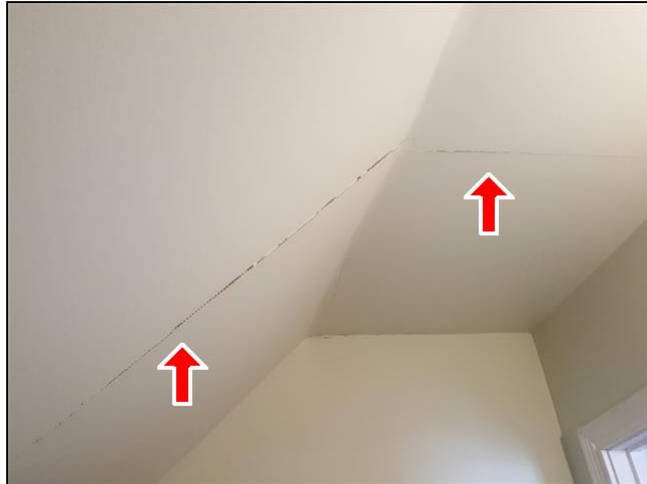
6.0 Item 2(Picture)

6.0 (3) The cracks in the ceiling in the 2nd bedroom closet (see photos for location) appear to be common settlement and/or shrinkage cracks. Cracks larger than 1/8" are of concern only. Cracks of this nature are caused by moisture, changing temperature, or framing shrinkage due to a lack of ventilation of vaulted ceilings and in the room. Recommend repairing cracks, replace solid door with a louver door to allow for ventilation to prevent high humidity in the room, then paint and monitor. If cracks reappear and become larger than 1/8" then would recommend a qualified contractor further investigate to determine cause and suggest repairs.

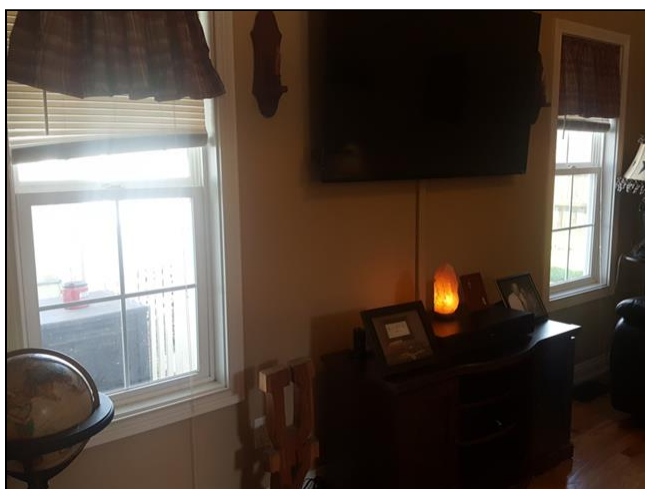
6.5 Item 1(Picture)

6.5 The windows in the living room where indicated in the photos are missing screens. Recommend these be installed to prevent insects entering the home when the window is opened. Replace as needed.

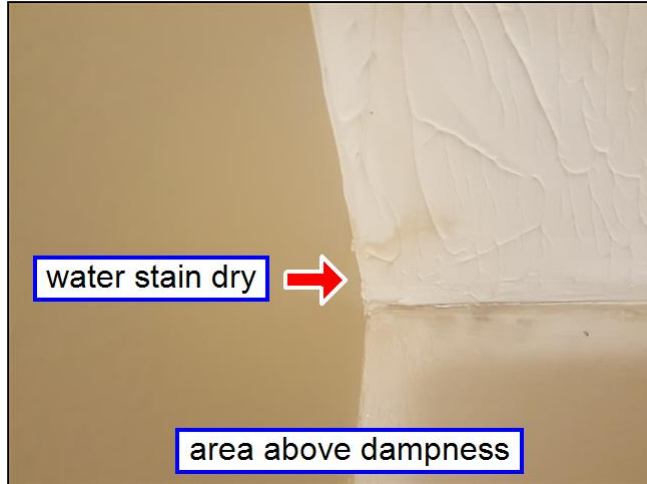
7.0 Item 2(Picture)

7.0 (2) The drywall was very damp on the wall where it butts up to the shower enclosure in the 2nd bathroom. This indicates there is water leak somewhere. There were no signs of leakage in the attic. I am unable to determine cause of dampness. The repair work will likely involve the removal of the covering in order to determine where the leak is coming from and if it still exists. The extent of the damage cannot be realized until the covering is removed. There could be mold behind the drywall. Recommend a plumber and/or roofing contractor further inspect, evaluate and repair/correct as needed.

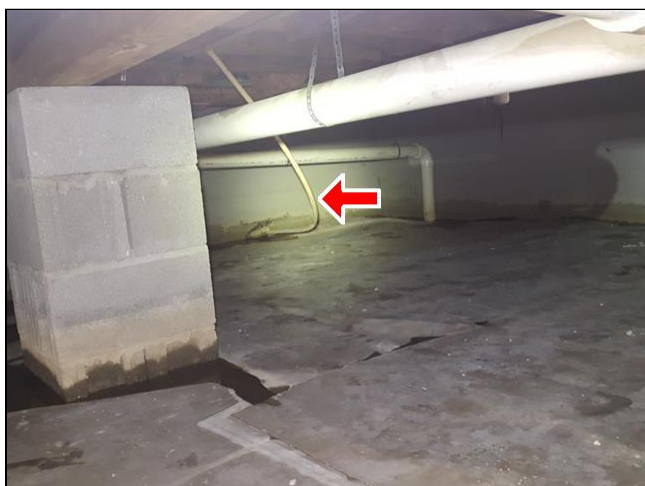
8.4 Item 2(Picture)

8.4 (2) Recommend insulating the main water supply line pipe in the crawlspace due to the pipe is located in an unconditioned area. This will ensure that the pipe does not freeze in winter which may cause a serious plumbing leak and prevent costly damage to the home. This is for your information.

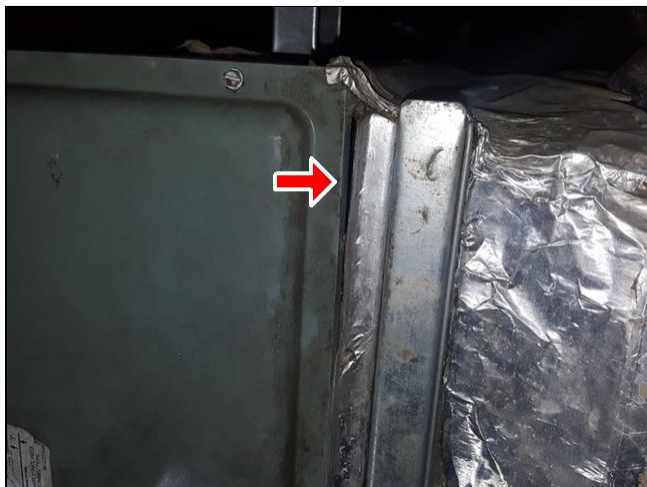
10.4.A Item 1(Picture)

10.4.A (3) The return air duct is not sealed at the plenum at the Air Handler in the crawlspace. This is allowing unfiltered air in the crawlspace to enter the home via the blower which is allowing contaminants to enter the unit. This is a health issue. This can also cause damage to the unit and blower, increase heating/cooling costs. Recommend a qualified HVAC repair ductwork where necessary.

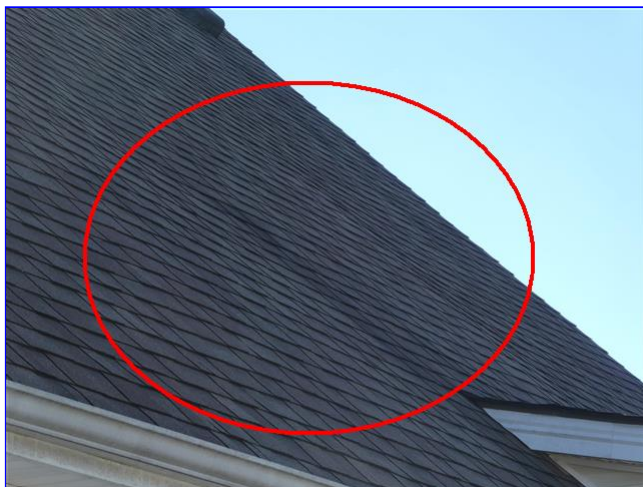
2.0 Item 5(Picture)

(2) The roof covering shows a mump-like appearance at the rear center of the home, see photos for location. These small little bumps might be caused by hot weather, in which some air beneath the cover layer has become hot and has expanded. These areas will eventually blister creating a water leak and the roof area will need replacing. Recommend a qualified roofing contractor further investigate and repair as needed as these bumps may cause ruptures, and cause leakage later on.
