Home Inspection Report

1 Main Street, Anytown, NY 12866

Inspection Date:

Monday, May 6, 2019

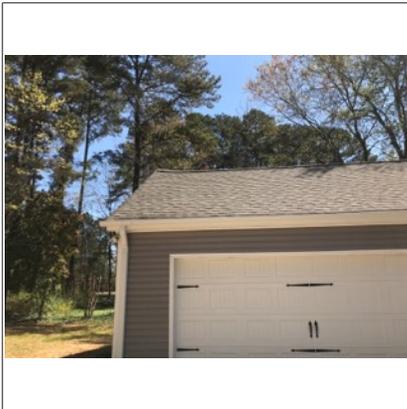
Foundations	<ul style="list-style-type: none"> •Cracks were observed on the foundation of this home. These cracks should be maintained for leakage.
Roof	<ul style="list-style-type: none"> •The ridge and rafters of the roof structure show evidence of sagging. Strengthening the roof structure would resist further movement. This improvement is not priority unless the roof is likely to be subjected to heavy loads from additional layers of roofing material whose weight could cause further damage. Additional support can often be added easily.

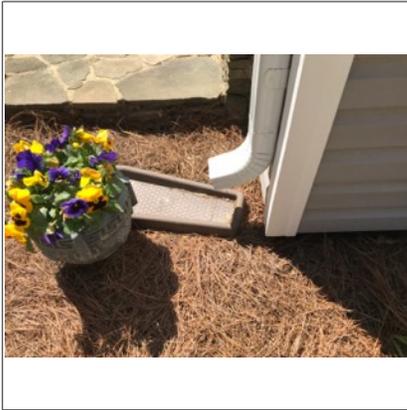
Sloped •Debris should be removed from the roofing to reduce risk of leaks and early roof wear.

Gutters & downspouts •The downspout(s) should discharge water at least five (5) feet from the house. Storm water should be encouraged to flow away from the building at the point of discharge.

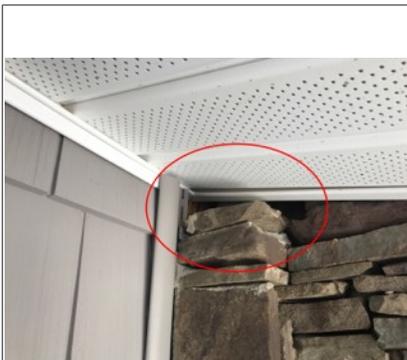
An opening above the veneer stone should be sealed as necessary.

- Ext. walls**
- The openings in the siding, such as the opening where the main service wire passes through the left exterior wall of this home, should be sealed and re-secured to avoid moisture and wind-damage.

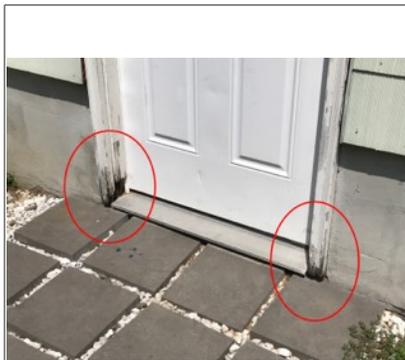
Localized rot on wood trim.

- Wood to soil contact should be avoided on the steps of the deck to reduce insect and rot-damage risk.
 - Localized rot was observed in the wood trim of this home. Following repair of the damaged areas (which should be combined with exterior painting/maintenance) proper maintenance of the wood trim and control of water from roof or surface runoff can avoid further damage. Vegetation should be trimmed away from the house to avoid damage to the building.

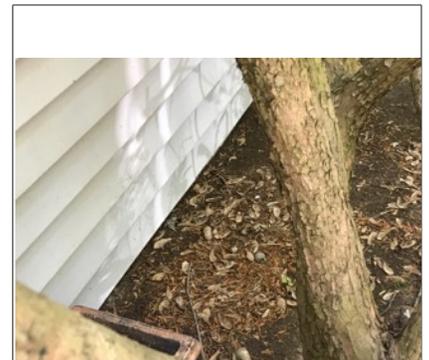
Siding to soil contact.

- Siding to soil contact should be avoided to prevent moisture and or insect activity.

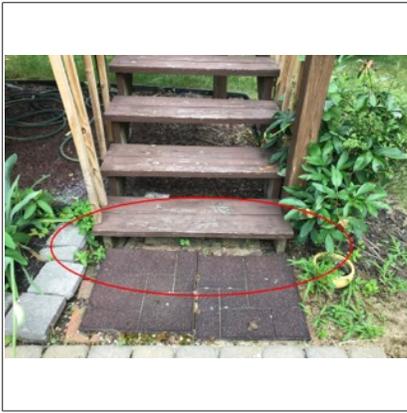
- Windows** •Damaged windows, such as the broken window located on the right wall of the garage, should be repaired or replaced as necessary. Watch for unsafe loose glass
- Garage** •The door between the house and garage should be weather-stripped, fitted with an automatic closer and rated to resist local fire codes. This will reduce the potential of toxic automobile gases entering the house.
•Pronounced floor cracks were noted in the garage. While this amount of cracking is unusual, this slab is not a structural component you should be aware of the trip hazard.
- Deck** •Wood to soil contact should be avoided on the steps of the deck to reduce insect and rot-damage risk.

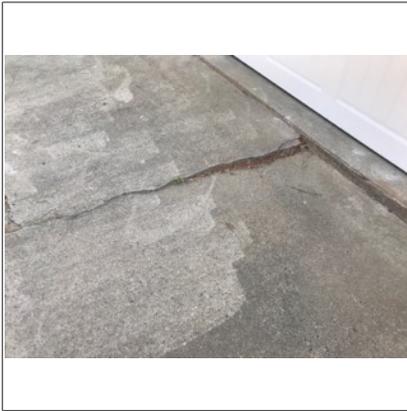
•The driveway shows evidence of cracking, spalling and heaving. Re-surfacing of the driveway would be a logical improvement.

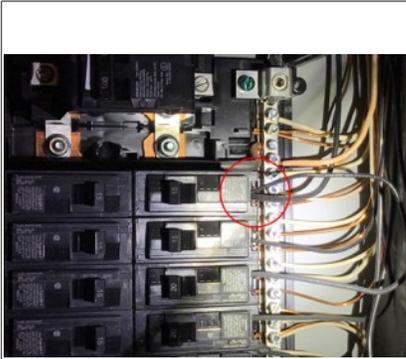
- Main panel** •There is one doubled up circuit labeled in the main electrical distribution panel as serving the basement and exterior of this home. Circuits within the main panel that are doubled up (referred to as "double taps") should be separated as discussed. Each circuit should be ideally served by a separate breaker.

Double tapped breaker.

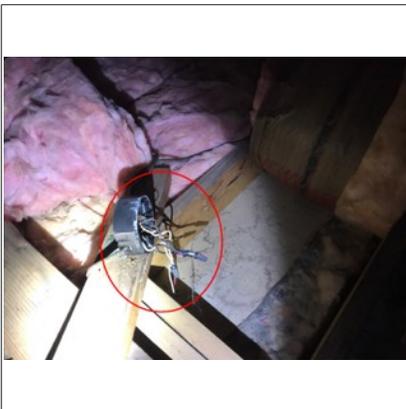
- Distribution wires** •Improper electrical connections should be repaired. All electrical connections should be made inside junction boxes fitted with cover plates.
•All junction boxes should be fitted with cover plates, in order to protect the wire connections.

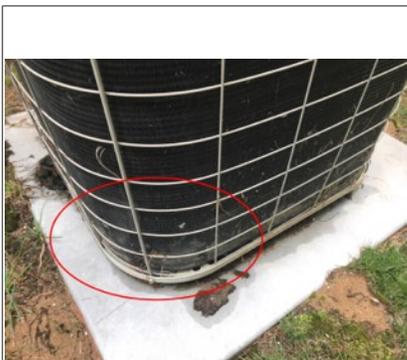
- The fins of the outdoor portion of the air conditioning system were observed to be damaged. This condition can reduce the efficiency of the system.
 - Damaged and or missing insulation on refrigerant lines should be repaired. These outside lines should be insulated all the way to the compressor unit to prevent condensation moisture damage (water pooling around the foundation).

Fin damage.

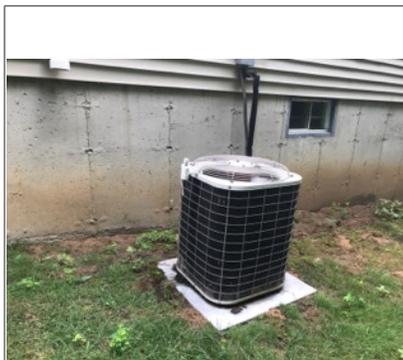
- The outdoor unit of the air conditioning system is out of level. This should be improved.
 - The outdoor unit of the air conditioning system is dirty and requires cleaning.

Outdoor AC unit out of Level.

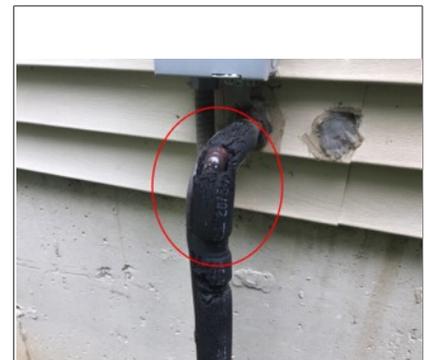
Damage / missing refrigerant line insulation.

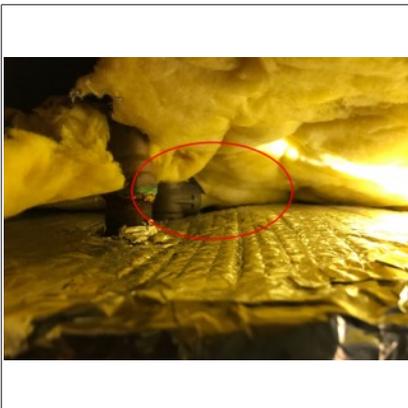
Water heater unit •The discharge piping serving the Temperature and Pressure Relief (TPR) Valve for the water heater is missing and one should terminate not less than 6 inches or more than 24 inches above the floor.

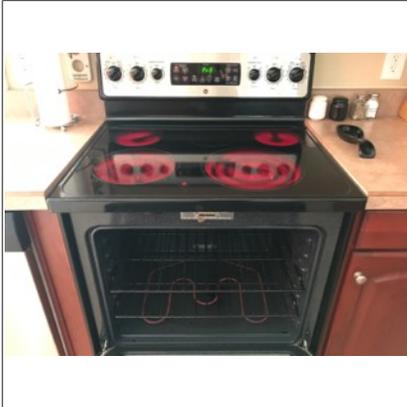
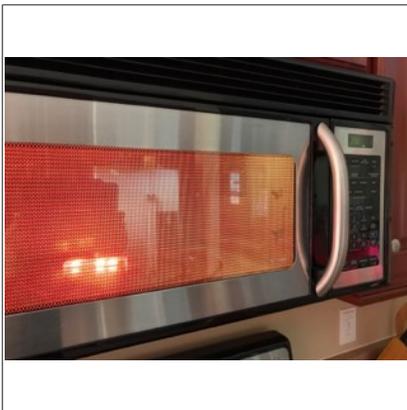
Electric range unit •The installation of an anti-tip bracket is recommended to safely secure an oven to the floor to provide extra protection when excess force is applied to an open oven door.

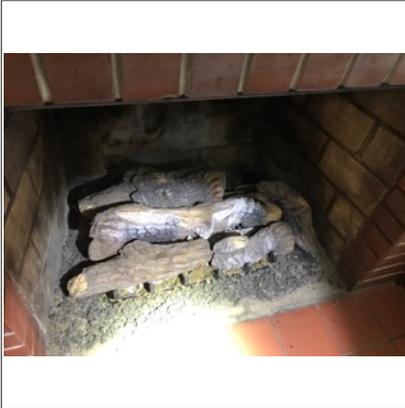
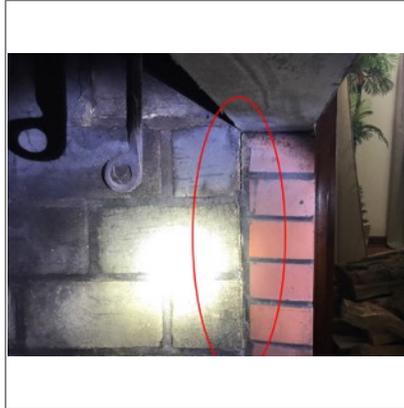
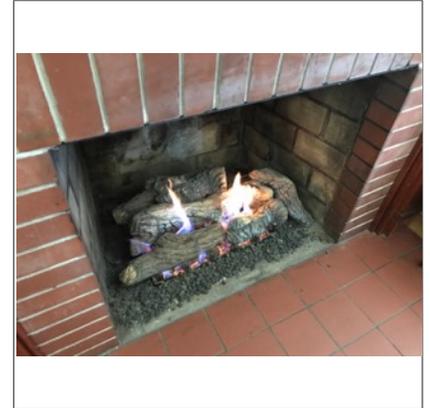
- Fireplace**
- The fireplace firebox mortar should be improved.
