**Re: Queen Esther Lake Dam, PADEP ID #D08-070  
Athens Township, Bradford County, Pennsylvania**

Enclosed please find one hard copy and one electronic copy of "Queen Esther Lake Dam (Dam Permit #D08-070) 2021 Inspection Report". A summary of our findings for the dam is presented below:

**DAM INSPECTION CHECKLIST**  
**Department of Environmental Protection**  
**Bureau of Waterways Engineering**  
**Division of Dam Safety**

**NAME OF DAM:** Queen Esther Lake Dam **DEP DAM NO.:** D08-070

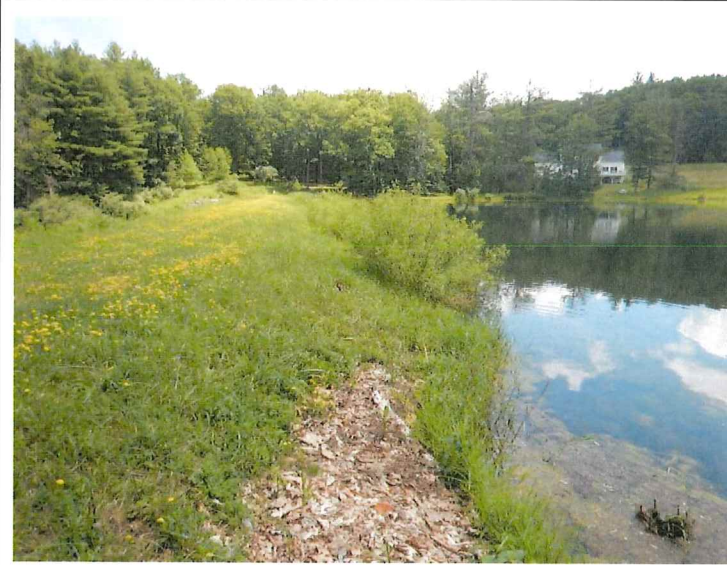
Additional Comments (Refer to item number if applicable): Item 15 - Tall vegetation along shoreline promotes animal burrowing. It is recommended that all brush, cattails, and tall vegetation be cut or removed.

1. View of the upstream slope from the left abutment. Note the tall vegetation along the shoreline.

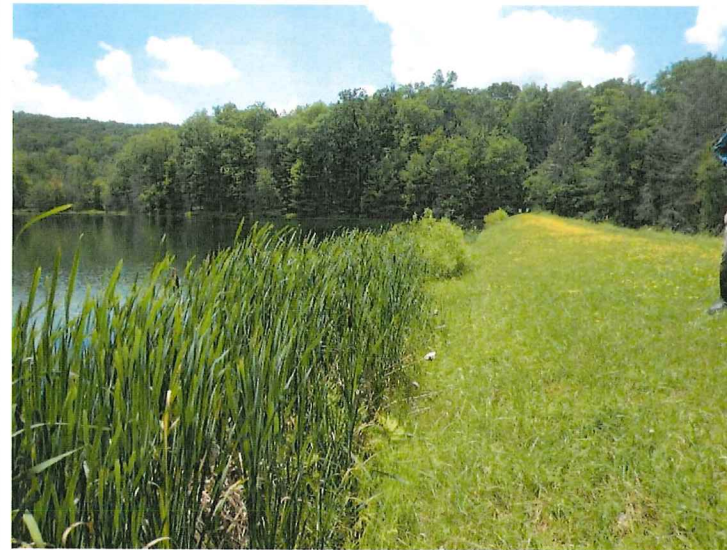
2. View of the upstream slope from the right abutment. Again, note the tall vegetation along the slope.

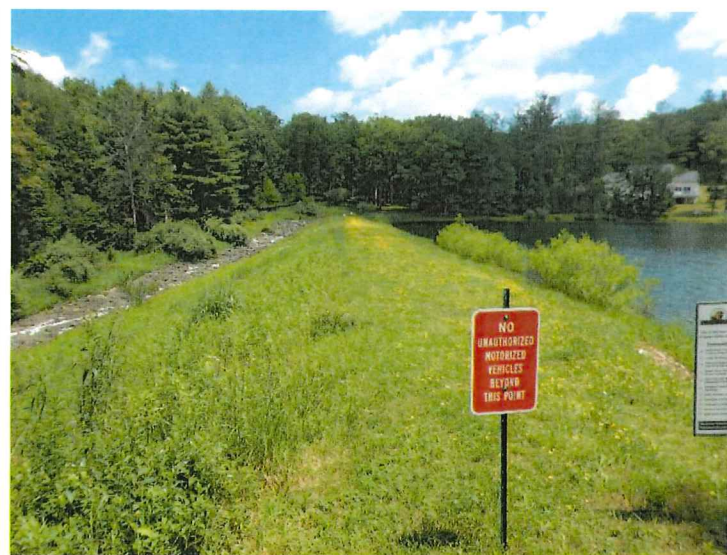
3. View of the crest of the dam from the left abutment.

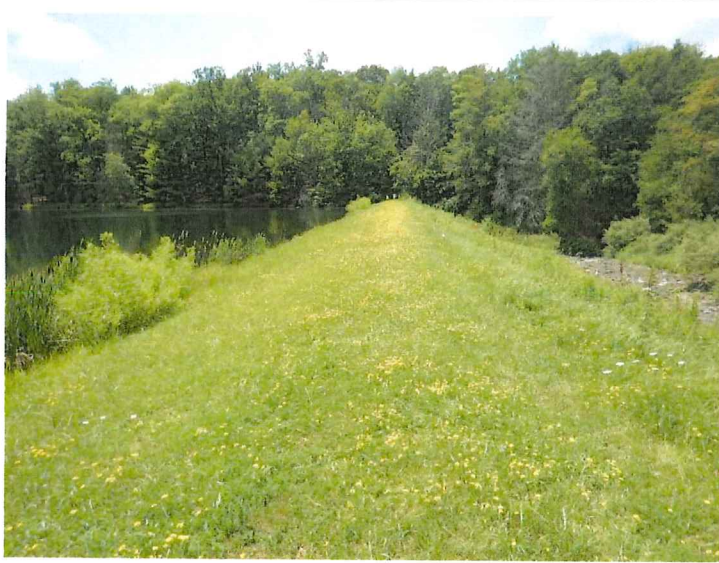
4. View of the crest of the dam from the right abutment.

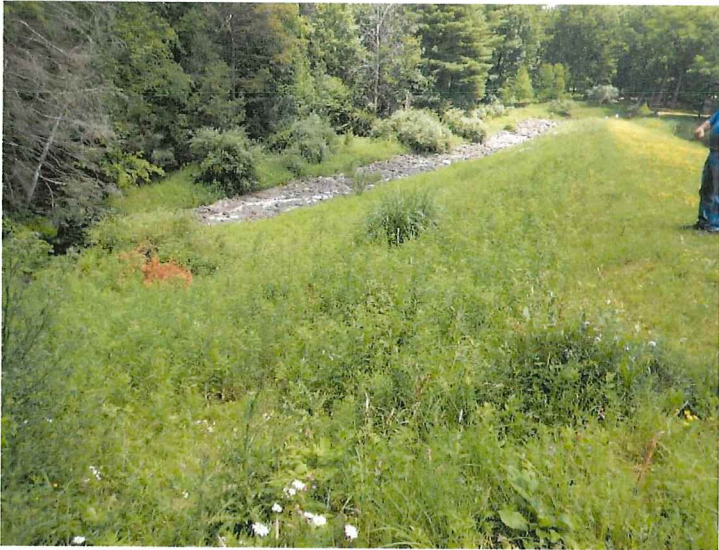
5. View of the downstream slope from the left abutment. Note the tall grass.

Additional Comments (Refer to item number if applicable): Item 25 – Tall vegetation on slopes promote animal burrowing and make visual inspection difficult. It is recommended that all vegetation be maintained to 12 inches or less.

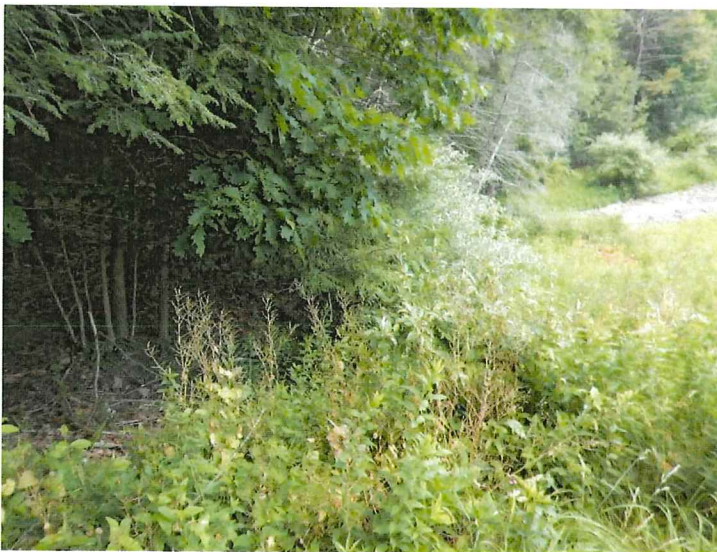
6. View of the dense brush growing in the left groin.

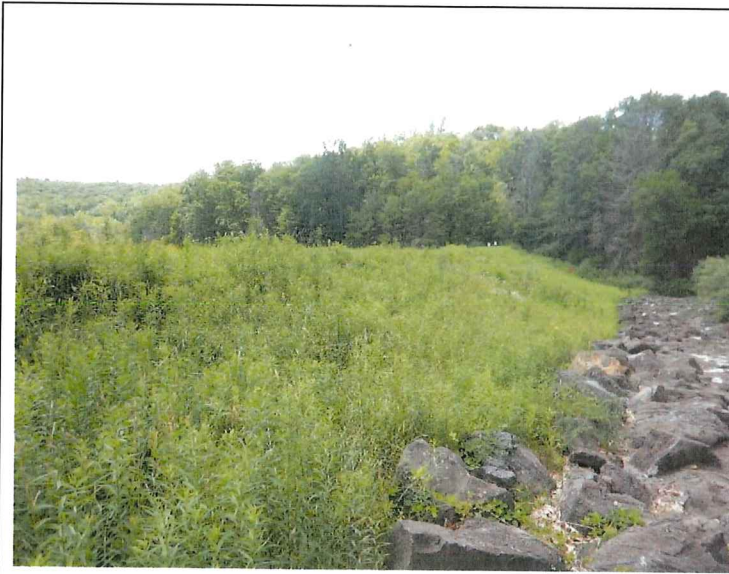
7. View of the downstream slope from the right abutment. Note the tall grass.

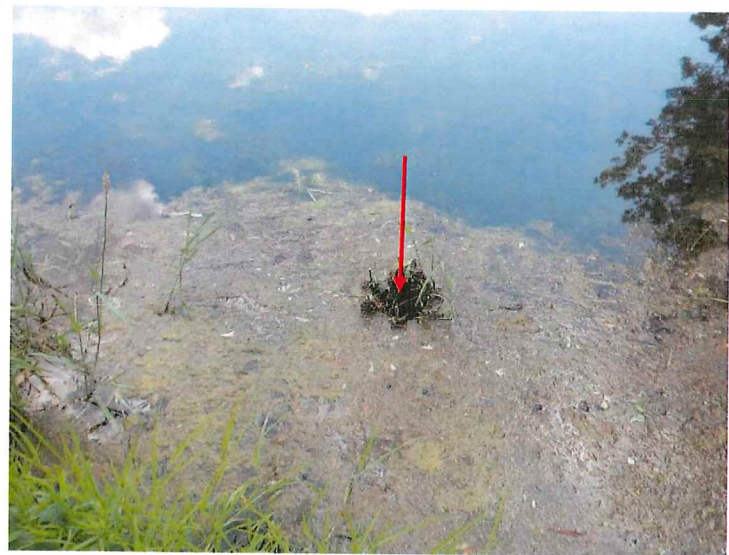
8. View of the principal spillway inlet.

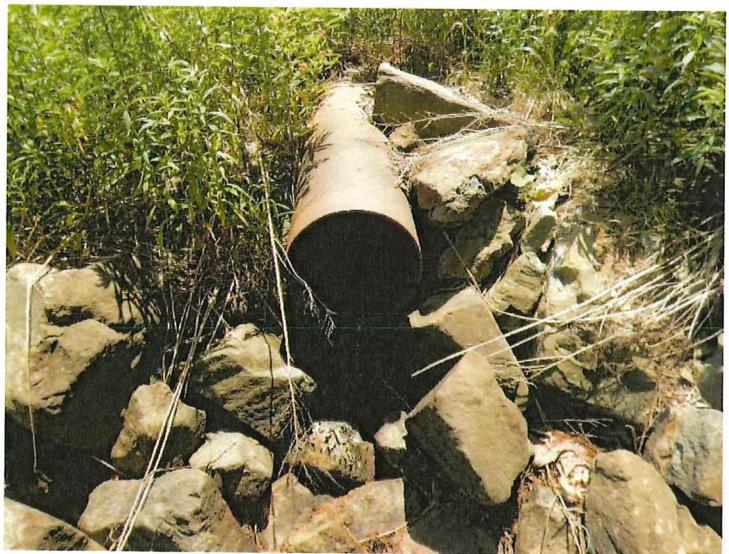
9. View of the principal spillway discharge pipe.

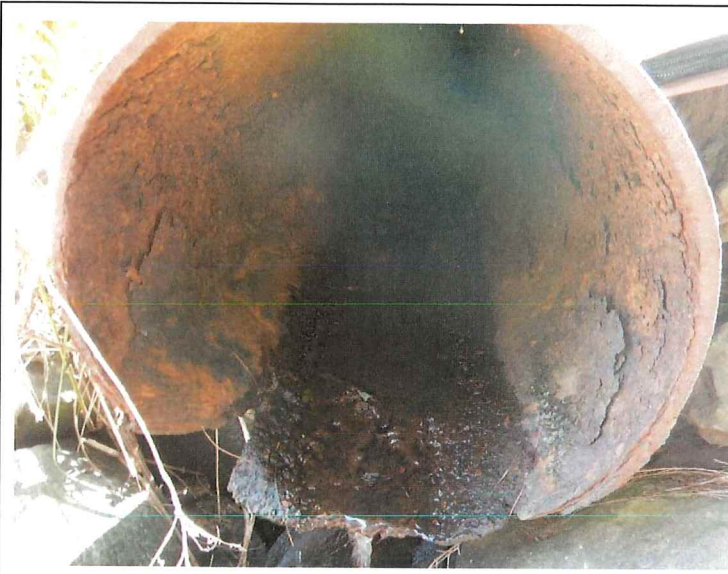
Additional Comments (Refer to item number if applicable): Item 76 – smooth steel discharge is heavily scaling. Monitor for continued deterioration. Item 81 – Remove the brush and vegetation from the principal spillway outlet channel.

10. View inside the principal spillway discharge pipe. Note the scaling of the metal.

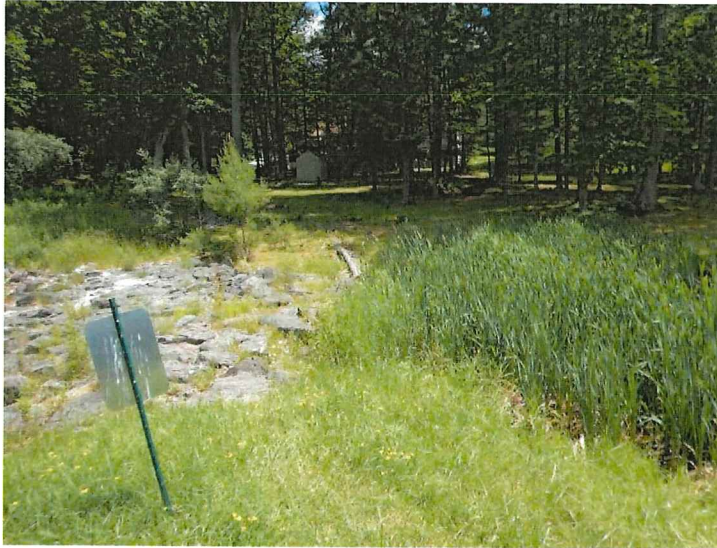
11. View of the inlet of the auxiliary spillway channel. Note the cattails at the inlet.

<p>Additional Comments (Refer to item number if applicable): Item 57/61 Grouted rip rap recently repaired with fresh grouting. Item 59 – Tall vegetation on dams promotes animal burrowing. Remove the cattails at the inlet of the auxiliary spillway.</p>					
<b>SPILLWAYS: DROP INLET</b>					
65	Intake Structure	8-in-diameter smooth steel pipe	<input type="checkbox"/>	<input type="checkbox"/>	<input type="checkbox"/>
66	Trash rack	None	<input type="checkbox"/>	<input type="checkbox"/>	<input type="checkbox"/>
67			<input type="checkbox"/>	<input type="checkbox"/>	<input type="checkbox"/>
68			<input type="checkbox"/>	<input type="checkbox"/>	<input type="checkbox"/>
69			<input type="checkbox"/>	<input type="checkbox"/>	<input type="checkbox"/>
<p>Additional Comments (Refer to item number if applicable):</p>

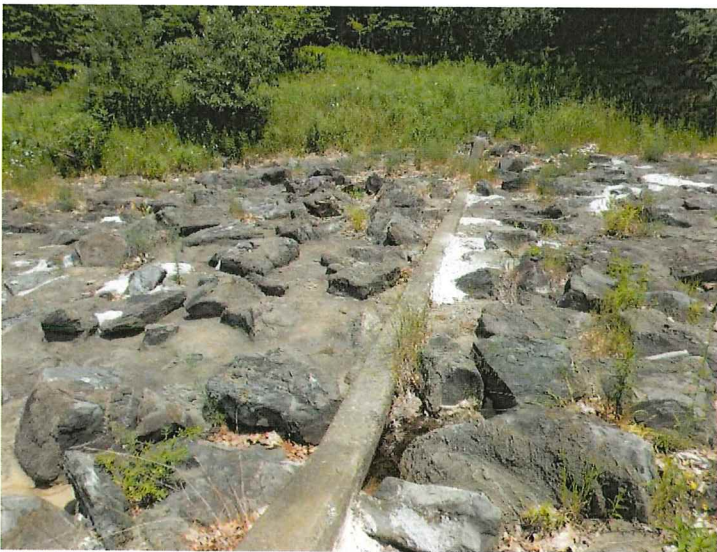
12. View of the concrete cut-off wall in the auxiliary spillway channel.

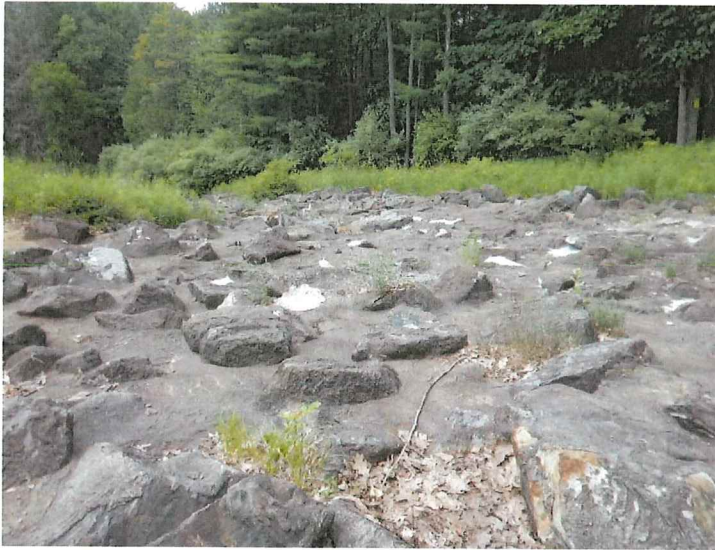
13. View looking downstream in the auxiliary spillway channel.

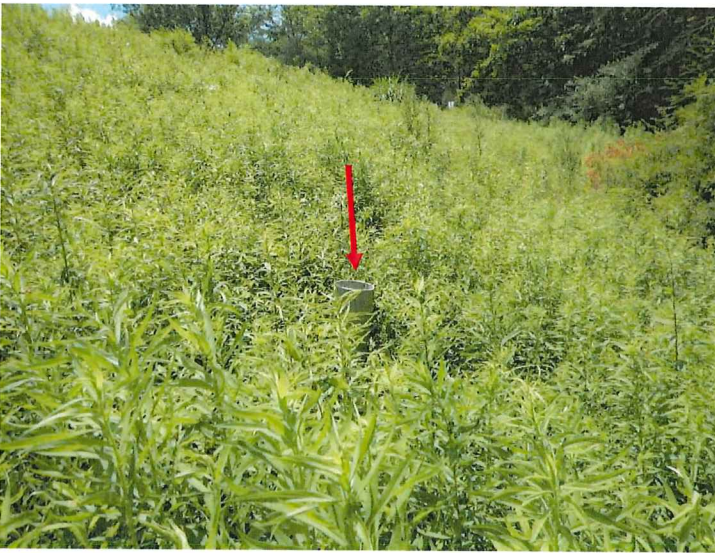
14. View of the lake drain valve control standpipe.

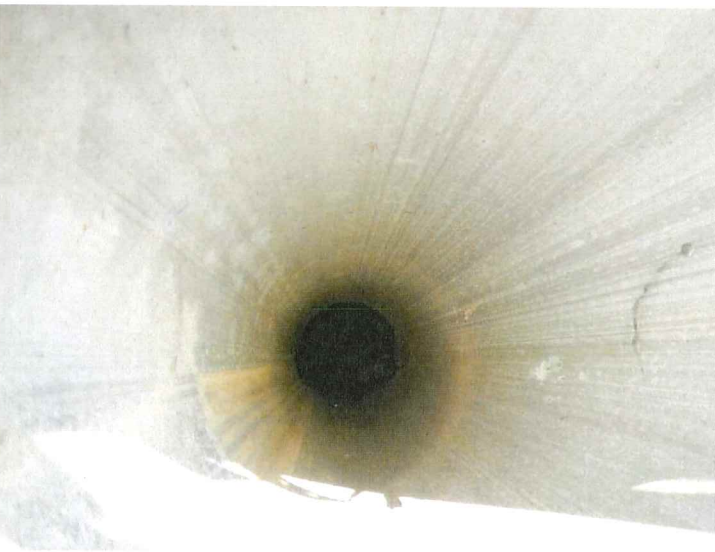
15. View inside the lake drain valve control standpipe.
