CONEJOS RIVER

DIVERSION INFRASTRUCTURE INVENTORY

Structure Name: SMITH BROS D

Date: April 16, 2019

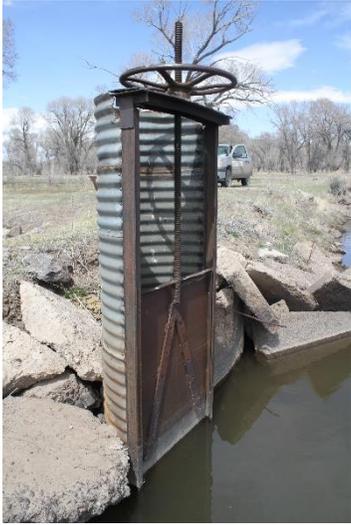
Structure Description: Located on the mainstem Conejos River just upstream of East Bend Ditch. Channel avulsion has occurred upstream of the diversion, but the river migrated very little in the last 20 years. Cut banks and accelerated bank erosion is an issue near the diversion, however. There is no diversion dam at this structure. The headgate is located on the outside of a meander that is stabilized with concrete rubble. Despite this stabilization, the headgate is tilted sideways. It still functions but could be reset or set in concrete. The flume is also tilted.

Headgate looking downstream

Repair(s) or Improvement(s) Currently Needed: The streambank in this area needs to be restored to reduce erosion and improve river and ditch function. Riparian vegetation restoration should be included as part of any bank restoration work. Existing fish and boat passage should be maintained as part of any improvements to the diversion. The flume should be leveled to improve long term accuracy.

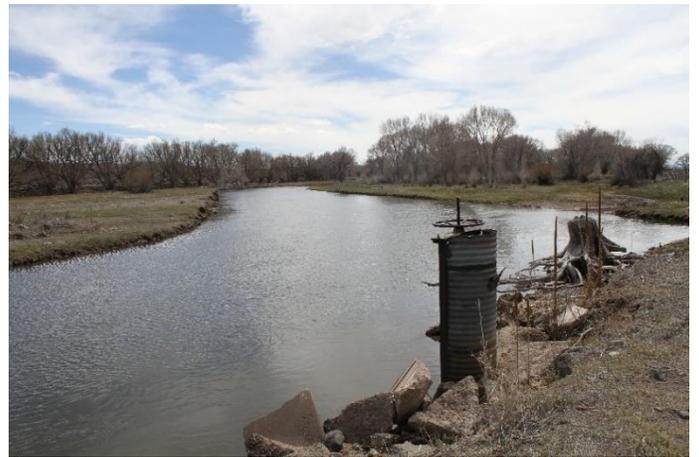
Headgate and diversion dam

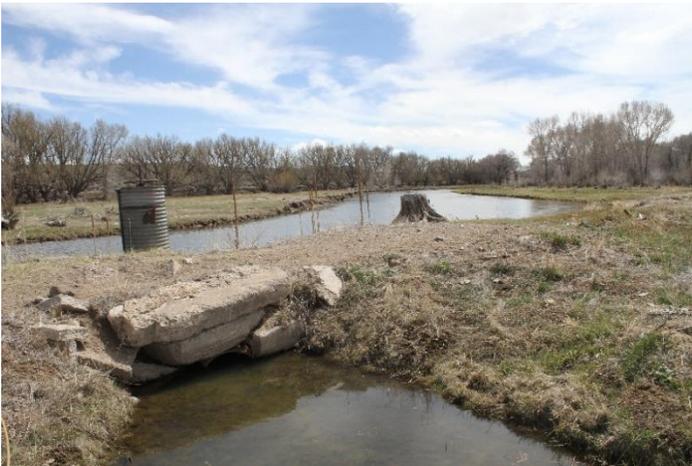
Headgate outlet looking upstream

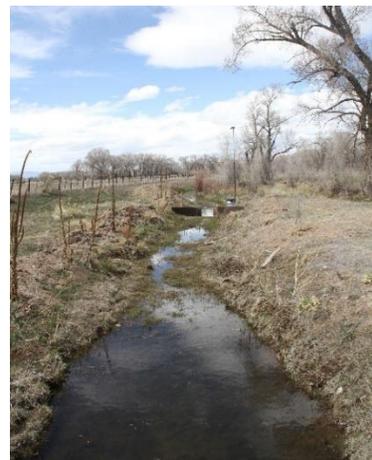
Ditch downstream of headgate

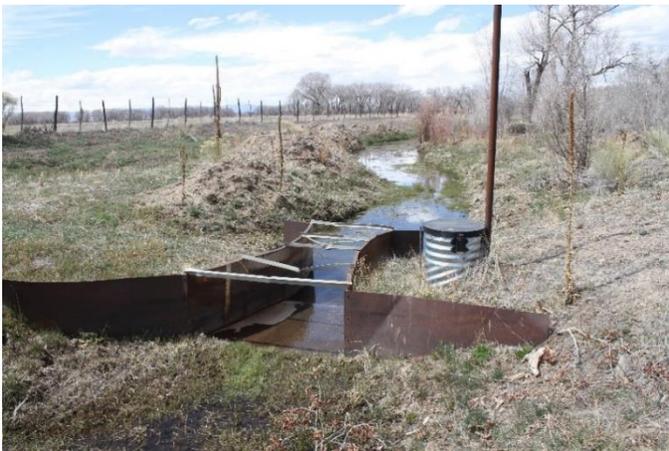
Parshall flume looking downstream

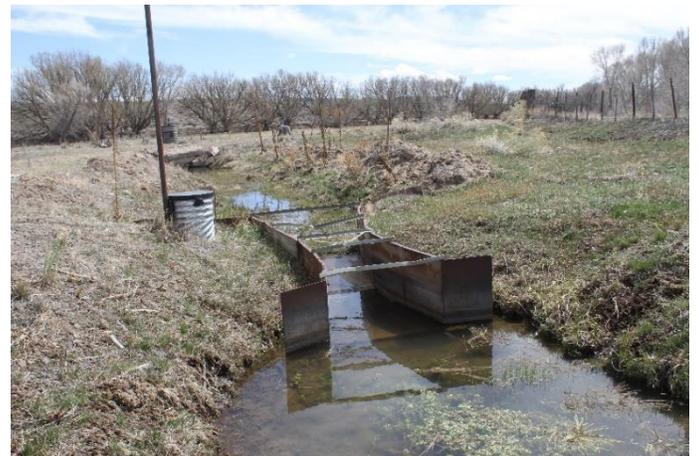
Parshall flume looking upstream

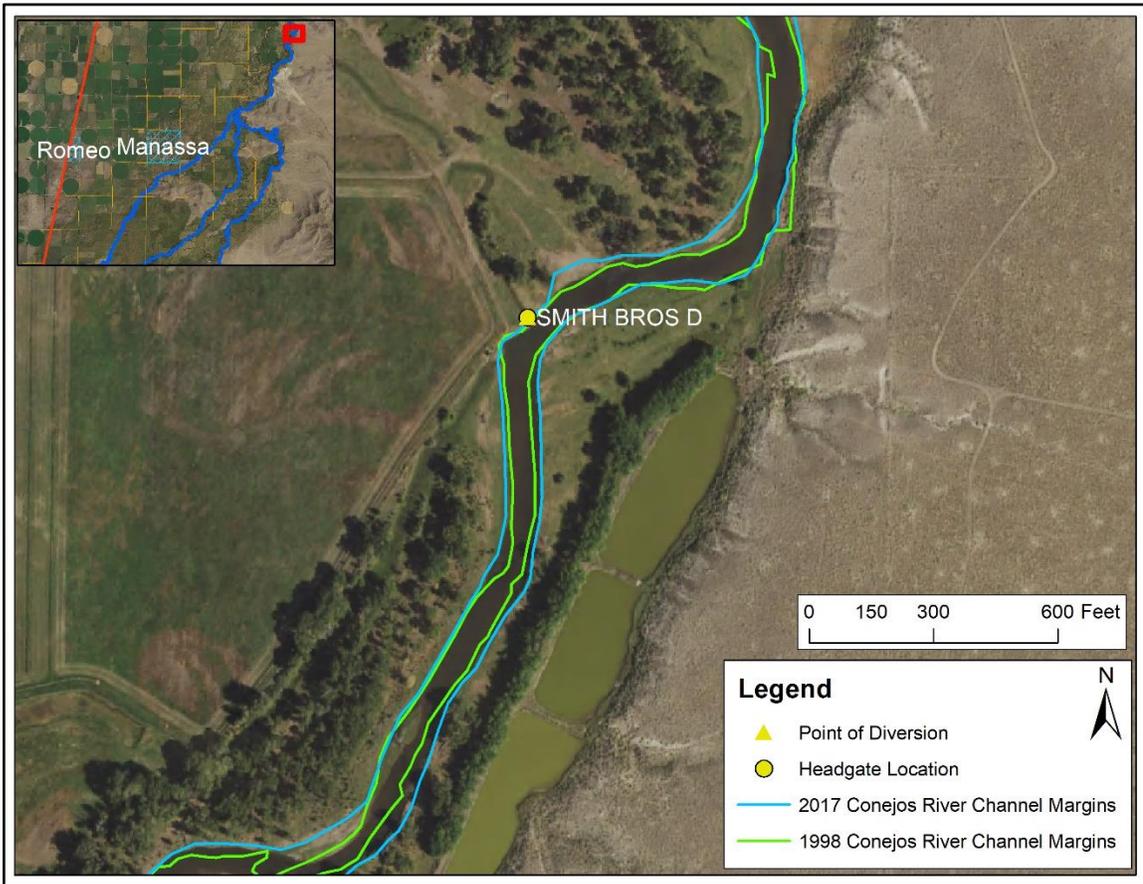
Map of headgate location with 1998 and 2015 channel margins overlaid.

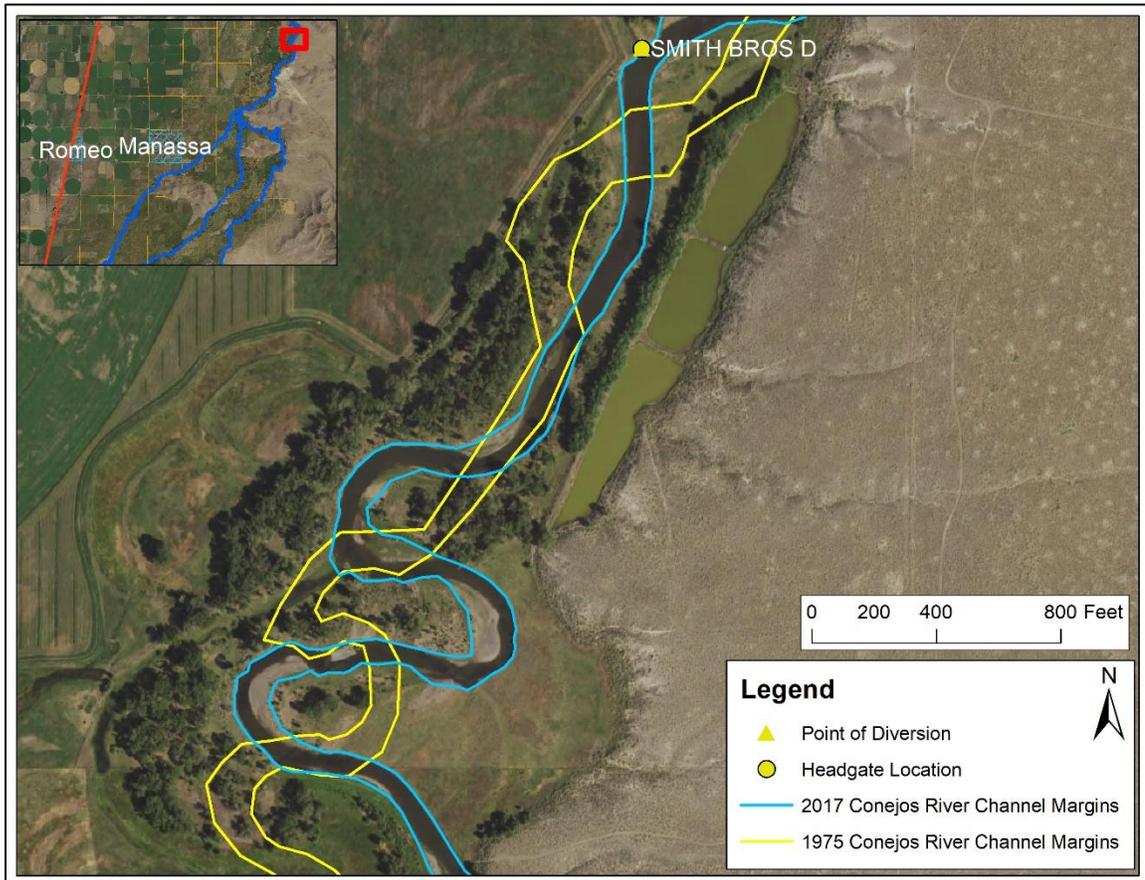
Map of 1975 and 2015 channel margins, illustrating channel avulsion upstream of diversion.
