**RE: Village at Dadeland Condominium Association, Inc. – Demand for Unit Owners to Complete Electrical Repairs – Miami-Dade County Unsafe Structures Violation (Case # DCF2018005041U)**

## **Structural Damage Report**

**VILLAGE AT DADELAND CONDO**  
**Miami, FL 33143**

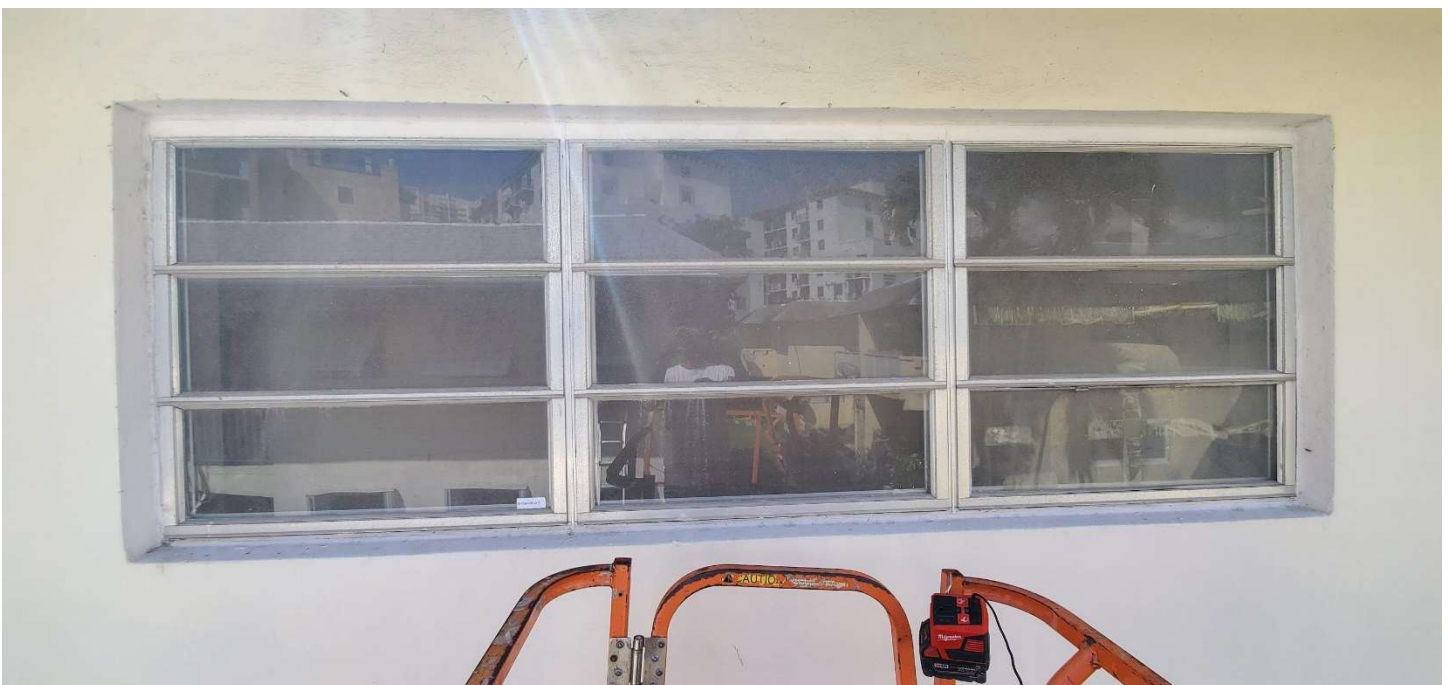
Awning Window B-7320-BR-04 photo taken from boom lift

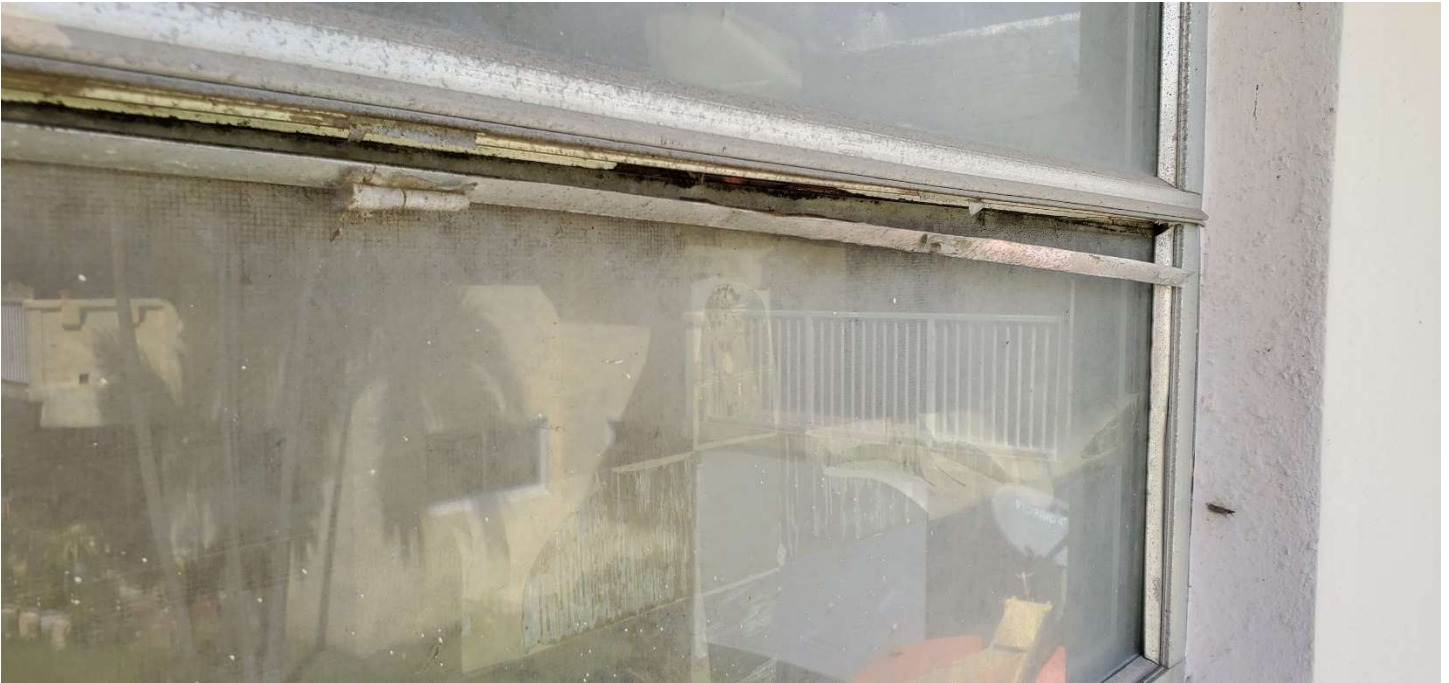
Awning Window B-7320-BR-04 Example of loose glazing due to negative wind pressures from Hurricane Irma

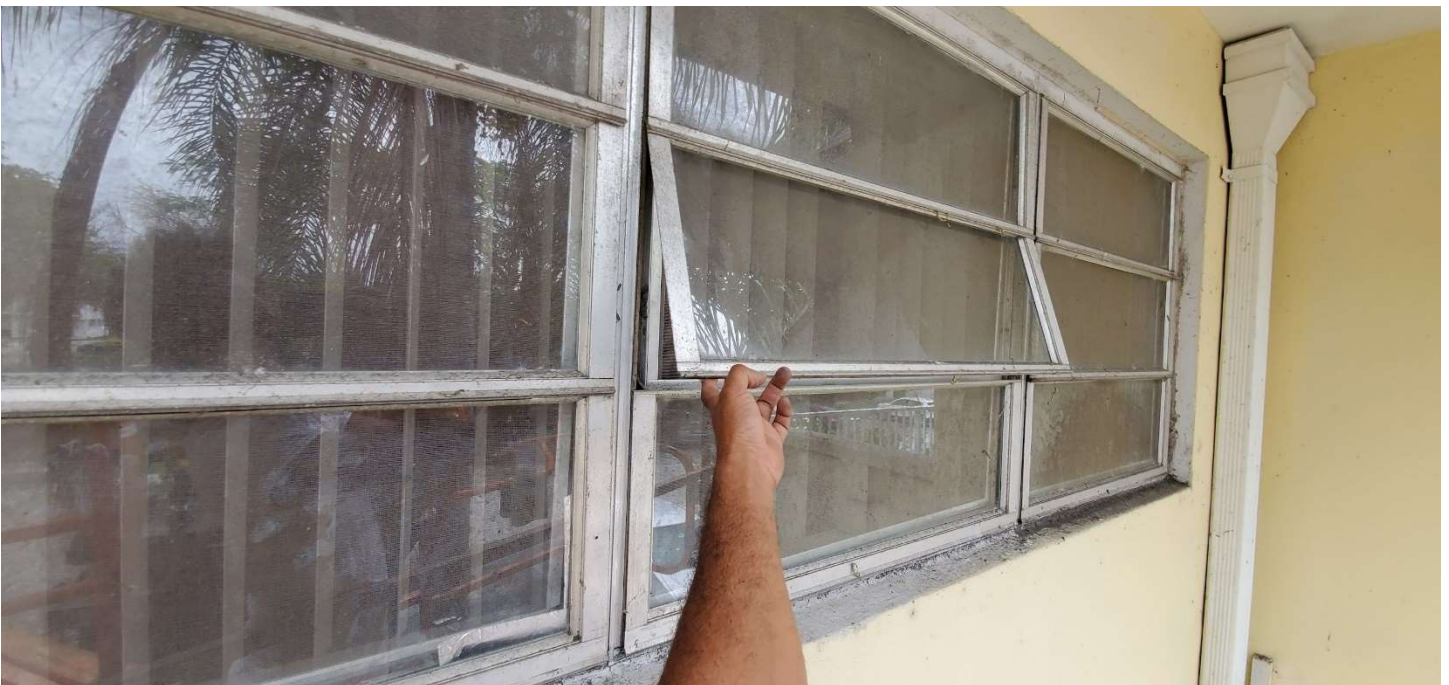
Awning Window A-7310-BB-05 Example of a loose window awning. The window awning locking mechanism has been compromised by the wind pressures from Hurricane Irma. Due to this damage, the window cannot be locked or be weather tight.

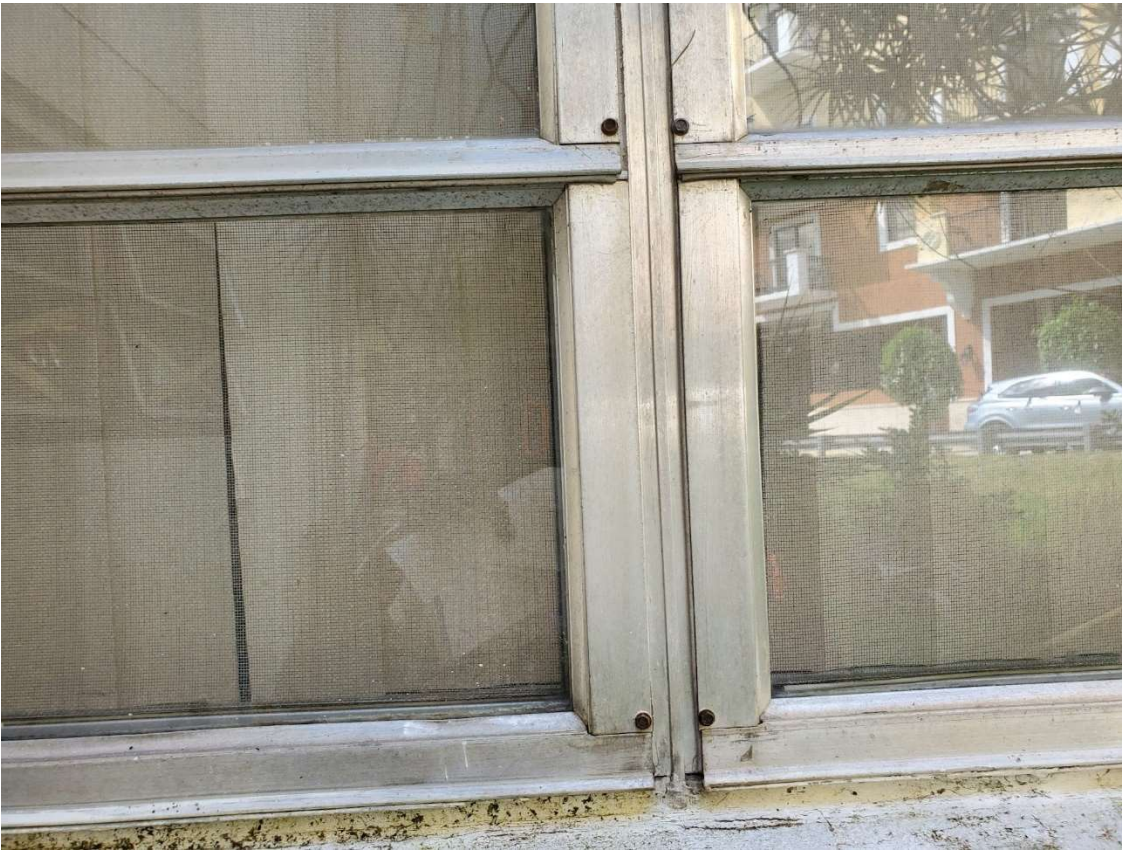
Awning Window B-7324-AB-05 this window has been screwed closed with self-taping screws from the outside by the owner to keep the window closed and attempt to make the window weather tight. This is another example of winding/ locking mechanisms being affected by the wind pressures from Hurricane Irma. Without the screws installed by the owner, the window would flap or sag open.

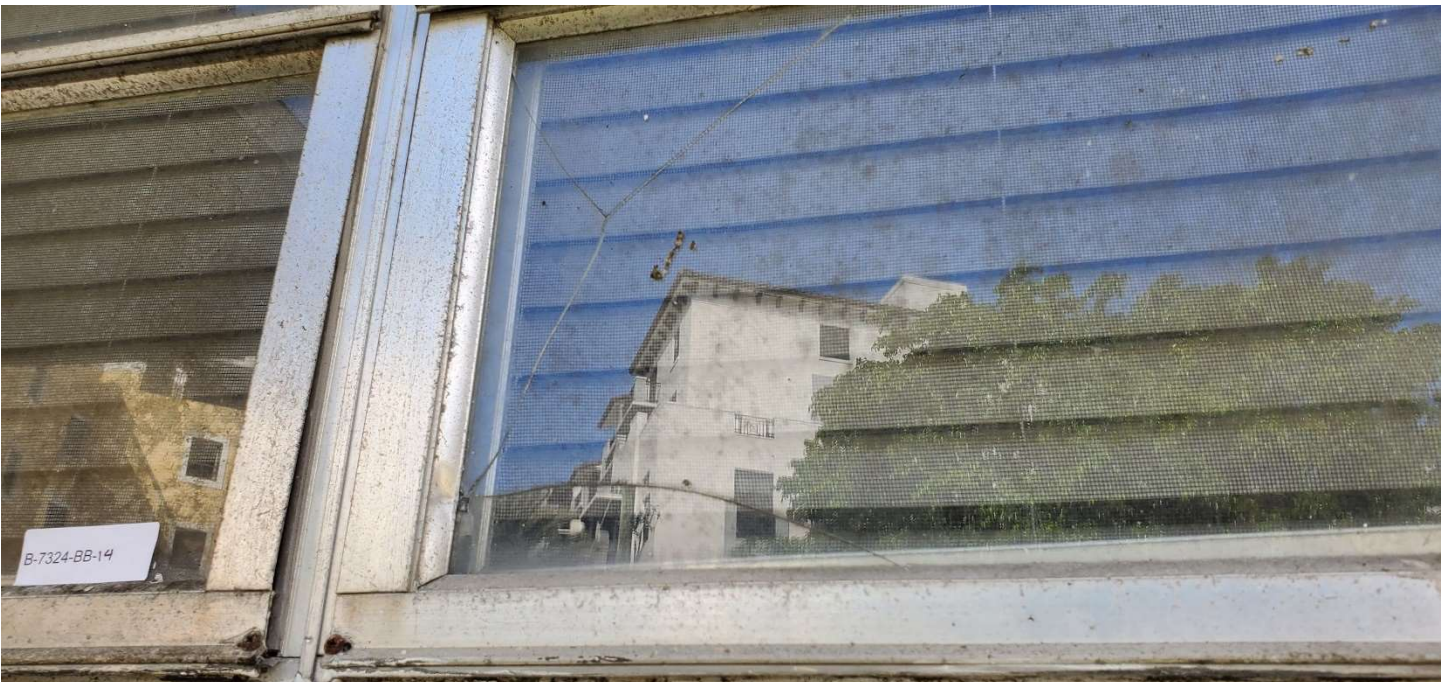
Window B-7324-BB-14 is another example of an owner who has attempted to screw the awning closed on the window and impact damage cracking the glazing of the window due to Hurricane Irma.

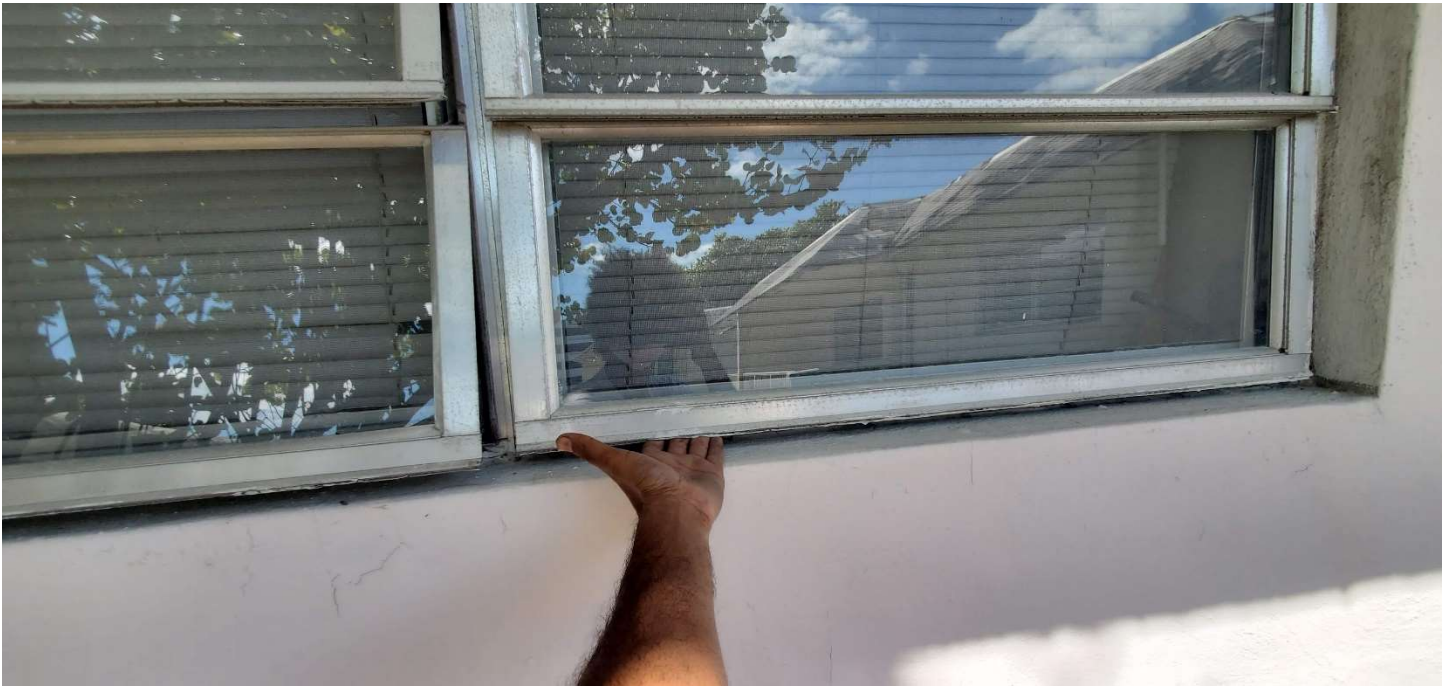
Awning Window C-7340-BR-02 example of winding/ locking mechanisms be affected by the wind pressures from Hurricane Irma. The window cannot be locked or completely closed and is not weather tight.

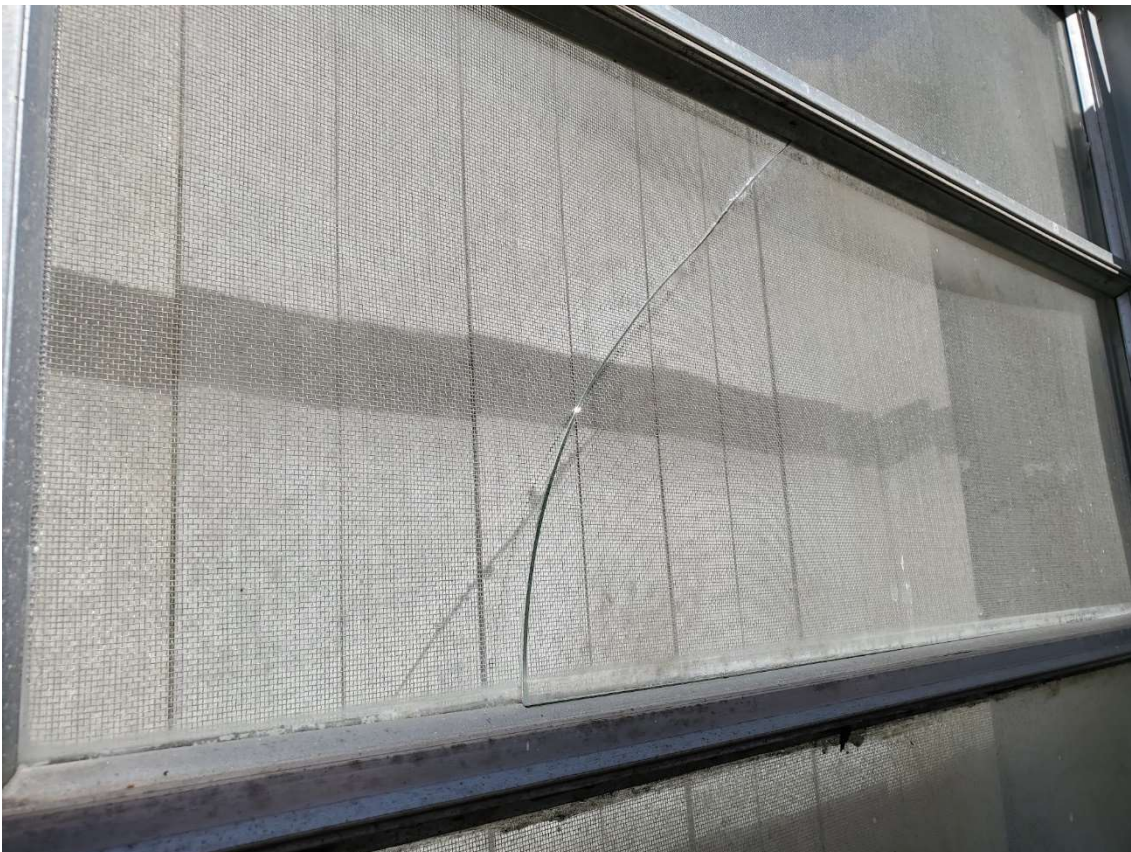
Awning Window C-7350 AL-01 example of broken window glazing due to deflection of the window awning frame.

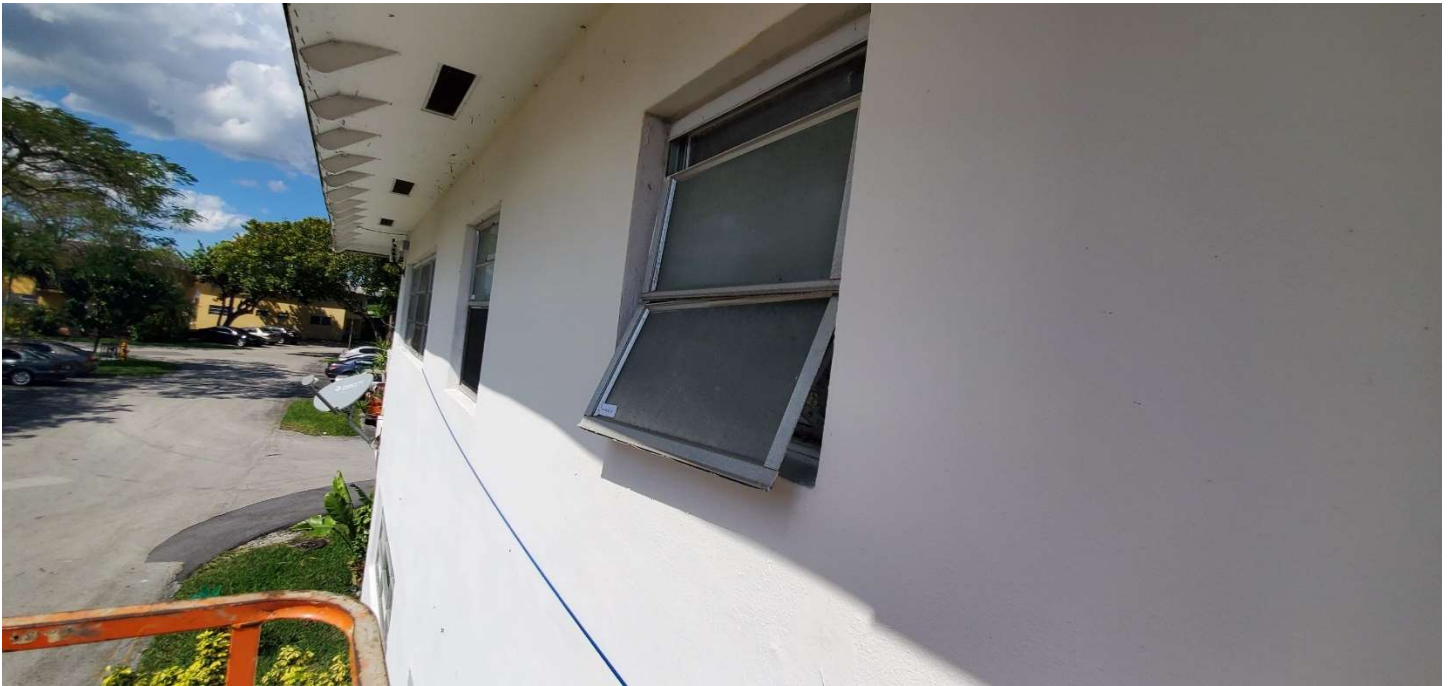
Awning Window B-7320-BL-03 Example of a loose window awning. The window awning locking mechanism and hardware have been damaged by the wind pressures from Hurricane Irma. Due to this damage, the window cannot close and is stuck in an open position.

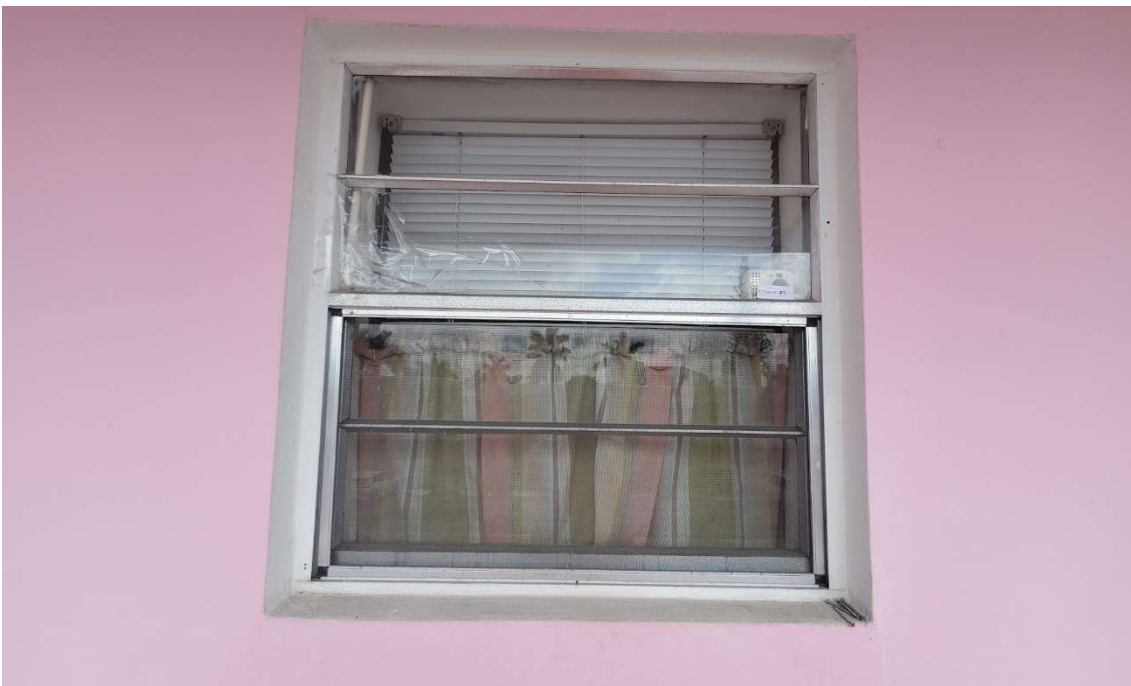
Single-hung window G-7500 BF-07 example of broken window glazing due to impacts from debris from Hurricane Irma

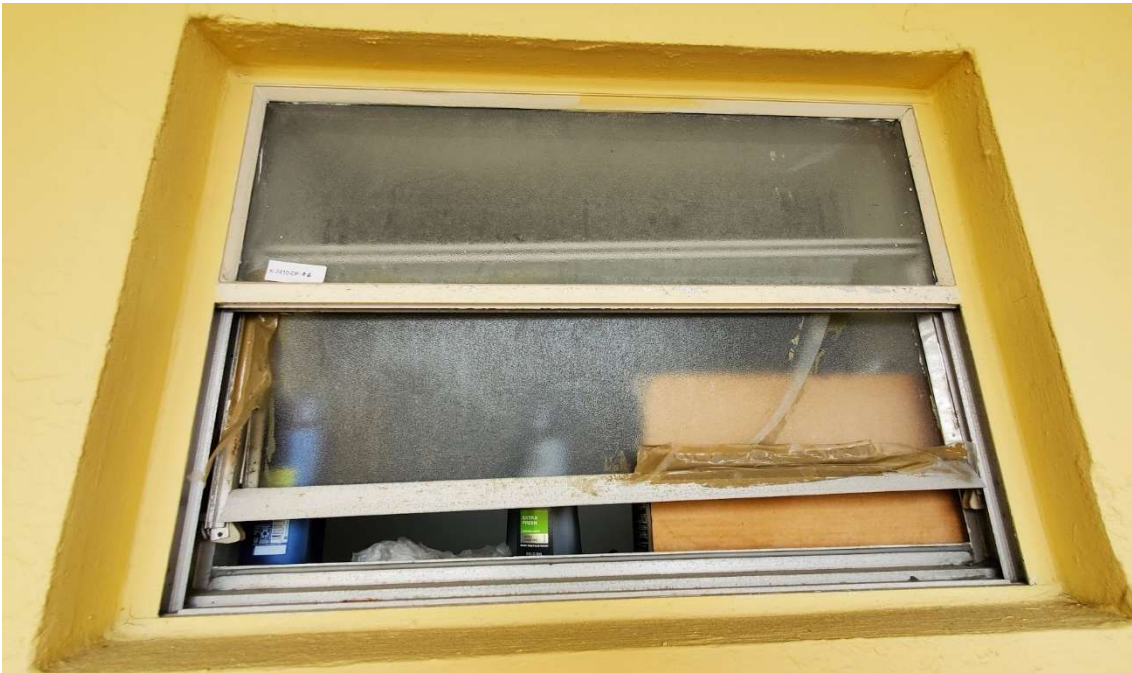
Single Hung Window K-7410-DF-06 example of a window with a damaged window sash, balancer, and cracked glass pane. These damages are a result of the window balancers being dislodged by the wind pressures and vibrations from Hurricane Irma causing binding and deformation of the sash.

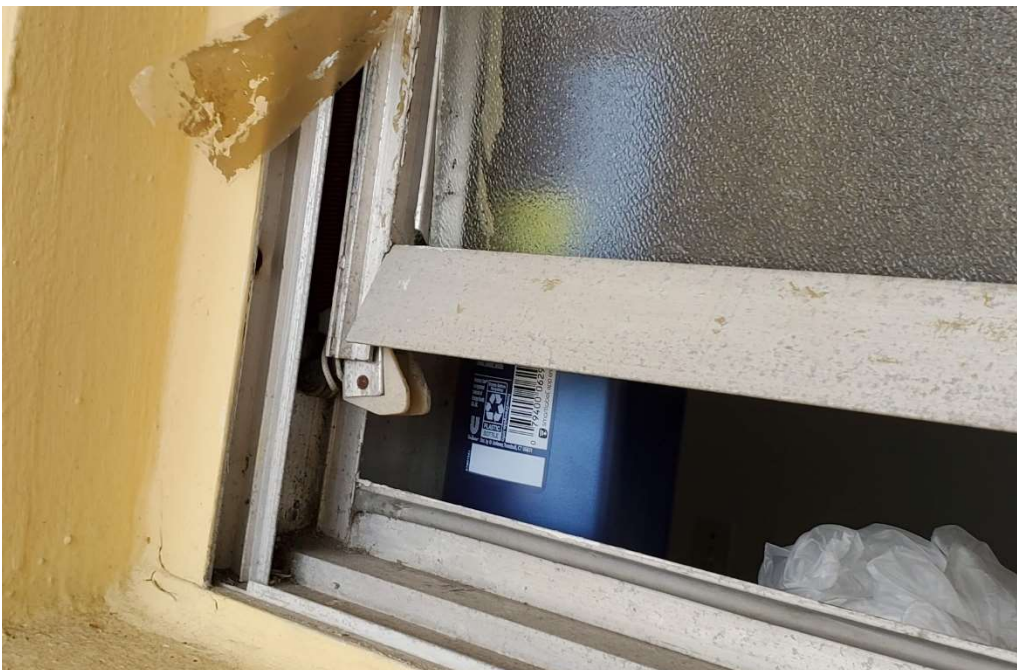
Single Hung Window K-7410-DF-06 example of a window with a damaged window sash, balancer and cracked glass pane. These damages are a result of the window balancers being dislodged by the wind pressures and vibrations from Hurricane Irma causing binding and deformation of the sash.

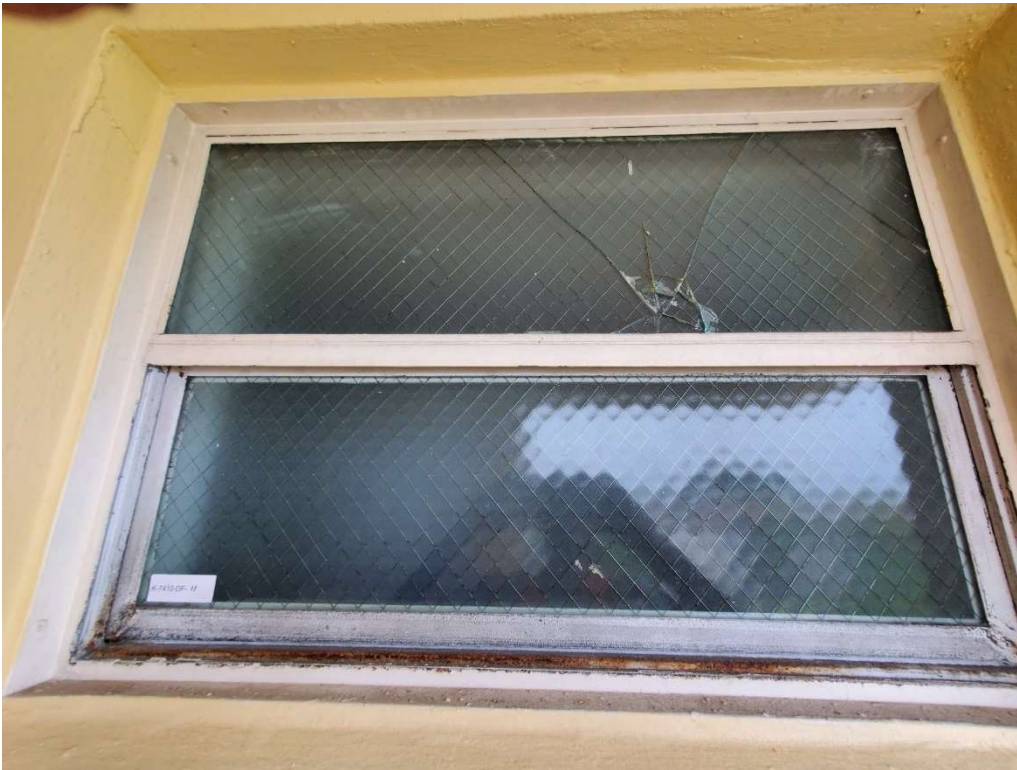
Single Hung Window K-7410-DF-11 example of a window with damage to broken glazing due to wind-borne debris from Hurricane Irma

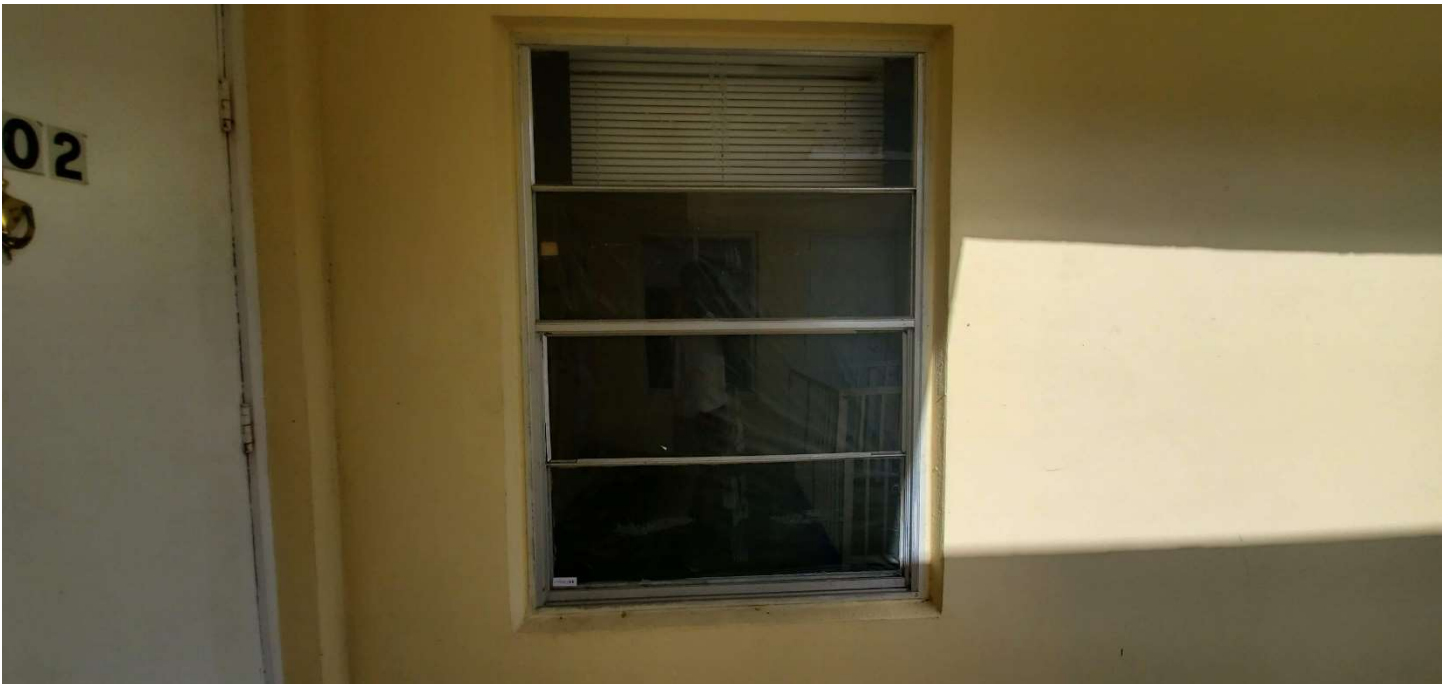
Single Hung Window A-7300-BF-05; Example of the single hung window that has new temporary glazing installed due to the original glass being broken from Hurricane Irma.

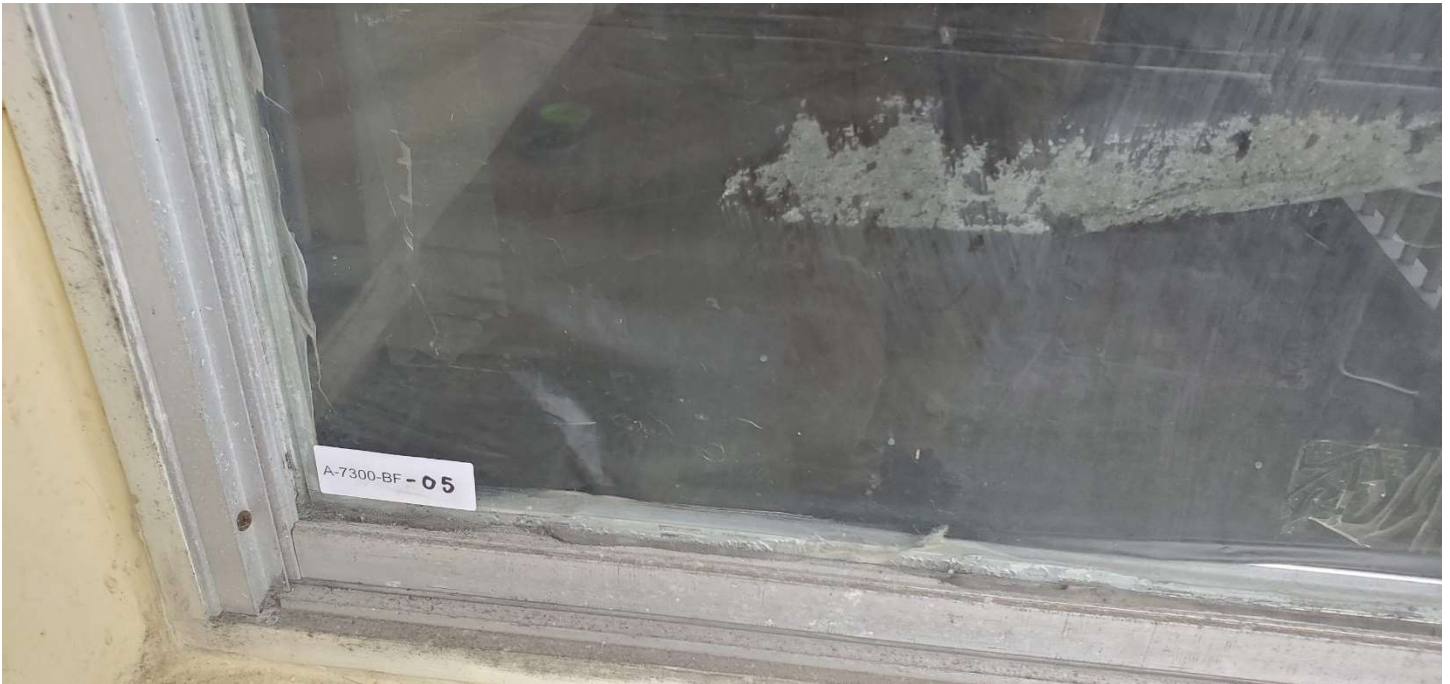
Closeup of Single Hung Window A-7300-BF-05; Example of the single hung window that has new temporary glazing installed due to the original glass being broken from Hurricane Irma

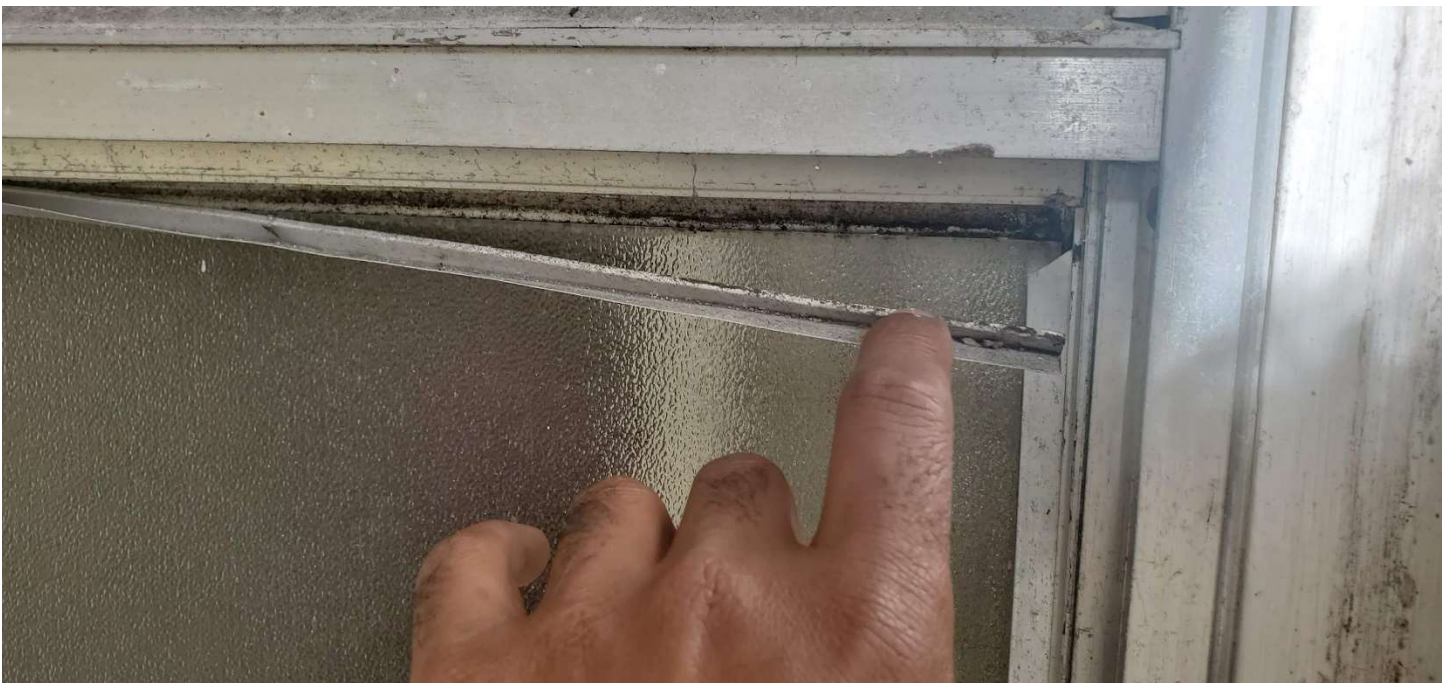
Single Hung Window A-7300-BF-12; Example of loose glazing in window sash/frame as a result of negative wind pressures from Hurricane Irma.

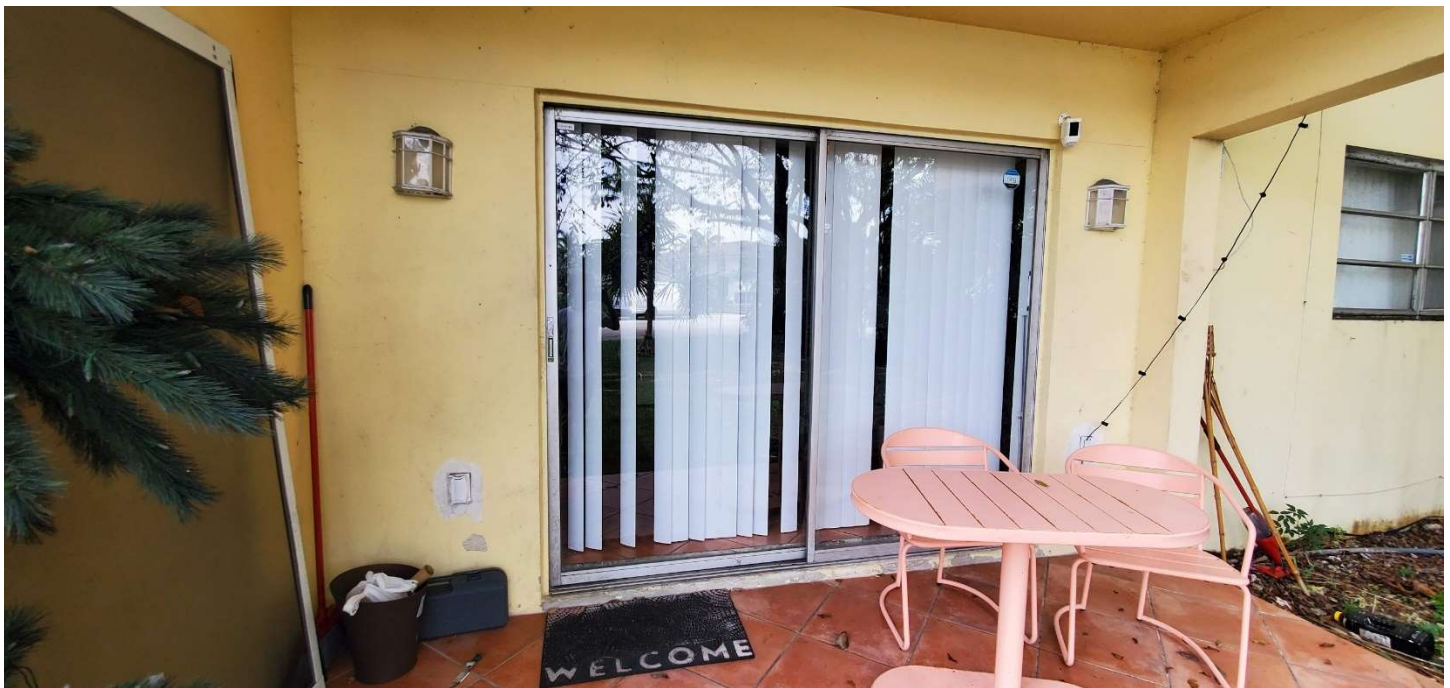
Sliding Glass Door, A 7300 AB 03 example of damaged door hardware allowing out of a plain moment of the door panel due to winds from Hurricane Irma.

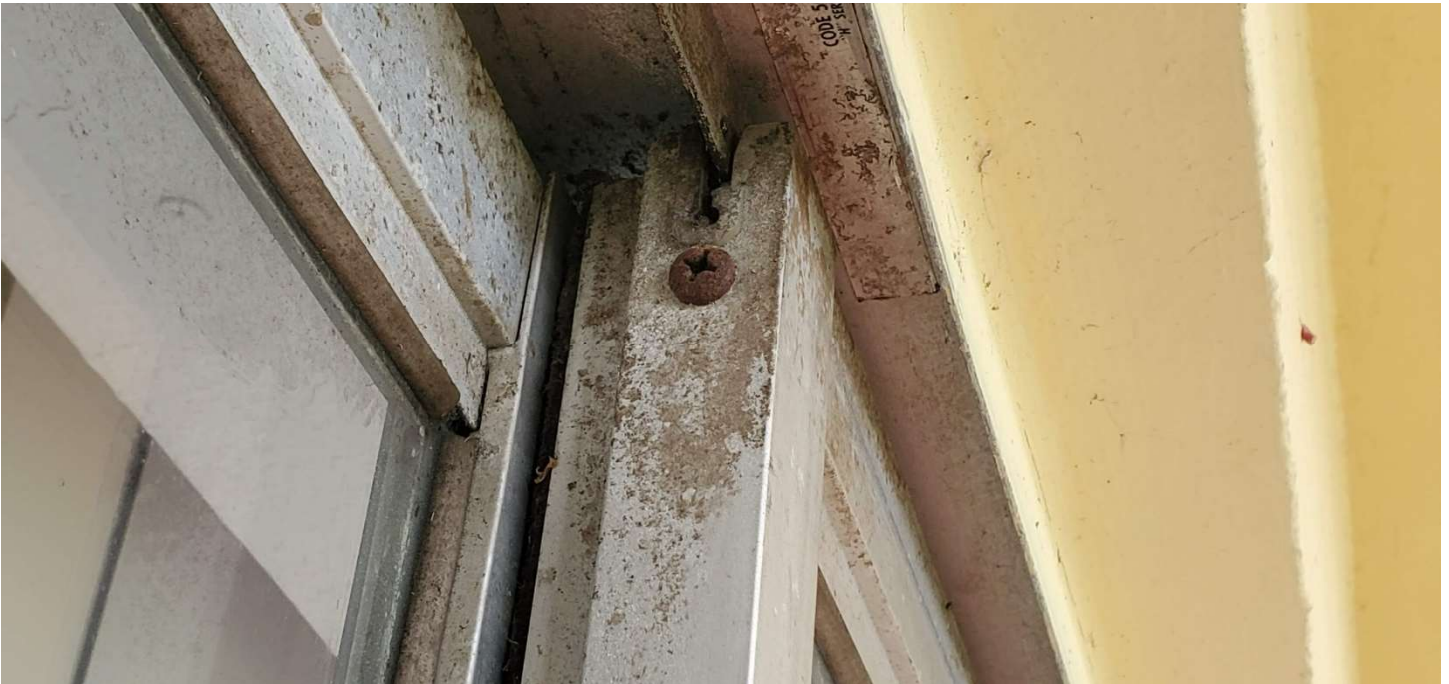
Sliding Glass Door, A 7300 AB 03 example of damaged door hardware allowing out of a plain moment of the door panel due to winds from Hurricane Irma.

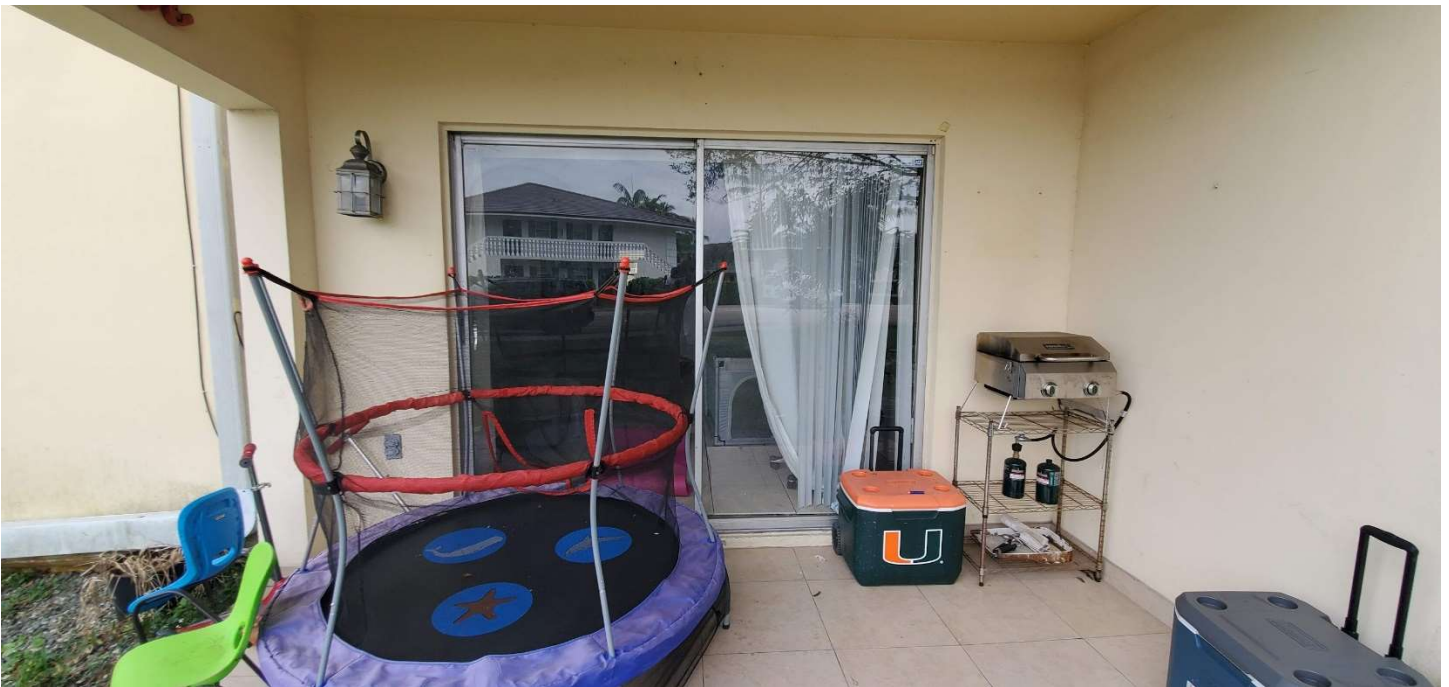
Sliding Glass Door, A 7300-AB-02 example of deformation to the door frame and failures of the door hardware causing binding during operation and out of the plane movement of the door panel as a result of winds from Hurricane Irma.

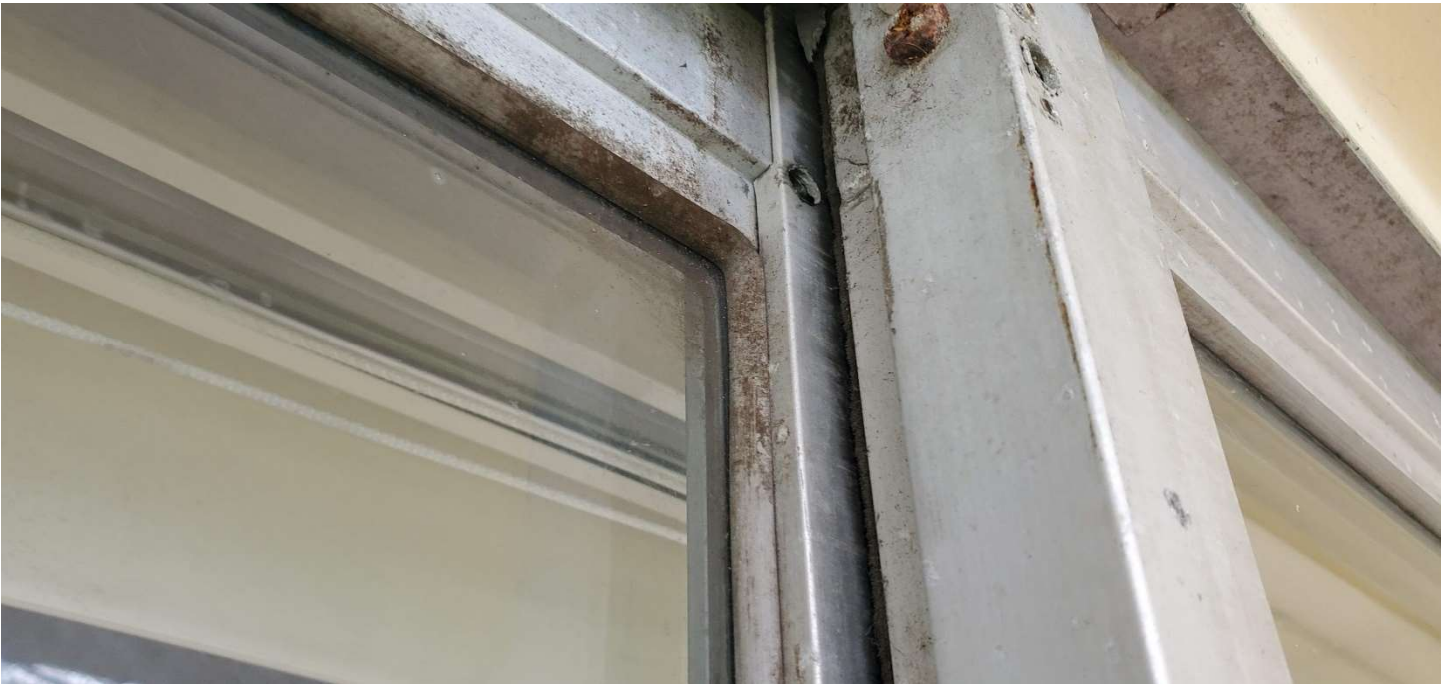
Close up of Sliding Glass Door A 7300-AB-02 example showing deformation to the door frame and failures of the door hardware causing binding during operation and out of the plane movement of the door panel as a result of winds from Hurricane Irma.

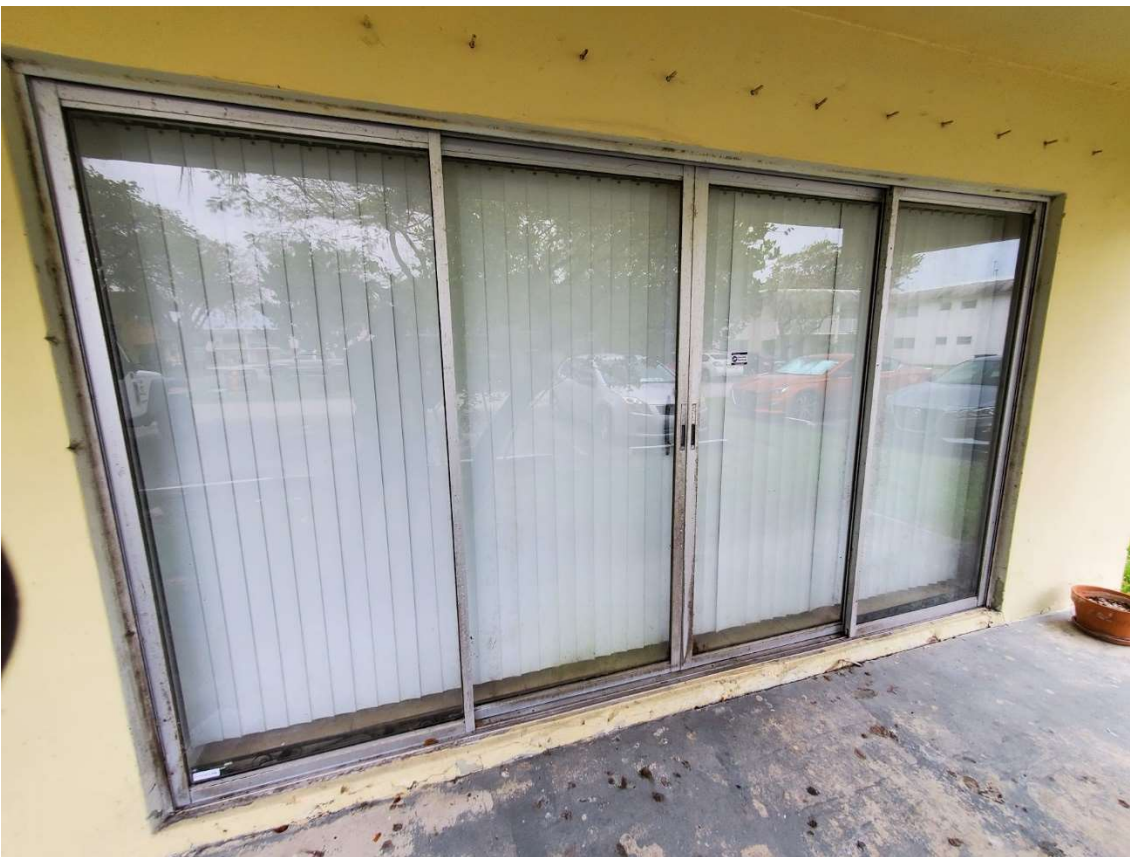
Sliding glass door, A-7310-AB-06 Example of the door without plane movement of the door panel.

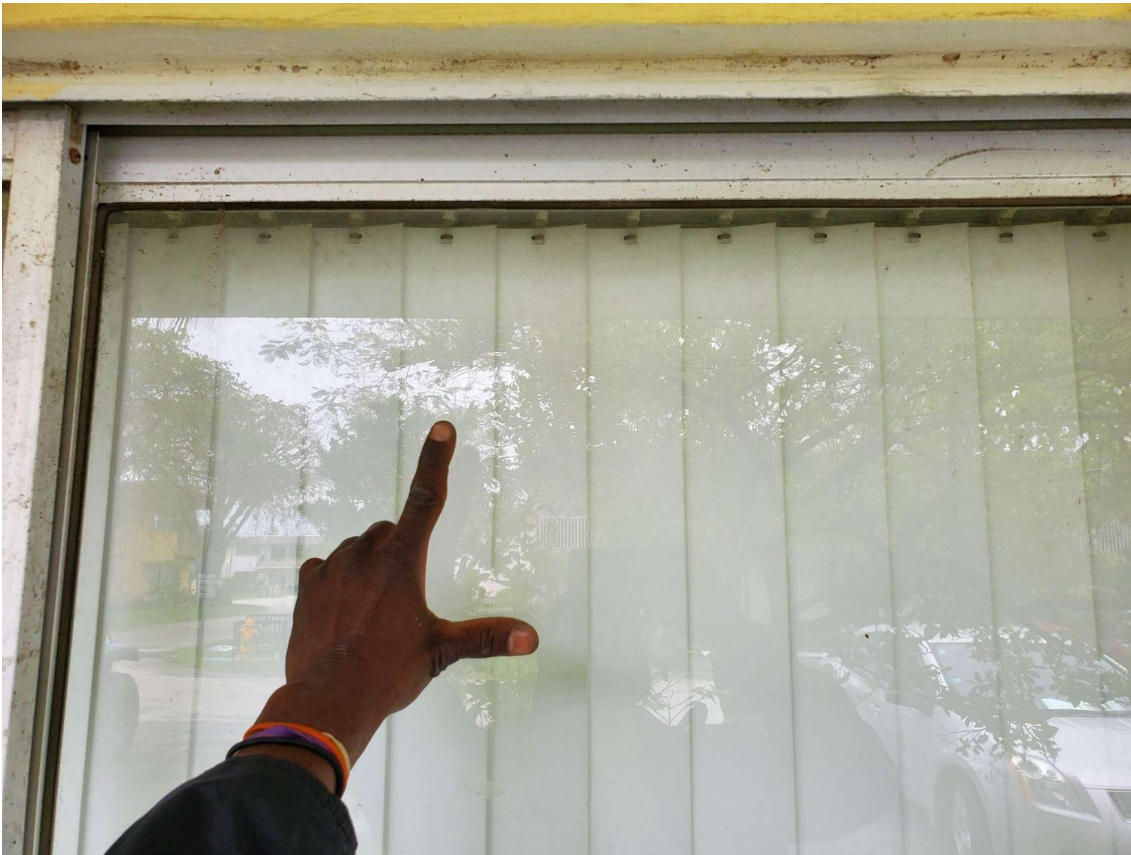
Sliding glass door, A-7310-AB-06 Example of the door without of plane movement of door pane. A photo with an L made with the fingers indicates that the door was inspected and exhibited out of the plane movement of the door panels.

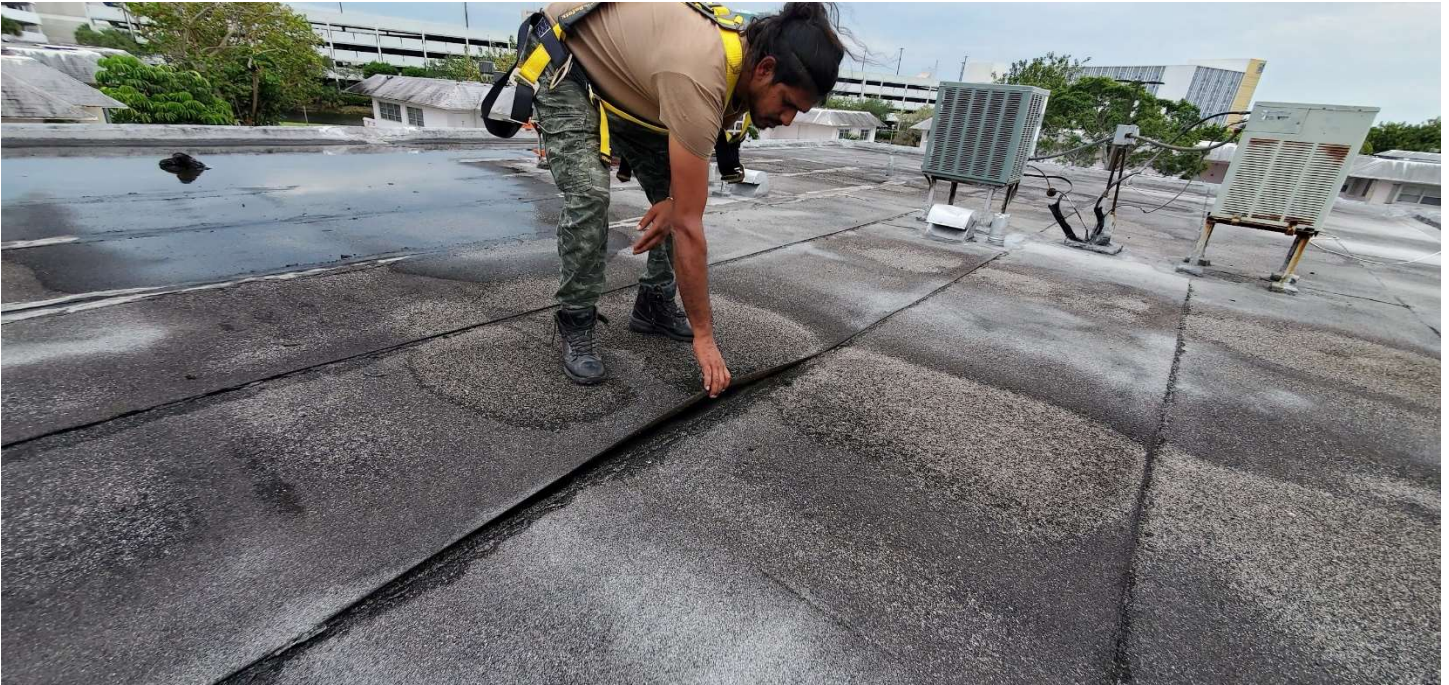
The roof of Building 1217; an example of up-lift pressures causing delamination of the “modified bitumen membrane” top ply at the seams of the roof and ponding water on the roof deck as a result of water damage perlite roof insulation collapsing.

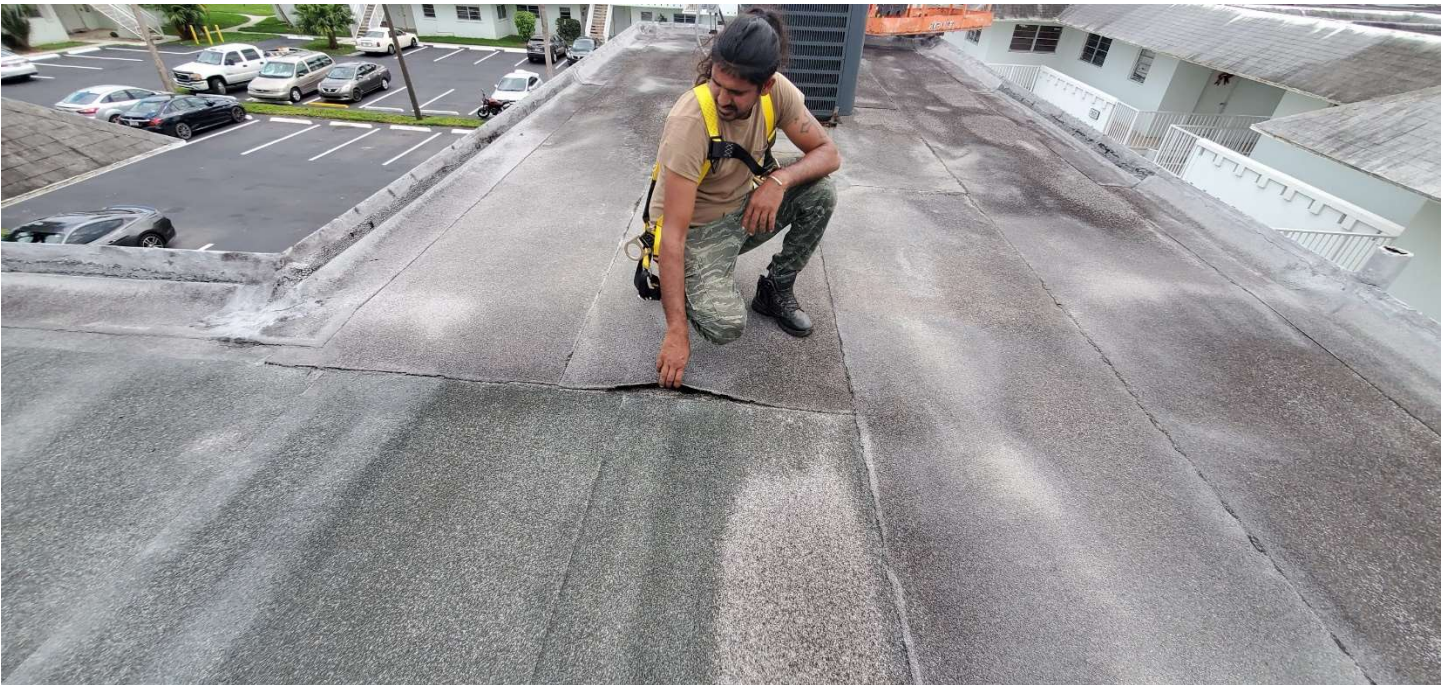
The roof of Building 7680 portrays an example of up-lift pressures causing delamination of the “modified bitumen membrane” top ply at the seams of the roof.
