**RE: Village at Dadeland Condominium Association, Inc. – Demand for Unit Owners to Complete Electrical Repairs – Miami-Dade County Unsafe Structures Violation (Case # DCF2018005041U)**

## **Structural Damage Report**

**VILLAGE AT DADELAND CONDO**  
**Miami, FL 33143**

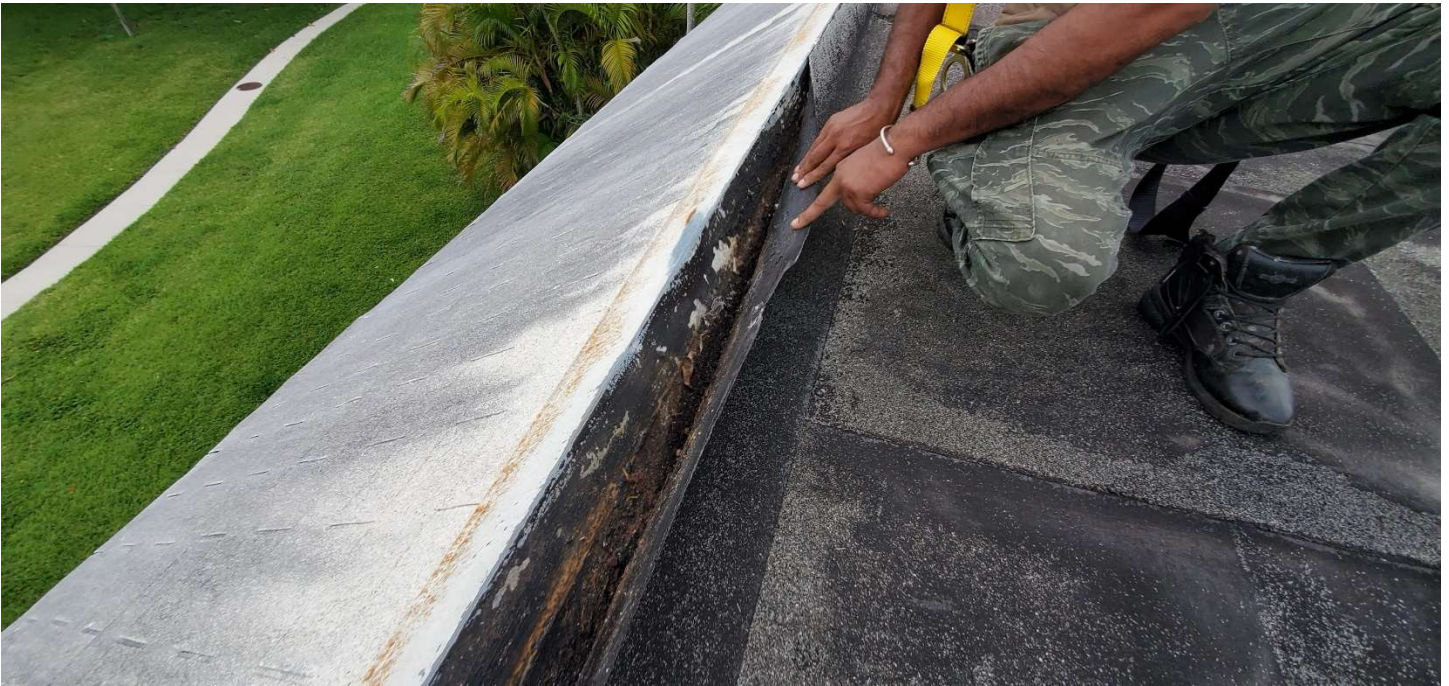
The roof of Building 7590; Example of delimitation of the build-up roof from the eave metal around the perimeter of the roof.

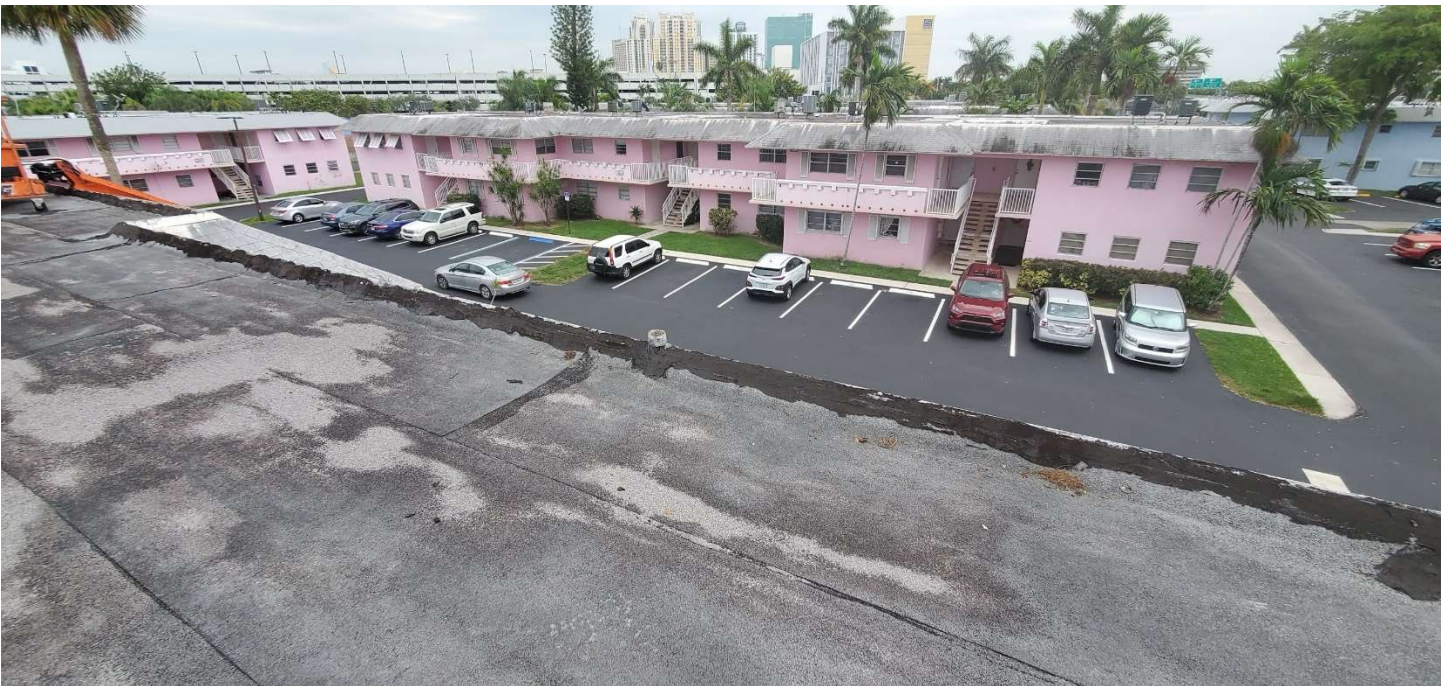
The roof of Building 7530; Example of delimitation of the build-up roof from the eave metal around the perimeter of the roof that has temporary repairs performed that were performed by the management company.

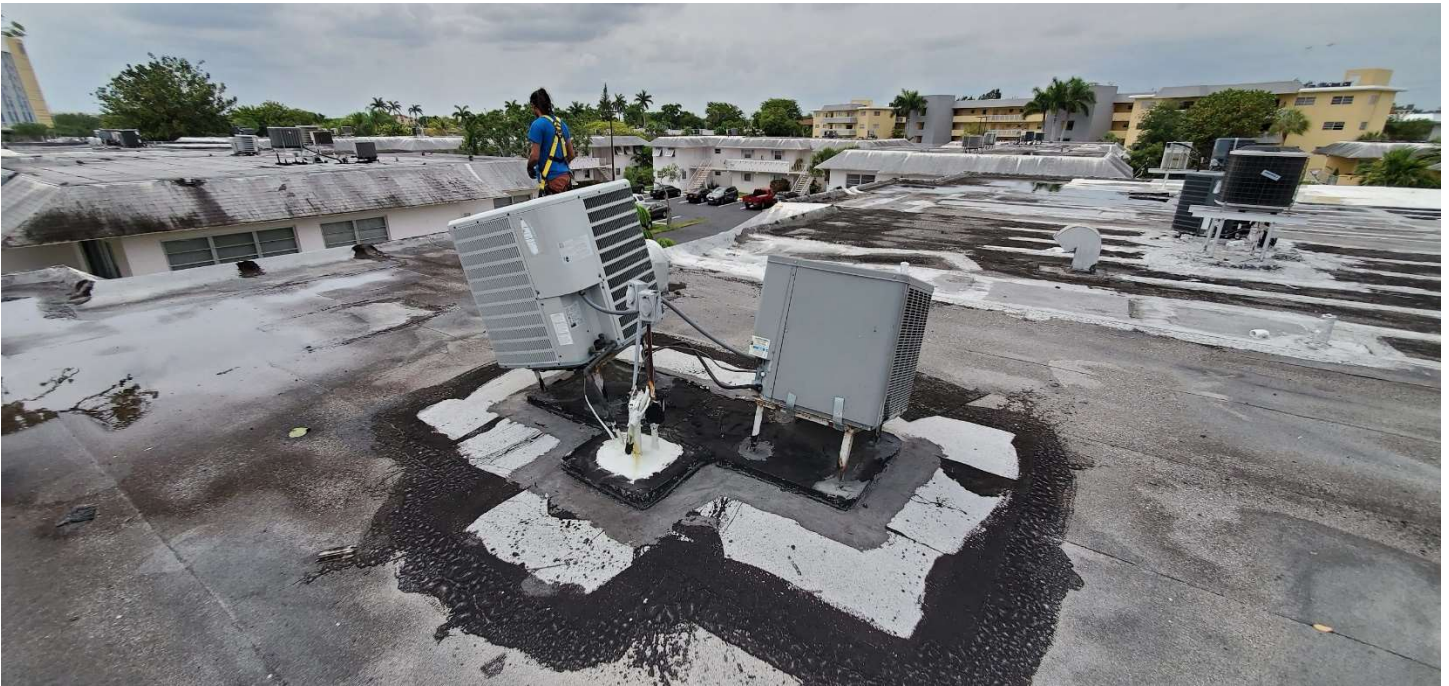
The roof of Building 7350; Example of damages to A/C condenser units and A/C stands on the roof, a temporary roof repair has been made around the stands to prevent further water intrusion.

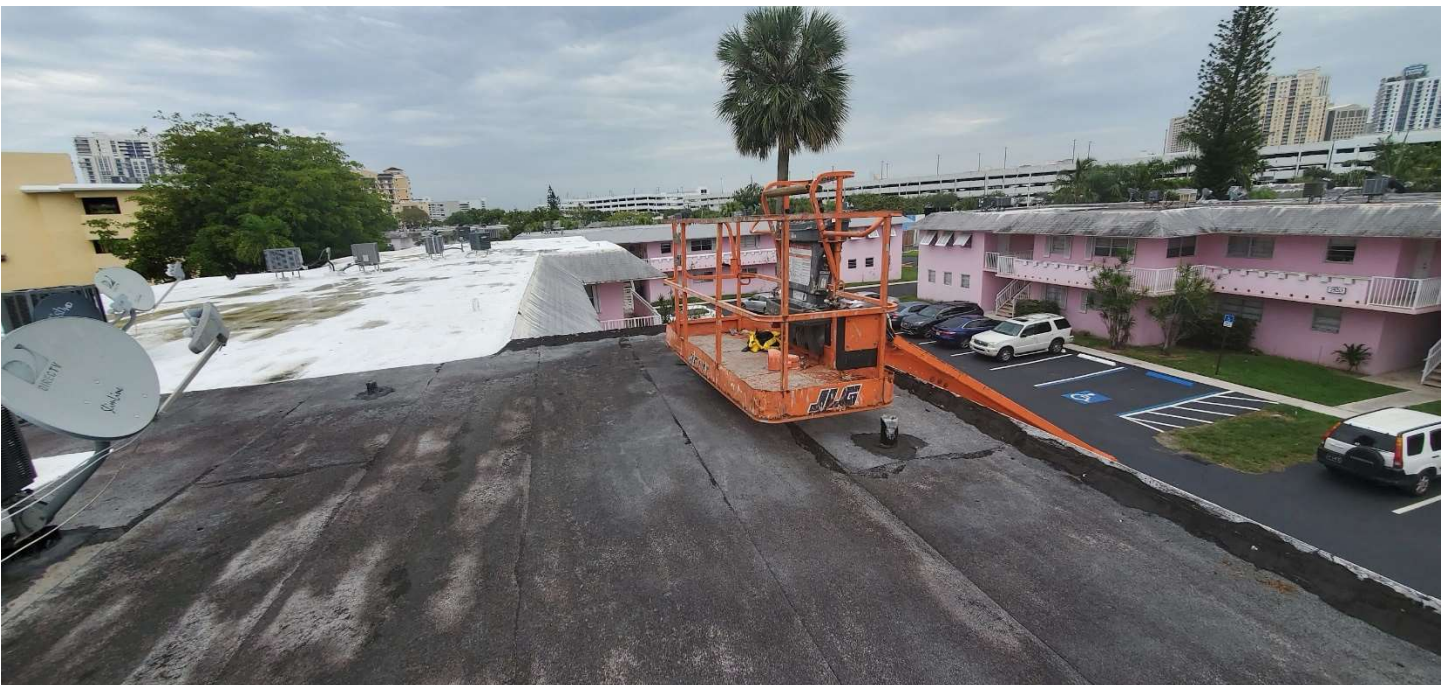
The roof of Building 7530; Example temporary roof repairs via a white sealant applied to the roof deck and temporary repairs to the delaminated build-up roof at the eaves.

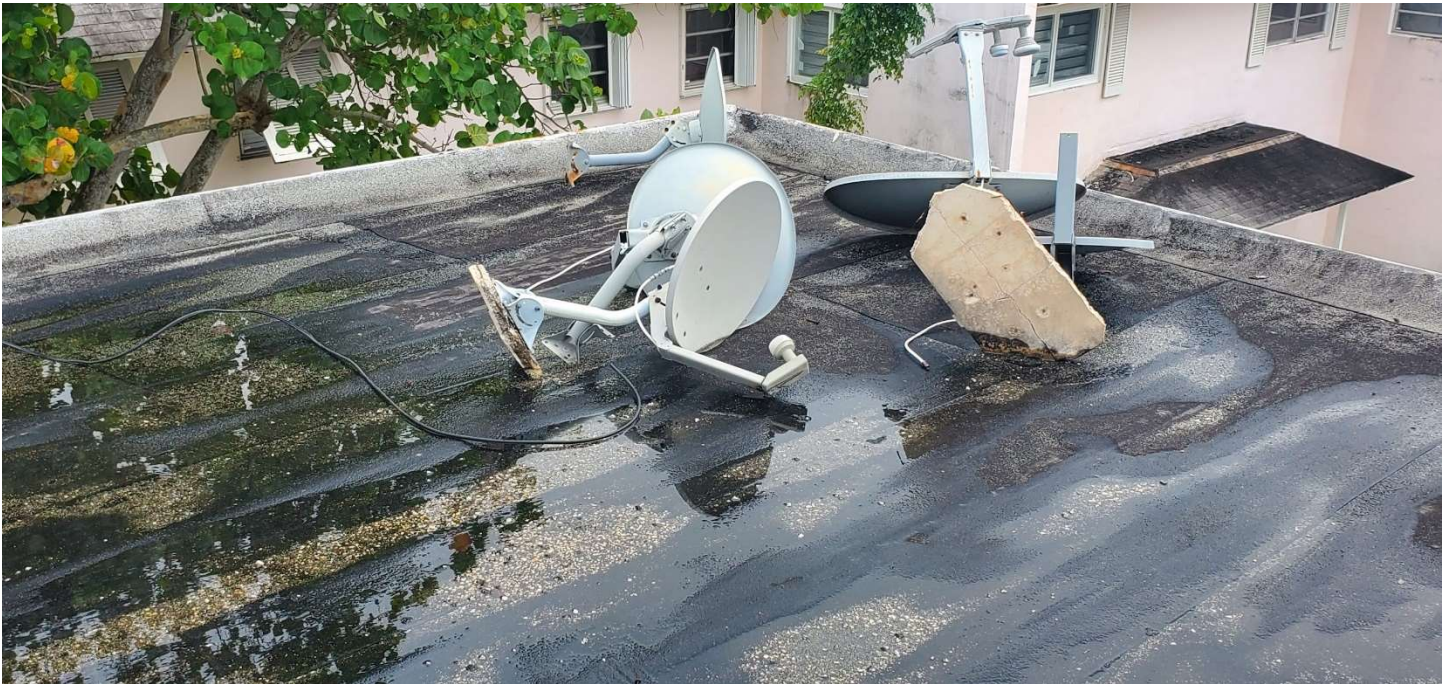
The roof of Building 7340; Example of wind-borne debris in the form of satellites that were blown around on the roof deck causing damage, there is also evidence of damages perlite roof insulation allowing water to pool on the roof deck.

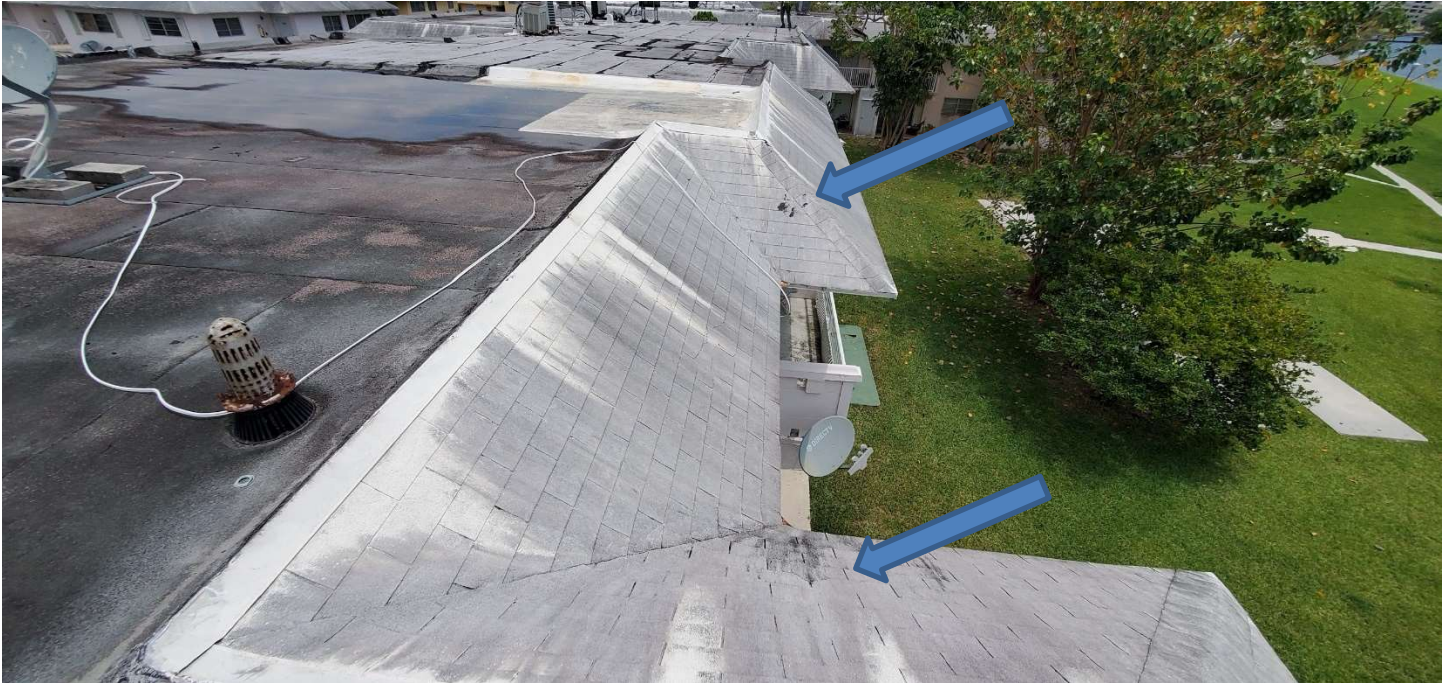
The roof of Building 7420; Example of wind damages to shingled mansards

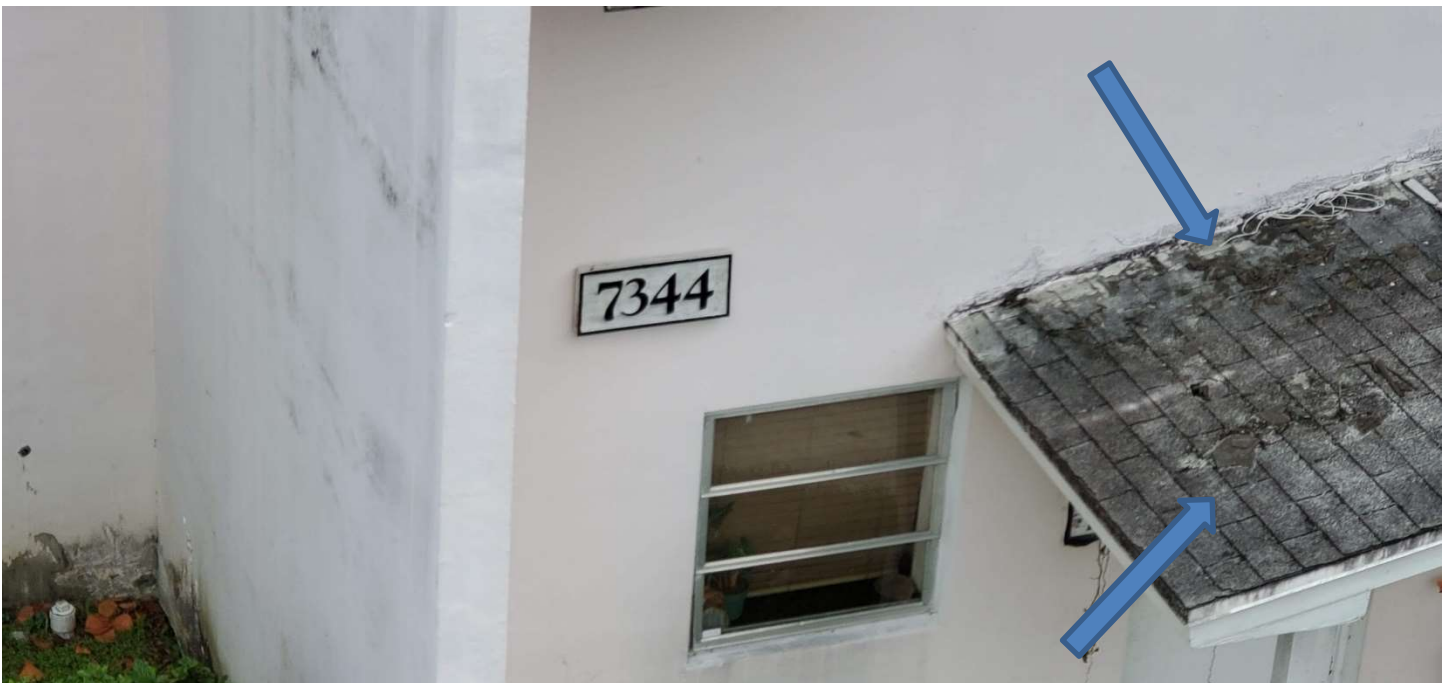
The roof of Building 7344; Example of wind damages to the shingled roof overhang

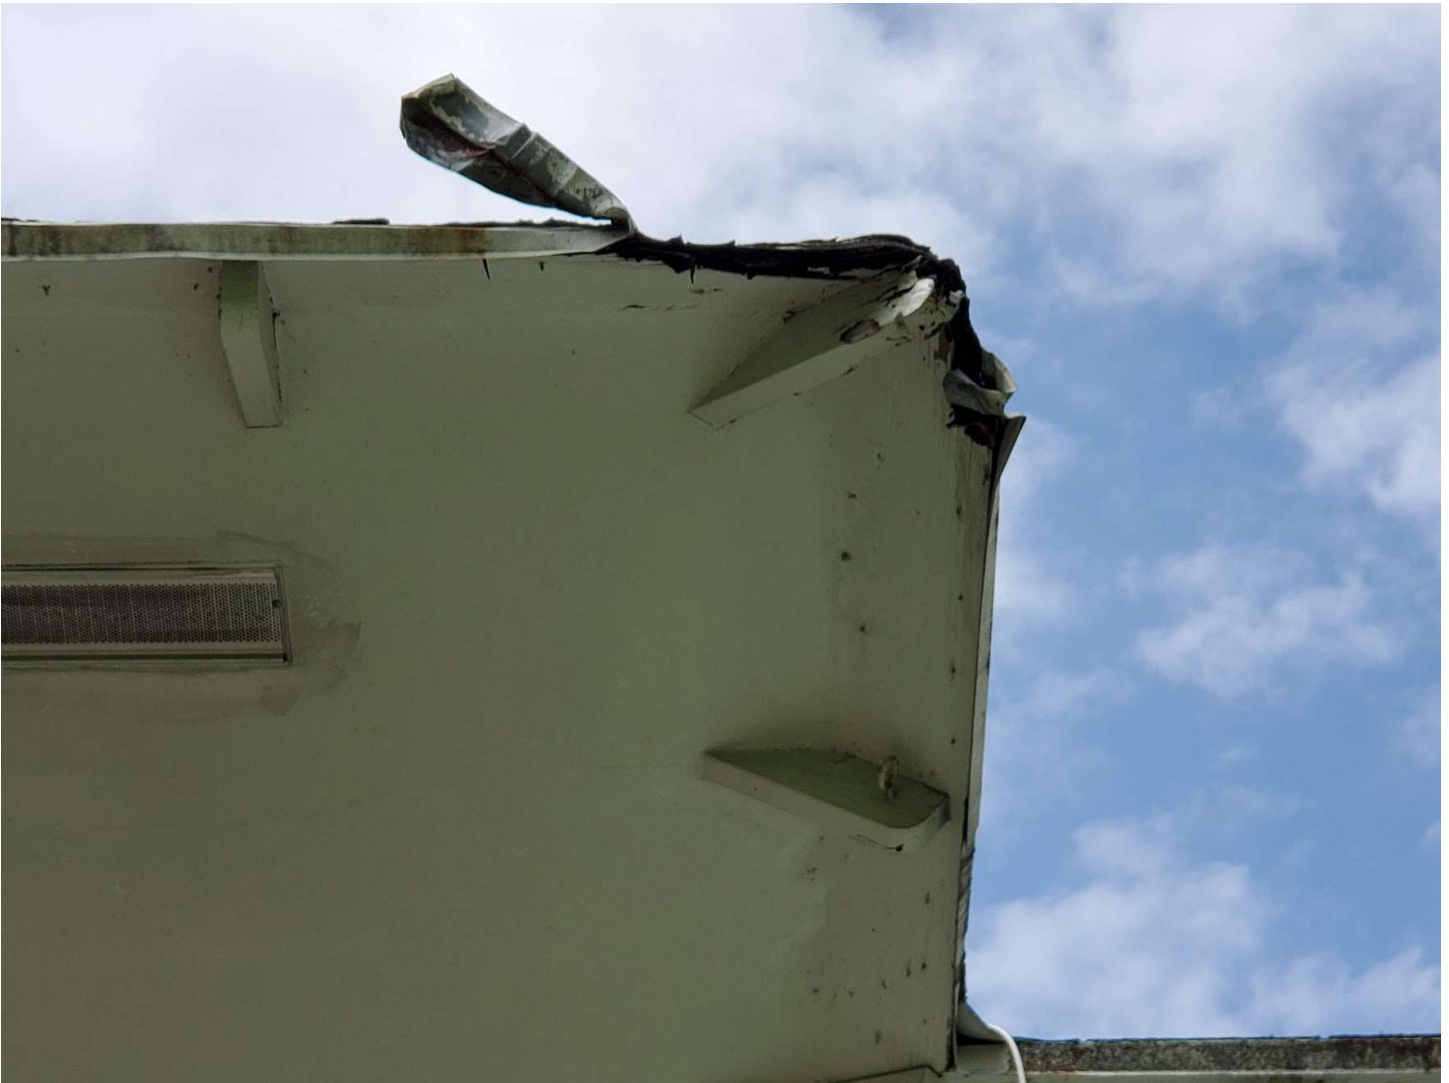
The roof of Building 7660; Example of damage to the eave of the mansard roof from trees adjacent to the building.

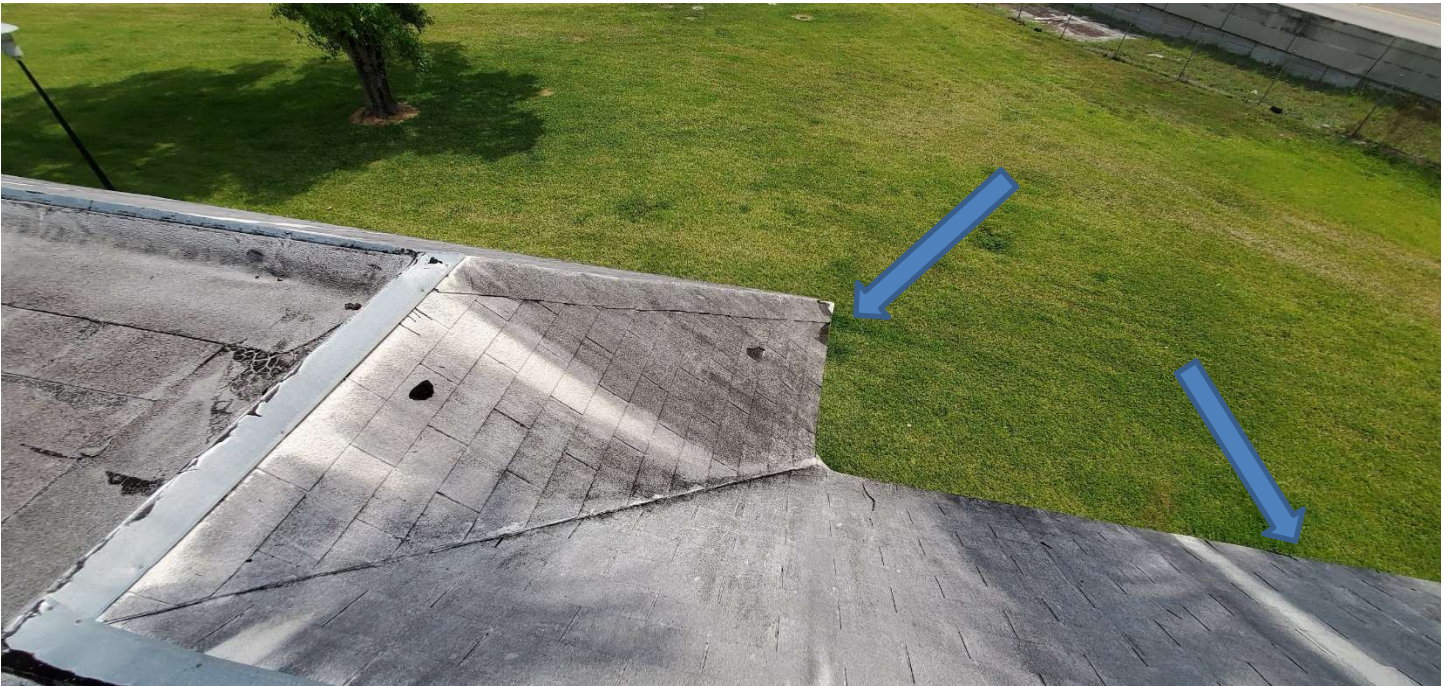
The roof of Building 7680; Example of wind damages to shingled mansards
