RIO GRANDE DIVERSION INFRASTRUCTURE INVENTORY

Structure Name: ATENCIO D

Date: April 1, 2019

ATENCIO DITCH

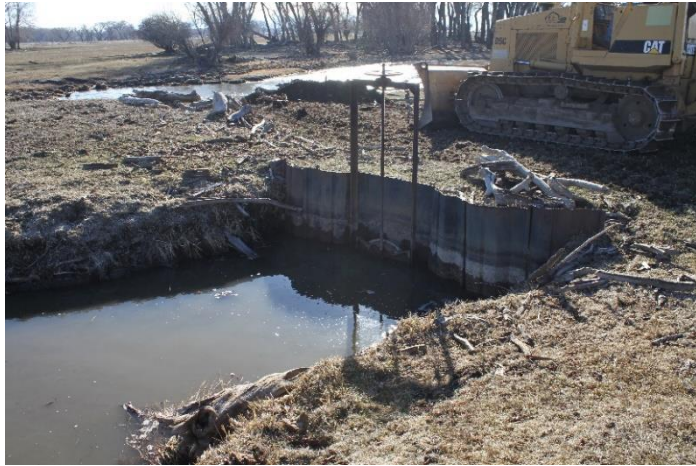
Headgate looking downstream

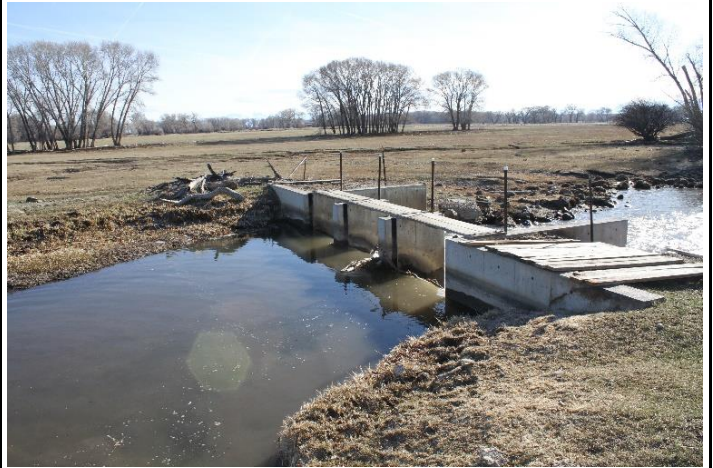
Feeder ditch diversion (CONSOLIDATED SLOUGH WEIR)

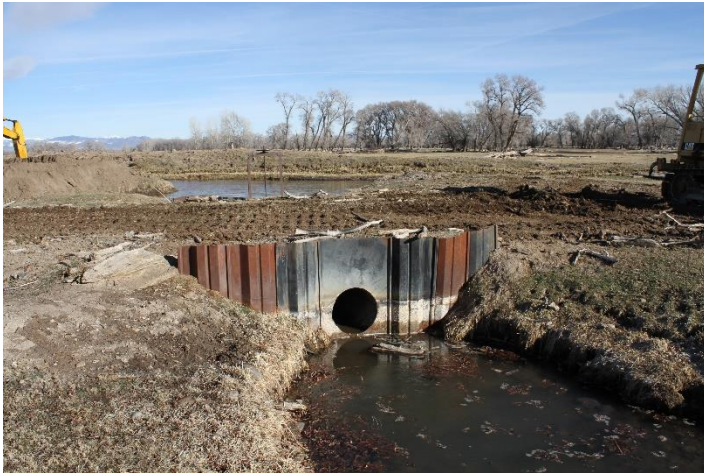
Headgate outlet

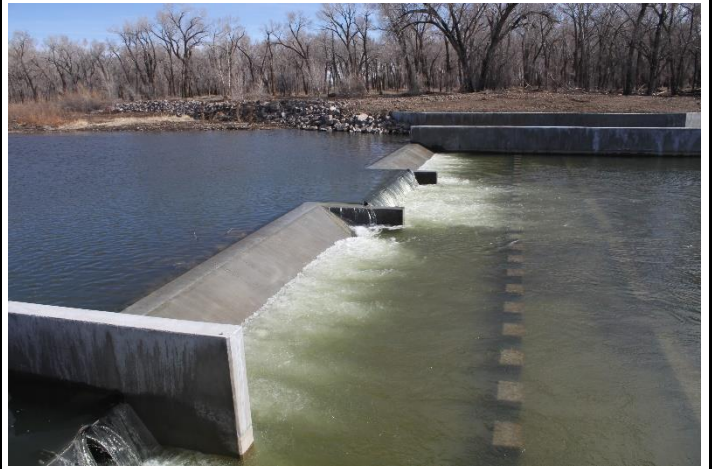
Diversion dam (CONSOLODATED SLOUGH)

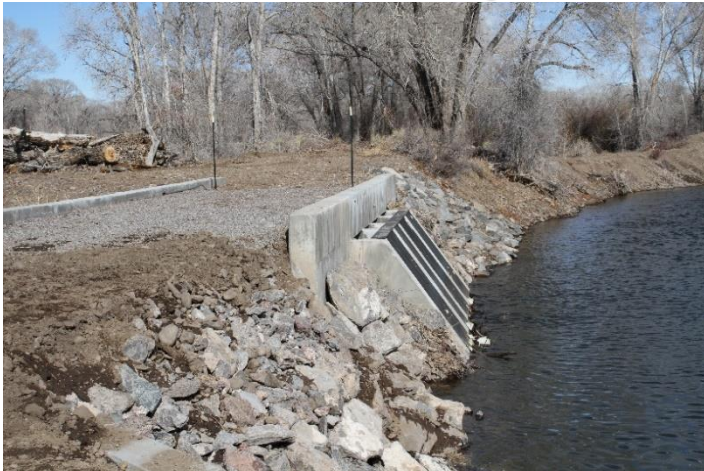
Trash rack at river headgate

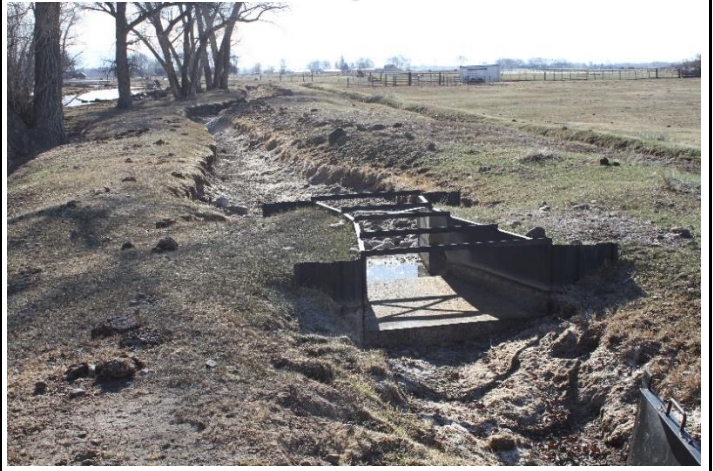
Repair(s) or Improvement(s) Currently Needed: The flume gets submerged at high flows and could be reset. However, it measures accurately as is.

Flume looking downstream
