RIO GRANDE DIVERSION INFRASTRUCTURE INVENTORY

Structure Name: SPRING RANCH D

SPRING RANCH DITCH

Rio Grande Stream
Management Plan

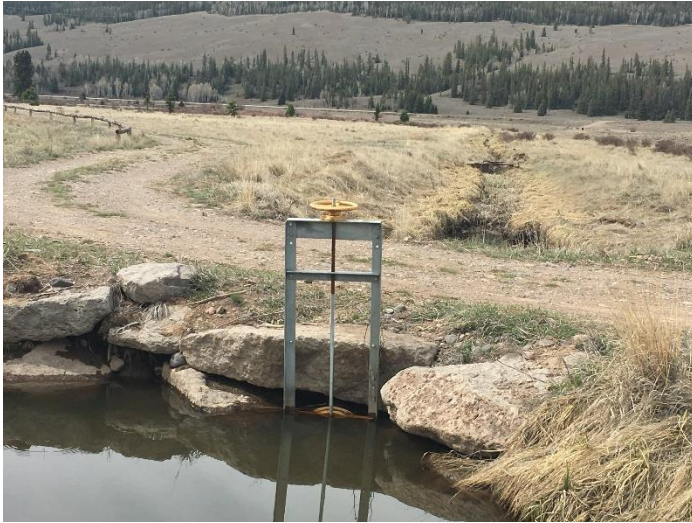
Headgate looking downstream

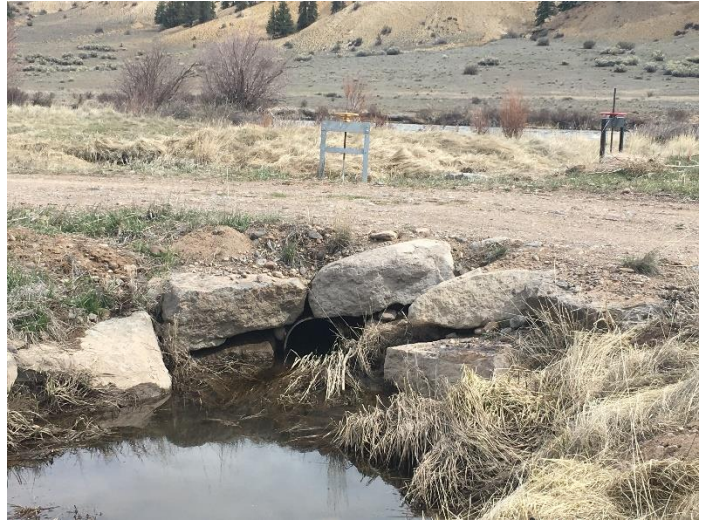
Headgate outlet

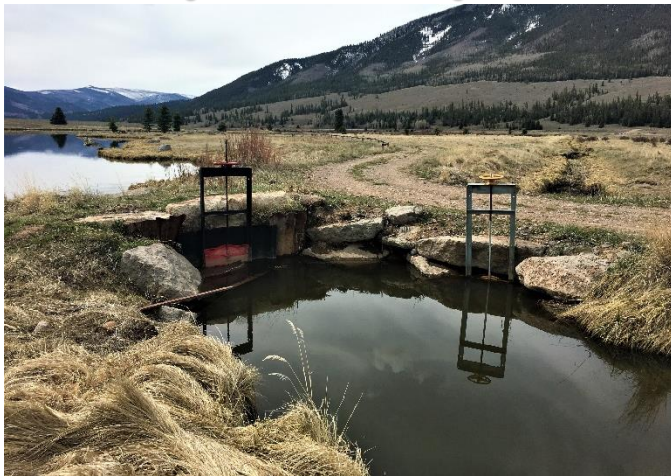
Headgate and return flow gate

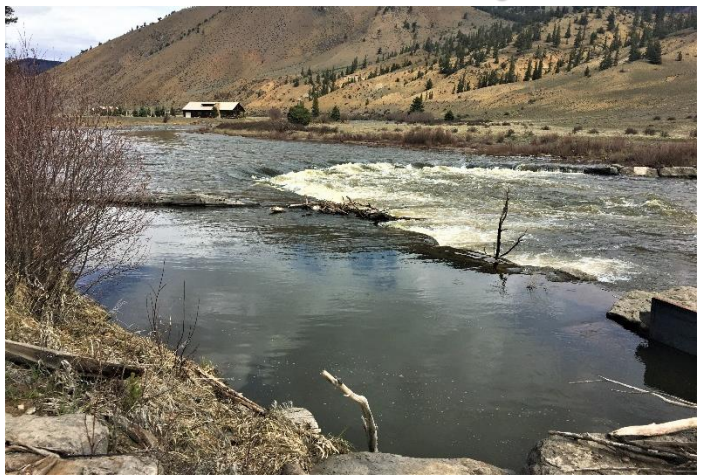
Diversion dam and sluice gate

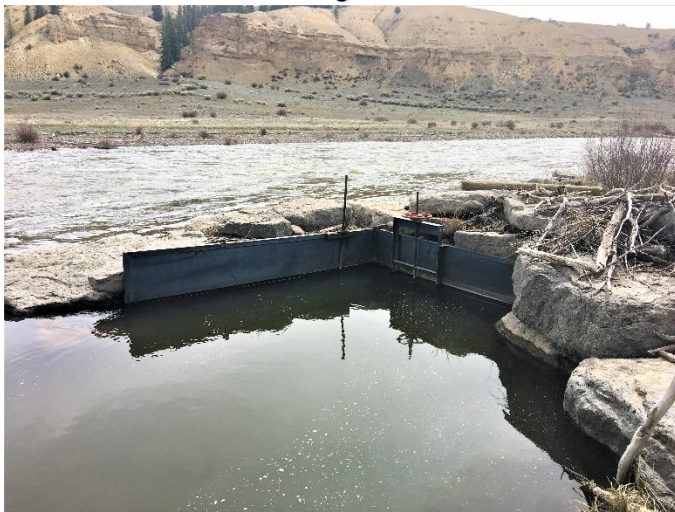
Flume looking downstream

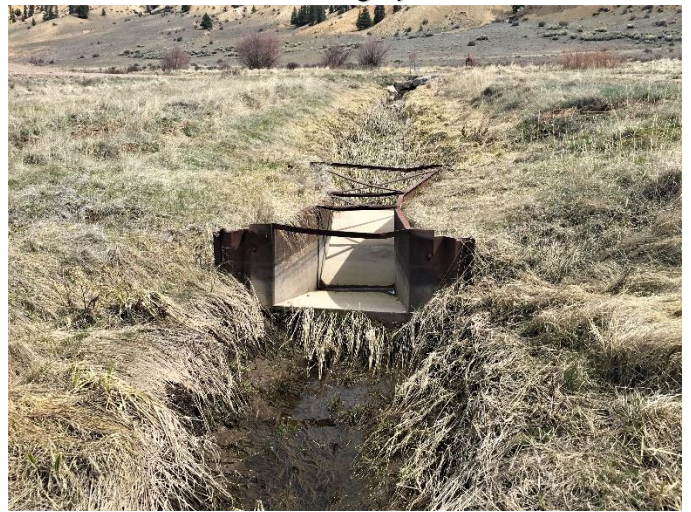
Flume looking upstream
