# SAGUACHE CREEK DIVERSION INFRASTRUCTURE INVENTORY

**Structure Name:** MOSES GOFF D 2

**Date:** April 11, 2019

Saguache Creek Stream  
Management Plan

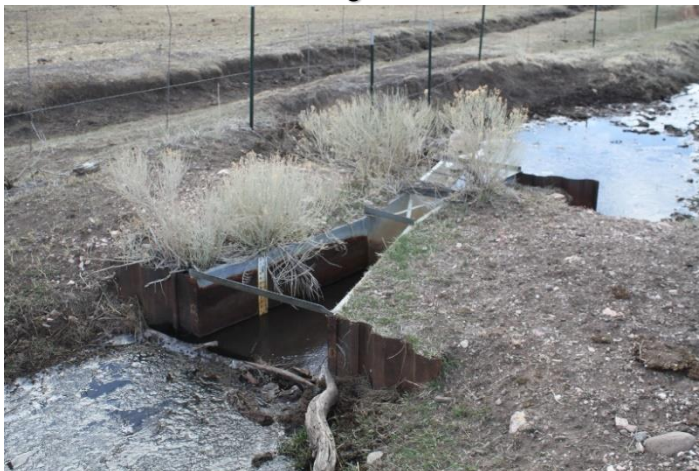
Flume looking downstream

**Structure Description:** This ditch is located just downstream of County Rd Z. Head pressure is adjusted using a 2' wide culvert checkboard structure. Sediment and debris accumulation is a major issue at this structure. Water runs around flume and is eroding it.

**Repair(s) or Improvement(s) Currently Needed:** The flume needs to be stabilized or filled to prevent further erosion. The ditch requires continued maintenance to clean sediment and debris from headgate and channel.
