SAGUACHE CREEK DIVERSION INFRASTRUCTURE INVENTORY

Structure Name: WOODARD BROS D

Date: April 4, 2019

Saguache Creek Stream
Management Plan

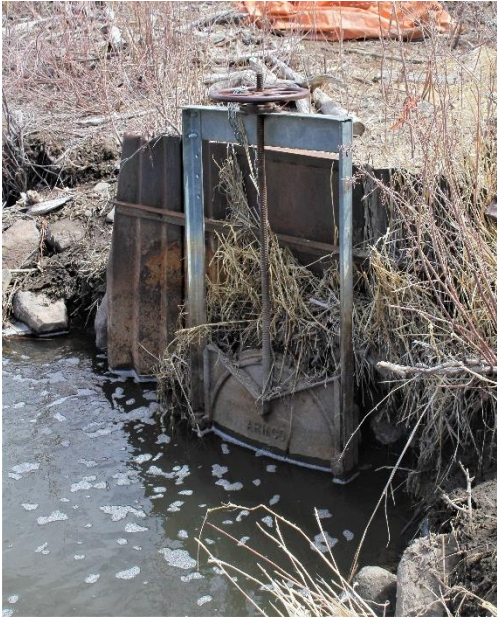
Headgate looking downstream

Structure Description: The diversion dam is a stacked rock structure with a telephone pole. It directs water to the headgate on the south bank of the stream. Sediment accumulation is an issue at this structure. The headgate leaks excessively.

Repair(s) or Improvement(s) Currently Needed: The leaky headgate needs to be repaired. To address the sediment accumulation issue, a sluice gate could be installed adjacent to the headgate. The flume measures accurately. Fish passage and riparian restoration should be considered as part of any future repairs or improvements.
