**ARCHAEOLOGICAL ASSESSMENT REPORT**  
**on the**  
**COLORADO-YULE MARBLE CO. FINISHING MILL SITE**  
**Town of Marble, Gunnison County, Colorado**

SHF Grant No. 2003-AS-005

November 2002

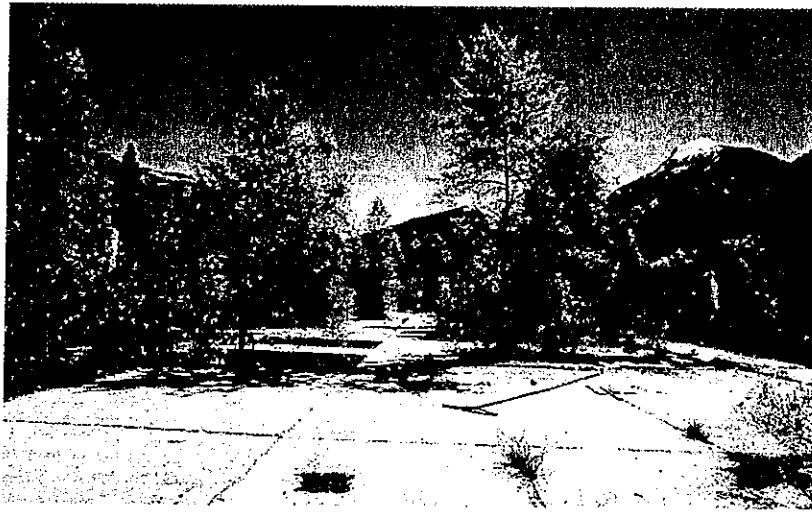
Figure 7. Overview of Shop 2, looking west. Concrete slab floor is intact and boundaries are well-defined.

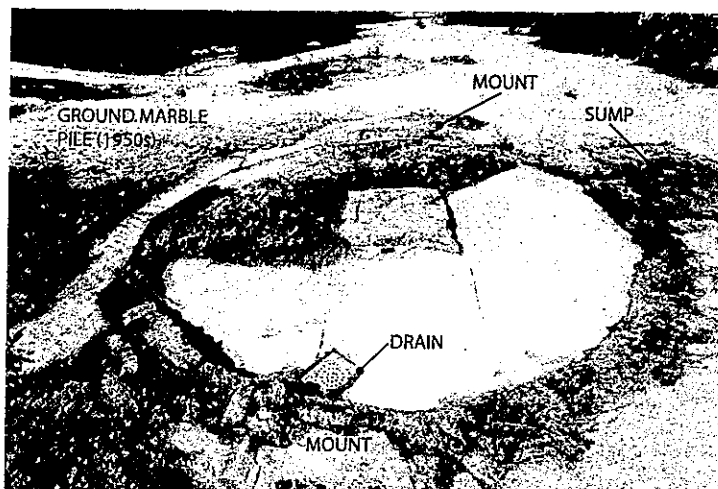
Figure 9. Half of rubbing machine base S2.3 in Shop 2 was excavated to expose its details. Photo looking west.

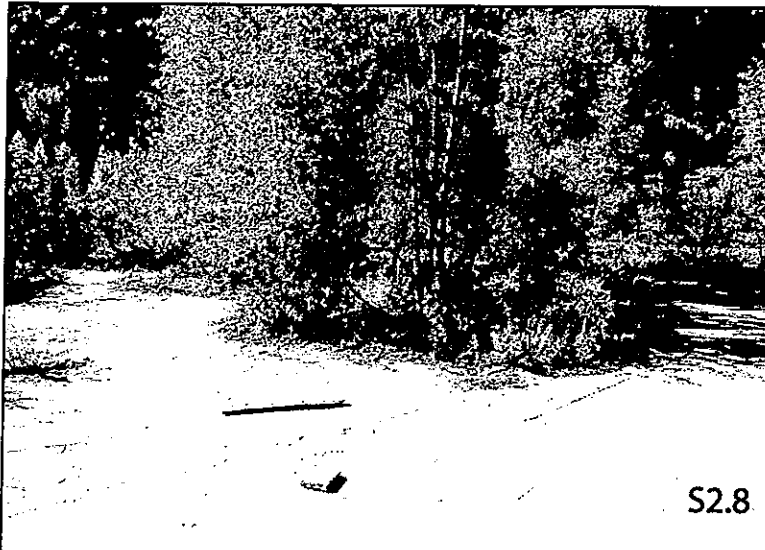
West of the rubbing machines, three large machine bases were discovered, obscured by dense patches of vegetation growing among them (Figure 6: features S2.8, S2.9, S2.13 and Figure 10). Some subsurface exploration revealed the shape and dimensions of the bases as shown on Figure 6. Several historic photos taken in 1909 are helpful in determining which machines corresponded with

Figure 10. Shop 2 machine bases S2.8, S2.9 and S2.13 are obscured by heavy vegetation. Photo looking south-southwest.

6. Remove some of the dense vegetation to expose the shop's south foundation wall. Removal of all vegetation is not necessary nor recommended. Remove some of the vegetation along the north side of the shop as well.

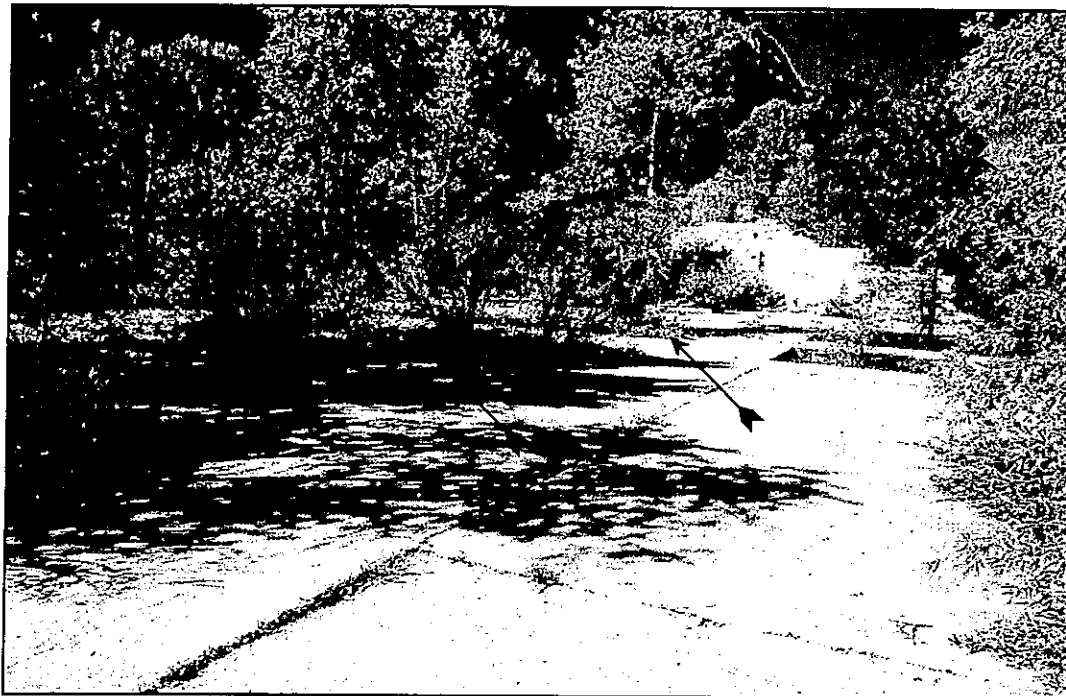
Figure 12. Reproduction of the Shop 2 historic view in Figure 11 shows current conditions and locations of machine bases, looking southwest.

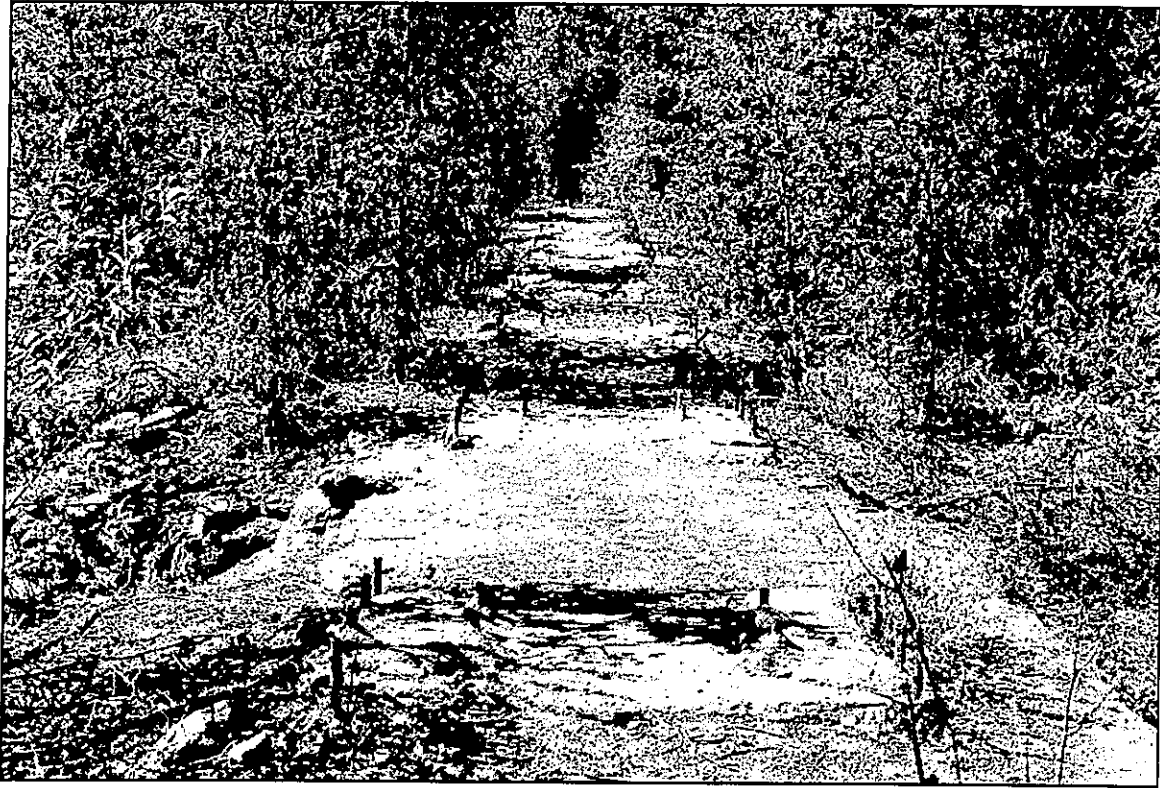
Figure 15. Long row of repetitive machine bases in Section B of Mill B, looking west.

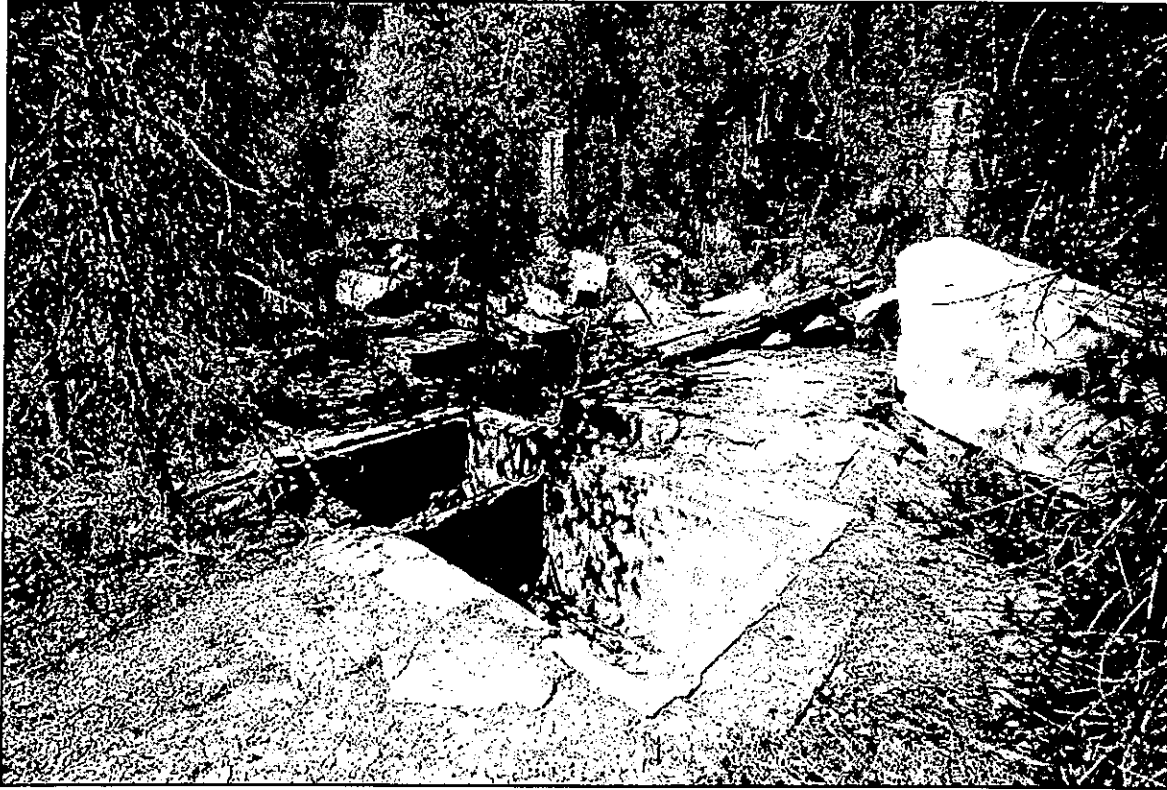
Figure 17. Large open drainage sumps and collapsed concrete flooring characterize Section C of Mill B, which make this area hazardous for visitors. Photo looking northeast.

2. To compliment the fence at the east and west ends, another fence can be installed in the Stone Yard area along the length of the northern boundary of Mill B, between the two firewalls. Once again, this type of fence is not designed to completely block access. An iron post, single-chain fence about 4½ feet high would be enough, and it would be visually unobtrusive. Hang signs along the fence that tell visitors to stay out of the Mill B area for safety reasons.
3. To help prevent visitor accidents in Mill B and to protect resources from further deterioration, it is advisable to fill open holes in Section C with clean sand. This includes sumps, areas of floor collapse, pits, drains, and so on.

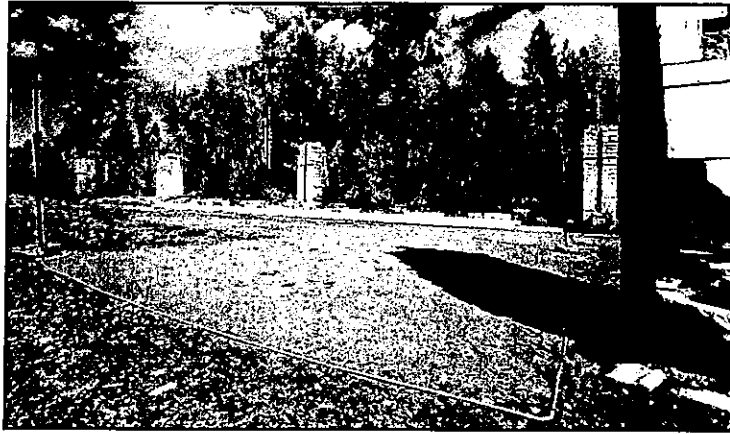
Figure 19. The east end of the Stone Yard is currently being reused as an ice rink in winters. The north side of the yard is defined by a row of marble support piers. Concrete footings between the piers are obscured by dense vegetation.

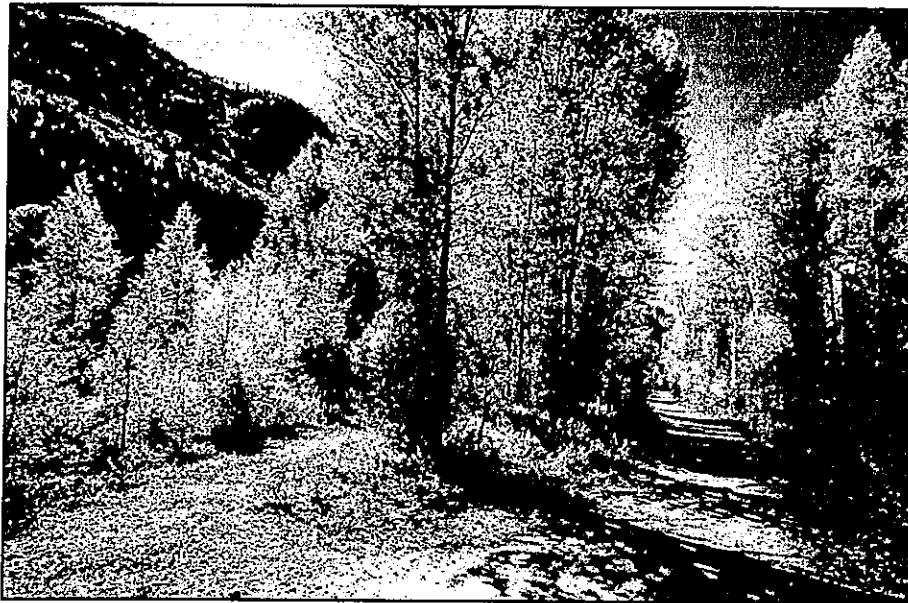
The machines used in the Stone Yard— the overhead cranes, the wire saw, and railroad/tram equipment— are no longer intact. Vegetation has grown so thick in the Stone Yard that it is difficult to discern the marble piers to the north or the mill area to the south from the path itself (Figure 22). The long marble reinforcement piers are an impressive and memorable part of the site and are important in defining the mill's northern boundary. The Stone Yard and crane served an essential function in processing at the mill and should be interpreted.

Figure 22. Thick vegetation in the Stone Yard obscures views of the mill area in all directions. Photo looking west-southwest.

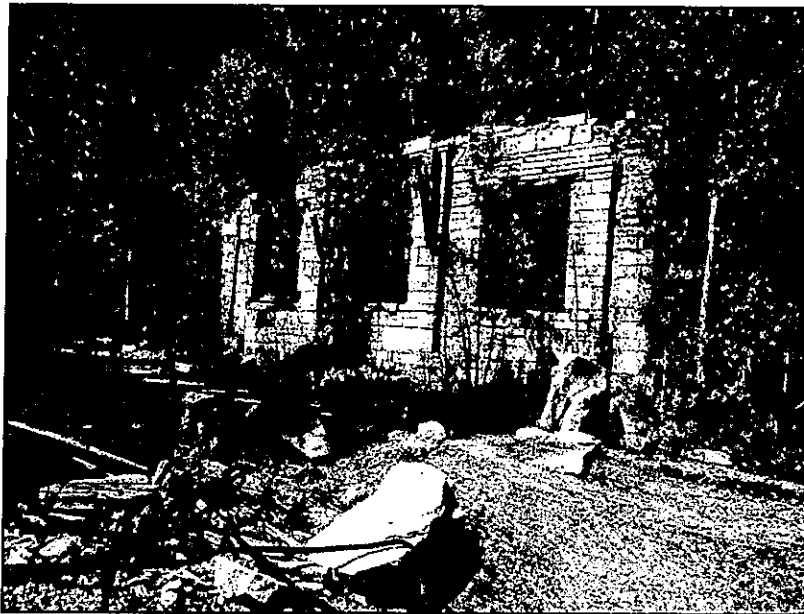
Figure 24. Crane support piers are located adjacent to Shop 4's west side. The crane yard was covered in this area and a large machine bed is located between this wall and the north wall of the Coping Shop. Photo looking northwest.

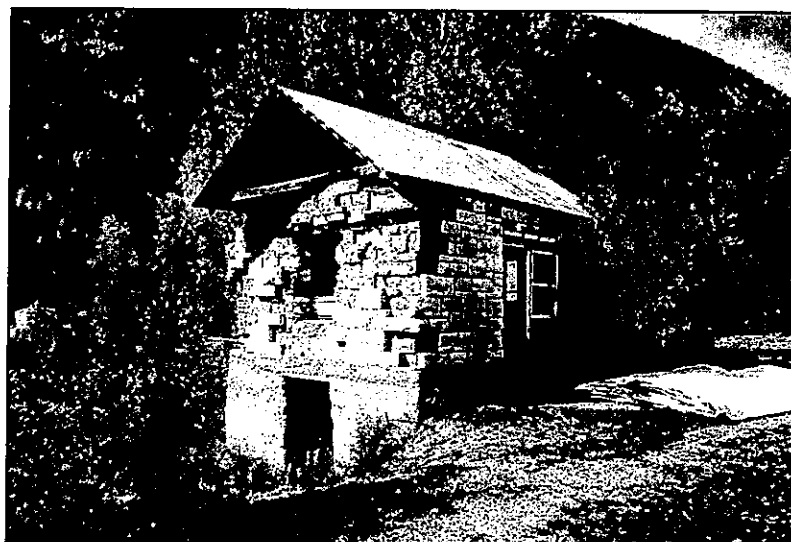
Figure 29. The Document Storage Vault is one of two structures that remain standing today. Much of the marble facing has been robbed, and the window/doorway is not original. The gable roof was installed to protect the building from weathering. Photo looking south-southeast.

The gable roof on the vault today is clearly not original, but was installed to protect it from further water damage. There is a large 6-foot 7-inch by 7-foot 4-inch doorway on the north side and a 3-foot by 3-inch by 4-foot 8-inch window opening on the east side, neither of which are original. Their construction and reinforcement are roughly done, with little concern for finish or appearance. On the west side, an original 3 by 6-foot doorway that provided the only access to the vault from the Front Offices. The concrete foundation is exposed on three sides where it is obvious that the surrounding fill has been removed some time ago. The southwest foundation corner of the structure is exposed just over 7 feet from the ground level to bottom of the first course of stone. It is likely that most of the vault's foundation is exposed on the south and east sides. The foundation itself is of a curious design because it was left open at the rear (west) side of the building (Figure 30). The 3 by 5-foot corridor through the center of the foundation contains a 2-foot-high iron framework constructed of standard and narrow gauge rail. Its function was part of a conveyor system installed in the 1950s by the Basic Chemical Co. to move crushed marble from the Front Offices area into trucks for transportation to market.

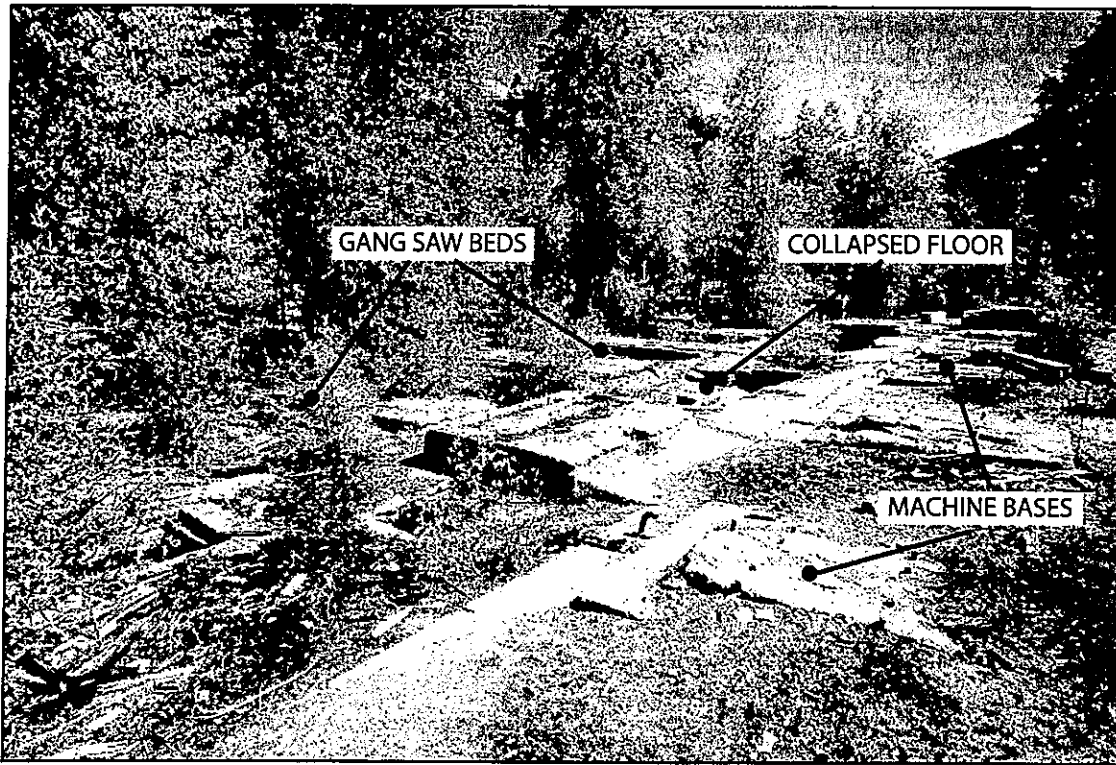
Figure 35. Overview of Mill A remains, looking east-northeast.

4. Fill the holes and sumps in the broken floor area with clean sand. This will improve the safety of the area for visitors and preserve the underlying elements with a distinctive soil if archaeological excavation is ever contemplated in the future.

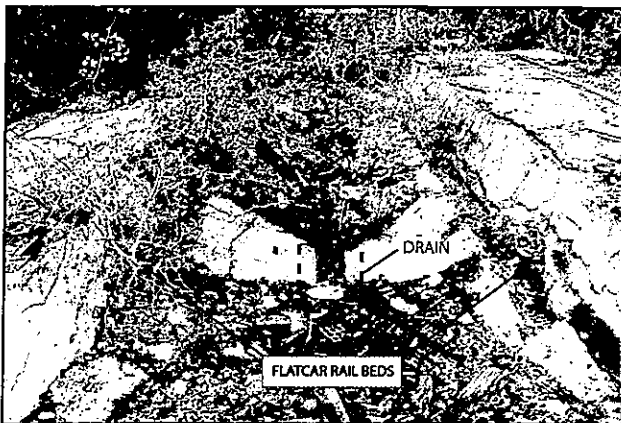
Figure 36. A 4 inch by 10 foot drain runs the length of each saw bed. The intact iron cover of this drain in Mill A was exposed through excavation. Photo looking north.

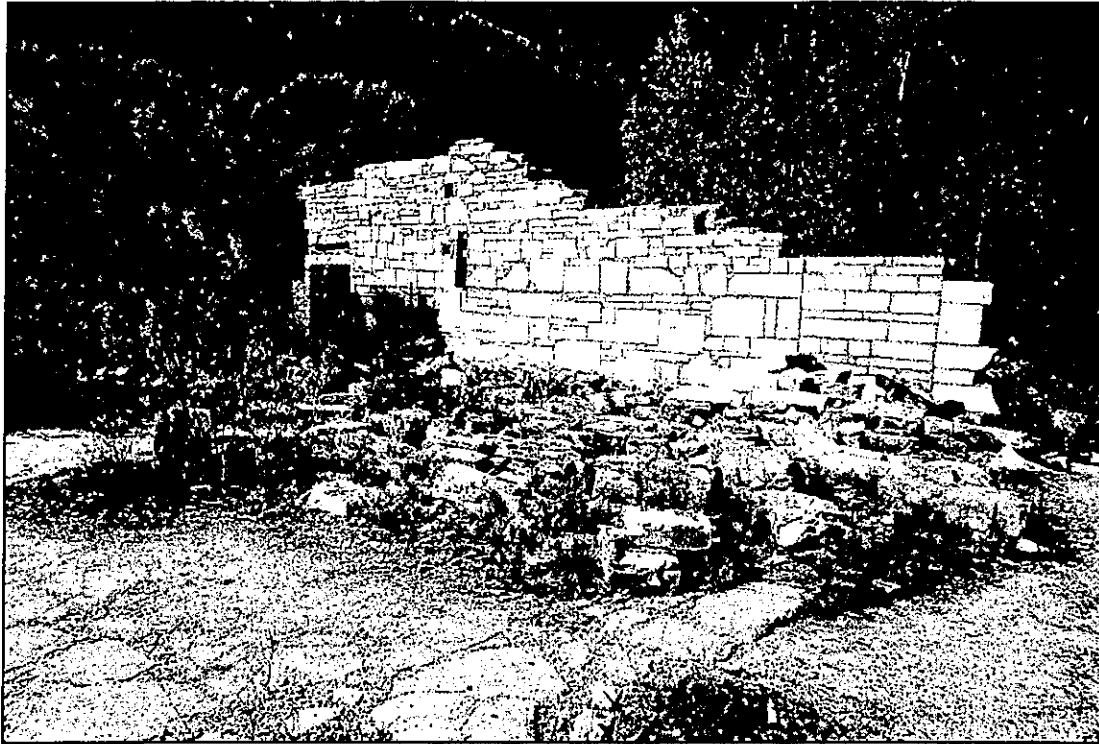
Figure 44. Although partially collapsed, Firewall No. 1 between Shop 2 and Mill B appears stable. Photo looking south-southwest.

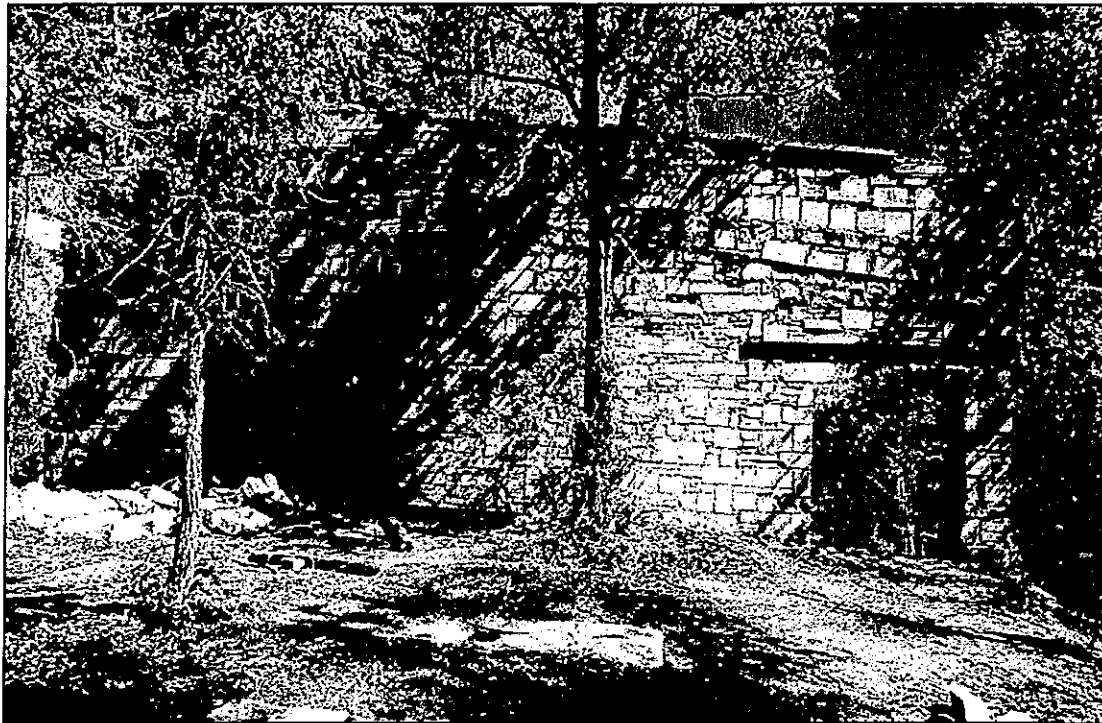
Figure 45. Firewall No. 2 between Mill B and the Coping Shop is at its original height and appears stable. Photo looking east.
