# RIO GRANDE DIVERSION INFRASTRUCTURE INVENTORY

**Structure Name:** OFF D

**Date:** April 9, 2019

**PHOTO LOG**

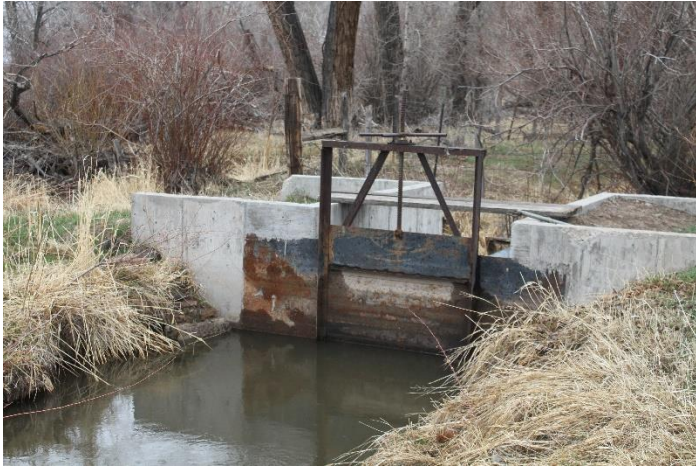
Headgate looking downstream

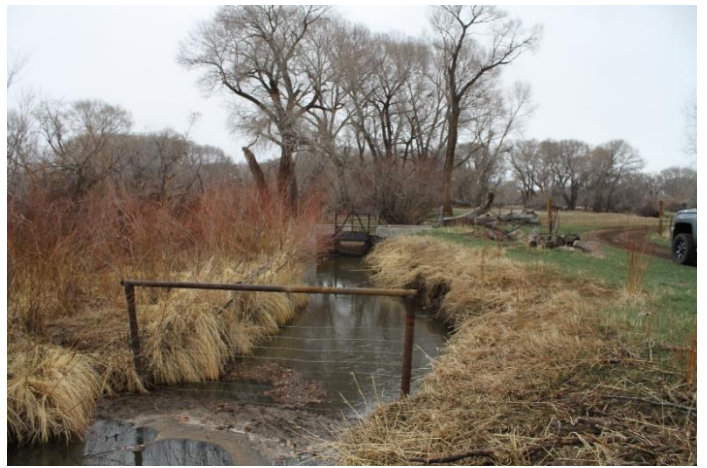
**Structure Description:** Located on the North Channel of the Rio Grande. The channel in this area is very stable. There is a concrete rubble diversion dam across the river, just downstream of the structure, that directs water to a short feeder ditch and the headgate, which sits along the south bank of the Rio Grande. A wire fence serves as a trash rack at the entrance of the feeder ditch.

Headgate and trash rack

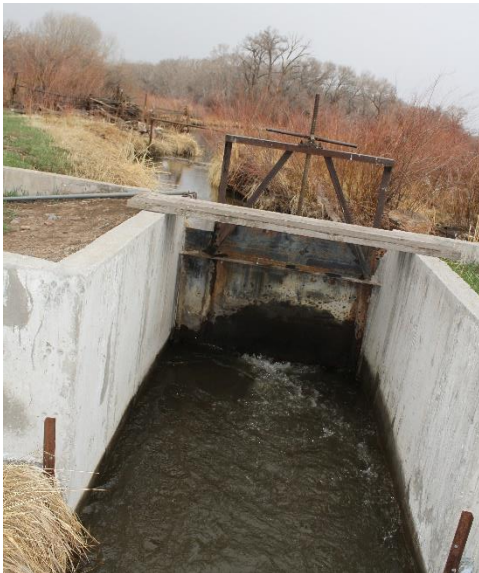
Headgate outlet

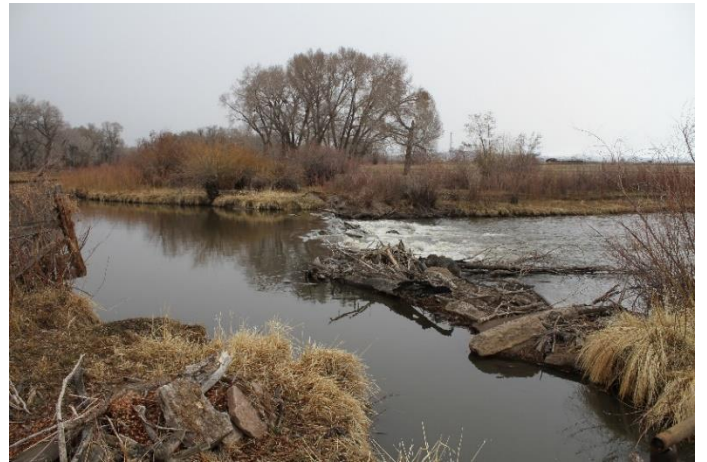
Diversion dam and feeder ditch

**Repair(s) or Improvement(s) Currently Needed:** The diversion dam needs some maintenance, and could be improved with a new stacked rock structure. However, it functions well when maintained. Fish passage and riparian restoration should be considered as part of any repairs or improvements.

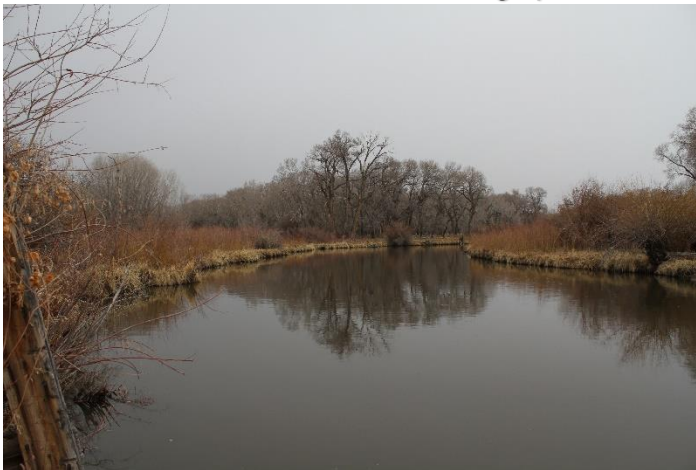
North Channel Rio Grande looking upstream

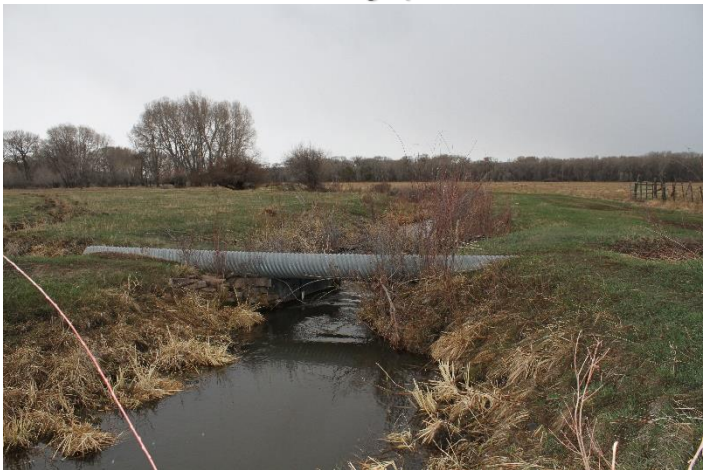
Flume looking upstream
