When it's Rust Call US! **Railings—Anodized Aluminum**

Corrosion Control on existing railings—Cortec VpCI-239

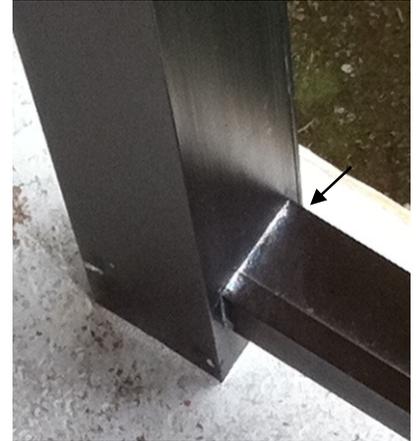
Anodizing does a great job on the surfaces that are exposed to the environment, but when this surface is interrupted, such as a cut area that is seen where the bottom of the rail enters the rail upright/vertical, the edge begins to corrode because there is zero anodizing where the cut was performed. This is the "hot" corrosion area where the electrons are working the hardest to do what you see....corrode.

NOTE: white deposits are not salt—do attempt to scratch off. Do not use any abrasives, such as an aluminum polish or anything that contains a grit in the compound or on paper such as sand paper on aluminum railing.

To prevent this from getting worse, use of CORTEC VpCI -239 ElectriCorr spray will aid in reducing the corrosion attack. CORTEC Electric Corr VpCI-239 should be applied at the first sign of white aluminum oxides. The rule of thumb here is once treated is to inspect the treated areas once a month or so, and note what is seen. Once the aluminum white oxide appears again, it is time to refresh the treatment.

It is important with the application to inject the product with the small red tube the can comes with, into the areas where the rails intersect and run into the vertical uprights. This injection is done under can pressure and will aid in helping the product to migrate to the cut ends of the tubing where the corrosion protection is needed.

Recommend that this be done with the first application 2 times with a week break between the first and second application. **DO NOT WIPE AWAY THE RESIDUAL PRODUCT!** This will aid in better corrosion prevention. If you allow the excess to sit for several days, the better off the corrosion protection will be. The surface can be wiped free within a 2 week period, but if you can leave the product on the rail you'll allow the product to be absorbed for best CPAC procedure.

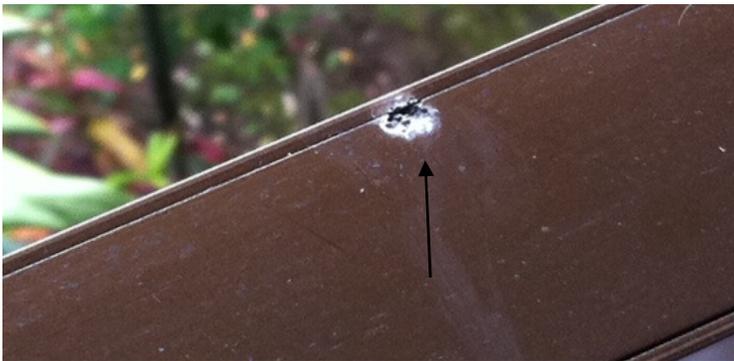
Additionally, the image seen where there is a perforation of the surface and the white particulate build up - that white build up is aluminum oxides - and is often confused with salt deposits.

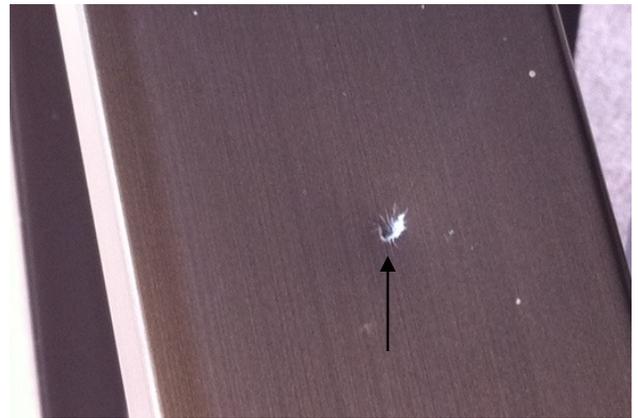
The surface ding area looks to be from something that may have impacted the rail and wore through the anodizing.

These situation may be due to potentially these activities but not limited to: uneven anodization, highly acidic rainfall and fretting, which is a wear down (fretting) of the passivating oxides (passivating oxides help control the corrosion, but fretting - rubbing of the 2 parts due to vibration when the rail is used wears the anodizing and the passivating oxides away from the aluminum surface and allows an acceleration of corrosion to begin).

This highly localized attack is a galvanic corrosion issue, so there is a name to what you see.

In order to prevent this from getting worse....**DO NOT USE BRUSHES!** Especially STIFF brushes. Brushes will aid in wiping away corrosion protection - the very minute layer of oxides - the aluminum rust is similar to galvanized coated steel corrosion as both surfaces passivate. Again, that white powder is aluminum oxides, the by-product of elevated corrosion activity. Those oxides are the spent fuel from the corrosion activity that is starting to consume the rail.
