# SAGUACHE CREEK DIVERSION INFRASTRUCTURE INVENTORY

**Structure Name:** FULLERTON D 3

FULLERTON DITCH 3

PHOTO LOG

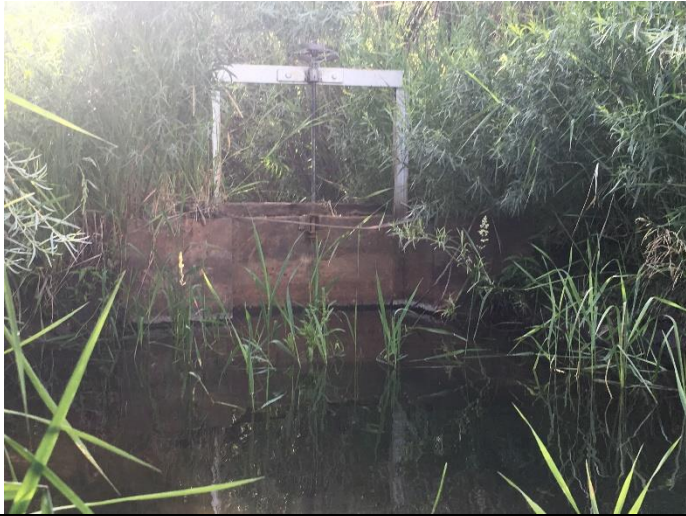
Headgate looking downstream

**Repair(s) or Improvement(s) Currently Needed:** The headgate could be repaired or replaced. The diversion dam should be improved to more effectively divert water despite sediment and debris accumulation. The flume should be leveled, reset, and regularly cleaned. Fish passage and riparian restoration should be considered as part of any future repairs or improvements.

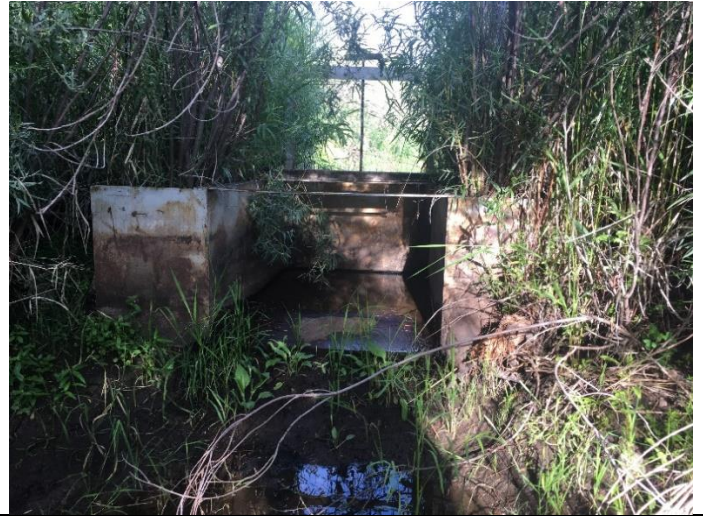
Headgate outlet

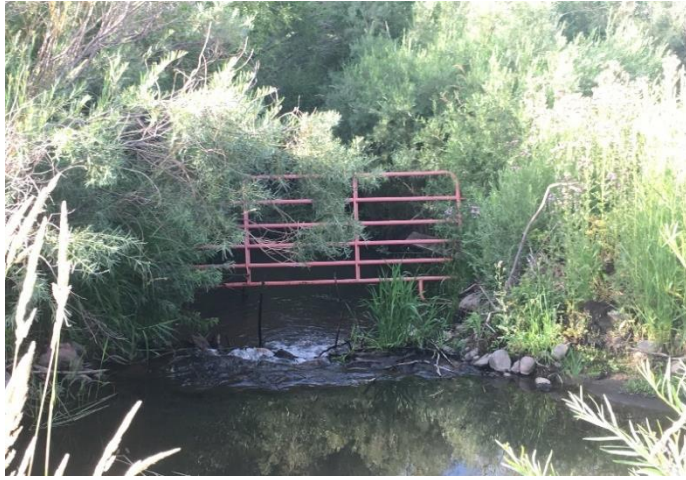
**Structure Description:** This structure is located just downstream of Fullerton Ditch 2 on the Werner Arroyo. The diversion dam is a combination of a checkboard structure and stacked rocks, but the checkboards were recently removed due to debris accumulation and should be repaired or replaced. Beaver dams also negatively impact the diversion structure and channel capacity. The headgate leaks and its frame is twisted. The flume does not measure accurately due to willow encroachment and sediment accumulation.

Diversion dam looking downstream

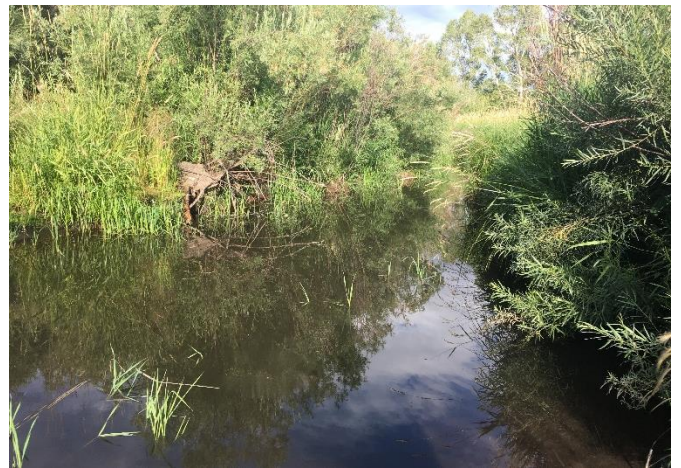
Diversion dam

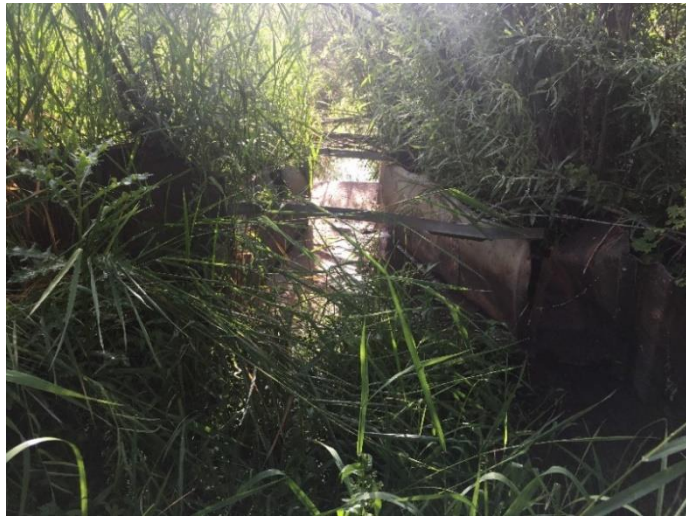
Flume looking downstream

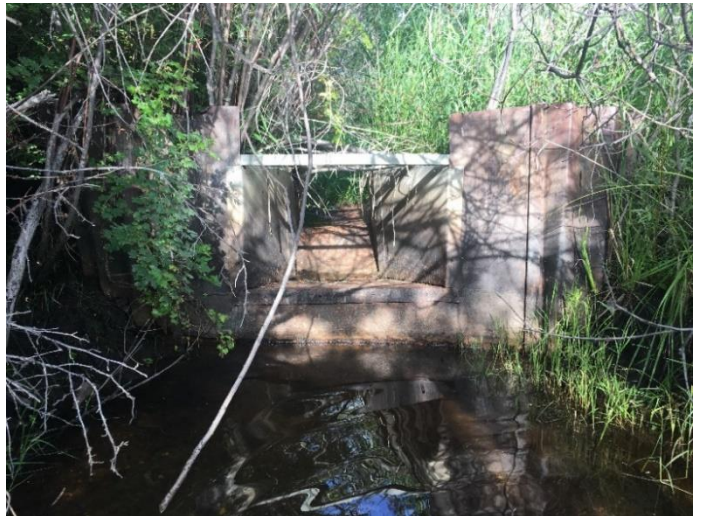
Flume looking upstream
