SAGUACHE CREEK DIVERSION INFRASTRUCTURE INVENTORY

Structure Name: WALL D

WALL DITCH

Saguache Creek Stream Management Plan

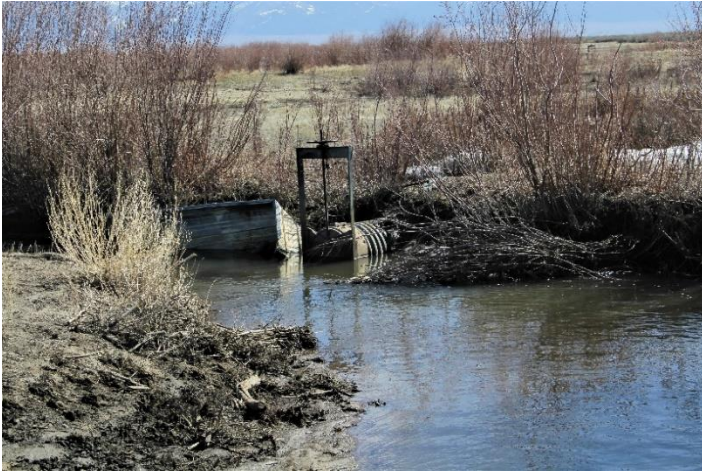
Headgate looking downstream

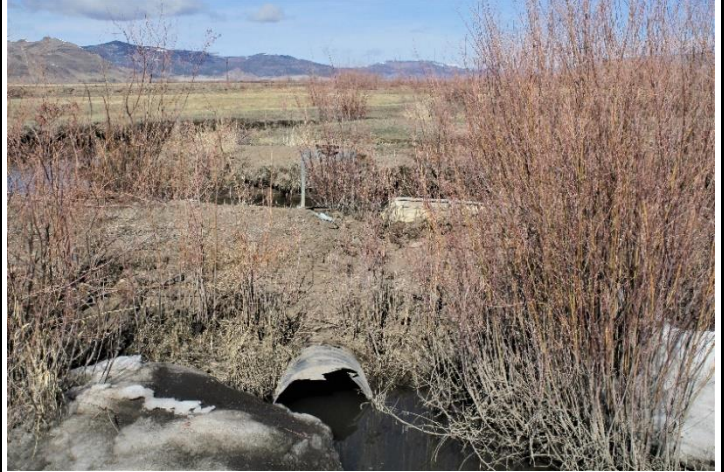
Headgate outlet

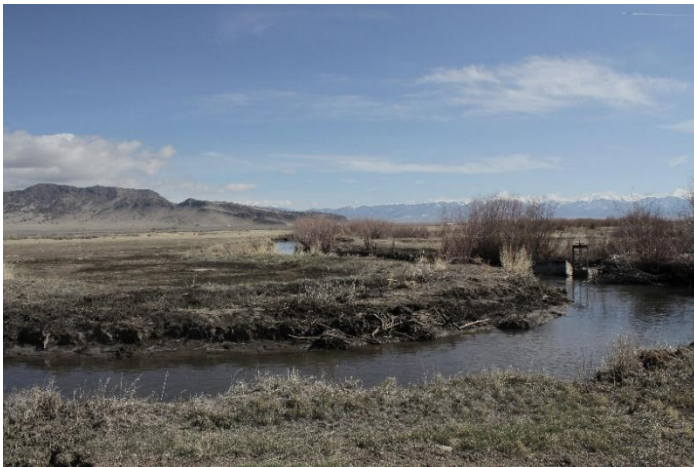
Channel looking downstream

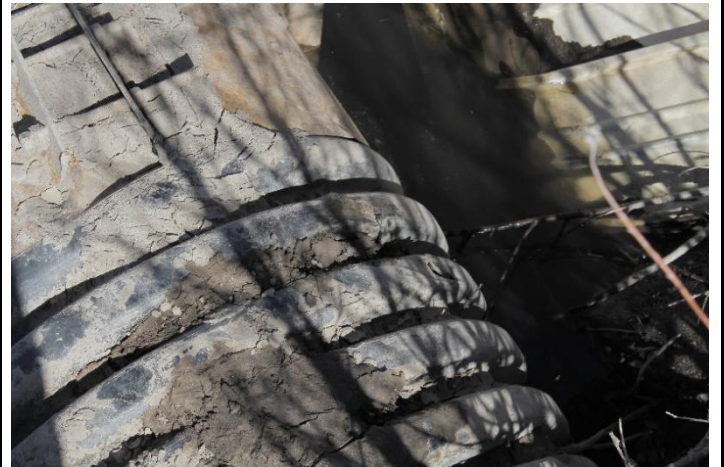
Damage to headgate culvert

Repair(s) or Improvement(s) Currently Needed: The diversion dam should be replaced with a low maintenance structure that is integrated with the headgate. The headgate culvert needs to be repaired or replaced. The flume should also be replaced. Fish passage and riparian restoration should be considered as part of any future repairs or improvements.

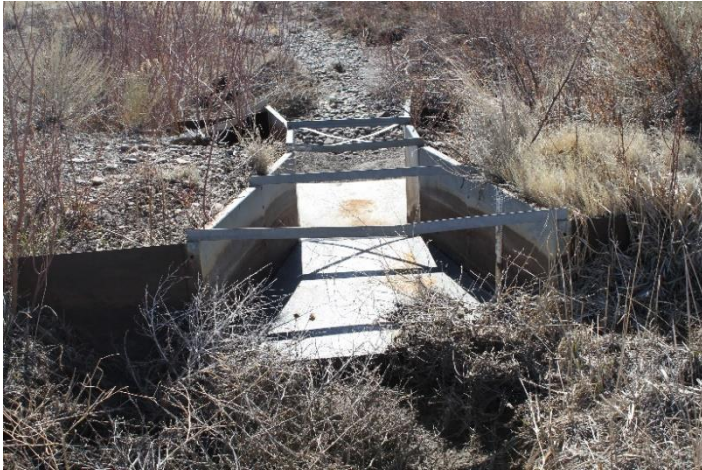
Flume looking downstream

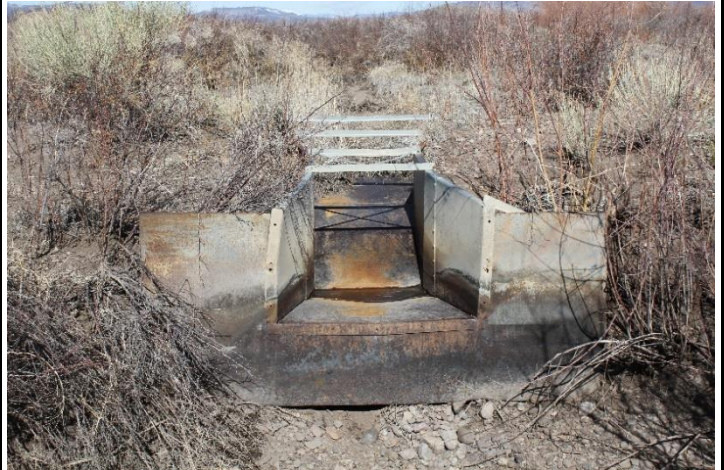
Flume looking upstream
