Inspection Report

Property Address:
2914 Crimea Street
Versailles KY 40383

Talon Home Inspections, LLC

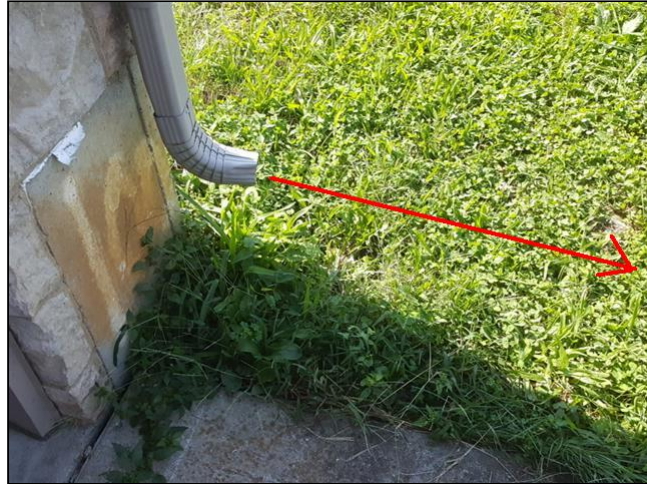
2.3 Item 1(Picture) rear left corner of home

2.3 (1) The downspout is missing a splashblock and is discharging on the ground next to the foundation of the home where indicated in the photos. The downspouts should discharge water through leaders then onto splash blocks at least 5 feet from the home. Storm water should be encouraged to flow away from the foundation/home at the point of discharge to prevent water entering the basement and to prevent settlement of the foundation. Recommend repair and correcting as needed by a general contractor.

Note: You may wish to consider burying the extension to prevent a tripping hazard. See photos for example.

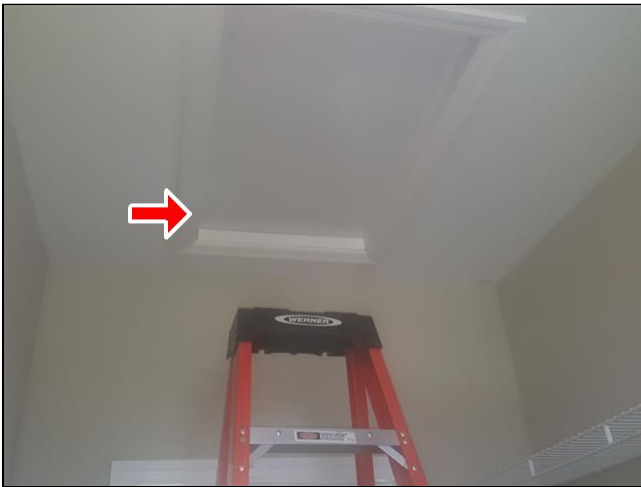
2.4 Item 1(Picture) master bedroom closet

2.4 (1) Attic access location (see photo)

2.4 (2) Recommend the attic access hatch be insulated to prevent air and heat loss for energy conservation.

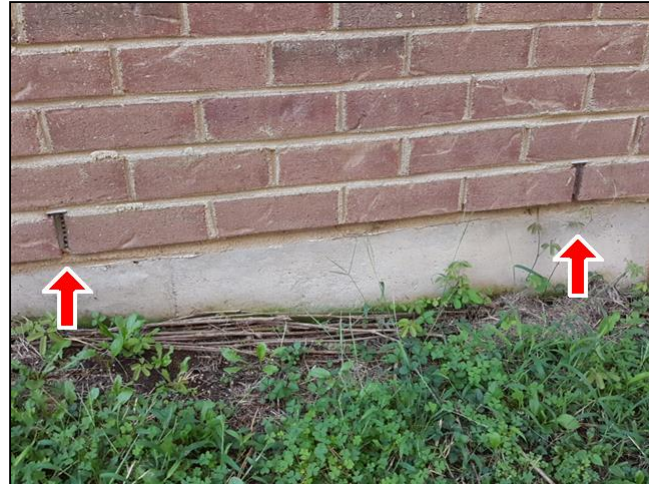
3.0 Item 1(Picture) above garage

3.0 Missing mortar in these areas of the brick siding are known as weep holes. They allow moisture to escape from behind the wall siding. They should not be filled in. This is for your information.

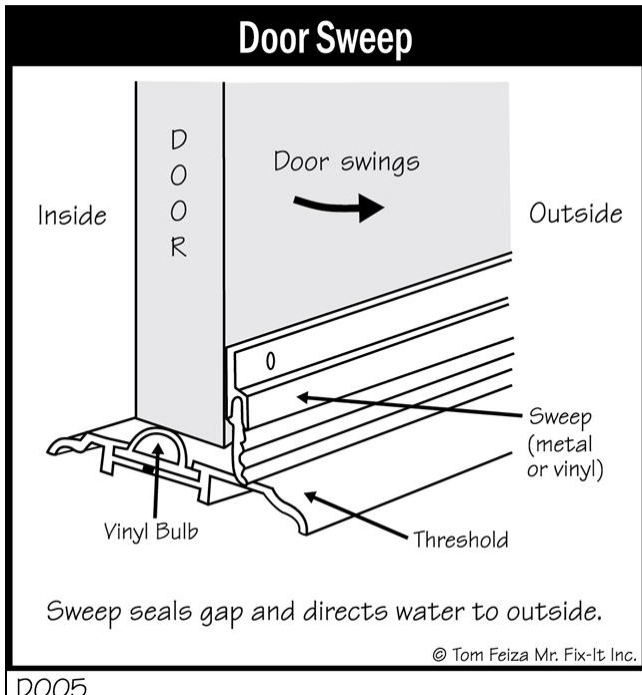
3.3 Item 1(Picture)

3.3 (1) I would recommend a door sweep be installed at the rear basement door of the home to ensure water intrusion does not occur especially in winter when it snows. This is for your information

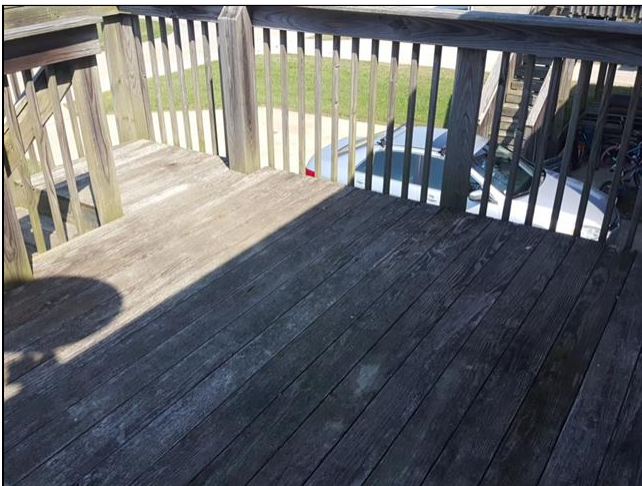
3.6 Item 1(Picture)

3.6 (1) Treated wood used for decks and railings has a limited life span of 10-15 years. Recommend sealing the deck and posts to prevent deterioration via the boards drying, cracking, and splitting.

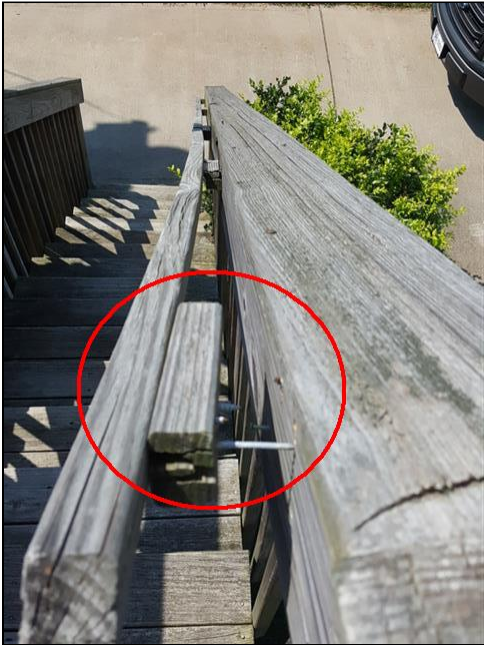
3.6 Item 3(Picture)

3.6 (2) The stair case rail on the on the left side at the rear deck is not secured properly. This is extremely dangerous and is a safety concern. For your safety it should be strengthened and secured. Recommend a qualified contractor repair as needed before closing.

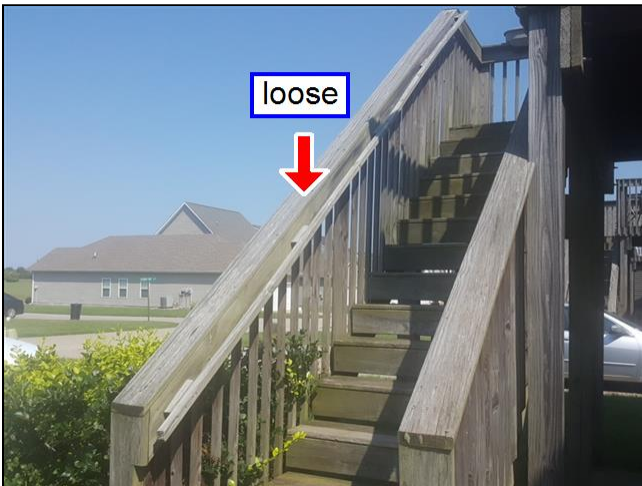
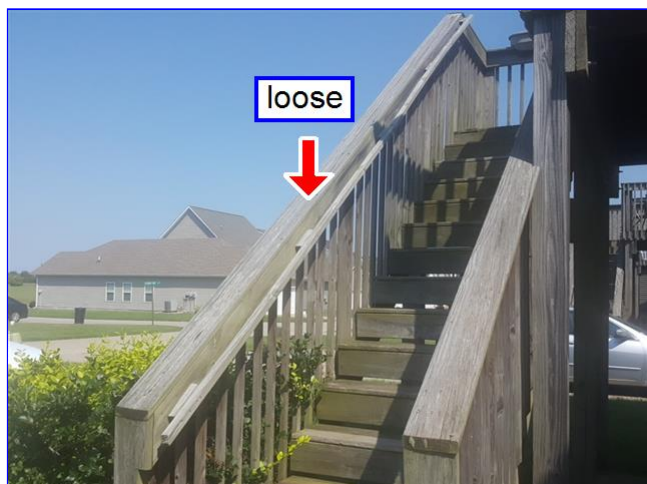
3.6 Item 4(Picture)

3.6 (3) The stair case guard rail on the left side at the rear deck is unstable, wobbles and is not secured properly. This is extremely dangerous and is a safety concern. It may fail under a medium or heavy force or if someone was pushed against or was leaning on the railing. For your safety it should be strengthened and secured. Recommend a qualified contractor repair as needed before closing.

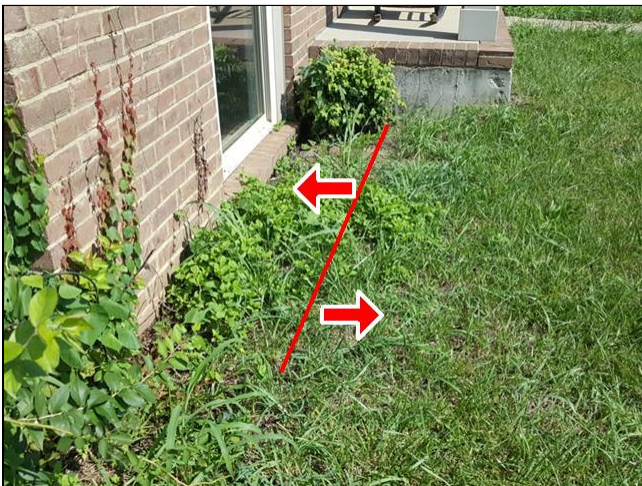
3.10 Item 1(Picture)

3.10 There are depressions in the soil around the foundation perimeter at the front left side of the home. Recommend filling all depressions and re-grading the soil so the soil slopes away from the home around the foundation to ensure water pooling does not occur in these areas. Water pooling could lead to to basement leakage.

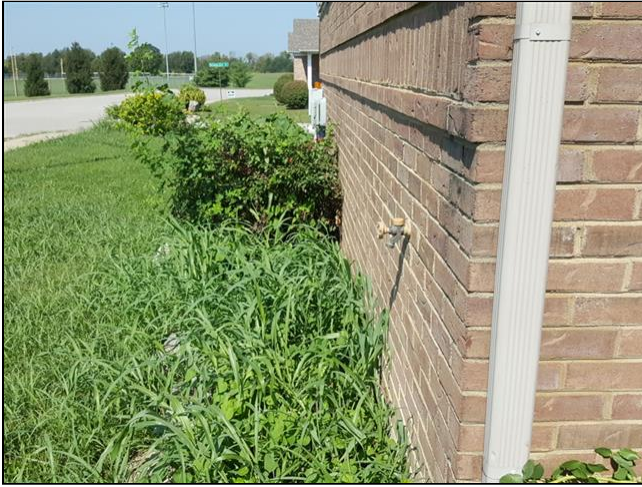
3.11 Item 1(Picture) left side of home

3.11 (1) The vegetation where indicated in the photos should not to be in contact with the home, especially dense foliage and ivy. Plants can hold moisture against the building, slow down the drying effect of circulating air and they provide a hiding place for rodents. Recommend that all vegetation be kept neatly trimmed and away from the foundation, wall siding, and window frames to prevent damage to the home and allow proper venting and inspection of house. A 6" clearance is recommended. Cutting back plants from the walls is a good idea.

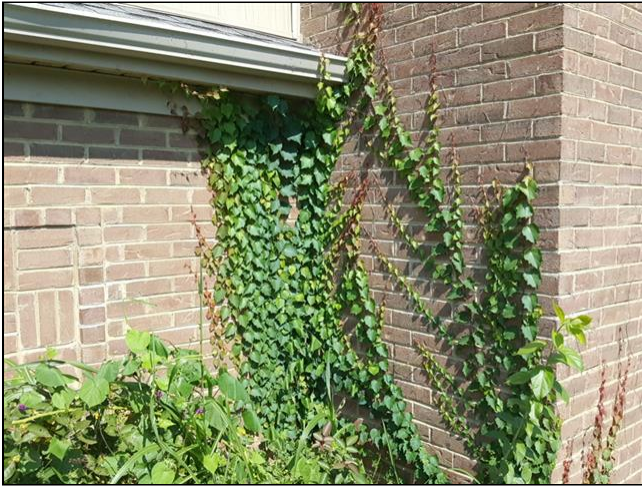
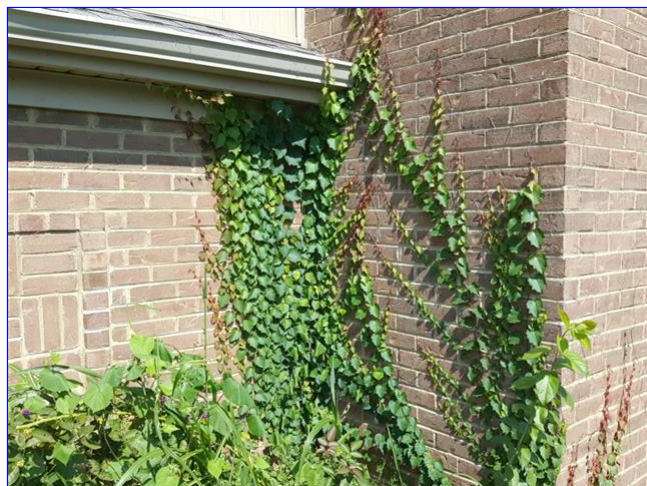
3.11 Item 4(Picture) front left side of home

3.11 (2) Vines growing on exterior walls at the front left side of the home should not be in contact with siding, window trims and the eaves to reduce the risk of insect and water damage to the building. Recommend removing plant.

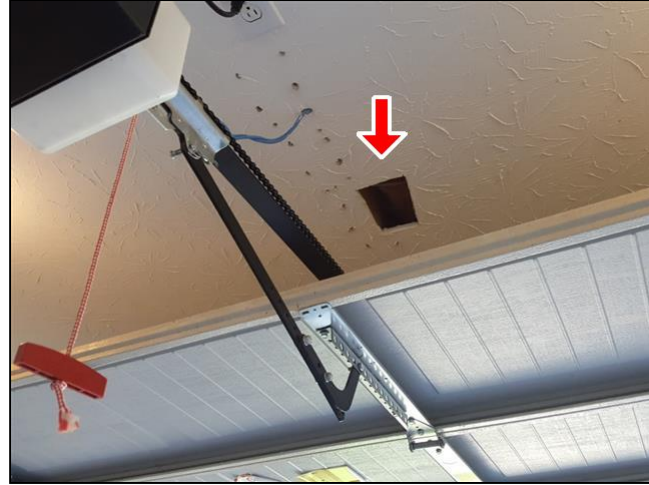
4.0 Item 1(Picture)

4.0 Openings in the ceiling of the garage were noted and are hazardous. Openings and exposed wood may allow a garage fire to quickly spread into the home. These openings should be well sealed to prevent fire spreading into the above living areas in the home. This is a safety issue. Recommend a qualified contractor repair holes and openings in the garage ceiling as needed for your safety.

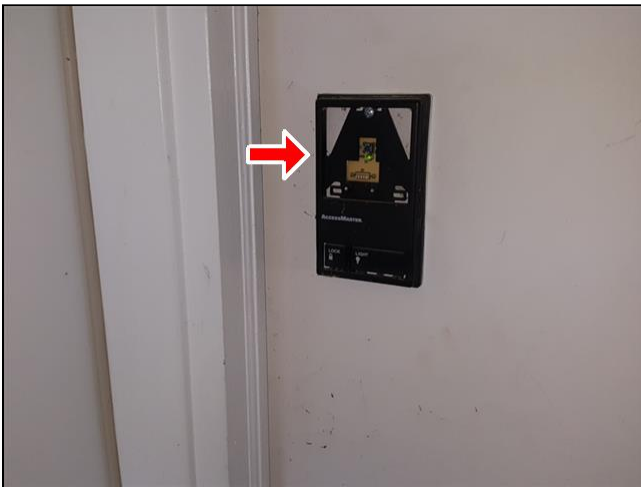
4.3 Item 1(Picture)

4.3 (2) The garage door opener is missing a cover. Recommend one be installed to allow ease of opening the garage door and to prevent a possible electric shock.

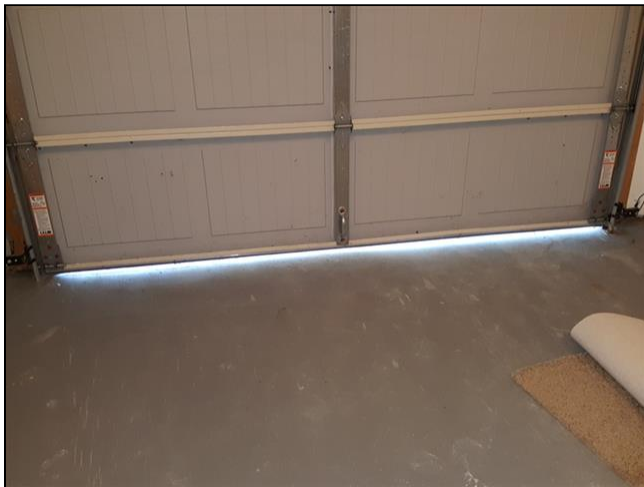
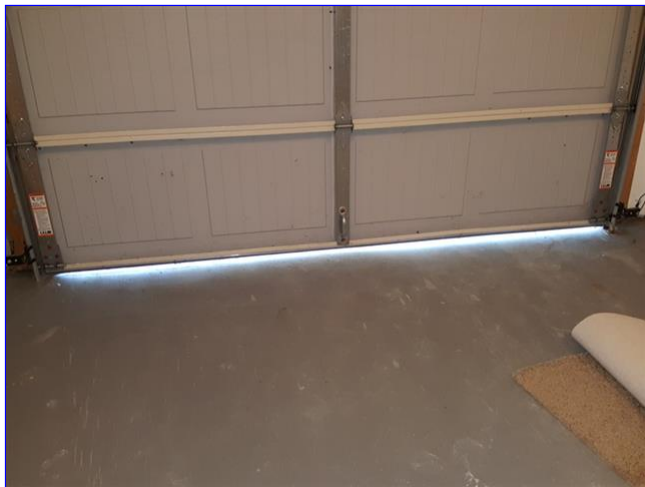
4.3 Item 4(Picture)

4.3 (4) The garage door weather stripping at the bottom is not sealing against the flooring. Recommend replacing or correcting door to close closer to the ground to prevent insect, rodent, or weather entry. A qualified garage installer is recommended for this repair/correction.

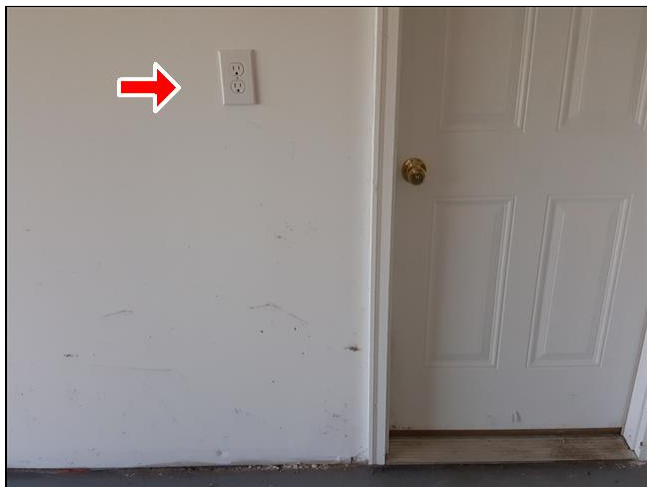
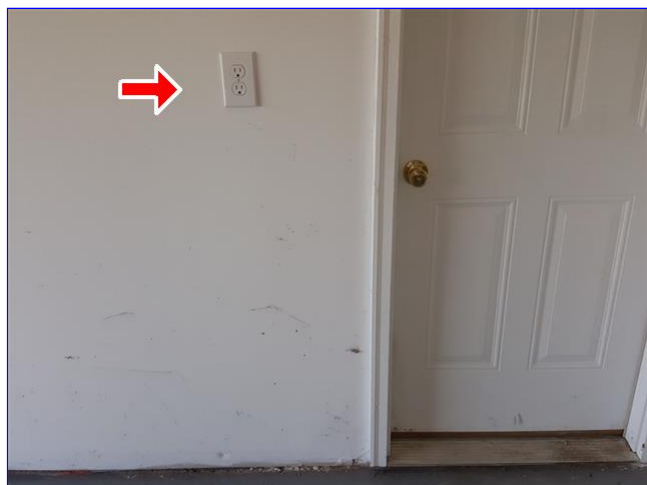
4.6 Item 1(Picture)

4.6 (3) The outlet(s) in the garage where indicated in the photo(s) are loose at the wall or in the outlet box. Electrical issues are considered a hazard until repaired. This is a safety issue that needs to be corrected due to an electric shock or fire from loose connections could occur if not repaired. Recommend a qualified licensed electrical contractor correct as needed.

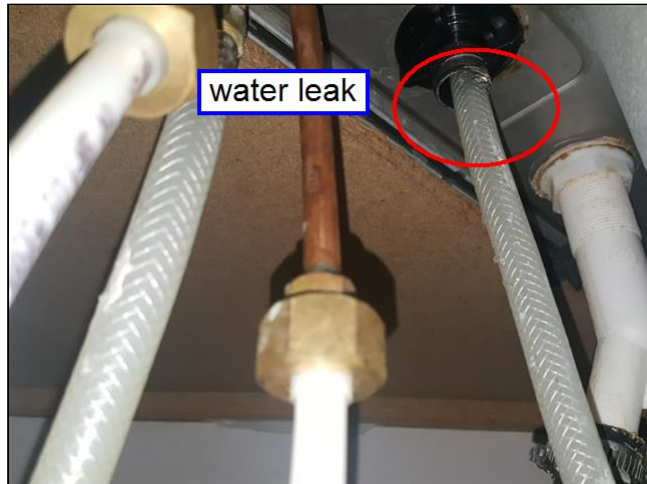
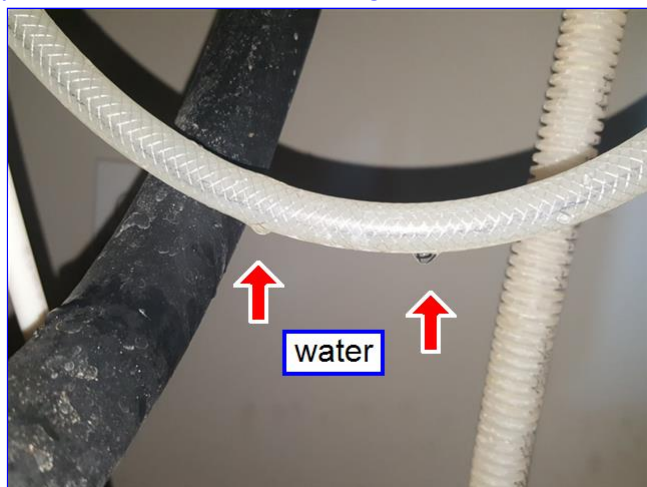
5.0 Item 1(Picture)

5.0 (1) There appears to be a minor water leak at the line for the spray nozzle in the kitchen. Recommend a plumber repair as needed to prevent damage to the base of the cabinet and to prevent mold from occurring.

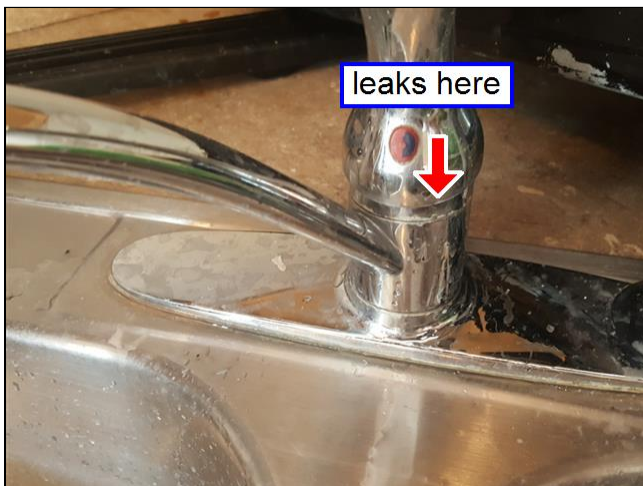
5.0 Item 4(Picture)

5.0 (4) The water faucet faucet leaks at the stem when water is turned on at the sink in the kitchen. Repairs by a licensed plumber is recommended to prevent possible damage to the counter top and base of the cabinet as water dripping was experienced under the cabinet at the time of the inspection. Recommend a qualified plumber repair as needed to prevent possible mold from occurring under the sink and to prevent damage to the bottom of the cabinet.

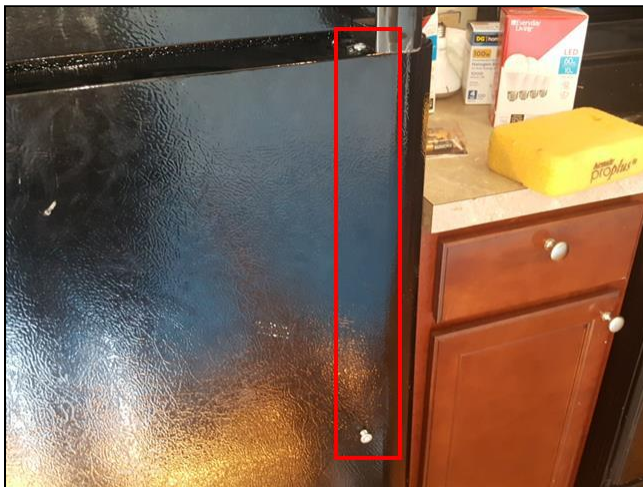
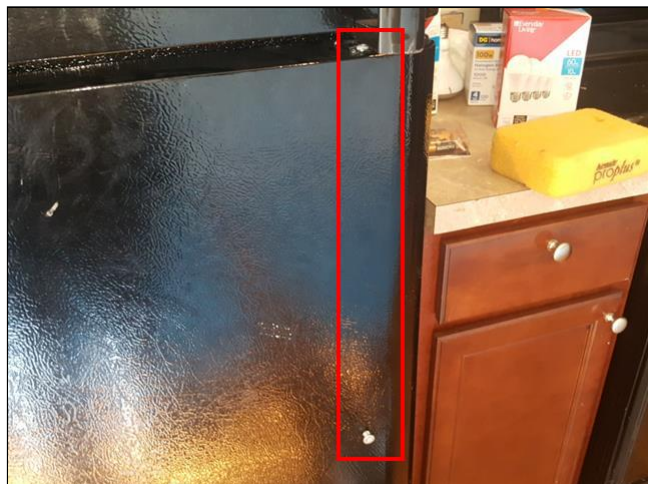
5.6 Item 1(Picture)

5.6 (1) The refrigerator door handle is broken/missing. Recommend replacement as needed.

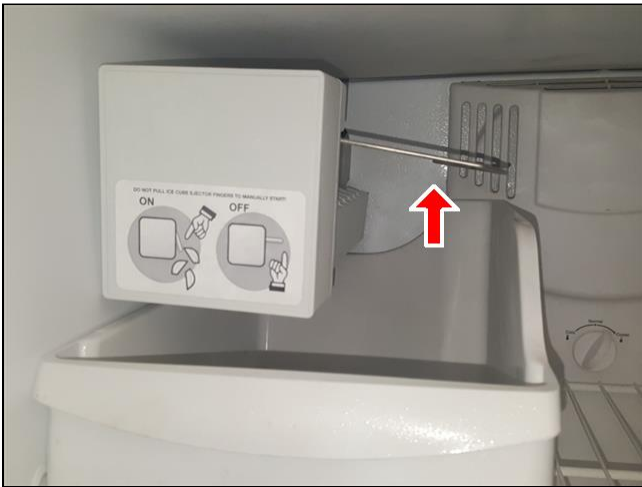
5.6 Item 2(Picture)

5.6 (2) The ice maker was turned off at time of inspection. Cannot determine if there is a visible water line entering the refrigerator due to access. Check with the owner for reason why the ice maker is turned off. This is for your information.

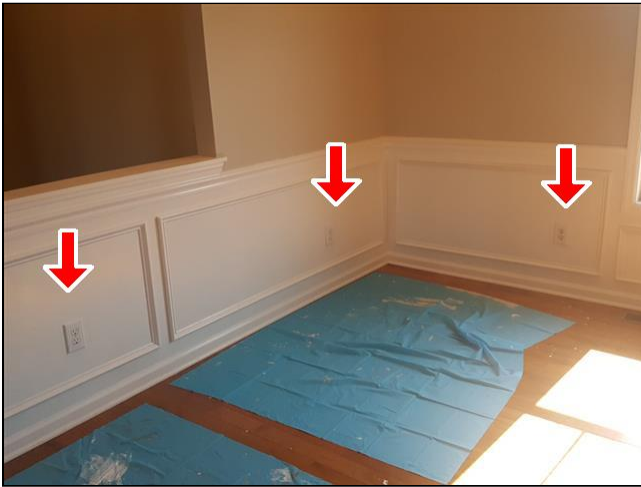
5.9 Item 1(Picture)

5.9 (2) The outlets in the kitchen are not GFCI protected where indicated in the photo. GFCI (Ground fault circuit interrupters) outlets should be considered for installation as a safety upgrade in all locations where water is present if the outlets are not presently connected to a GFCI. They are now required in all bathrooms, kitchen, unfinished basements, garages, exterior outlets, or other locations within 6' of a water source or sink. GFCI outlets may not have been required when this house was built but should be considered for safety. Personally recommend a licensed electrician replace or correcting as needed.

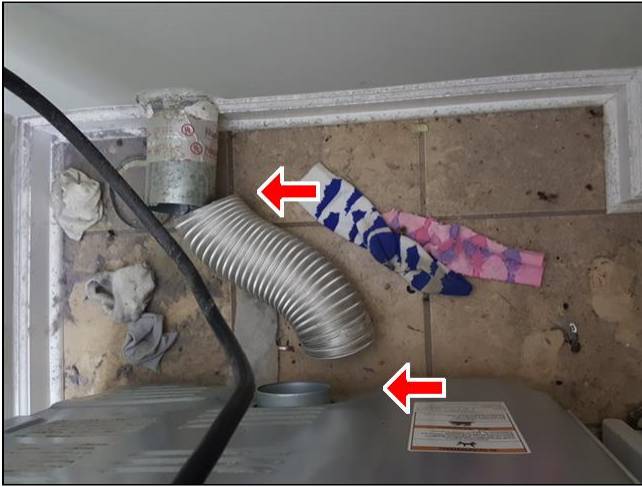
5.10 Item 1(Picture)

5.10 (1) The dryer vent piping is not connected to dryer or the to the exhaust port in the washer/dryer room closet. This is allowing lint and moisture to be released in the air and is not healthy in closed rooms. Recommend repair as needed prior to using the dryer in the home.

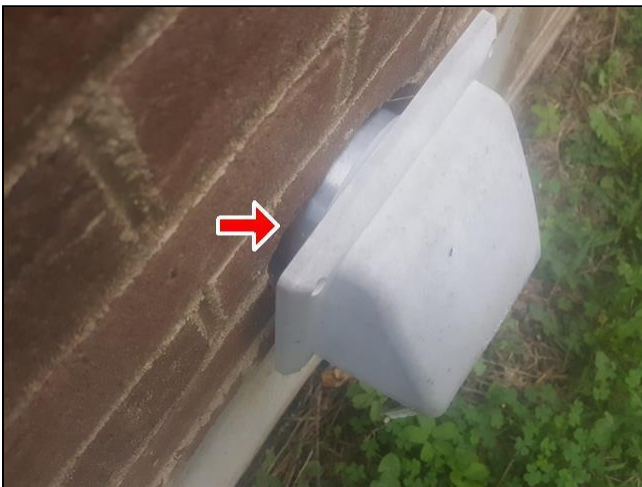
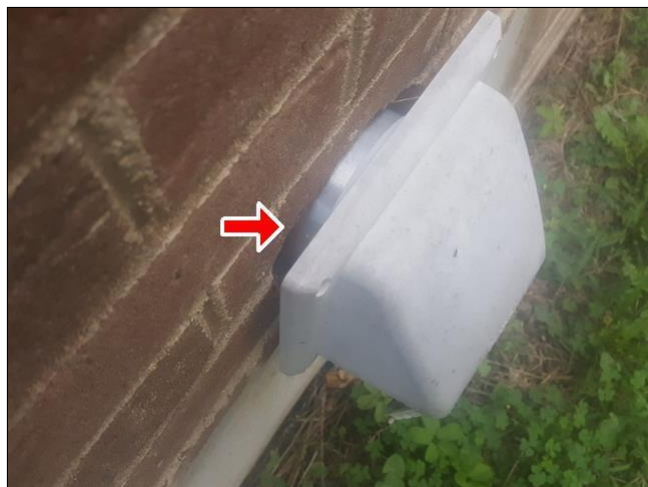
5.10 Item 2(Picture)

5.10 (2) The dryer vent cover at the right side of the home of home is not secured to the wall. It needs securing and gaps sealed to prevent possible water intrusion inside the wall cavity which could lead to deterioration of the wall sheathing or structure. Recommend it be repaired as needed by a general contractor.

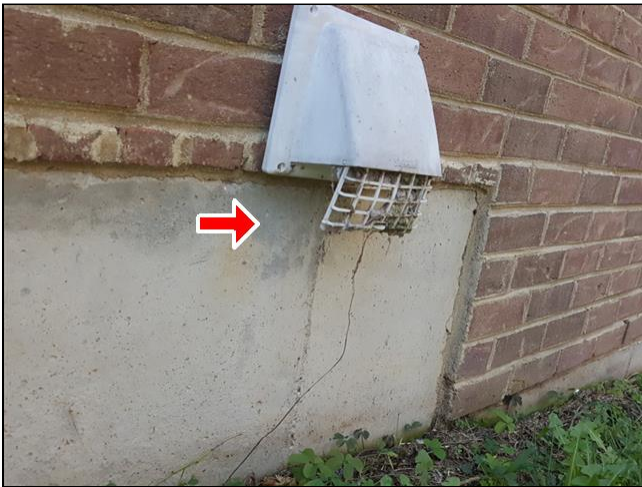
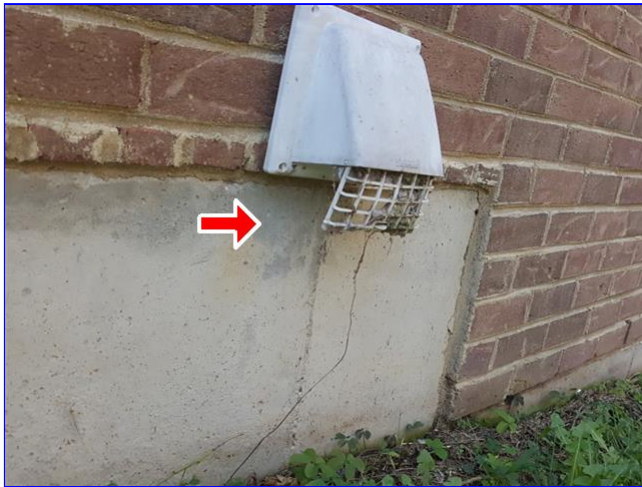
5.10 Item 3(Picture)

5.10 (3) The dryer vent cover is damaged at the right side of the home. The opening can allow rodents or birds to enter then building a nest which may cause a blockage that could result in fire and/or poor venting. Recommend a new vent cover be installed as needed.

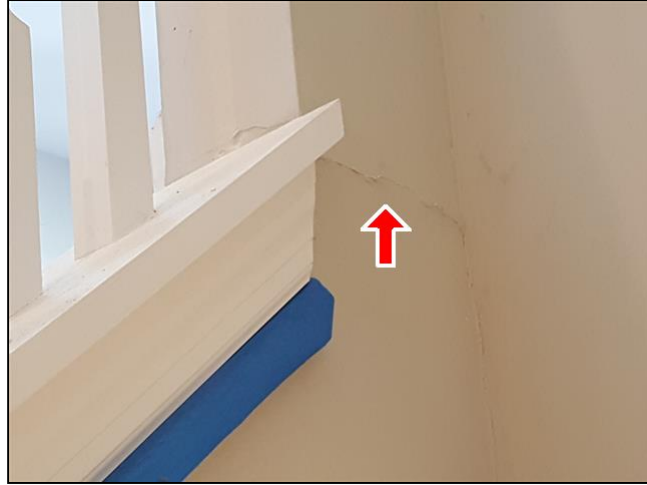
6.1 Item 1(Picture) living room above door right side

6.1 The crack(s) noted on the walls where indicated in the photo(s) are common minor settlement horizontal crack(s). Cracks larger than 1/8" wide are of concern only. Minor settlement of the home has occurred perhaps via framing shrinkage. This damage is considered to be cosmetic and a small repair issue for your information. Recommend prep prime and paint as needed.

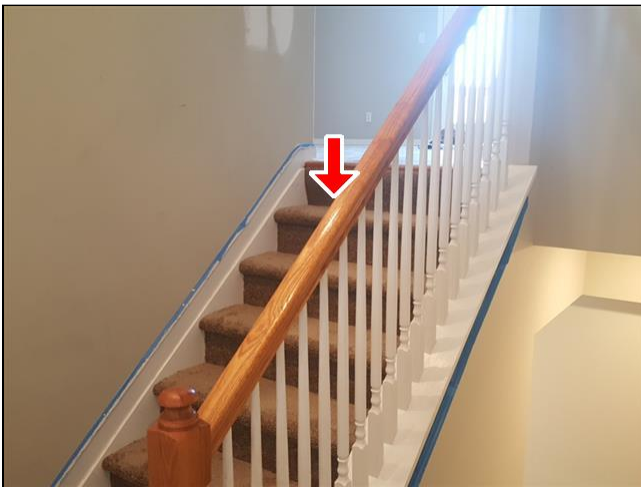
6.3 Item 1(Picture)

6.3 The stair case rail on the on the right side is unstable and not secured properly. This is extremely dangerous and is a safety concern. It may fail under a medium or heavy force or if someone was pushed against or was leaning on the railing. For your safety it should be strengthened and secured. Recommend a qualified contractor repair as needed before closing.

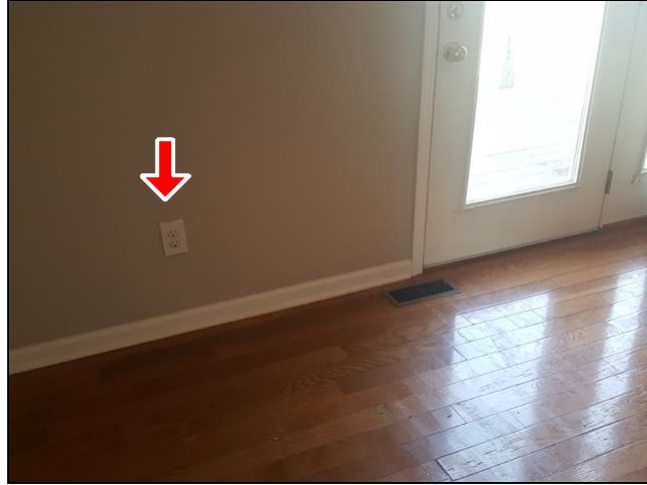
6.7 Item 1(Picture) living room

6.7 (1) The outlet(s) where indicated in the photo(s) are/is loose at the wall or in the outlet box. Electrical issues are considered a hazard until repaired. This is a safety issue that needs to be corrected due to an electric shock or fire from loose connections could occur if not repaired. Recommend a qualified licensed electrical contractor correct as needed.

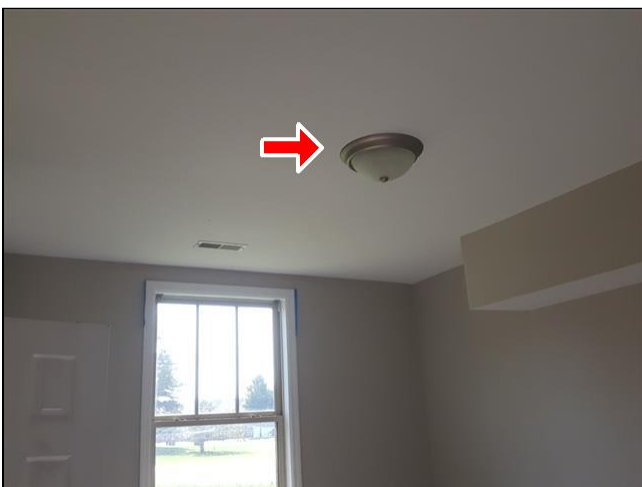
6.7 Item 9(Picture)

6.7 (3) The light fixture need bulbs replaced at the 2nd Bedroom. This is for your information.

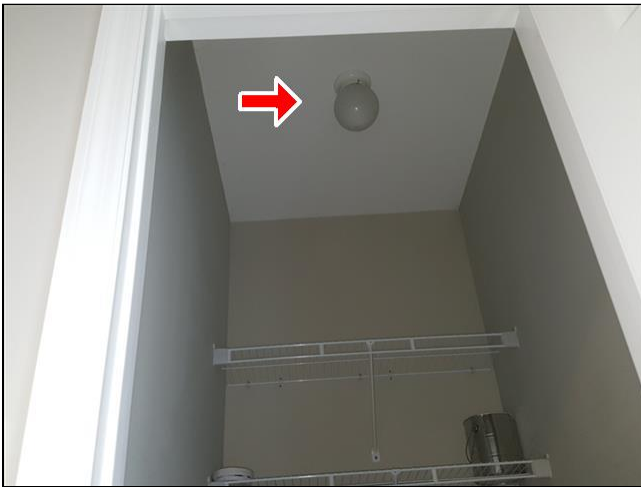
6.7 Item 10(Picture)

6.7 (4) The light fixture need bulbs replaced at the sitting room closet. This is for your information.

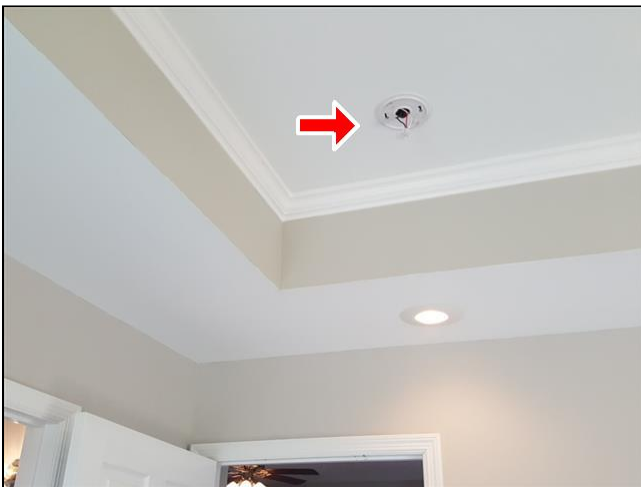
6.8 Item 1(Picture) master bedroom

6.8 The majority of the smoke detectors in the home have been disconnected intentionally and removed where indicated in the photo(s). Without a working smoke detector in your home you have no first alert to a possible fire. This is a safety issue. Strongly recommend installing or replace the smoke detector for your safety in the home. Recommend a qualified contractor install one before closing.

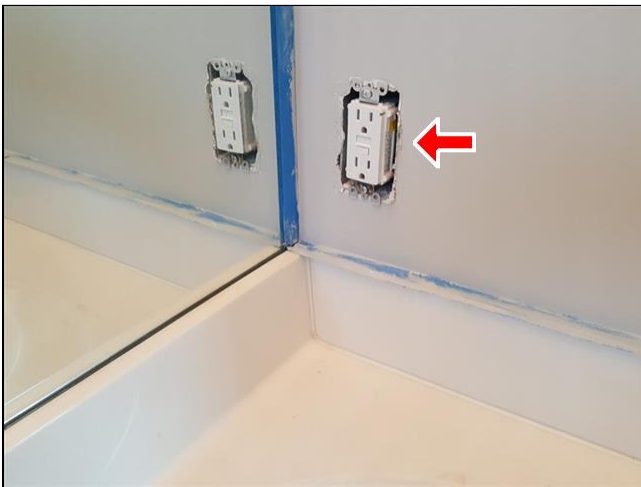
7.6 Item 1(Picture)

7.6 (2) The outlet(s) in the master bathroom is missing a cover-plate. All missing covers should be installed to prevent touching the sides of the devices to prevent an electric shock which can cause an injury or death. Electrical issues are considered a hazard until repaired, and this is considered to be unsafe. A qualified licensed electrical contractor should correct as needed prior to moving in.

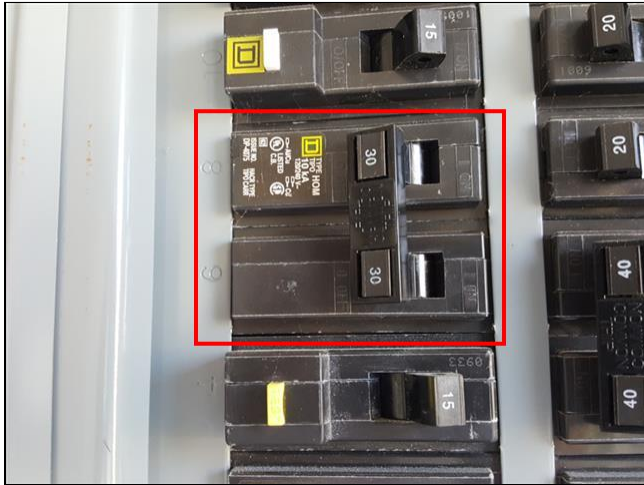
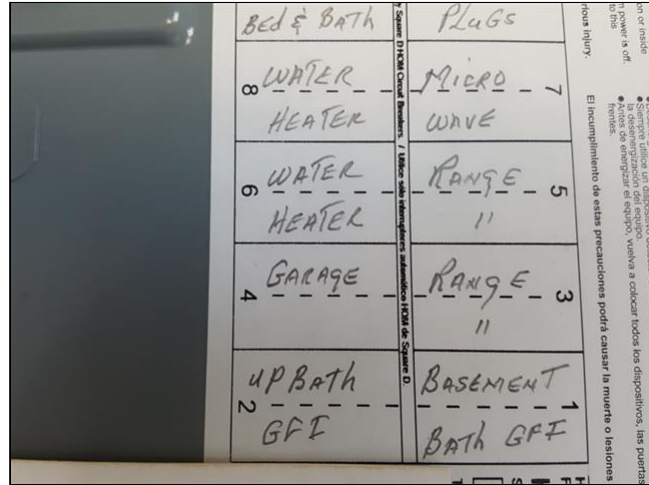
8.2 Item 1(Picture)

8.2 (2) The water heater was not inspected for function due to the breaker was turned off at the panel box. The inspector is prohibited from turning on any breakers in a panel box to operate a component for safety. The unit may be off for a reason. Recommend contacting the owner and have the water heater turned on and check unit for operation prior to closing. This is for your information.

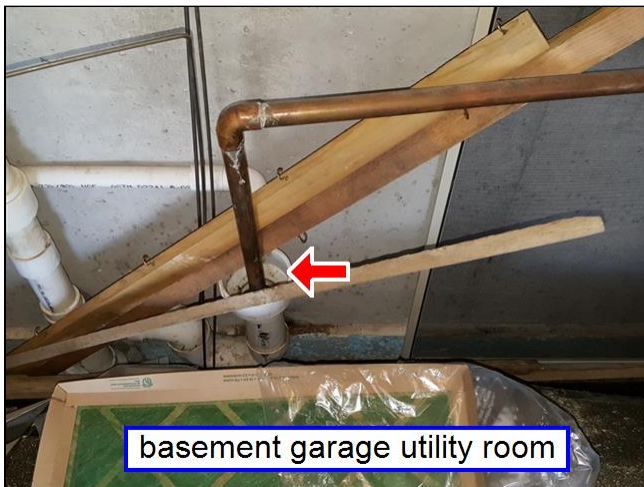
8.3 Item 1(Picture)

8.3 (1) Location of the TPR (temperature pressure relief) drain line to exterior. (see picture)

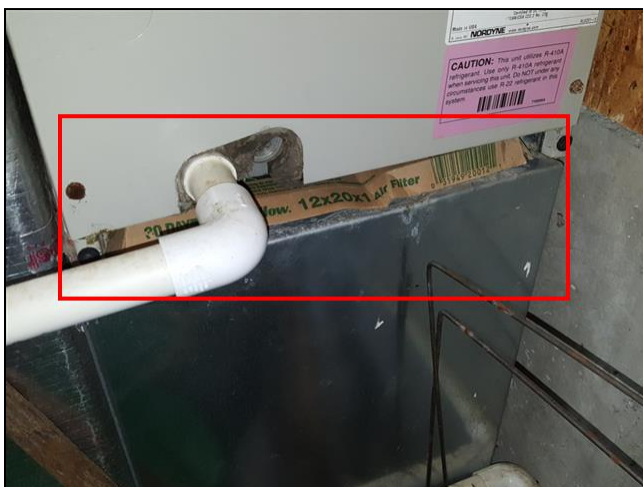
10.1 Item 2(Picture)

10.1 (2) The door to access the filter next to the Air Handler is missing at the garage utility room. This can allow dirt and debris to bypass the filter. The filter ensures clean air is distributed within the home and also protects the equipment from small debris entering which can lead to problems with the unit and duct work. Recommend replacement/correcting as needed by a qualified HVAC contractor.

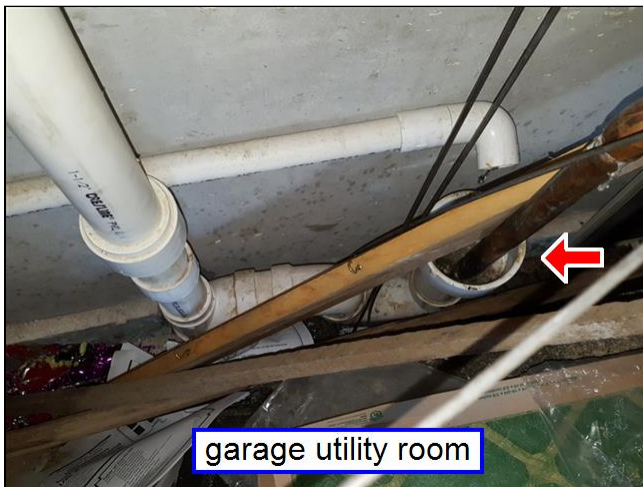
10.3 Item 1(Picture)

10.3 (1) Location of the condensate drain line to the exterior. (see photo)

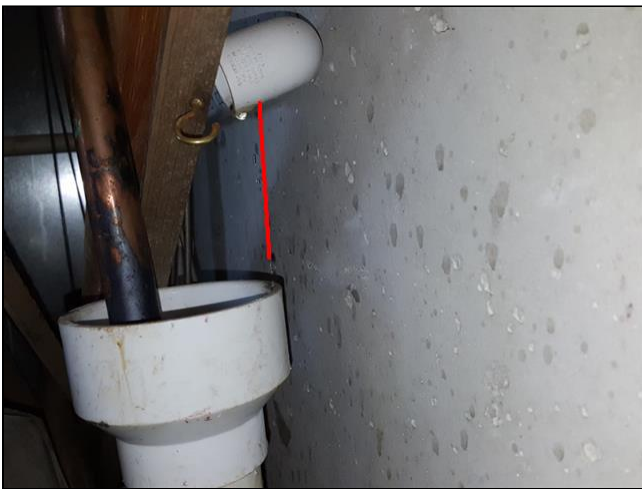
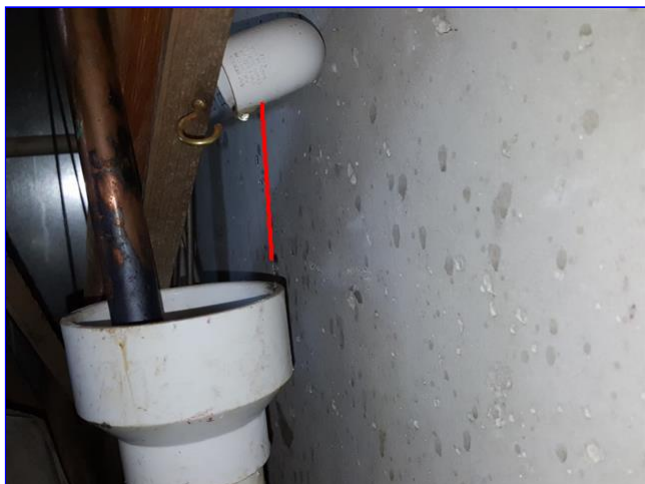
10.3 Item 2(Picture)

10.3 (2) Recommend the discharge for the condensate drain line be improved via directing the line into the drainage system. Currently half of the water is not being drained and is wetting the floor and foundation wall in the garage. Recommend a qualified HVAC contractor correct as needed to prevent water entering the basement garage and perhaps cause mold to form.

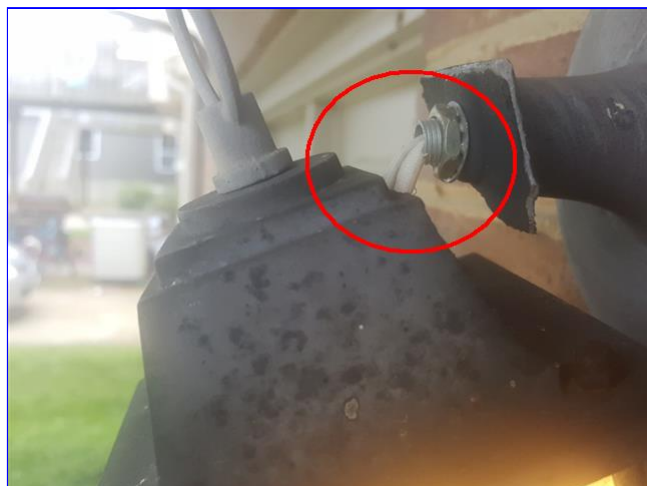
3.13 Item 3(Picture)

(3) The light fixture is loose at the wall and there is exposed wiring at the light fixture at the rear of the home. This is a safety issue and is hazardous. Wires should not be exposed to weather or tampering. This is also placing strain on the wire connections. Recommend a licensed electrician correct and/or repair as needed prior to moving in.

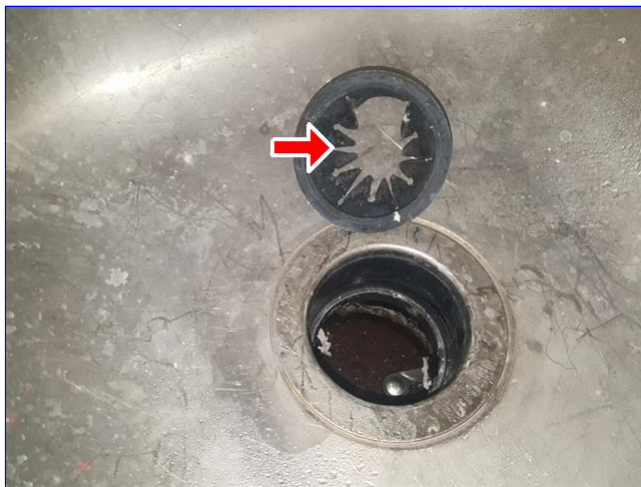
5.3 Item 1(Picture)

The food disposer rubber strainer/guard is damaged and no longer works as intended. This could allow waste to be expelled through the top. Recommend replacement of the rubber guard as needed for safety.

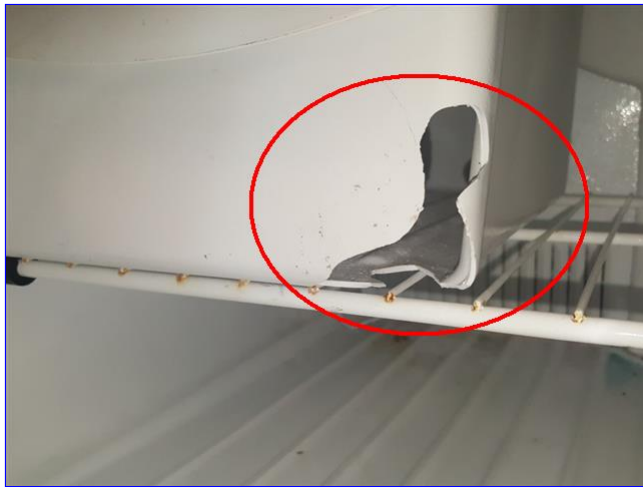
5.6 Item 3(Picture)

(3) The ice tray is broken in the refrigerator. Recommend replacement.

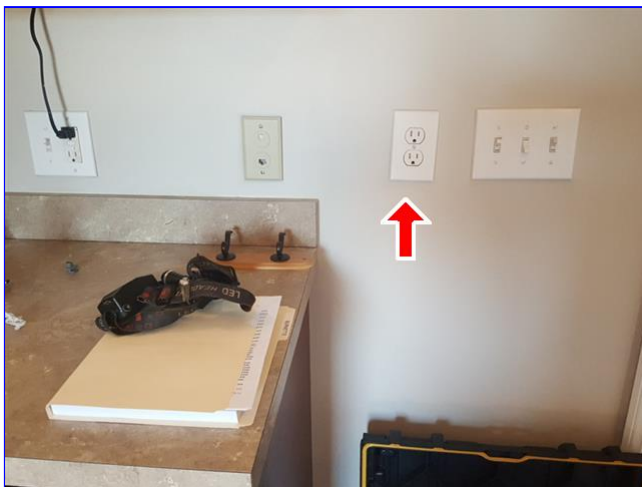
5.9 Item 2(Picture)

(3) The outlet(s) in the kitchen where indicated in the photo(s) are loose at the wall or in the outlet box. Electrical issues are considered a hazard until repaired. This is a safety issue that needs to be corrected due to an electric shock or fire from loose connections could occur if not repaired. Recommend a qualified licensed electrical contractor correct as needed.

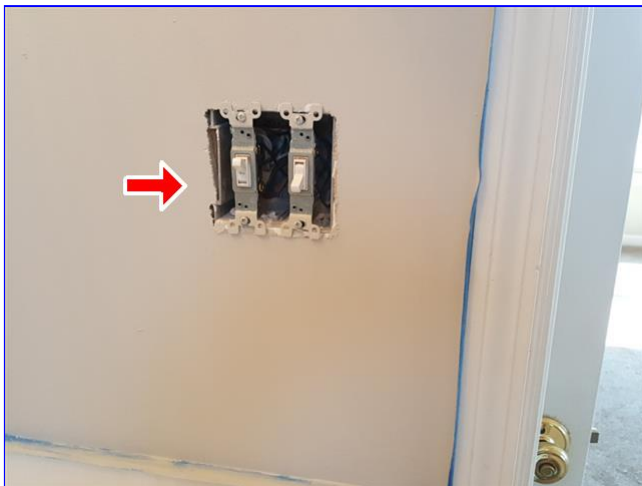
7.6 Item 2(Picture)

(3) The light switch(s) in the Master bathroom is missing a cover-plate. All missing switch covers should be installed to prevent touching the sides of the devices to prevent and electric shock which can cause an injury or death. Electrical issues are considered a hazard until repaired, and this is considered to be unsafe. A qualified licensed electrical contractor should correct as needed prior to moving in.

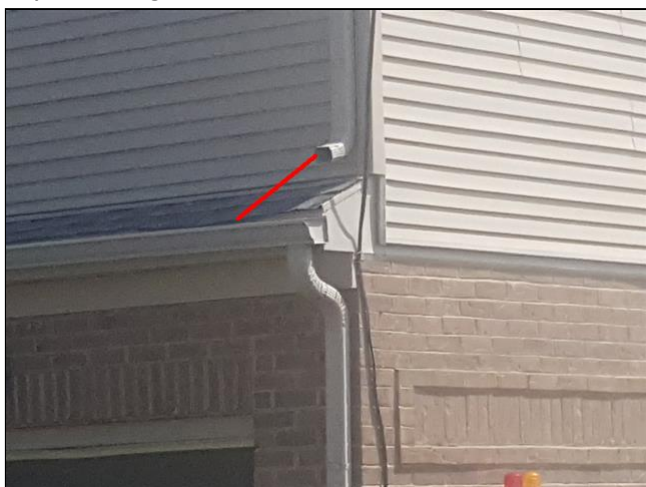
2.3 Item 6(Picture) rear right corner of home

(3) Recommend the downspout(s) that discharge onto the roof be extended to discharge water directly into the gutter below. This condition, if left unattended, can result in premature deterioration and staining of the roofing material under the end of the downspout. The excessive discharge of storm water onto roof from downspout also puts stress on building materials designed to prevent water entry into the structure of home. Recommend correcting all around the home as needed using a qualified gutter installer.

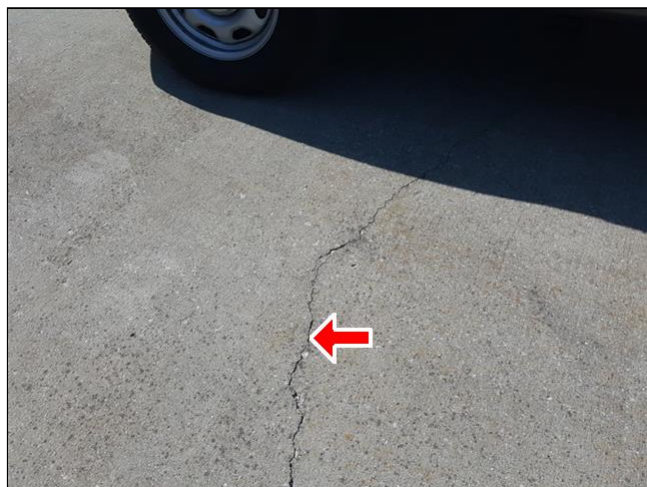
3.7 Item 1(Picture)

The concrete drive at the rear of home has minor shrinkage cracks. Water intrusion can cause further deterioration if not repaired and sealed properly. Recommend repair as needed using a masonry caulk.
