SAGUACHE CREEK DIVERSION INFRASTRUCTURE INVENTORY

Structure Name: FRIESE D 2

Date: April 11, 2019

Saguache Creek Stream Management Plan

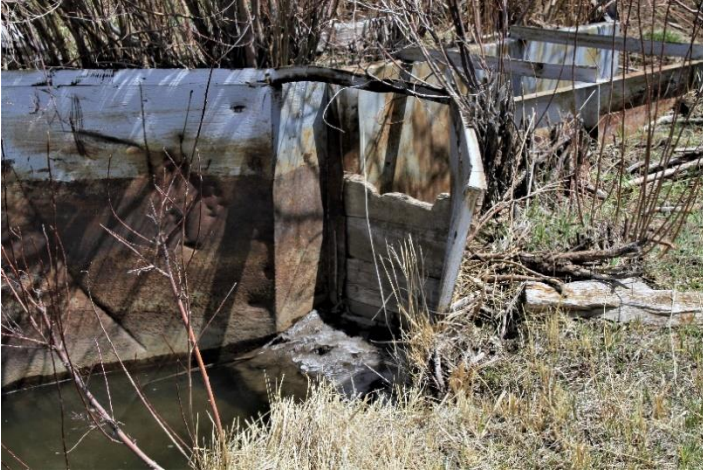
Structure Description: This ditch is located just upstream of Friese Ditch 1 at the apex of a meander. There is no diversion for this structure, as this ditch is a junior priority and the river is flowing sufficiently when it is in priority. The headgate functions very poorly and the flume was removed from the ditch at the time of inspection.

Headgate looking downstream

Repair(s) or Improvement(s) Currently Needed: A new slide headgate with adjustment and locking capabilities needs to be installed. The flume needs to be replaced. Bank stabilization is also recommended between Friese Ditch 2 and Friese Ditch 1. Existing fish passage should be maintained and riparian restoration should be considered as part of any future repairs or improvements.

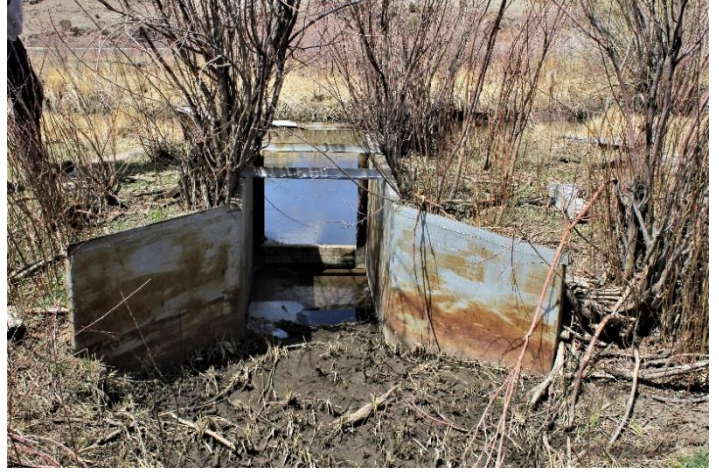
Headgate outlet

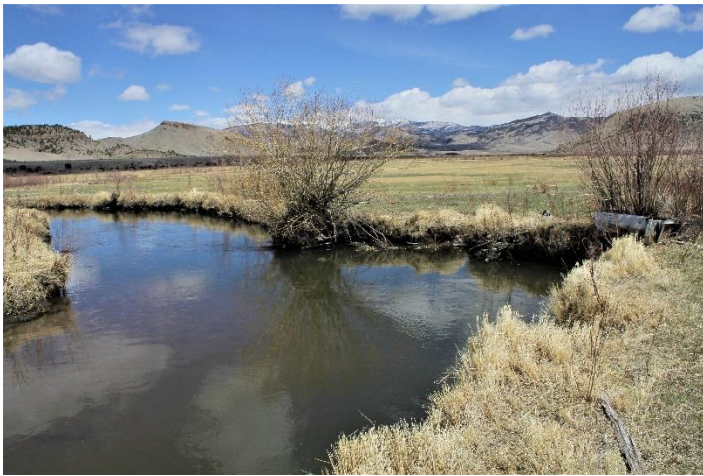
Headgate and point of diversion

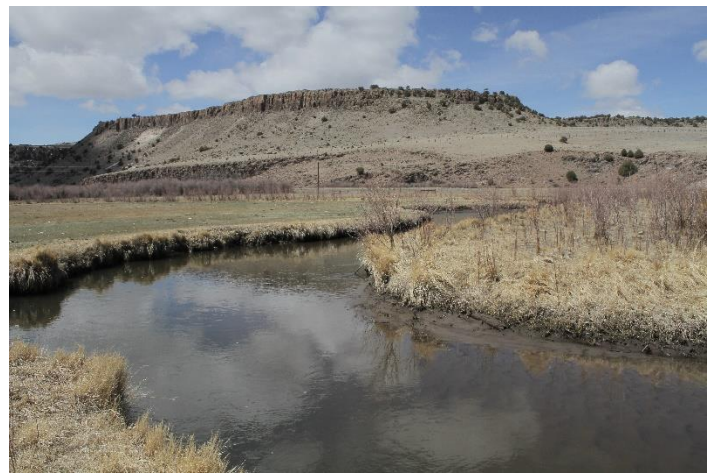
Saguache Creek upstream of structure

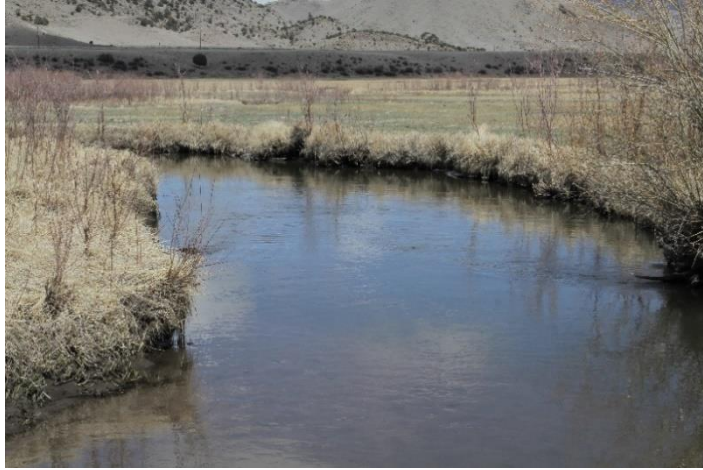
Channel downstream of structure

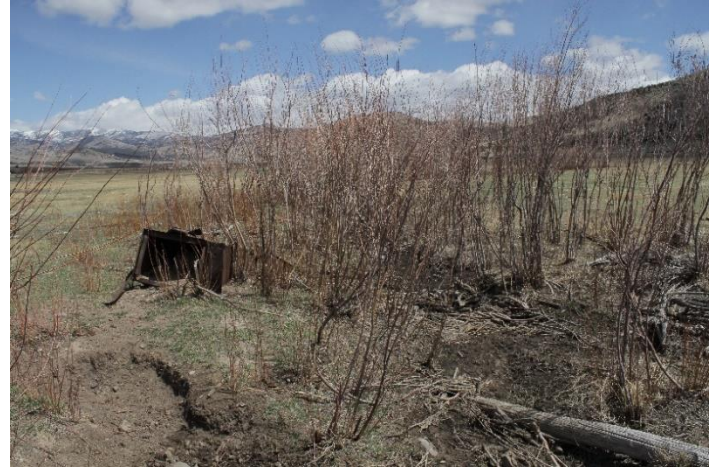
Flume looking upstream
