# CONEJOS RIVER

## DIVERSION INFRASTRUCTURE INVENTORY

**Structure Name:** WILLIAM STEWART CO IRR D

**Date:** April 16, 2019

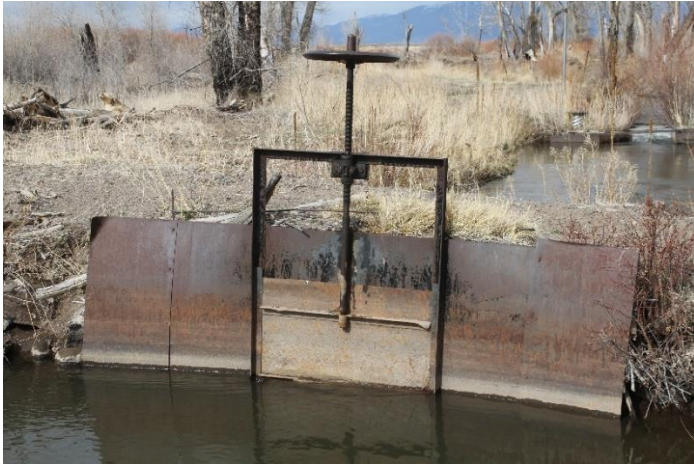
Headgate looking downstream

**Repair(s) or Improvement(s) Currently Needed:** Recommended improvements include the installation of a new diversion dam and headgate (with adjacent sluice gate) designed to deliver water to the headgate at various flows, reduce annual maintenance, and improve river function by improving sediment transport and aquatic habitat. Fish and boat passage should be considered as part of any improvements to the diversion. Riparian vegetation restoration should also be included as part of any improvements. A useful reference and potential model is the Alamo Ditch, the next structure upstream, which was recently improved and functions well.

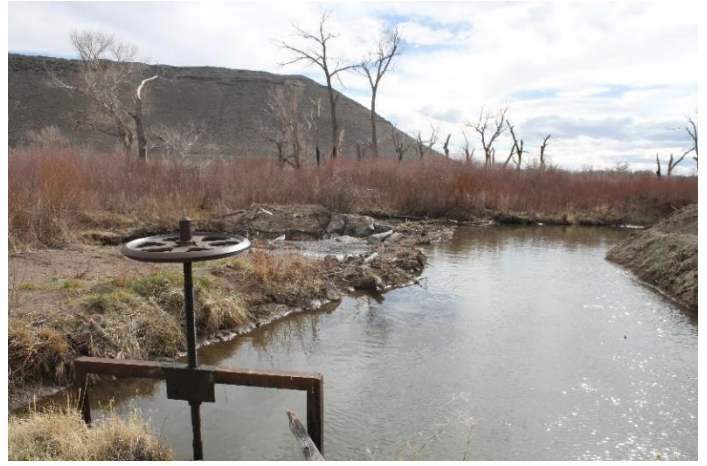
Headgate and diversion dam (on feeder ditch)

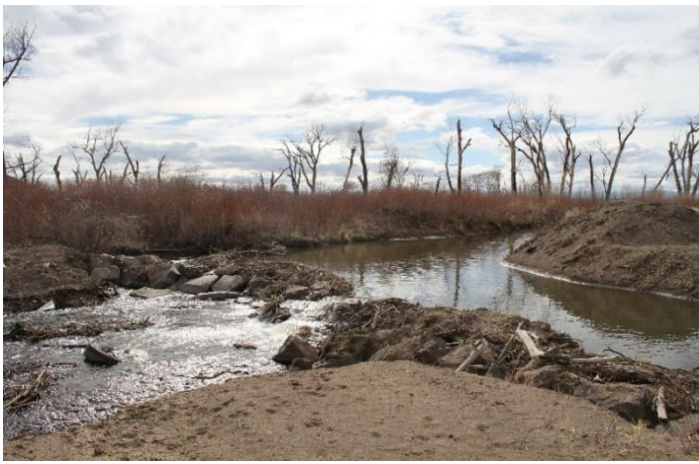
Diversion dam on feeder ditch

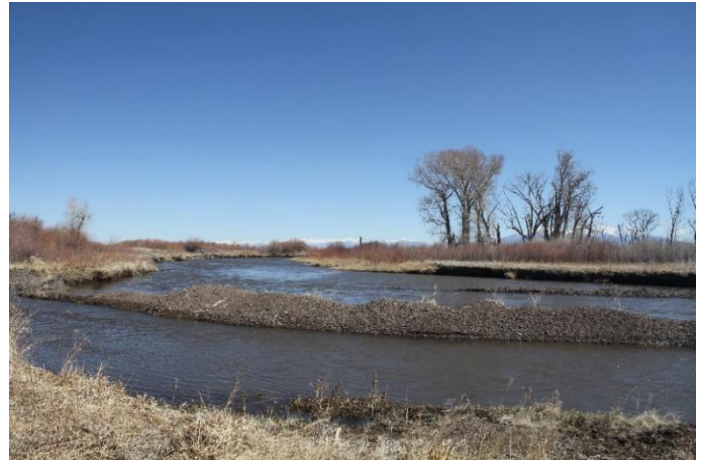
Diversion dam looking downstream

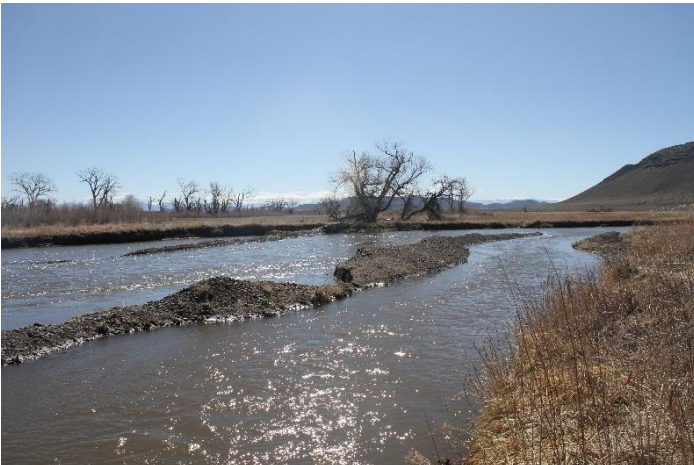
Diversion dam looking upstream

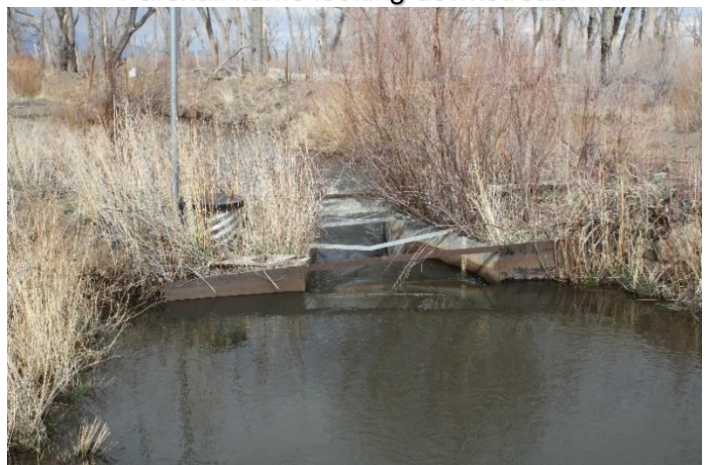
Parshall flume looking downstream
