TALC
Home Inspe

Inspection Report

Property Address:
211 Wellington Road
Paris KY 40361

Date: 10/17/2018	Time: 10:00 AM till 02:00 PM	Report ID: 181017SCNEIDER
Property: 211 Wellington Road Paris KY 40361	Customer: Ms. Gail Schnieder	Real Estate Professional:

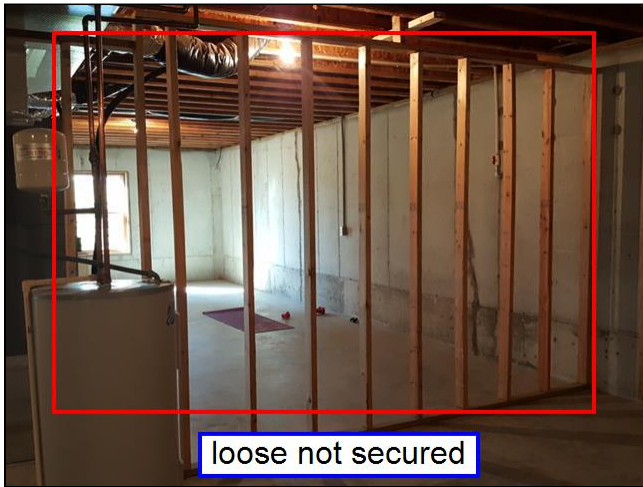
1.1 Item 6(Picture)

1.1 (3) The wall framing is loose and not secured to the ceiling or wall in the basement. This is a safety issue as the wall could fall causing an injury of a person or damage to appliances/equipment in the basement. Recommend a qualified contractor correct and repair as needed prior to closing. This is not a structural wall.

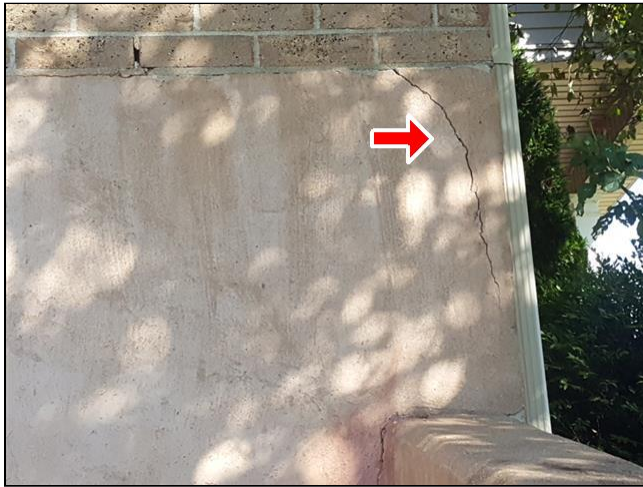
1.1 Item 10(Picture) front left corner of home

1.1 (4) Surface deterioration (cracking, spalling, crumbling material) was observed on the foundation walls on the concrete parging where indicated in the photos. This condition does not usually represent a serious structural concern unless there is a substantial loss of material. The concrete parging is designed to protect the concrete walls from moisture penetration. In an effort to prevent long term deterioration, recommend re-parging over deteriorated areas then sealing concrete with an exterior paint to prevent moisture penetration. [Here is a link explaining how to parge a foundation wall.](#)

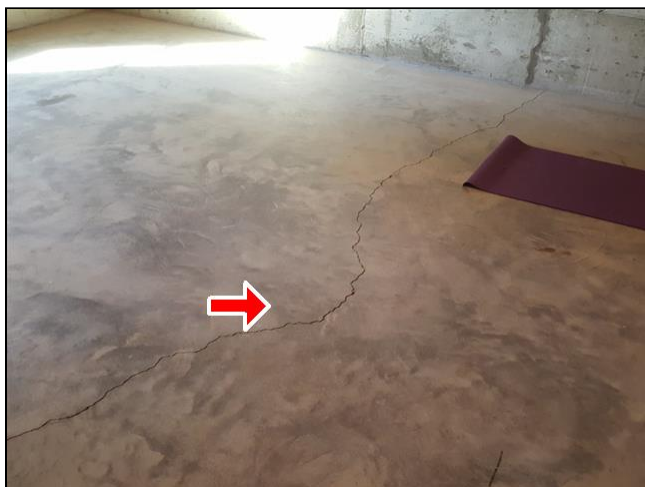
1.3 Item 1(Picture)

1.3 The basement flooring has typical cracks in areas highlighted in photos. These cracks do not appear significant and seem typical. Cracks that are usually 1/8 inch or wider are need for concern. The cracks are usually the result of shrinkage or settling of the slab. Recommend these cracks be sealed then apply an epoxy coating on the floor to ensure water intrusion does not occur. It is recommended that you monitor annually after repairs. [Caulk for Concrete Cracks](#)

Note: some of the cracks are located in areas where there is substantial weight/force placed on flooring and most cracks. It could be the result of missing control/expansion joints placed on the concrete flooring. If these cracks re-appear after repairs and are over 1/8 inch in opening, a structural engineer who is familiar with foundation repair or qualified foundation repair contractor should be consulted.

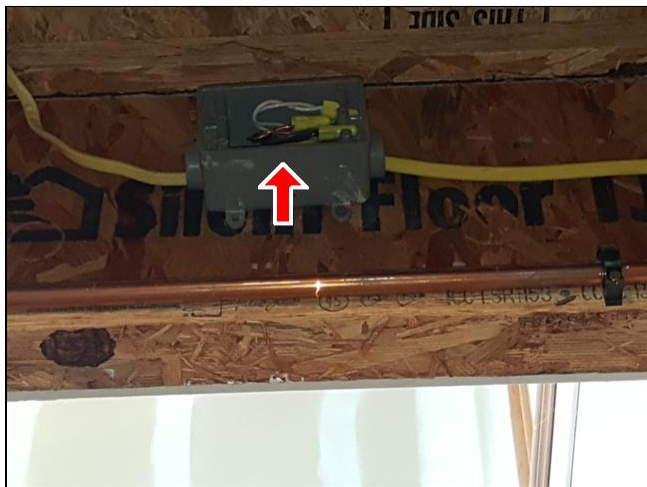
1.8 Item 4(Picture)

1.8 (3) All junction boxes in the basement should have covers installed to prevent tampering, protect the wire connections, and for personal protection. This is a safety issue that needs to be corrected. If a leak was to occur it could result in a short then a fire in the home. Recommend a qualified licensed electrician correct as needed.

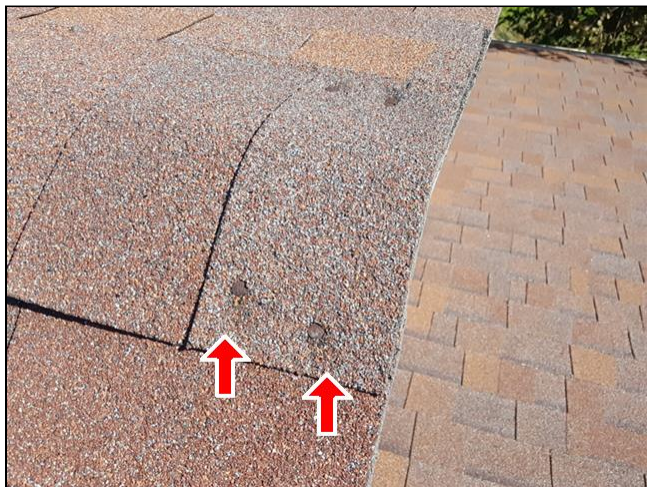
2.0 Item 3(Picture)

2.0 (2) Exposed nail heads were seen at the roof near the peak ends. All exposed nails should be properly sealed by a qualified roofing contractor. A sealant compatible with the roofing or flashing material should be applied to the nail. This will prevent and reduce future water entry and/or leaks into the attic.

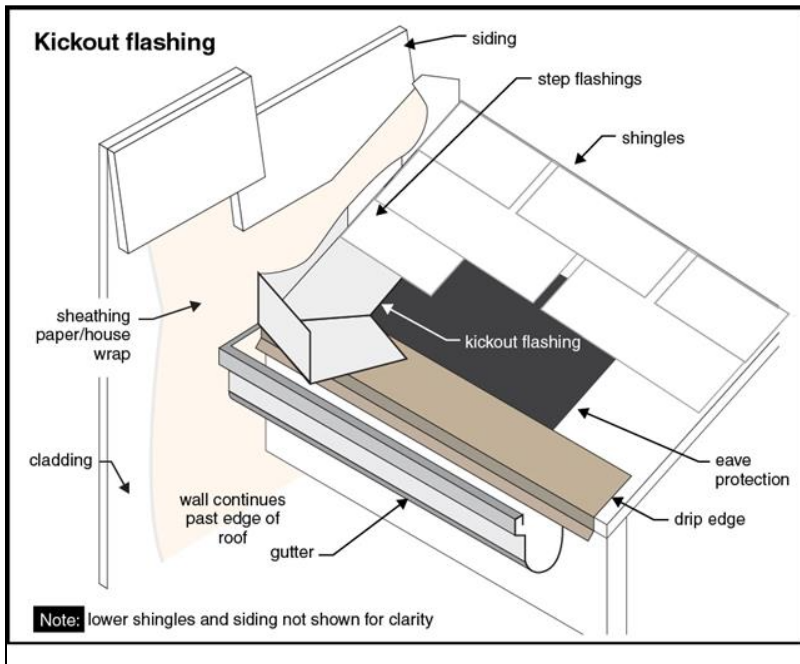
2.1 Item 5(Picture)

2.1 (2) The diverter flashing/step flashing is missing between the roof and wall at the front and rear of home where indicated in the photos. Water stains on the exterior brick siding was noted. This can cause damage to the siding and may allow water intrusion between the gutter and the wall structure. Recommend a qualified roofing contractor further evaluate and repair as needed.

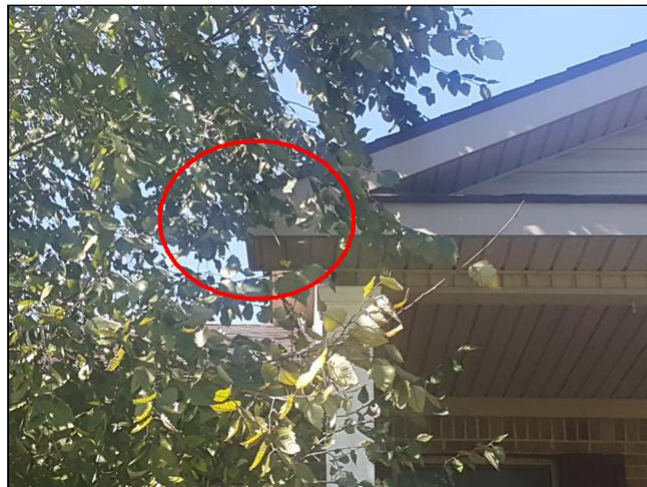
2.3 Item 14(Picture)

2.3 (4) Gutter and downspout is missing and should be installed at the front right and left corners of the porch at the home above the porch area to avoid spilling roof runoff around the building - a potential source of water entry or water damage. It could cause settlement of the front porch in the future if not corrected. Recommend a qualified contractor install a gutter system. This will prevent soil erosion below and possible water leakage into the basement.

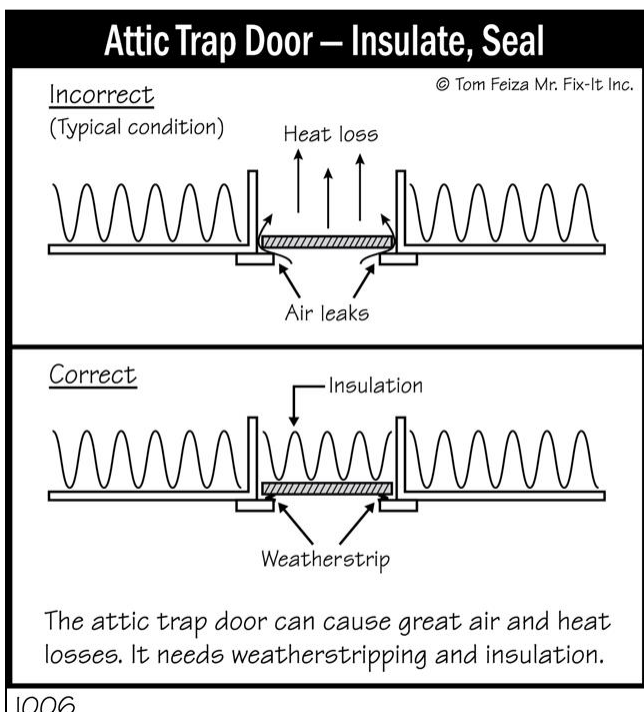
2.4 Item 3(Picture)

2.4 (2) Recommend the attic access hatch in the master bedroom closet be insulated to prevent air and heat loss for energy conservation.

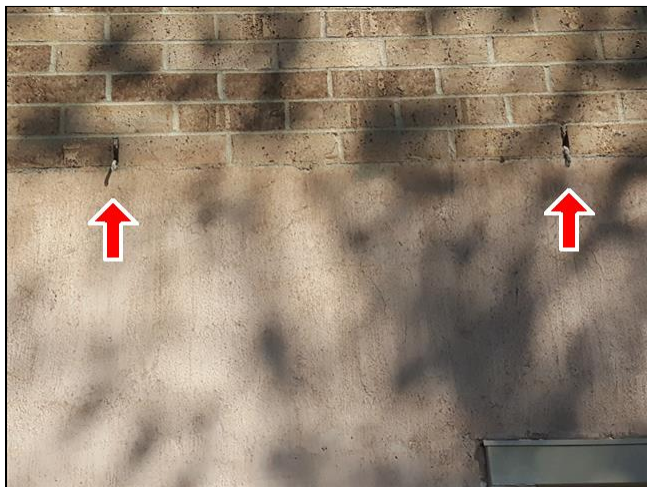
3.0 Item 1(Picture)

3.0 (1) Rope protruding out of the brick siding are known as weep holes. These pieces of rope should not be pulled out. They will deteriorate over time, however they should have been trimmed after the house was built. Weep holes are openings close to the bottom of brick mortar joints that allow drainage. They are also recommended over door and window openings. This is for your information.

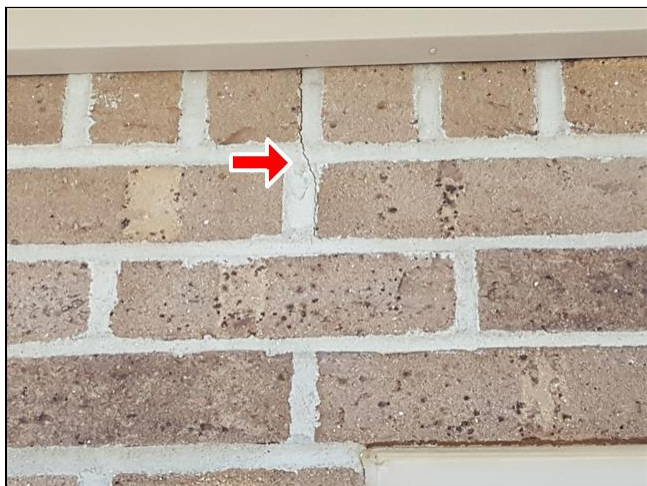
3.0 Item 2(Picture) above garage left corner

3.0 (2) Typical shrinkage cracks, at the mortar joints on the exterior siding was observed at the front left corners of the garage. These cracks do not appear significant. Shrinkage cracking is the result of moisture in the concrete mortar evaporating and shrinking. This generally is not a cause for concern as all concrete shrinks. Due to freeze/thaw via water intrusion, the cracks should be sealed to minimize further cracking, flaking or deterioration. A qualified contractor or skilled masonry contractor should perform the repairs via tuck pointing mortar. It is recommended that you monitor periodically. Should any of these cracks begin to grow, then further attention and evaluation would be recommended.

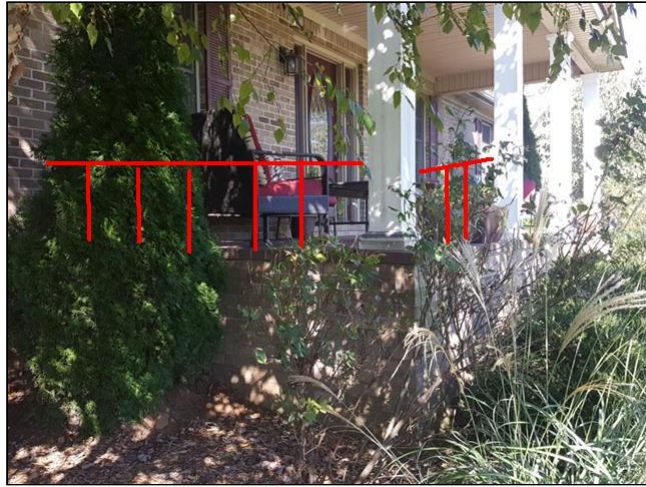
3.5 Item 1(Picture)

3.5 Recommend a guard rail be installed around the front of the porch to prevent a fall from occurring which may result in an injury of a person. This is a potential safety issue. The railing needs to be at least 36 inches high and balusters need spacing to be at least 4 inches. Recommend a qualified contractor install one for safety.

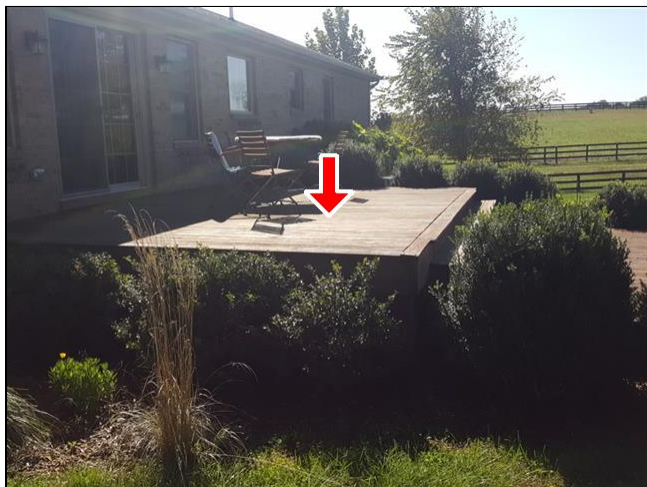
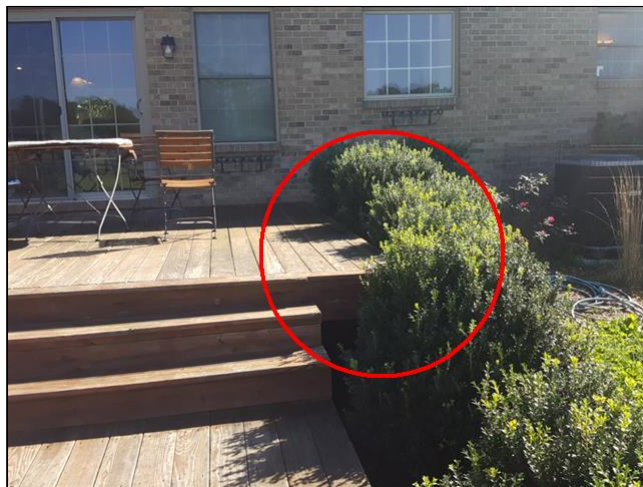
3.6 Item 1(Picture)

3.6 (1) The guard rail for the rear deck is missing in some areas. Recommend a guard rail be installed around the rear deck to prevent a fall from occurring which may result in an injury of a person. This is a potential safety issue. The railing needs to be at least 36 inches high and balusters need spacing to be at least 4 inches. Recommend a qualified contractor correct where needed for safety prior to moving in.

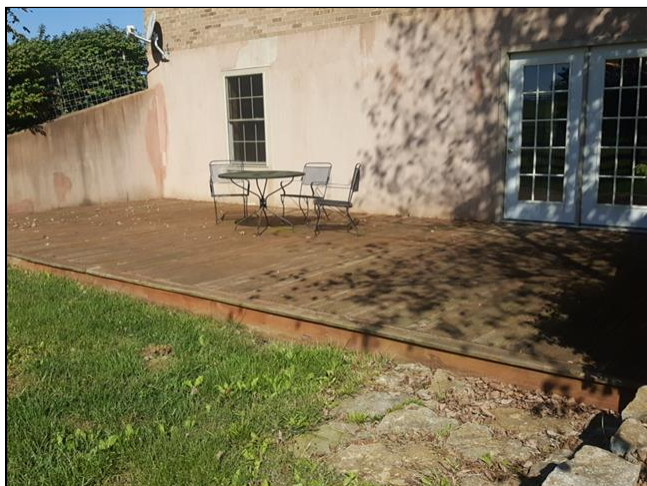
3.6 Item 3(Picture) left side of home

3.6 (2) The rear and side deck is built on grade and the sides extend to the ground. I was unable to completely inspect the underside. The area under the deck was limited. Some areas could not be viewed.

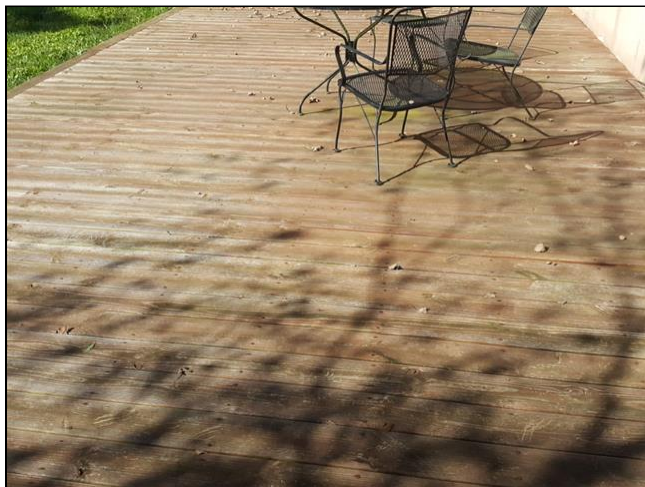
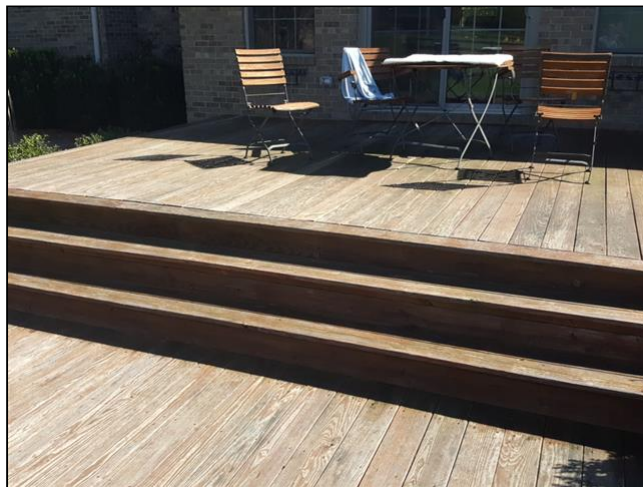
3.6 Item 4(Picture) left side of home

3.6 (3) Treated wood used for decks and railings has a limited life span of 10-15 years. The stain on the deck is getting thin. It should be re-stained to prevent excessive aging and deterioration. This is for your information.

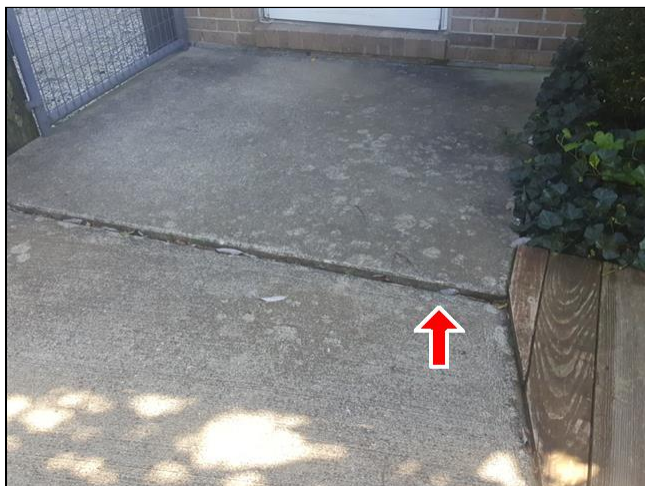
3.7 Item 1(Picture)

3.7 The rear walkway leading up to the garage at the rear left side of the home has settled creating a tripping hazard. For safety recommend the walkway be repaired or replaced to prevent a tripping hazard and/or a fall or injury from occurring. Recommend a qualified masonry contractor repair or replace as needed.

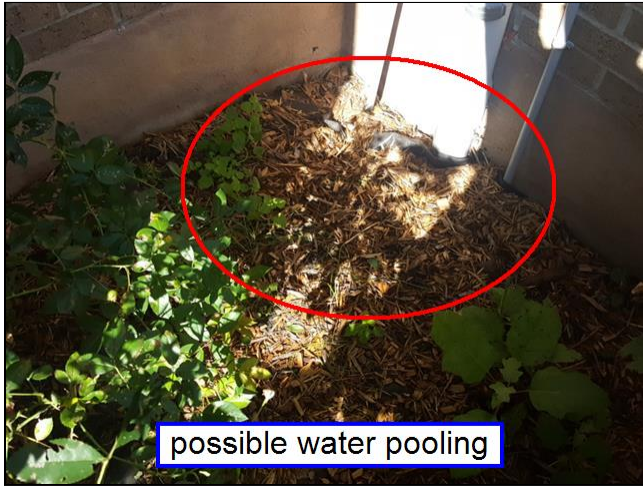
3.9 Item 1(Picture)

3.9 (1) There are depressions in the soil around the foundation perimeter at the front right side of the home near the electric meter. Recommend filling all depressions and re-grading the soil so the soil slopes away from the home around the foundation to ensure water pooling does not occur in these areas. Water pooling could lead to to basement leakage.

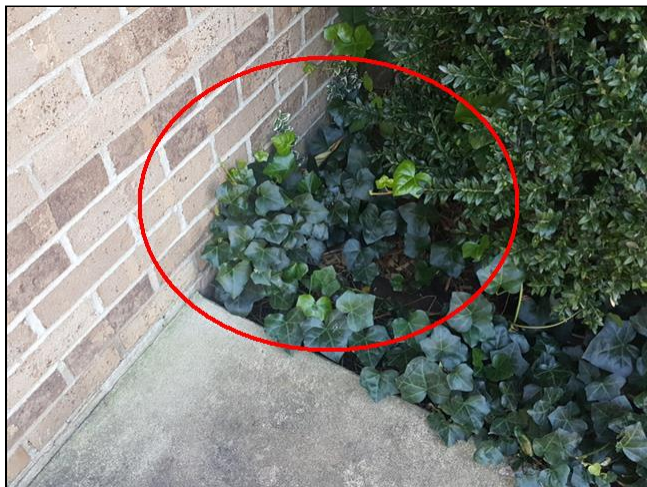
3.10 Item 7(Picture)

3.10 (3) Vines growing on exterior walls at the rear of the garage should not be in contact with siding, window trims and the eaves to reduce the risk of insect and water damage to the building. Recommend removing plant.

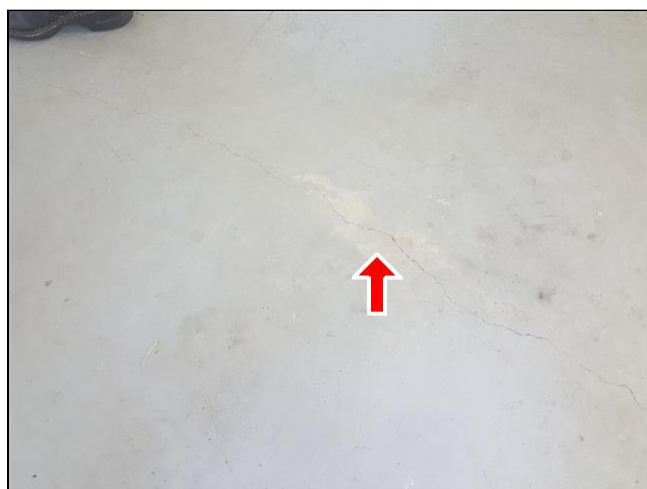
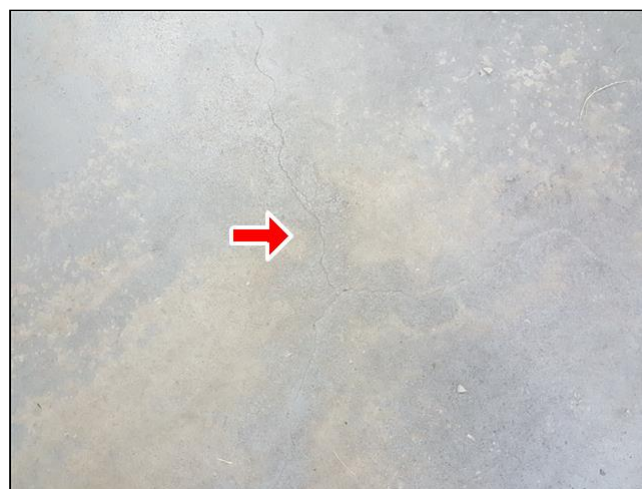
4.2 Item 1(Picture)

4.2 The garage flooring has typical cracks in areas highlighted in photos. These cracks do not appear significant and seem typical. Cracks that are usually 1/8 inch or wider are need for concern. The cracks are usually the result of shrinkage and/or settling of the slab. Recommend these cracks be sealed then apply an epoxy coating on the floor to ensure water intrusion does not occur. [Caulk for Concrete Cracks](#) This is for your information.

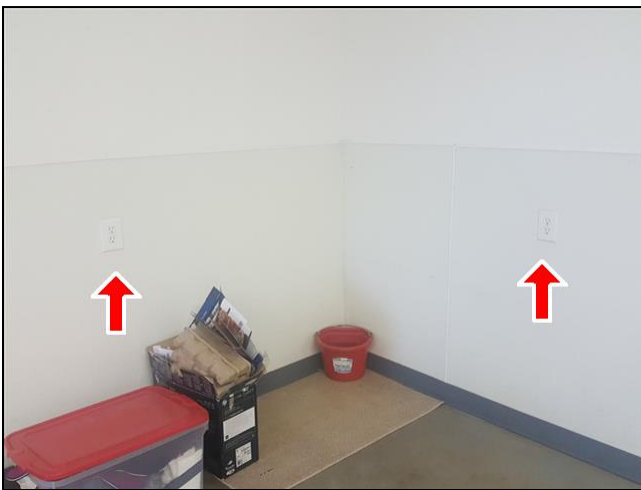
4.8 Item 1(Picture)

4.8 The GFCI outlet(s) in the garage where indicated in the photo(s) did not trip in response to testing during the inspection. This is a safety issue. The GFCI offers protection from shock or electrocution. Recommend a qualified licensed electrician repair as needed.

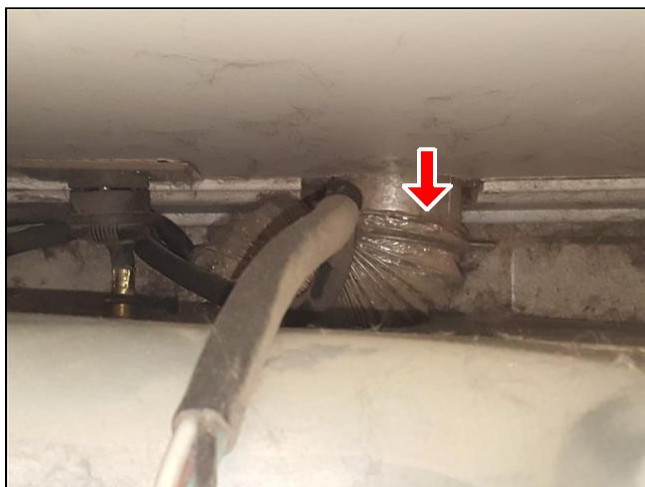
5.10 Item 1(Picture)

5.10 (1) A pleated Foil flex pipe is currently installed from the dryer to the exhaust vent. The current recommendations are for dryer vents to be heavy flexible or solid metal to help prevent crushing and damage from fires. Dryer lint fires are reported to be the third leading cause of fires. Exhaust ducts should be constructed of minimum 0.016 inch thick rigid metal ducts, having smooth interior surfaces with joints running in the direction of air flow. Exhaust ducts shall not be connected with sheet metal screws or fastening means which extend into the duct. All dryer vents should be disconnected and cleaned twice a year. This is a very common cause of fires. Recommend replacing duct for proper operation and for your safety using a qualified contractor.

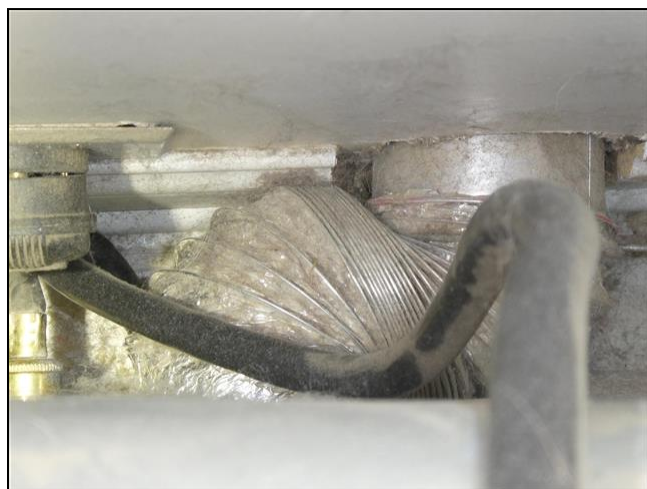
5.10 Item 5(Picture)

5.10 (2) The dryer vent piping is damaged and appears to have a minor leak due to large build up of lint behind the dryer in the Washer/Dryer room. This is allowing lint to be released in the air and is not healthy in closed rooms, crawlspaces or basements. Moist air escaping can lead to mildew or mold to develop on the walls. Recommend repair or replacement as needed. Ensure to use solid metal or flexible metal piping only.

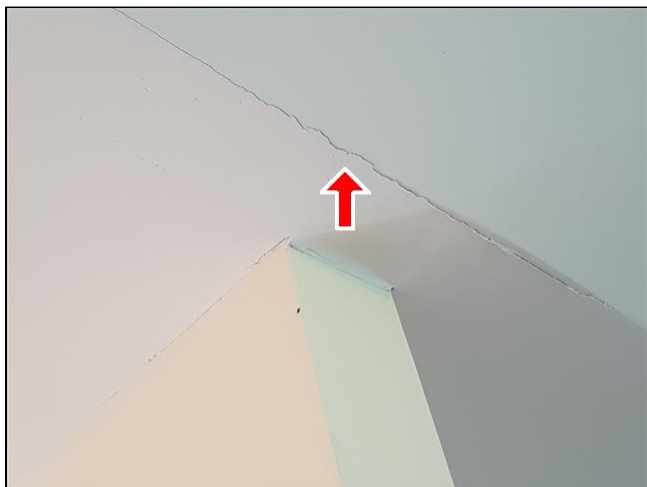
6.0 Item 1(Picture)

6.0 (2) The drywall has a vertical shrinkage crack(s) where the ceiling meets on the ceiling in the living room. Most minor cracking is due to shrinkage of construction materials. The crack is considered to be cosmetic and a small repair issue for your information. Recommend prep prime and paint as needed.

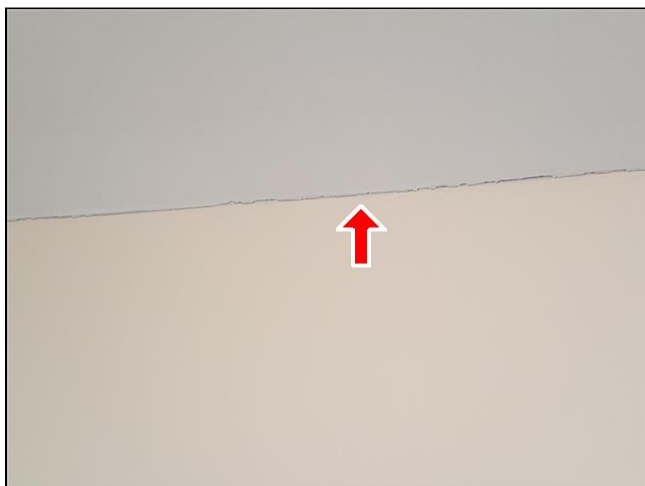
6.1 Item 1(Picture)

6.1 The drywall in the 2nd Bedroom has a hairline shrinkage crack where two pieces of drywall meet. Most minor cracking is due to shrinkage of construction materials. This damage is considered to be cosmetic and a small repair issue for your information. Recommend prep prime and paint as needed.

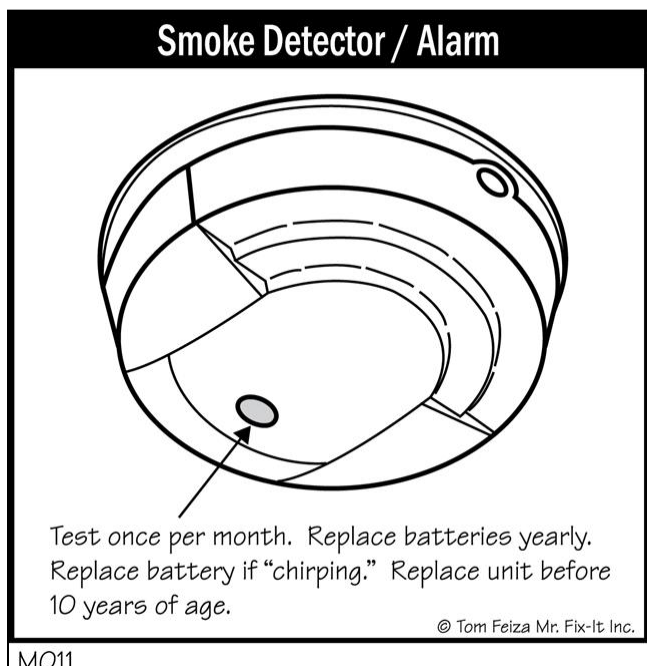
6.8 Item 1(Picture)

6.8 Testing of smoke and CO detectors is not part of a home inspection. We do not want to create a false alarm. All detectors in the home exhibit the active green light which indicates they are on and functioning. Recommend the smoke detectors be tested at common hallway to bedrooms upon moving in to home. Note: If the smoke/CO alarm is 10 years old or older, recommend replacement. Ensure the smoke alarm is a photoelectric type. Here is a link explaining type of alarm to use by the [Dept. of Fire and Emergency Services](#)

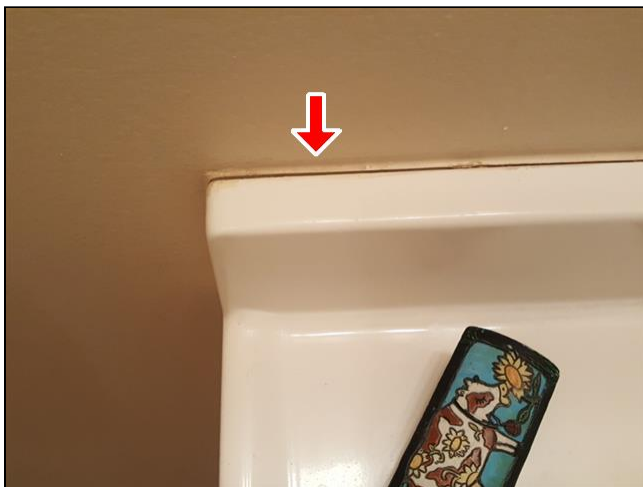
7.1 Item 1(Picture)

7.1 (1) The cabinetry in the half bath above the sink is loose and not secured to wall correctly. Recommend a general contractor repair as needed and caulk between the sink and wall to prevent water intrusion.

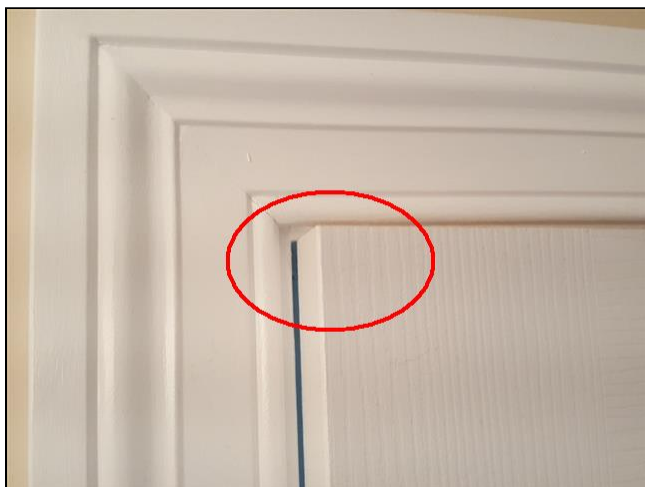
7.2 Item 1(Picture)

7.2 The entry door in the Master bathroom does not close properly, however it rubs at the door jamb when closing where indicated in photos. This is a maintenance issue and is for your information. Sometimes correcting the door opening can require the door trim to be removed then touch up painting or doors will need to be rehung or trimmed down. Recommend a qualified contractor repair as needed.

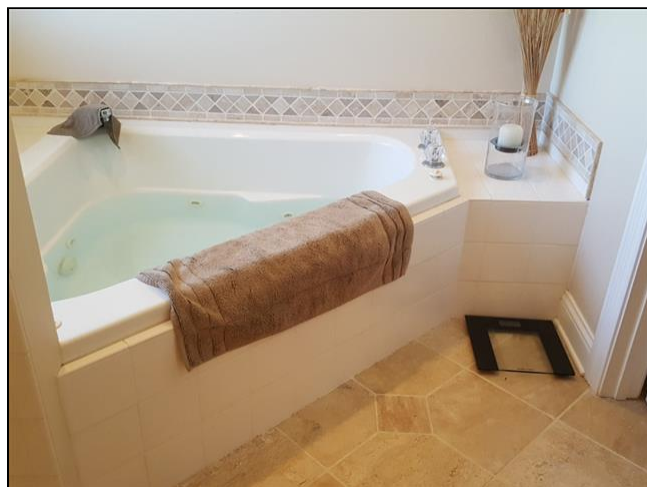
7.8 Item 1(Picture)

7.8 (1) Access to the pump and drain lines for the jacuzzi tub was not present. There is no access. Could not check for leaks at pipes or pump. Recommend an access point be installed in the event of servicing pump or pipes and to check for plumbing leaks.

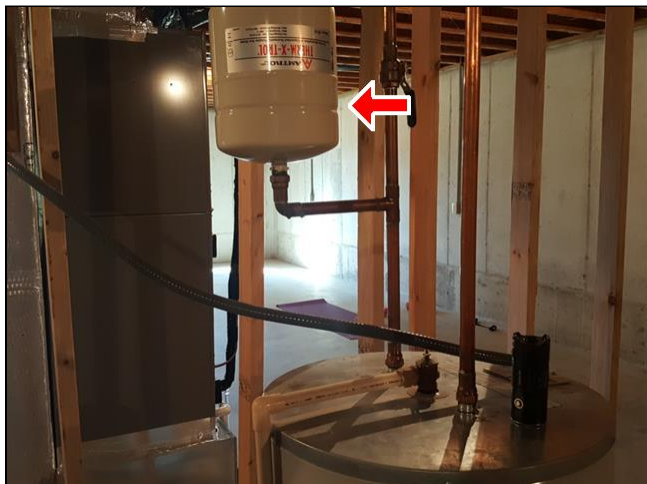
8.2 Item 3(Picture)

8.2 (3) Recommend additional support of the thermal expansion tank in the basement above the water heater to prevent stress on the pipes. A possible leak could occur at the water pipe joins. A plumber is recommended for correction and/or further advice on repairs.

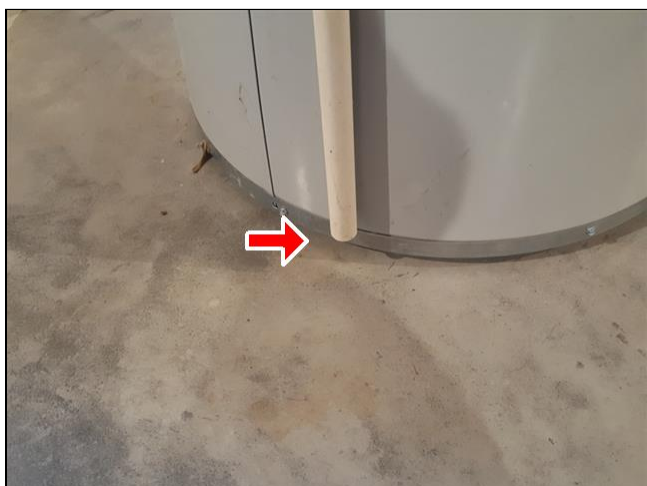
8.3 Item 1(Picture)

Recommend installing a tray under the TP Drain line in the basement to prevent water entering on the floor.

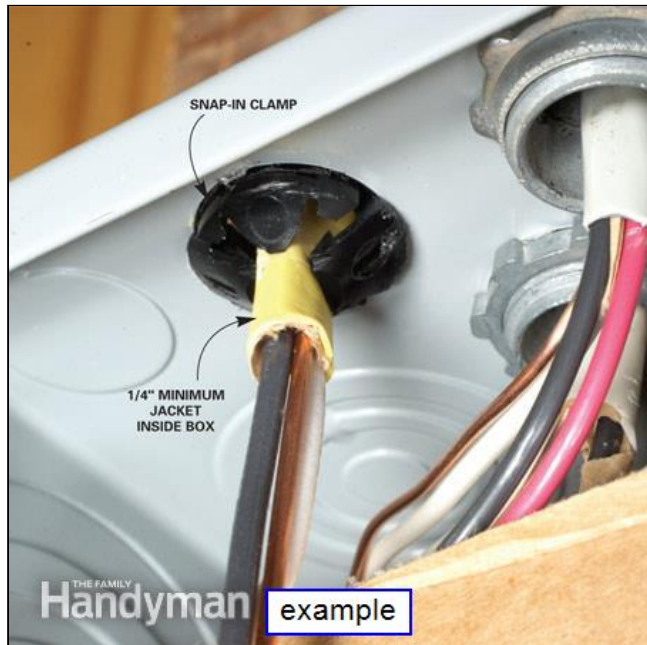
9.2 Item 3(Picture)

9.2 (2) Cable clamps (sometimes referred to as bushings or grommets) are required where wiring passes into the electrical panel box. Cable clamps serve to protect the wiring from the metal edges of the panel box to prevent a short from occurring or from the panel box becoming energized which can result in a death via electric shock. This is a safety issue. Recommend a qualified licensed electrician repair as needed.

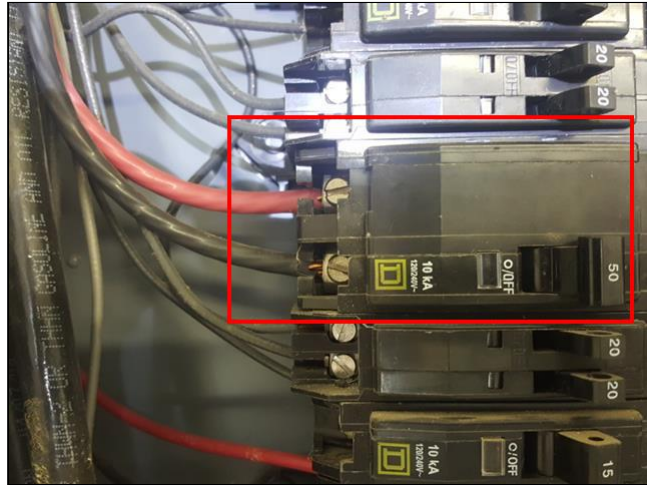
9.3 Item 1(Picture)

9.3 (1) The 50 amp gauge wire is not grounded in the panel. The current wire is connected to a 50 amp breaker. Could not determine what the function of the breaker is for. This is a potential safety issue as the appliance is not grounded. Strongly recommend a qualified electrician further evaluate and correct as needed prior to closing for safety of occupants in the home and to protect appliance.

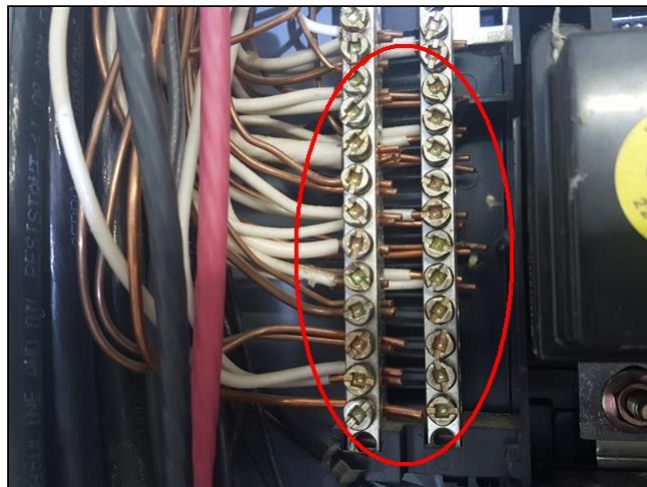
9.3 Item 3(Picture)

9.3 (2) More than one common (white wires) on a single lug of the neutral bar is not recommended but was found in this panel. Separation of these commons is recommended when any other electrical work is done by a qualified licensed electrician.

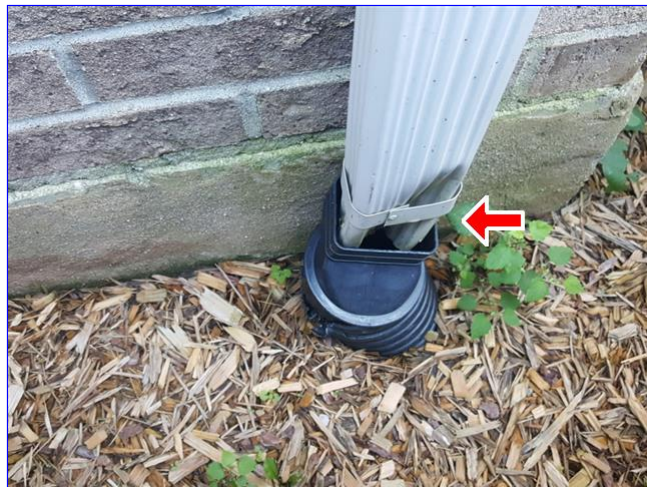
2.3 Item 12(Picture) between garage and home at the rear

(3) The downspout is crushed at the end where indicated in the photo. This is restricting the discharge of water. Recommend the downspout be repaired at the end so water will flow freely and extend into the downspout extension. A general contractor should repair or replace as needed.

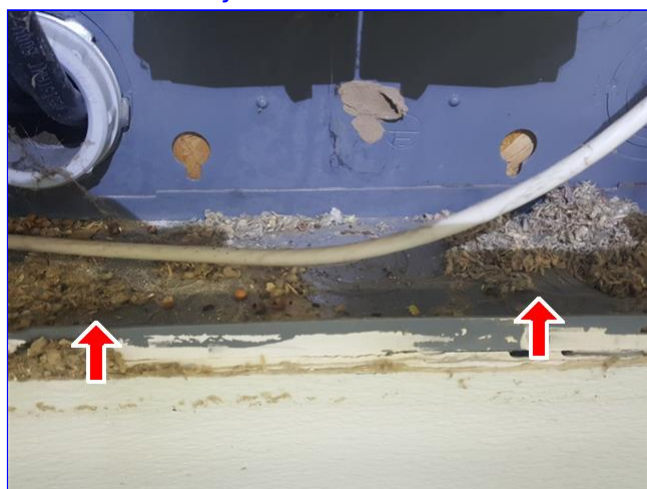
9.2 Item 1(Picture)

(1) The panel box has insulation (debris) inside and at the top of the entry cables. This is a safety issue that needs to be corrected. The insulation can attract moisture which can lead to connections or breakers corroding which may cause a fire. Recommend a qualified licensed electrician clean as needed for safety.

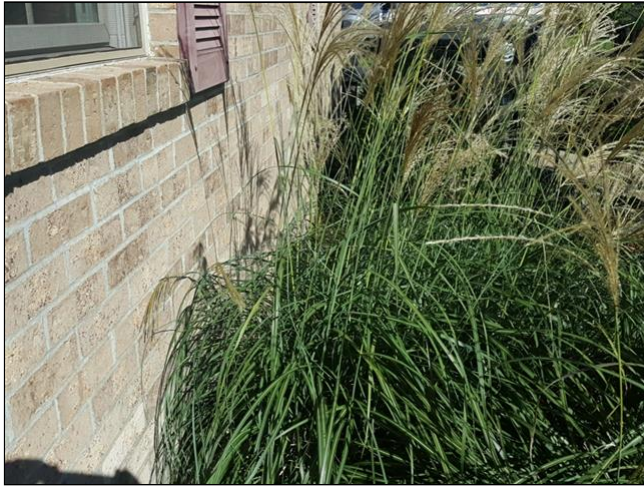
3.10 Item 3(Picture) front right side of home

(2) The vegetation is overgrown around the perimeter of the home where indicated in the photo(s). Recommend that all bushes, shrubs and trees where applicable be kept neatly trimmed and away from the foundation, wall siding, and window frames to prevent damage to the home and allow proper venting and inspection of house. A 6" clearance is recommended.

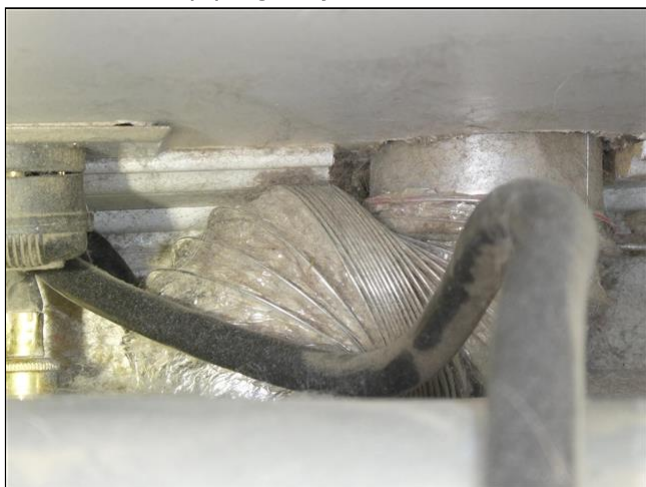
5.10 Item 5(Picture)

(2) The dryer vent piping is damaged and appears to have a minor leak due to large build up of lint behind the dryer in the Washer/Dryer room. This is allowing lint to be released in the air and is not healthy in closed rooms, crawlspaces or basements. Moist air escaping can lead to mildew or mold to develop on the walls. Recommend repair or replacement as needed. Ensure to use solid metal or flexible metal piping only.

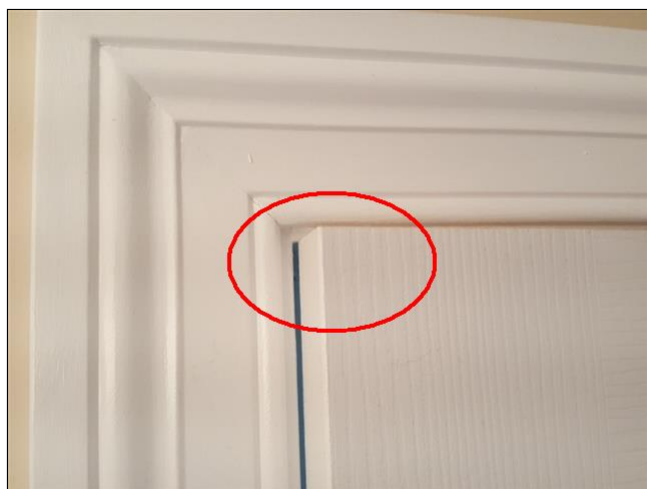
7.2 Item 1(Picture)

The entry door in the Master bathroom does close properly, however it rubs at the door jamb when closing where indicated in photos. This is a maintenance issue and is for your information. Sometimes correcting the door opening can require the door trim to be removed then touch up painting or doors will need to be rehung or trimmed down. Recommend a qualified contractor repair as needed.
