Kennedy Inspections
115 Gable Rd
Paoli PA 19301
610-833-8220
RossDKennedy@gmail.com

Report: 2102

Confidential Inspection Report

September 4, 2018

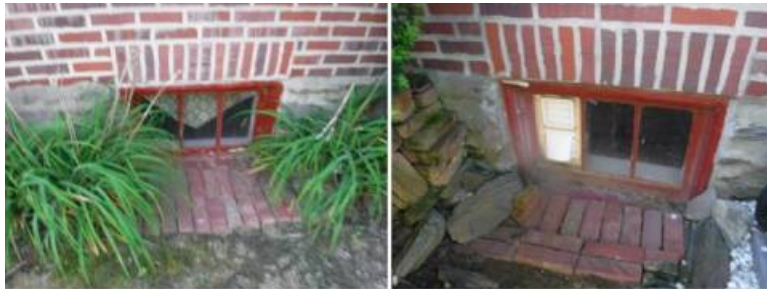
- Windows Wells:* Uncovered. Installing rain covers can improve drainage and protect foundation.

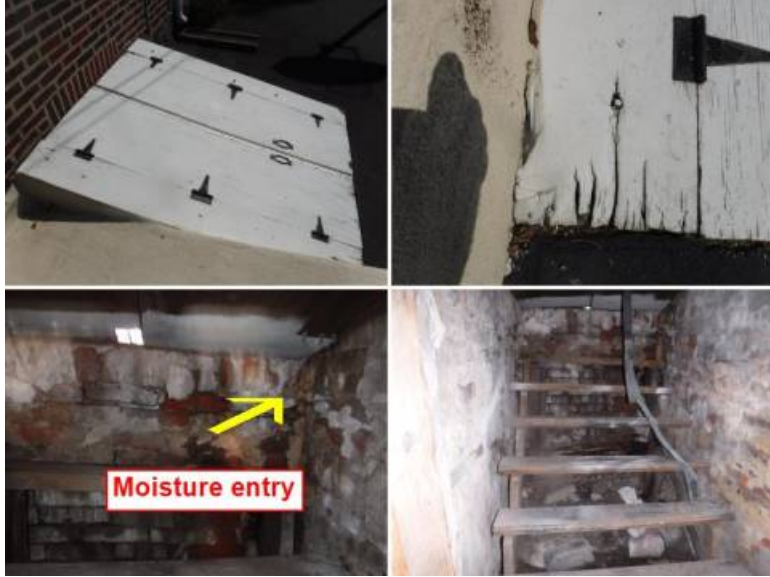
- Basement Stairs:* Wood bilco style basement doors. Wood is loose and rotted. Water penetration in the stairwell noted. Stairs are lopsided and suspect. Recommend repair or replacement by a qualified contractor.

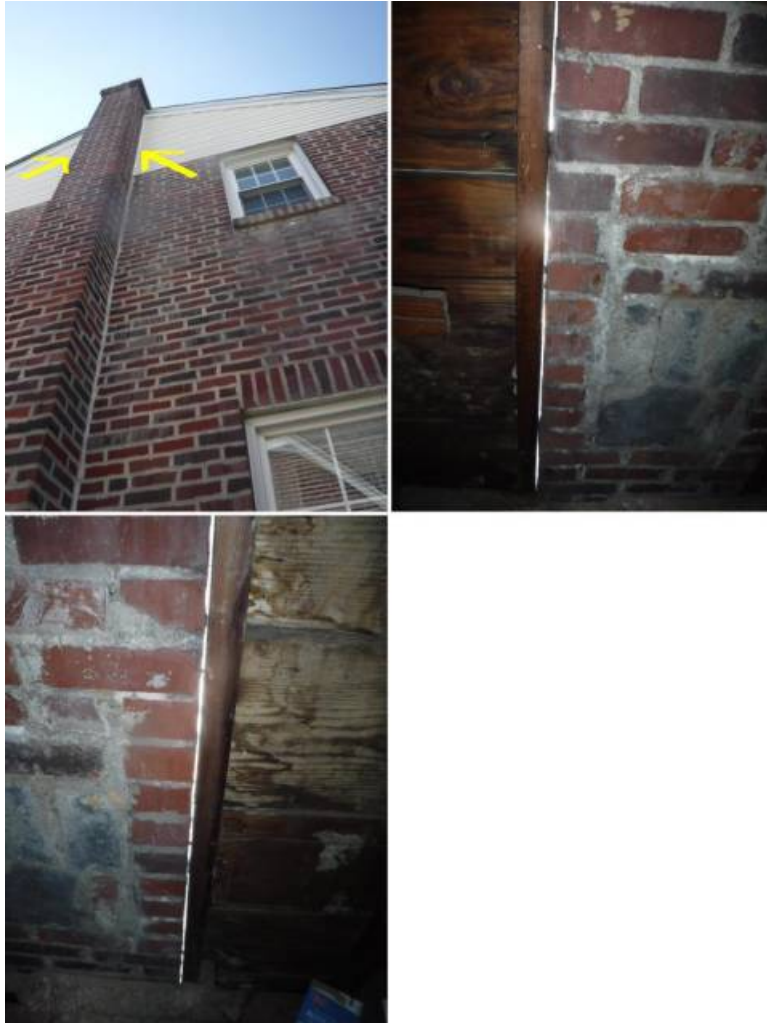
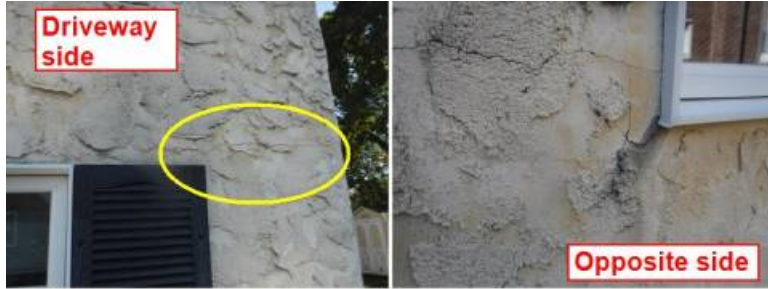
Stucco siding. Stucco requires annual maintenance to remain functional for preventing water entry into the structure. Damaged and/or missing caulk where stucco meets another material noted, such as trim and cladding. Cracks noted. Stains indicating water entry noted. Recommend full evaluation by qualified stucco inspector to determine the extent of the issues and for repair as needed by qualified stucco professionals.

- Vinyl siding. Gaps noted on both sides of the chimney (visible from the attic) where chimney connects with vinyl J channel. Recommend sealing or caulking to prevent moisture and insect entry.
- Brick.
- ⊙ Stucco siding. Stucco requires annual maintenance to remain functional for preventing water entry into the structure. Damaged and/or missing caulk where stucco meets another material noted, such as trim and cladding. Cracks noted. Stains indicating water entry noted. Recommend full evaluation by qualified stucco inspector to determine the extent of the issues and for repair as needed by qualified stucco professionals.

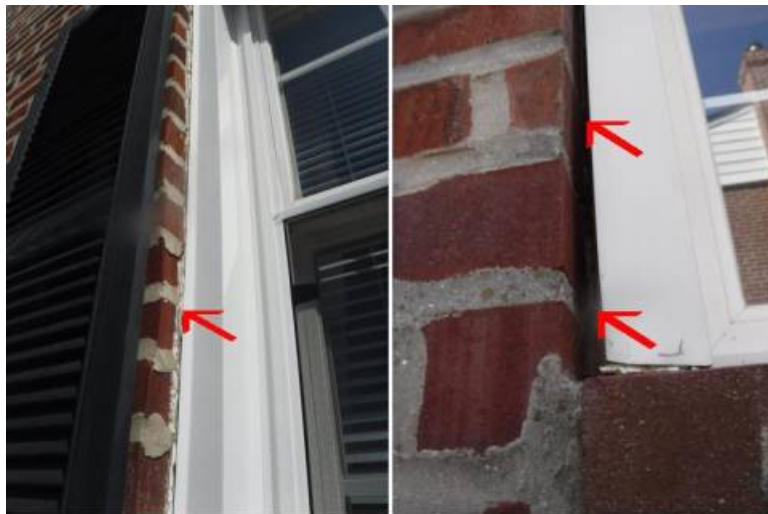
- Metal Cladding- metal cladding is a good way to prevent wood and structure damage from the elements. Maintain caulking at seams to prevent cladding from trapping moisture against wood surfaces. Caulk cracks visible at several windows. Recommend sealing all caulk seams with silicone caulk by a qualified painter or contractor to prevent moisture becoming trapped behind the metal cladding.

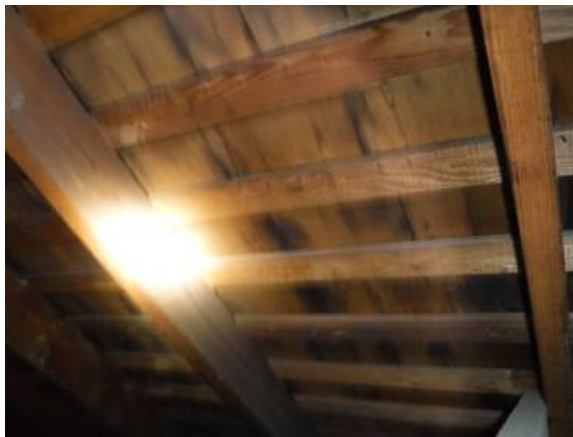
- Wood lathe boards and cedar shingles noted as sheathing, with asphalt composite roofing over. It was common to roof over existing cedar roofing with asphalt composite roofing in the day. In the future, recommend full roofing removal down to the lathe and installing plywood sheathing for improved support. Adequate modern ventilation is required when this is done. Address ventilation at that time to protect structure.

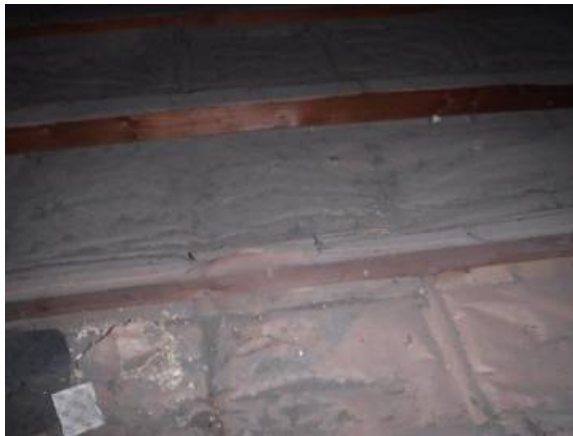
- 2-4 inches. Recommend adding insulation for increased efficiency. Modern R-30 insulation value = approximately 8 to 12 inches, depending on the material.

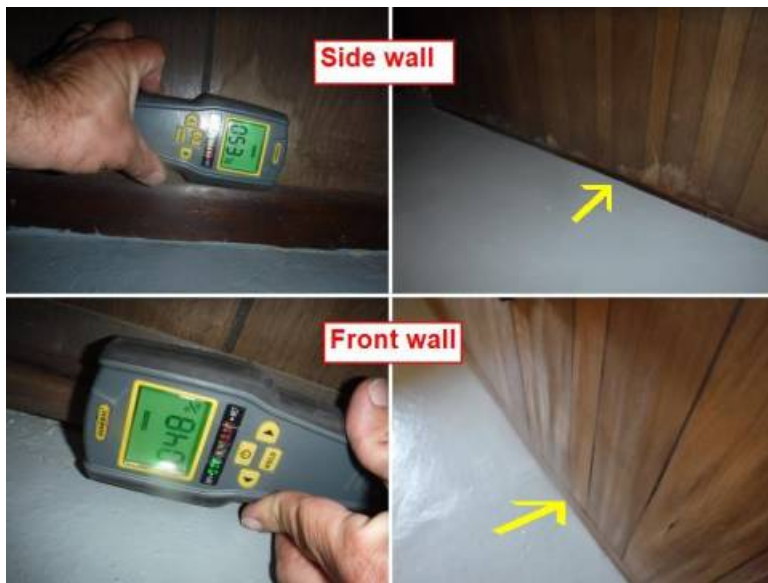
Paneling, Water stains noted at basement finished walls. Walls are actively wet at the base on the exterior side and front walls. Consult seller for more info on history. Consider contacting a water proofing contractor for moisture proofing the structure.

- Access:* Partially finished; Limited access to structure.
- Basement Stairs:* ○ Wood, Stairs are serviceable. Keep clear of trip hazards.
- Foundation Walls:* ○ Stone, Parging noted at foundation. Parging, sand based mortar coating on stone foundations, protects the stone and stone mortar and provides an added vapor barrier. This coating can be renewed by a mason to provide a clean surface and better moisture control.
- Interior Finished Walls* ○ Paneling, Water stains noted at basement finished walls. Walls are actively wet at the base on the exterior side and front walls. Consult seller for more info on history. Consider contacting a water proofing contractor for moisture proofing the structure.

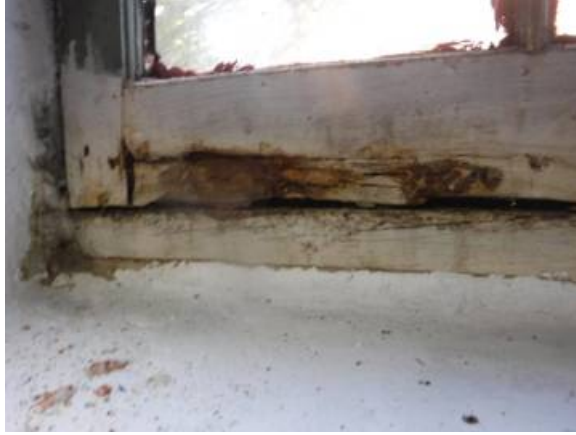
- Interior Finished Ceilings* ○ Acoustic tiles.
- Beams:* ○ Steel.
- Joists:* ○ Dimensional wood joists.
- Subfloor:* ○ Boards.
- Floor:* ○ Concrete floor.
- Windows:* ○ Wood. Typical of old basement windows, damaged wood noted. Recommend replacement.

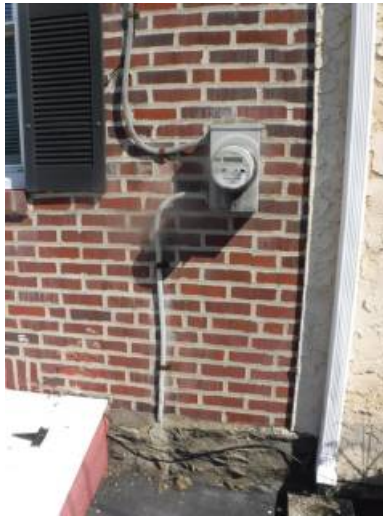
Grounding provided by connection to water supply pipe. Ground rod and associated wiring was not located. Recommend further evaluation to determine location and condition of ground rod and for repair/installation if needed by qualified electrician.

- ⊙ Grounding provided by connection to water supply pipe. Ground rod and associated wiring was not located. Recommend further evaluation to determine location and condition of ground rod and for repair/installation if needed by qualified electrician.

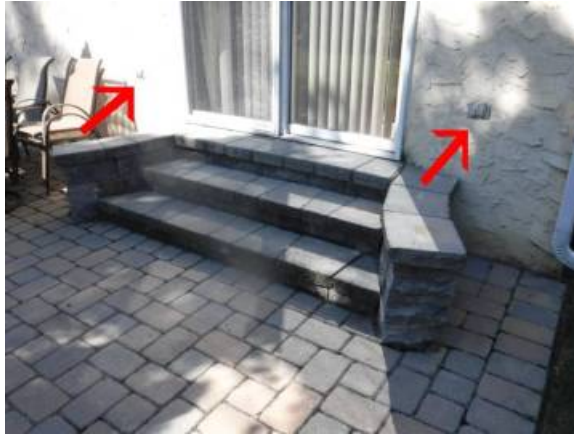
Ground Fault Circuit Interrupter (GFCI) protection is required at all exterior outlets. Recommend evaluation for installation or repair as needed by qualified electrician for safety. Outlets at both sides of the rear door require upgrade.

- ⊙ Ground Fault Circuit Interrupter (GFCI) protection is required at all exterior outlets. Recommend evaluation for installation or repair as needed by qualified electrician for safety. Outlets at both sides of the rear door require upgrade.

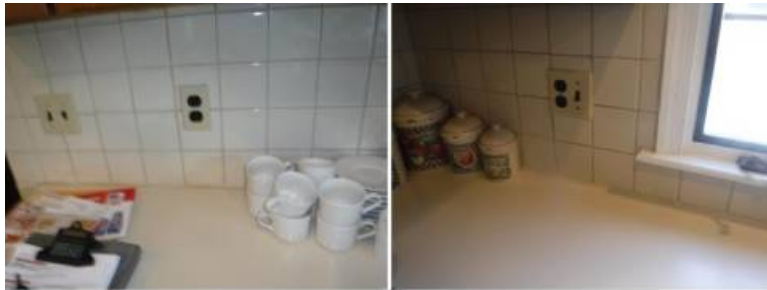
Missing GFCI protection noted at kitchen at all countertop outlets.. Ground Fault Circuit Interrupter (GFCI) protection is required at all outlets above kitchen counters and outlets for use related to kitchen counters. Recommend evaluation for installation or repair as needed by qualified electrician for safety.

- ⊙ Missing GFCI protection noted at kitchen at all countertop outlets.. Ground Fault Circuit Interrupter (GFCI) protection is required at all outlets above kitchen counters and outlets for use related to kitchen counters. Recommend evaluation for installation or repair as needed by qualified electrician for safety.

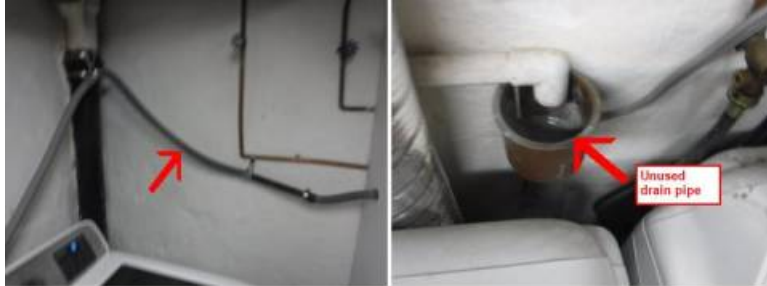
- Hot and cold supplies noted for washing machine. Using high pressure braided steel supply hoses is recommended. Down pipe for drain was bypassed and a long flexible drain connection was extend through the bathroom wall, cabinetry and to the laundry sink in the basement bath. Consult with seller as to why the downpipe drain was not utilized as intended. (the pipe is currently being used for the AC condensation drain and appears to be functioning normally).

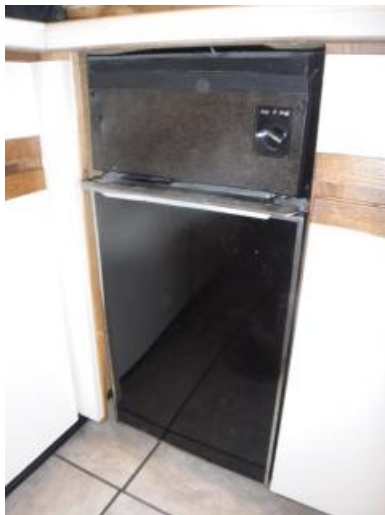
- Trash compactor appears inoperative. Standard bag noted instead of compactor liner. Consult seller for more info.

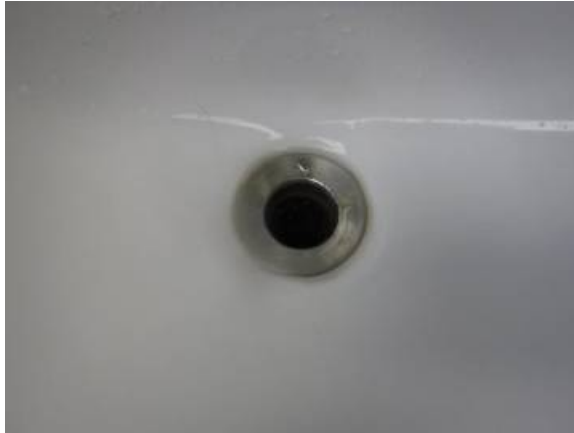
- Bathroom sinks and faucets were tested and found functional. Sink stopper inoperative at 2nd floor hall bath. Repair as needed for proper operation.

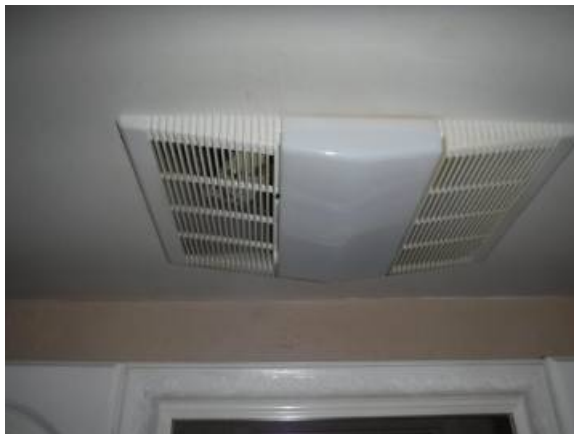
- Openable window for ventilation noted. Bathroom exhaust fan noted for ventilation. When tested, bathroom fan at basement bath did not function. Recommend repair or replacement as needed for proper operation.

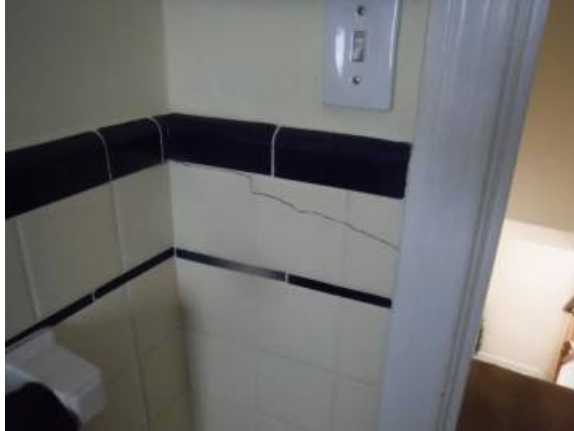
- Tile. Cracked tiles noted at left of door. This condition is most likely related to comments below concerning the floor deflection in the 2nd floor hallway. See below.

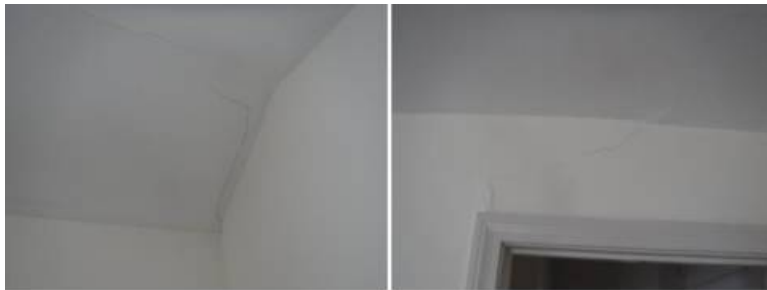
Plaster. Cracking noted above doors and at the wall corners in both front and rear bedrooms as a result of stress from the floor deflection in the 2nd floor hallway.

- Plaster. Cracking noted above doors and at the wall corners in both front and rear bedrooms as a result of stress from the floor deflection in the 2nd floor hallway.

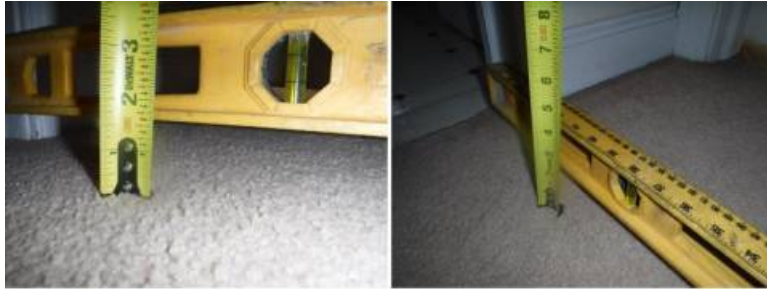
Significant deflection (sagging) noted at 2nd floor hall. Acceptable deflection at this location is approximately $>1/2$ " at the center sag line. Current deflection is $1\ 5/8$ inches. (see supplemental comments below in Wall, Ceilings, and Doors for additional evidence of structural concern related to this floor sag). Recommend complete analysis by a qualified structural engineer or invasive inspection by a qualified building contractor.

- Wood flooring, Carpet, Ceramic tile flooring.
- Significant deflection (sagging) noted at 2nd floor hall. Acceptable deflection at this location is approximately $>1/2$ " at the center sag line. Current deflection is $1\ 5/8$ inches. (see supplemental comments below in Wall, Ceilings, and Doors for additional evidence of structural concern related to this floor sag). Recommend complete analysis by a qualified structural engineer or invasive inspection by a qualified building contractor.

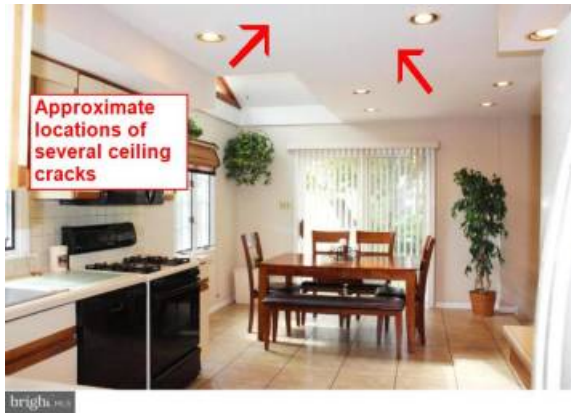
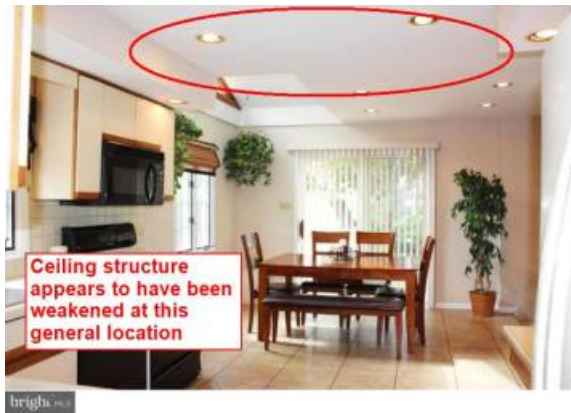
Plaster. Drywall. Cracking noted in kitchen ceiling below previous mentioned floor sag in the 2nd floor hallway and bathroom. A combination of factors may be contributing to the cracked ceiling and sagging floor including possible improper removal of support walls, beams, or columns where needed when the garage was converted to interior space, the addition of a cathedral ceiling in the dining area, and the weight of a bath tub and heavy tiling in the 2nd floor bathroom.

- ⊙ Plaster. Drywall. Cracking noted in kitchen ceiling below previously mentioned floor sag in the 2nd floor hallway and bathroom. A combination of factors may be contributing to the cracked ceiling and sagging floor including possible improper removal of support walls, beams, or columns where needed when the garage was converted to interior space, the addition of a cathedral ceiling in the dining area, and the weight of a bath tub and heavy tiling in the 2nd floor bathroom.

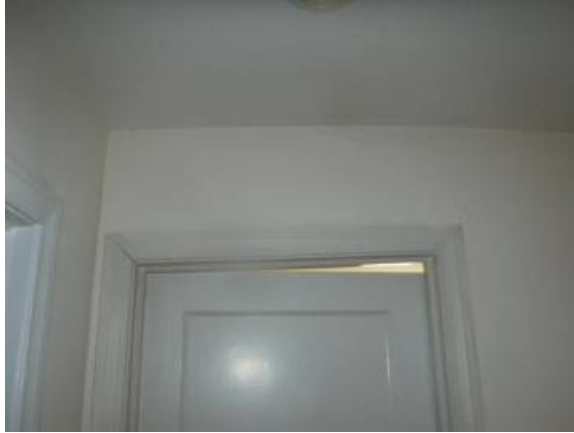
Wood. Large gap noted in 2nd floor bedroom doors as a result of a shifting frame due to floor deflection in the 2nd floor hallway. Door will not adequately close unless flooring and frame is reset by a qualified contractor.

- ⊙ Wood. Large gap noted in 2nd floor bedroom doors as a result of a shifting frame due to floor deflection in the 2nd floor hallway. Door will not adequately close unless flooring and frame is reset by a qualified contractor.
