CONEJOS RIVER

DIVERSION INFRASTRUCTURE INVENTORY

Structure Name: SERVIETTA D

Date: April 14, 2019 12.55

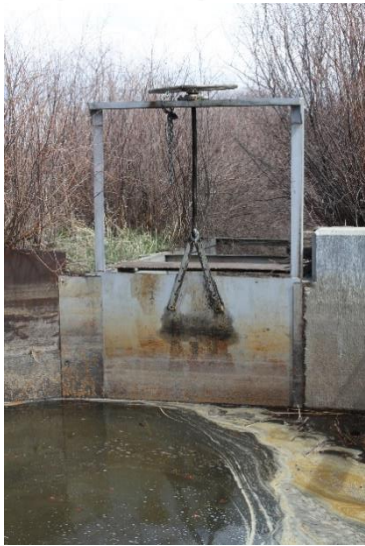
Headgate looking downstream

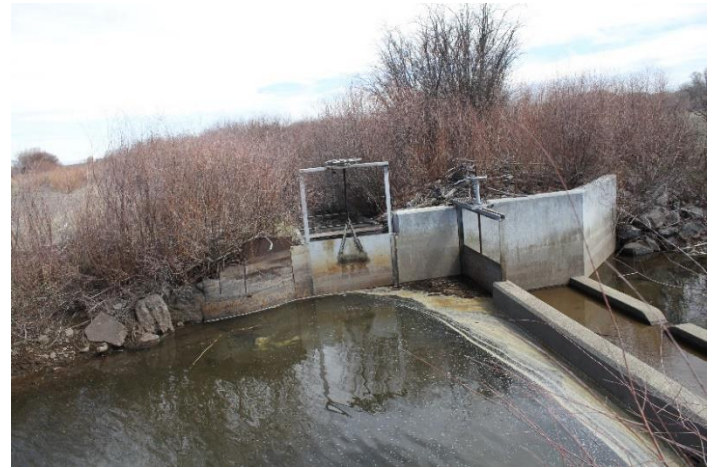
Headgate and diversion dam

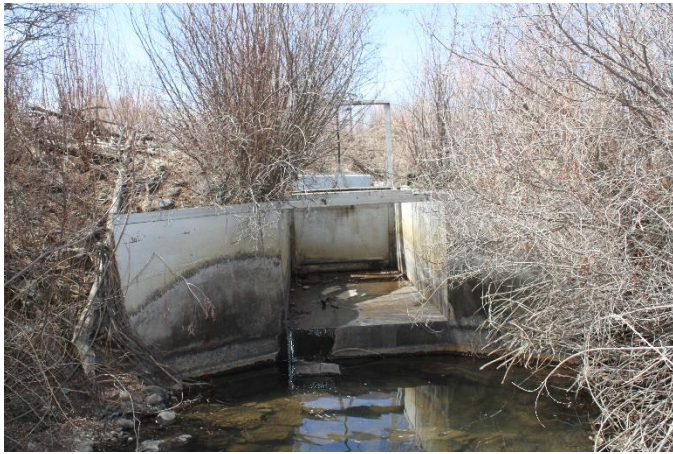
Headgate outlet

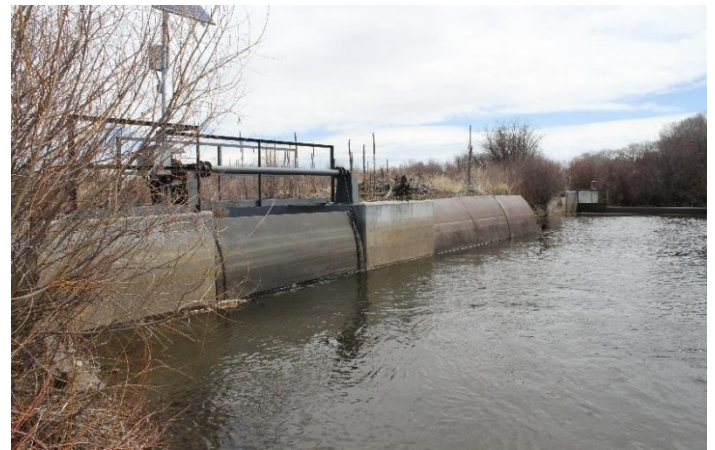
Diversion Dam

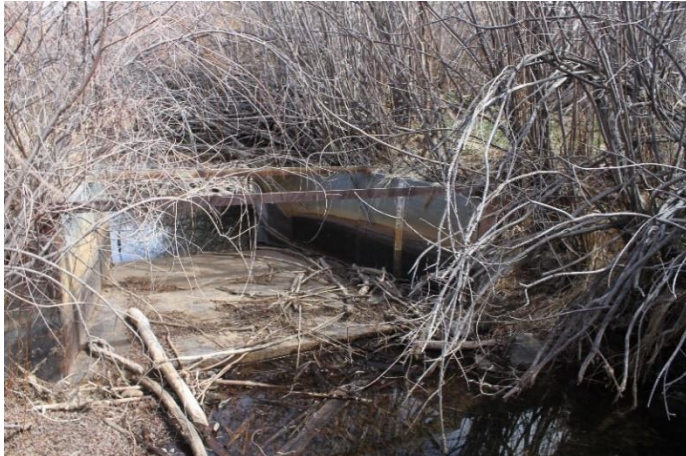
Flume looking downstream

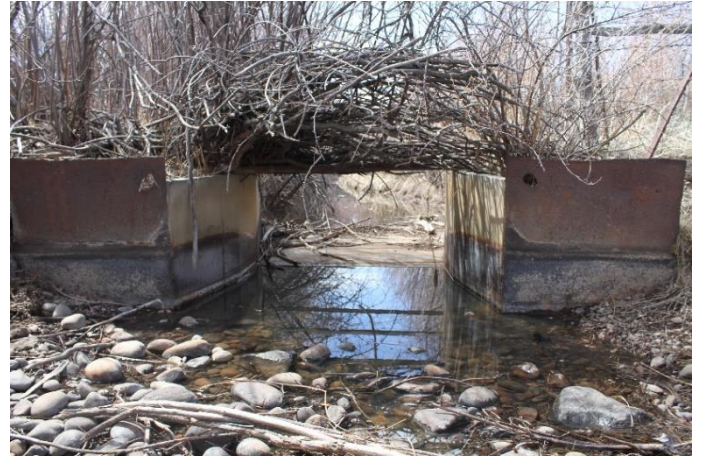
Flume looking upstream
