| SAFETY ALERT | |
| Aircraft Safety Alert # | AASA-01-3-2010 |
| Make & Model Affected | Lightning LS-1 SLSA & ELSA |

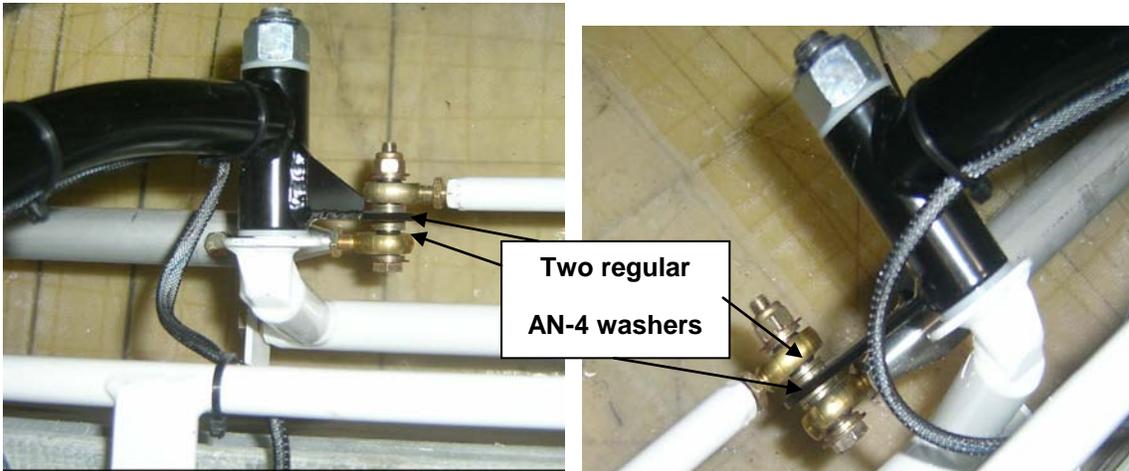
Attached are 2 photos. These pictures are taken of the lower control sticks output arms. Specifically, the photos are of the joint where the rod-end bearings from the long aileron pushrods and the mixer rod between the two sticks attach to each stick. We have noticed that in some aircraft the geometry of the lower stick attach location for the push rods will cause the rod-end bearings themselves to bind and not swivel when at full travel. This does not affect controllability of the aircraft, but will cause the push pull tubes to rotate instead of the rod-end bearing. This then may cause the jam nut to back off. The jam-nut loosening and backing off is the issue, not any type of control system lock up or binding.

This potential situation is most apparent in the full aft stick (or full up elevator) position of the stick. The rod-ends themselves are designed to swivel about 12 degrees, but with them bolted to the output arm directly, and with large area washers right next to them to hold the assembly together should the bearing itself fail, this limits the rod-end to only being able to swivel a few degrees. Thus the push pull rod will then turn and possibly loosen the jam nut.

Note that there are two regular AN-4 washers on the inside of the rod end bearings next to the stick lower push pull tube attach point. Then on the outsides of the rod end bearings, there is one regular AN-4 washer and one large area washer.

To remedy the issue it will be necessary to use a longer bolt, AN4-16A, to accommodate the two push pull rod end bearings and the washer arrangement shown in the photos. By adding 2 AN960-4 washers (AN4 standard washers) between the rod-end and the output arm, the ball is allowed to move its full range. Also you must always use a washer larger enough to capture the rod-end in the event of a bearing race failure (as mentioned above), so in this case also use a washer between the large area and the rod-end to allow the ball full range on the other side. Note that the front pushrod is attached in the same fashion.

- a. Remove the AN4 bolt that is currently installed using 7/16" wrenches. Make note that the pushrods are connected to the lower hole in the output arm.
- b. Install the AN4-16a and associated hardware in the following order; AN4-16A bolt, AN970-4 washer, AN960-4 washer, push rod end, 2 of AN960-4 washers, stick output arm, 2 of AN960-4 washer, stick mixer rod, 1 AN960-4 washer, 1 AN970-4 washer, AN365-428 elastic stop nut.
- c. Complete for opposite stick assembly.
